Reference: Glen Road Inspection and Monitoring Program

Further to our proposal of 02 July 2018 a walk through inspection of the storm sewer pipe which conveys Chedoke Creek underneath Main Street, King Street and Tope Crescent. The inspection included the following components:

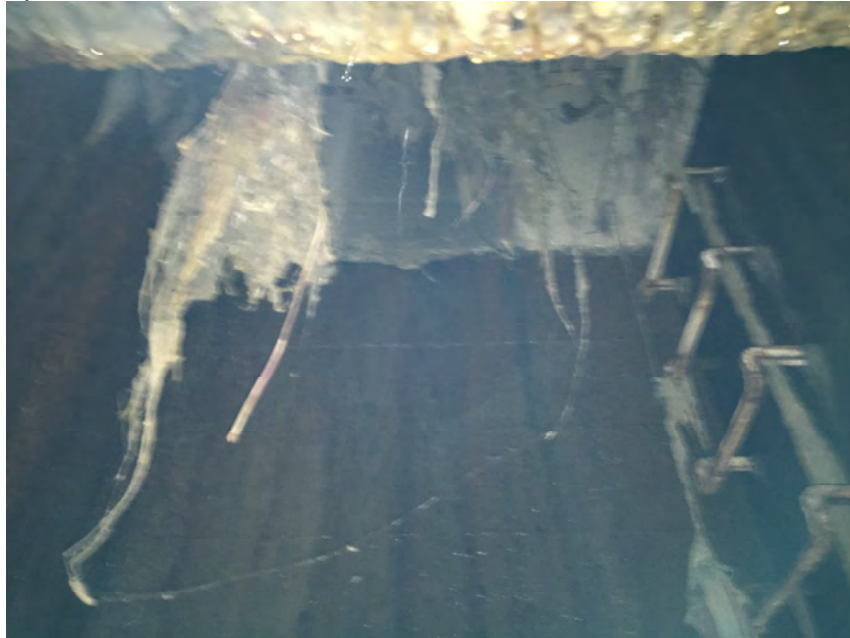
3. Manhole (HE09B118) - Glen Road Overflow: 31.4m from the North End

The overflow occurs at a manhole located on the west side of the pipe. The inlet pipe is approximately 4 meters above the invert of the Creek. There is significant sewer debris on the manhole steps and safety grate. Some of the manhole steps are missing and the safety grates look to be severely corroded and may not open. Maintenance work is recommended.

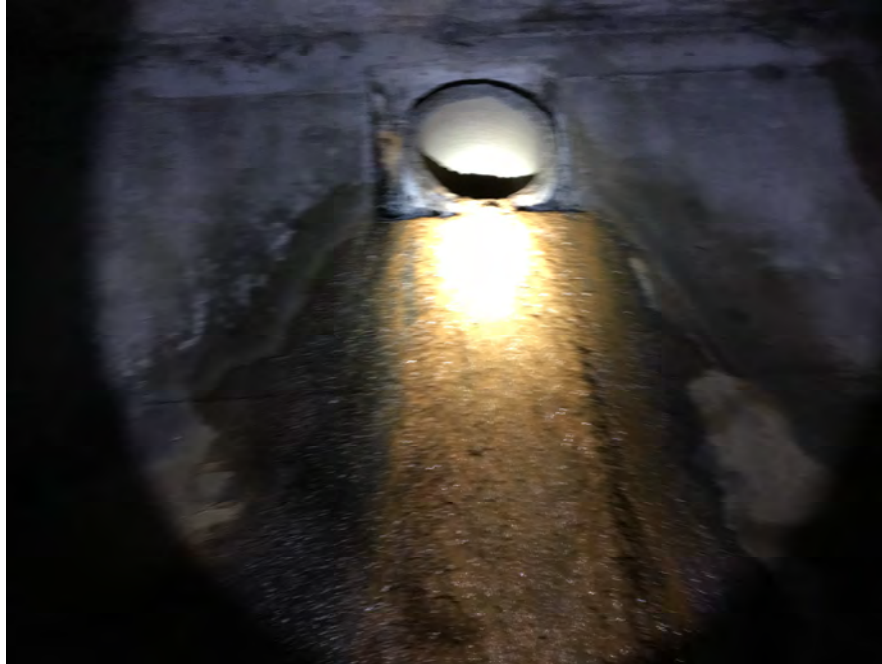
4. Storm Sewer: 97.3m from the North End
Flow: 0.2 lps . Clear Water
Sample: Yes . Bottle Set 3
The pipe is a 300mm diameter storm sewer entering the sewer at the pipe obvert.

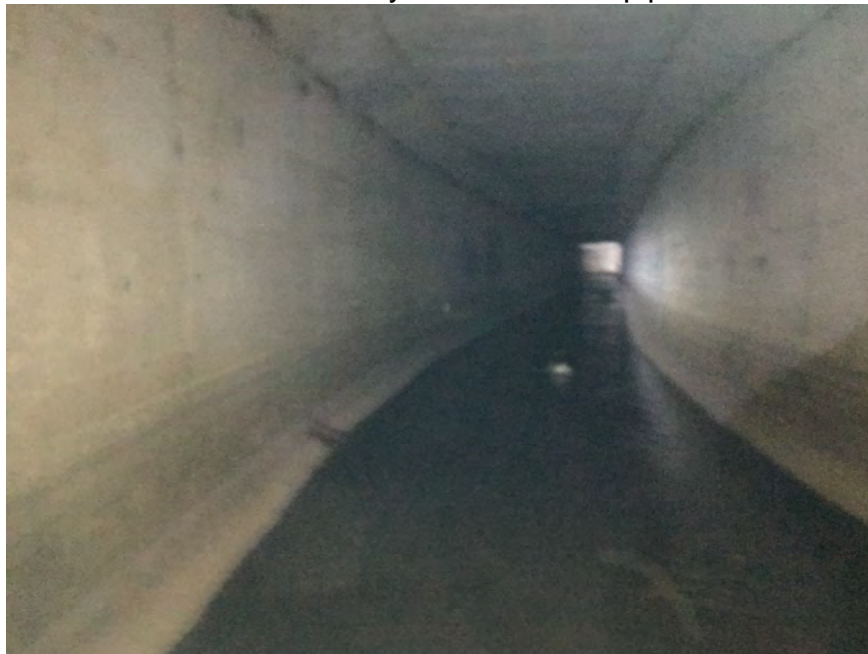
5. Chedoke Creek: 194m from the North End
Flow: 100 lps . Clear Water
Sample: Yes . Bottle Set 4
The location is at a doorway between the 2 pipes.

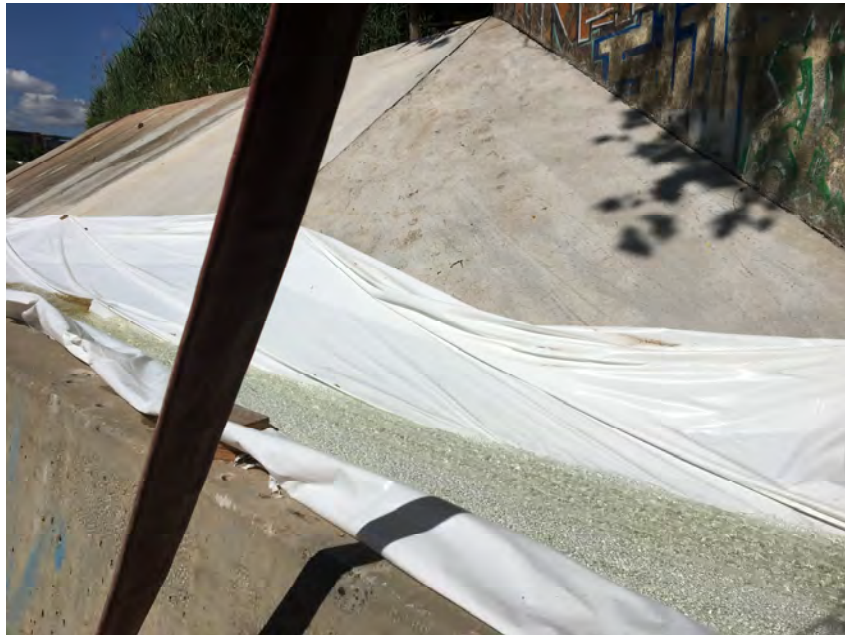
6. Chedoke Creek: Inlet (South End) 364m from the North End
Flow: 100 lps . Clear Water
Sample: Yes . Bottle Set 5
Sample collected from the invert of a plastic lined diversion channel constructed by the contractor which is undertaking work on the channel.

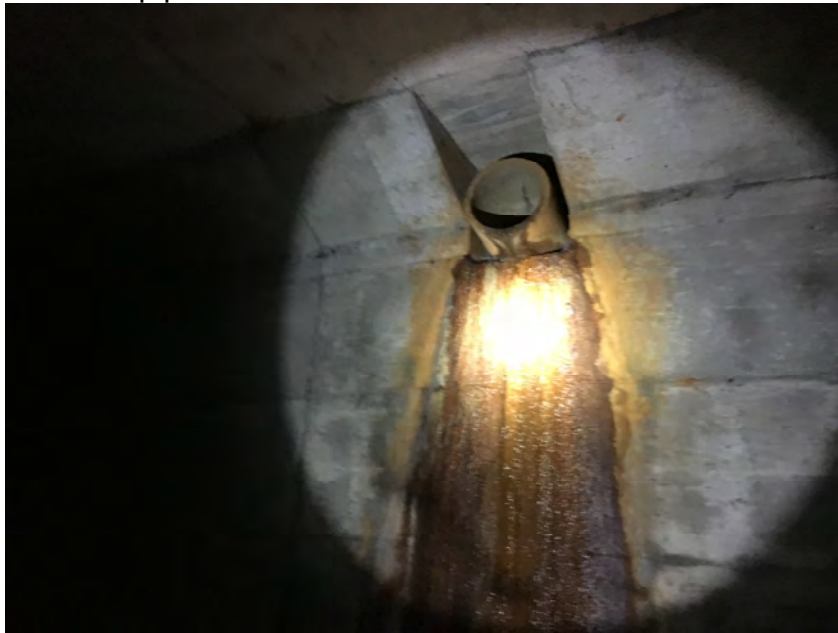
7. Storm Sewer: 134m from the South End
Flow: No Flow
Sample: No Sample Taken
The pipe is a 300mm diameter storm sewer entering at the pipe obvert on the East side of the pipe.

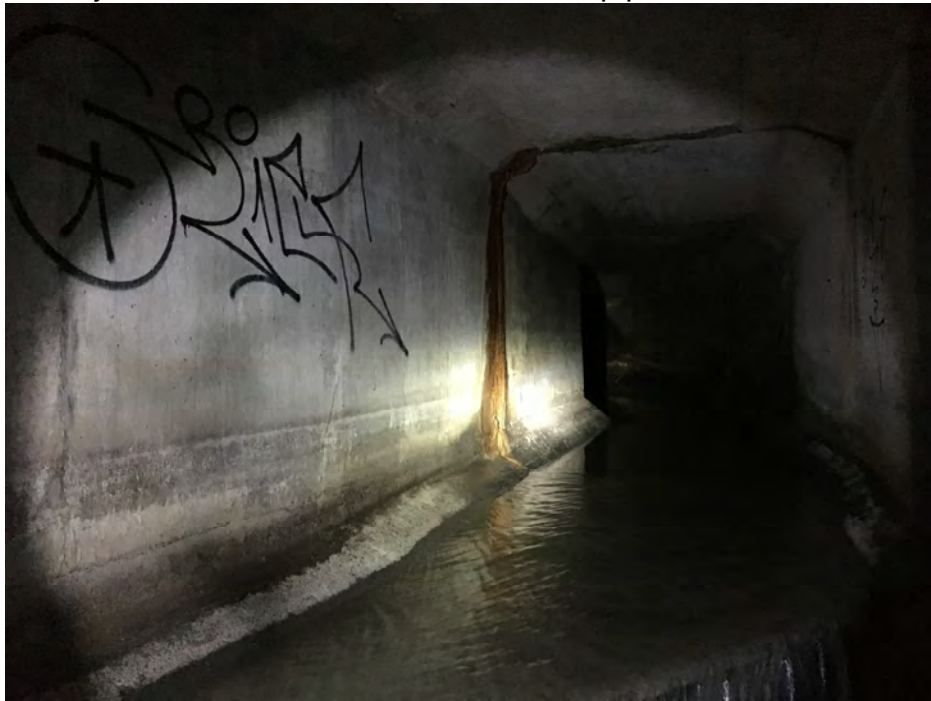
9. Main King Diversion: 245m from the South End
Flow: 30 lps
Sample: Yes . Bottle Sets 6 and 9 (duplicate taken)
The pipe is a 1.8m X 1.8m box. The water is cloudy with a sewage smell. There is no visible paper product in the flow or on the pipe walls. The pipe is approximately 0.6 m above the invert of the east pipe.

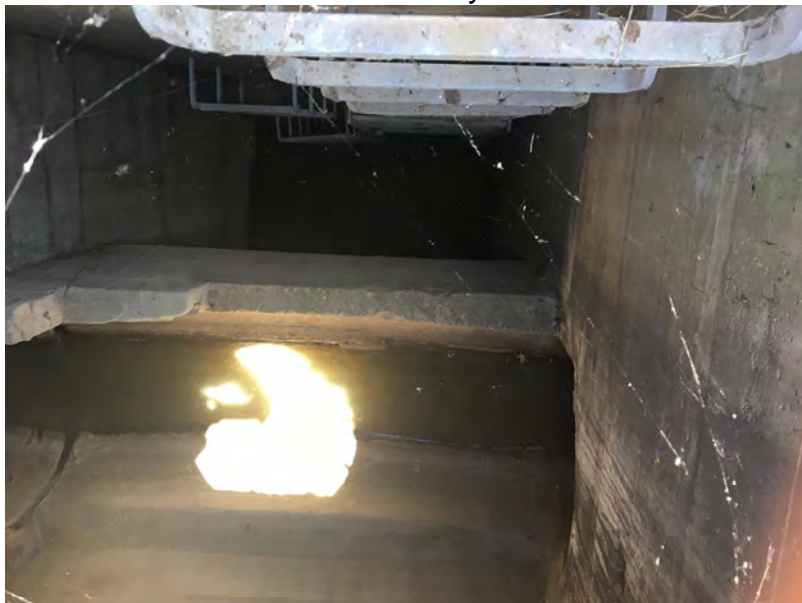
10. Manhole (HE09T003 and HE09E048) . 248m From the South End
Flow: N/A
Sample: N/A
There is an overflow in this manhole from the sanitary sewer on Tope Crescent. There is some sanitary debris on the manhole steps.

Manholes HE09B058 and HE09B059 do not exist. Manholes HE09T003 and HE09E048 are the same manhole.

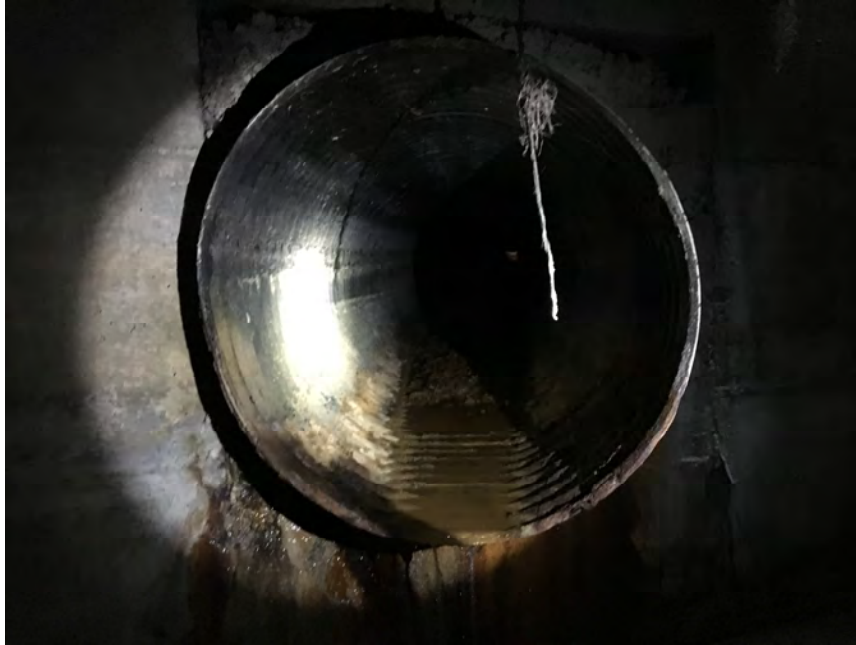
11. Storm Sewer . 251m From the South End
Flow: <0.1lps
Sample: Yes . Bottle Set 11
The pipe is a 900mm CSP with some corrosion on the invert. The water is clear with no indication of sanitary influence.

The CSP pipes identified during the inspection are not shown on the GIS mapping.

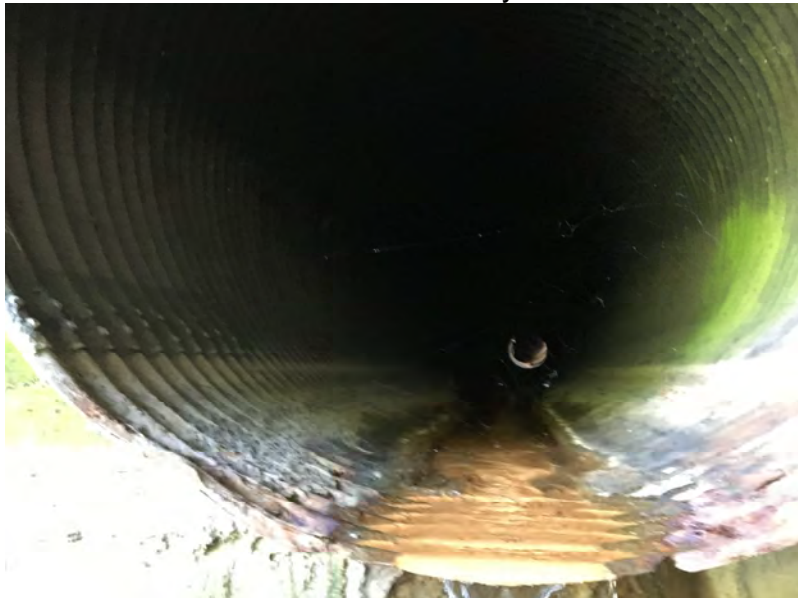
13. Storm Sewer . 367m From the South End
Flow: <0.1
Sample: Yes . Bottle Set 10
The pipe is a 1500mm CSP with some corrosion on the invert. The water is clear with no indication of sanitary influence.
