TO:	Mayor and Members City Council
DATE:	December 6, 2022
SUBJECT:	City Hall Pedestrian Access Walkway (Wishbone Structure) Repairs Communication Update (Ward 2) (EFFM22-02)
WARD(S) AFFECTED:	Ward 2
SUBMITTED BY:	Craig Murdoch Acting Director, Energy Fleet & Facilities Maintenance Public Works Department
SIGNATURE:

November 23rd 2022

**RE: Structural review of Existing Concrete Entrance Structure at the rear of the Building Located at 71 Main St. W, Hamilton, ON
Our Project No. 2022-JPS-101**

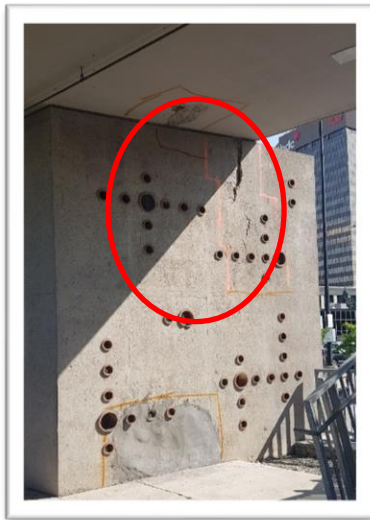
Figure 1: Partly Damaged Column and Slab

- The portion of the structural elements and areas identified in the attached drawings need to be repaired immediately as they may lead to a catastrophic structural damage and also are safety hazards.
- Barricades and adequate caution signage should be provided and not removed until concrete repairs identified in the drawings are undertaken.
- The deteriorated slab soffits are an immediate safety hazard and tenant/pedestrian access should be prohibited until repairs are completed.
- To prevent any catastrophic structural failures and to prevent injuries, it is our recommendation that concrete repairs should begin immediately in conjunction with the application of permit to perform the concrete repairs.

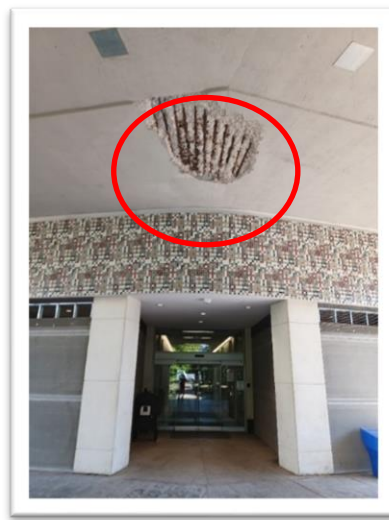
Figure 2: Spalled Concrete
