COMMUNICATION UPDATE

TO:	Mayor and Members City Council
DATE:	February 1, 2024
SUBJECT:	Longwood Road Bridge (Bridge 282) Upcoming Reconstruction (ENG24001) (City Wide)
WARD(S) AFFECTED:	City Wide
SUBMITTED BY:	Jackie Kennedy Director, Engineering Services Public Works Department
SIGNATURE:

Appendix "A" to Communication Update ENG24001: BRIDGE 282_2020_OSIM

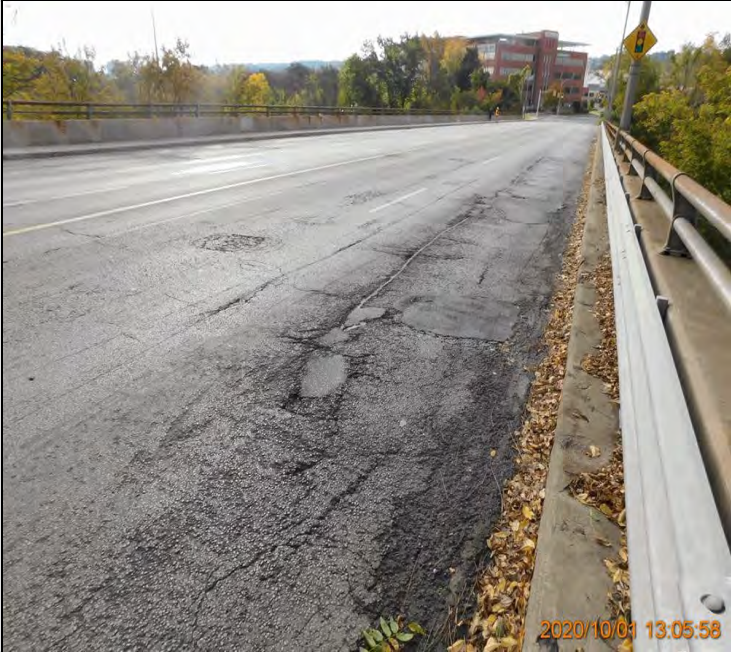
Description Bridge Deck From Northwest Corner. Note: Large asphalt patches and m-s pattern cracks.		
	Elem Grp/Class Elem Type Sub Element Material Type Locator Defect Descript1 Defect Descript2 Defect Other	Decks/Wearing surface Asphalt General Poor condition Cracks	
File Name	06 Bridge Deck From Northwest Corner.JPG

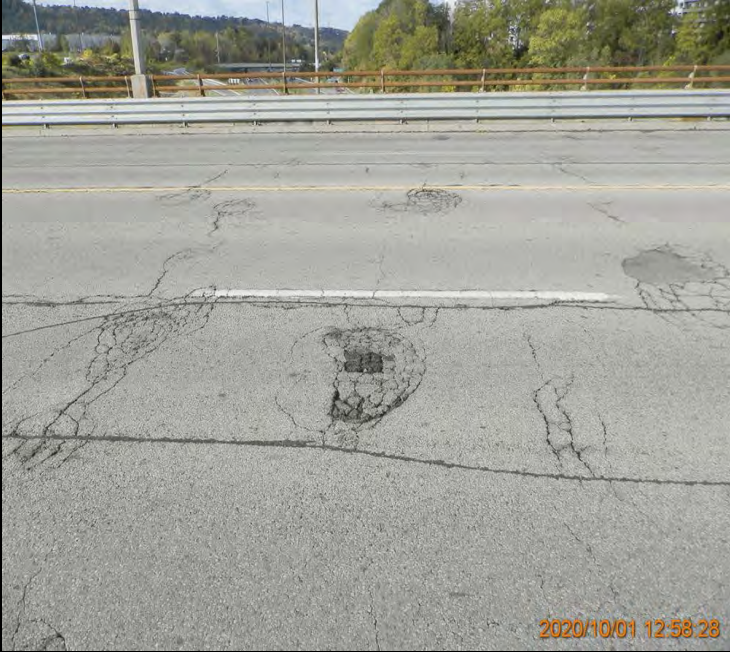
Description		
	M-S Pattern Cracks on Deck Wearing Surface @ Pier P3, Looking W		
	Elem Grp/Class Elem Type Sub Element Material Type Locator Defect Descript1 Defect Descript2 Defect Other	Decks/Wearing surface Asphalt General Poor condition Cracks	
File Name	07 M-S Pattern Cracks on Deck Wearing Surface @ Pier P3, Looking W.JPG

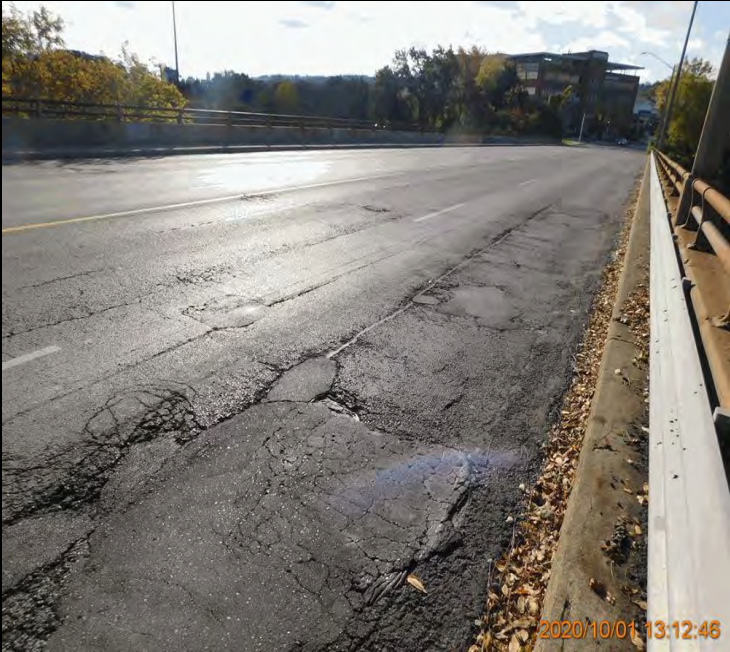
Description		
	Asphalt Patches, M-S Pattern Cracks & Longit Cracks in SBL (TYP)		
	Elem Grp/Class Elem Type Sub Element Material Type Locator Defect Descript1 Defect Descript2 Defect Other	Decks/Wearing surface Asphalt Typical Poor condition Cracks	
File Name	08 Asphalt Patches, M-S Pattern Cracks & Longit Cracks in SBL (TYP).JPG

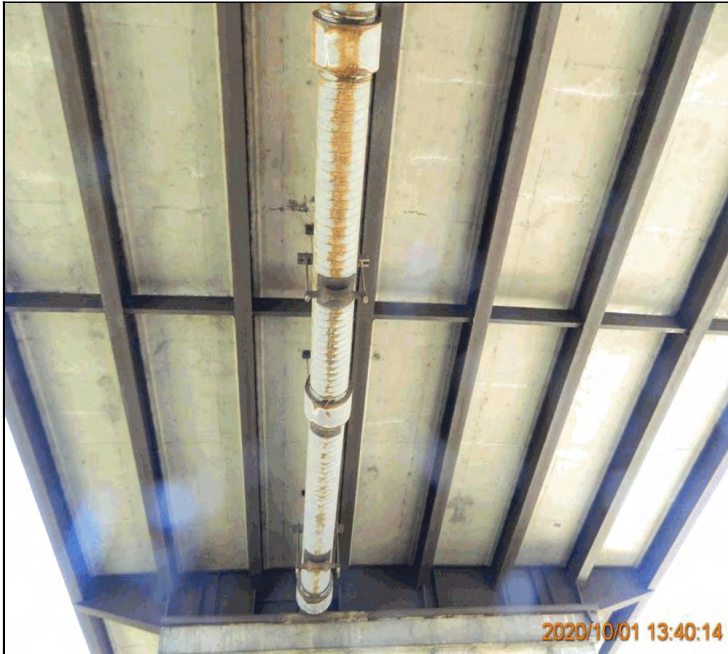
Description Interior Soffit at Pier 3, Looking North. Note: N-M efflorescence stained transverse cracks.	
Elem Grp/Class	Decks/Soffit - Thin Slab
Elem Type	
Sub Element	Interior
Material Type	Cast-in-place concrete
Locator	General
Defect Descript1	Poor condition
Defect Descript2	
Defect	Cracks
Other

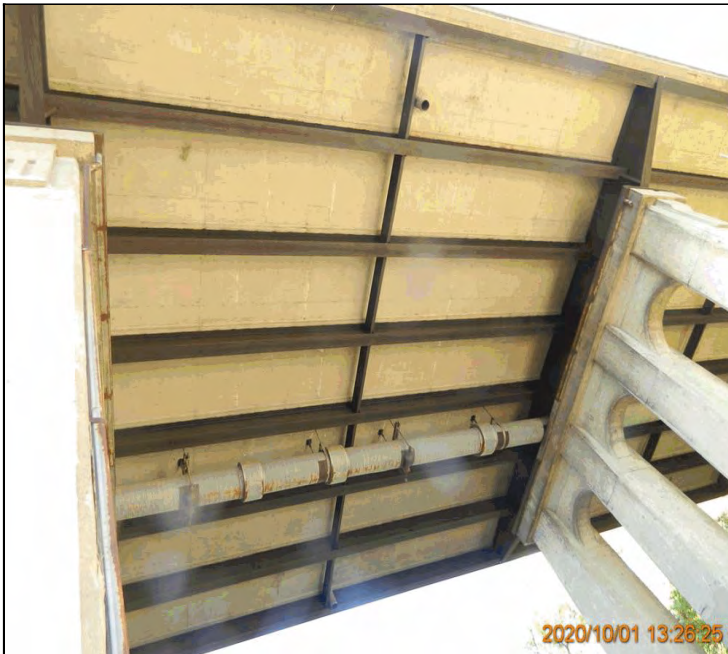
Description Interior Soffit and Girders at Pier 4 (Span 5), Looking West. Note: N-M transverse cracks.	
Elem Grp/Class	Decks/Soffit - Thin Slab
Elem Type	
Sub Element	Interior
Material Type	Cast-in-place concrete
Locator	General
Defect Descript1	Poor condition
Defect Descript2	
Defect	Cracks
Other

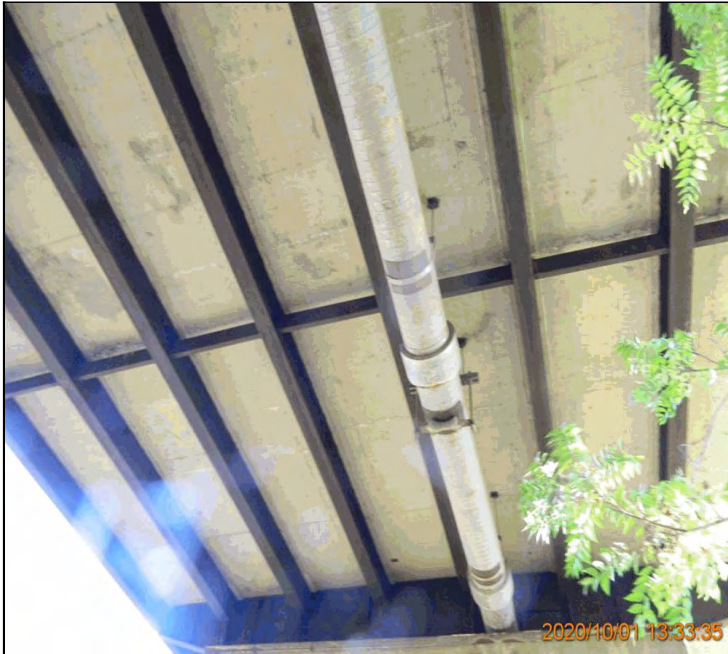
Description
Interior Soffit and Girders at Pier 6, Looking South.
Note: Local wet areas and N-M stained cracks.

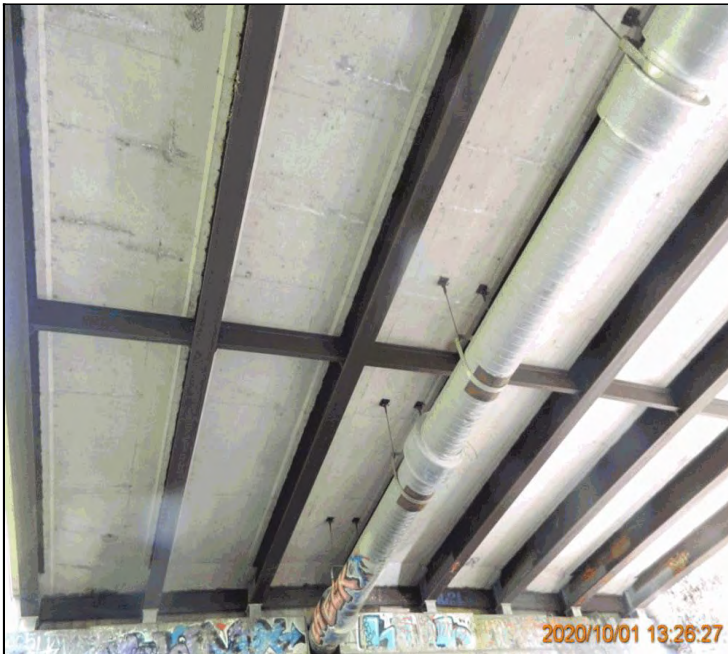
Description
Interior Soffit and Girders at Pier 7, Looking North.
Note: N-M stained cracks on soffit.

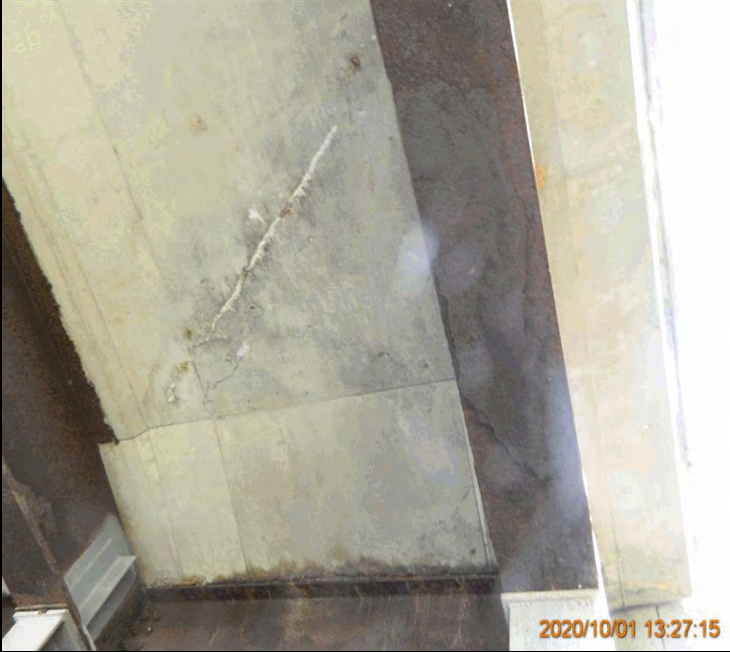
<p>Description N-M Wet Stained Diagonal Crack @ SW Corner of Soffit</p>

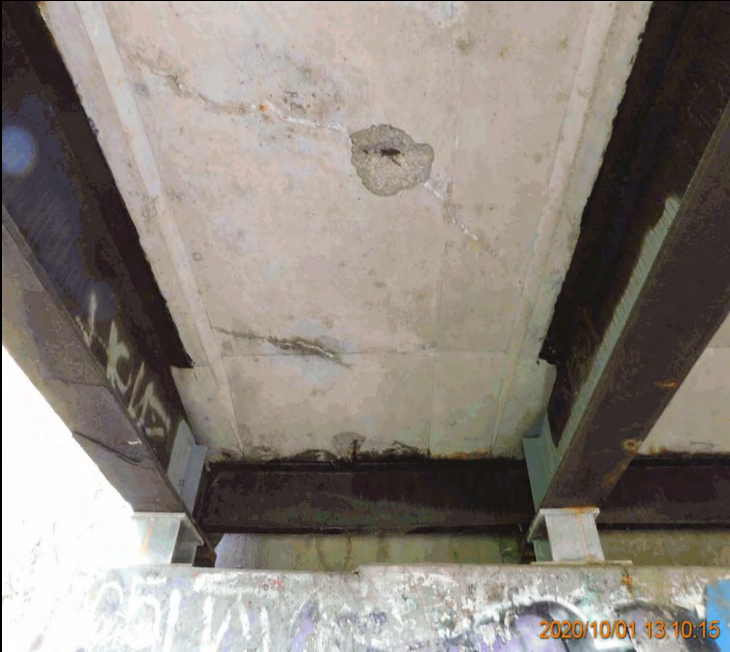
<p>Description Light Spall & N-M Stain Crack @ NW Corner of Soffit in Span 7</p>

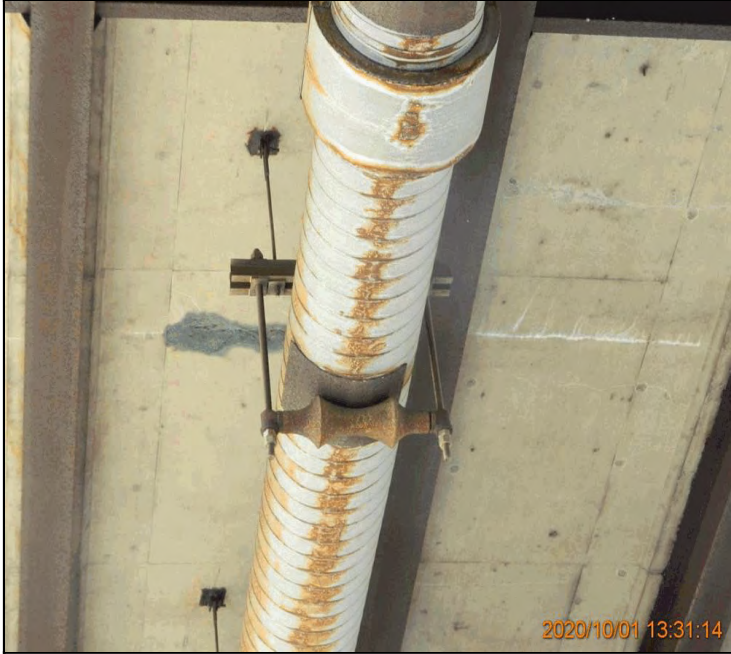
Description Severe Spall @ Central NW Section in Span 2 over Hwy 403EB	
Elem Grp/Class	Decks/Soffit - Thin Slab
Elem Type	Interior
Sub Element	Interior
Material Type	Cast-in-place concrete
Locator	
Defect Descript1	Poor condition
Defect Descript2	
Defect	Spalling
Other

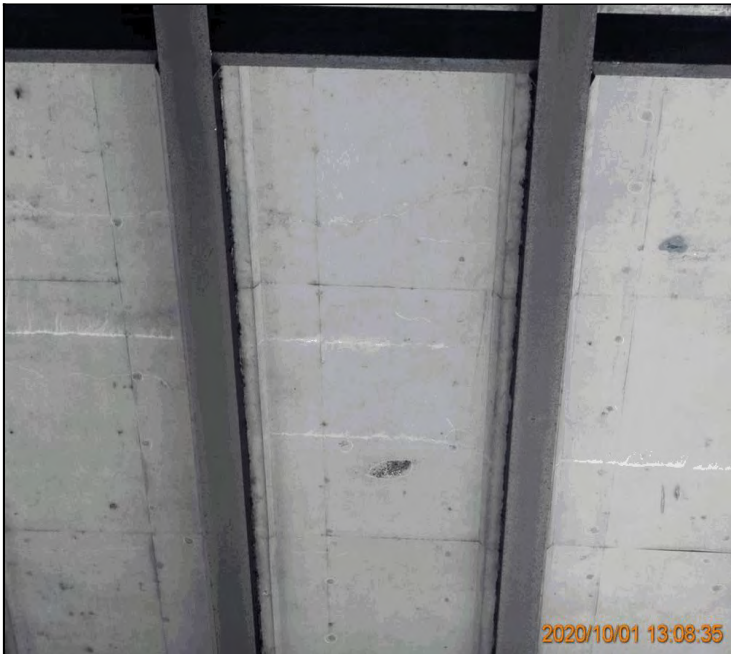
Description N-M Efflorescence Stained Transverse Cracks in Span 2 (TYP)	
Elem Grp/Class	Decks/Soffit - Thin Slab
Elem Type	Interior
Sub Element	Interior
Material Type	Cast-in-place concrete
Locator	Typical
Defect Descript1	Poor condition
Defect Descript2	Transverse
Defect	Cracks
Other

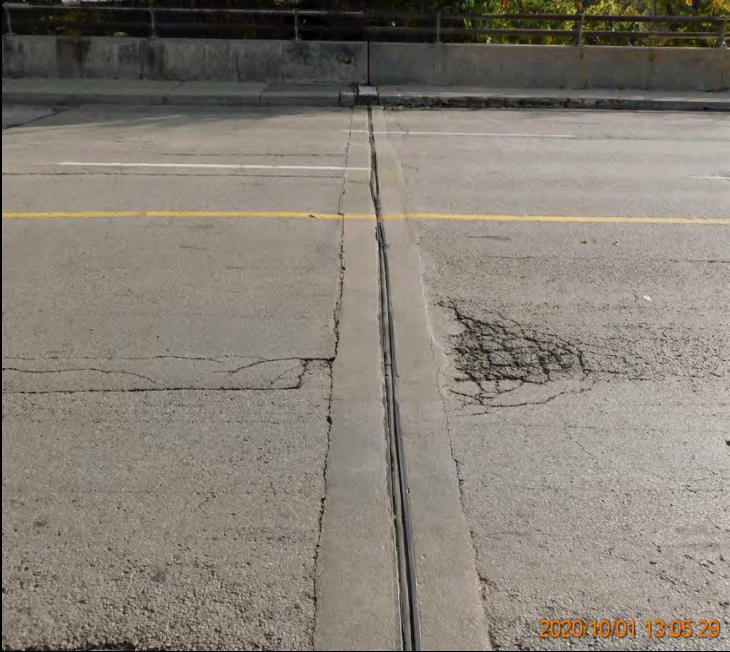
Description		
	North Expansion Joint, Looking East. Note: Dents in steel armoring.		
	Elem Grp/Class	Joints/Armoring/retaining device	
	Elem Type		
	Sub Element		
	Material Type	Steel	
	Locator		
	Defect Descript1	Poor condition	
	Defect Descript2		
	Defect	Damaged	
	Other		
File Name	29 North Expansion Joint, Looking East.JPG

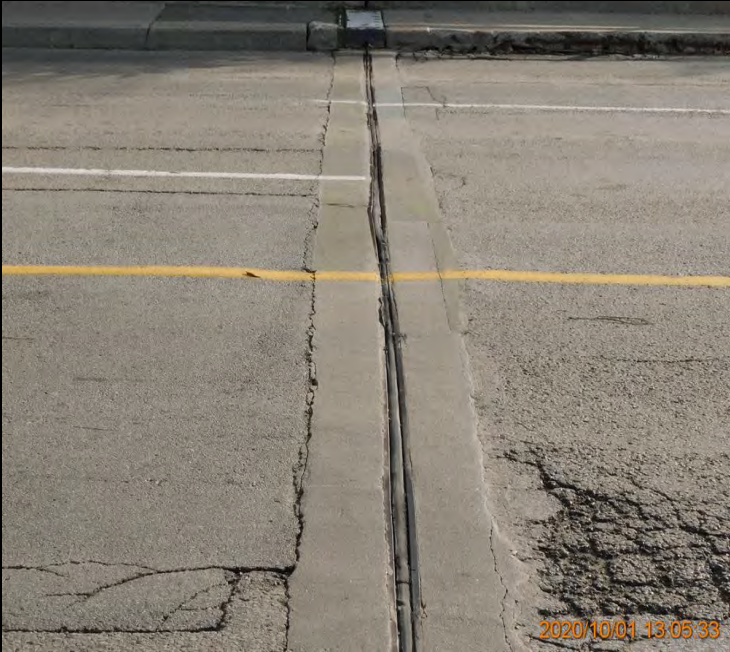
Description		
	Loose Seal @ Central Section of North EJ and Dents in steel armoring.		
	Elem Grp/Class	Joints/Seals/sealants	
	Elem Type	Compression seal	
	Sub Element		
	Material Type		
	Locator		
	Defect Descript1	Poor condition	
	Defect Descript2		
	Defect	Damaged	
	Other		
File Name	30 Loose Seal @ Central Section of North EJ.JPG

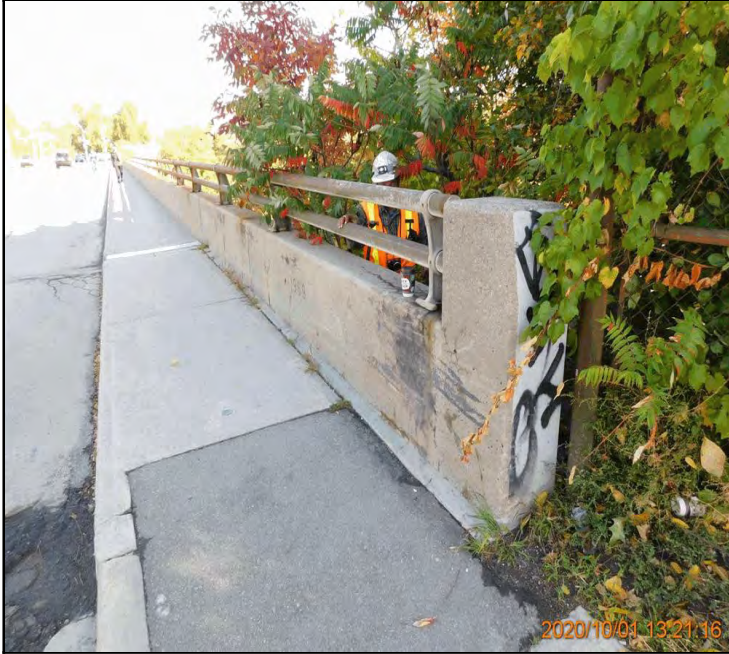
Description
East Parapet Wall and Sidewalk, Looking North. Note: N-M cracks and local staining on barrier walls.

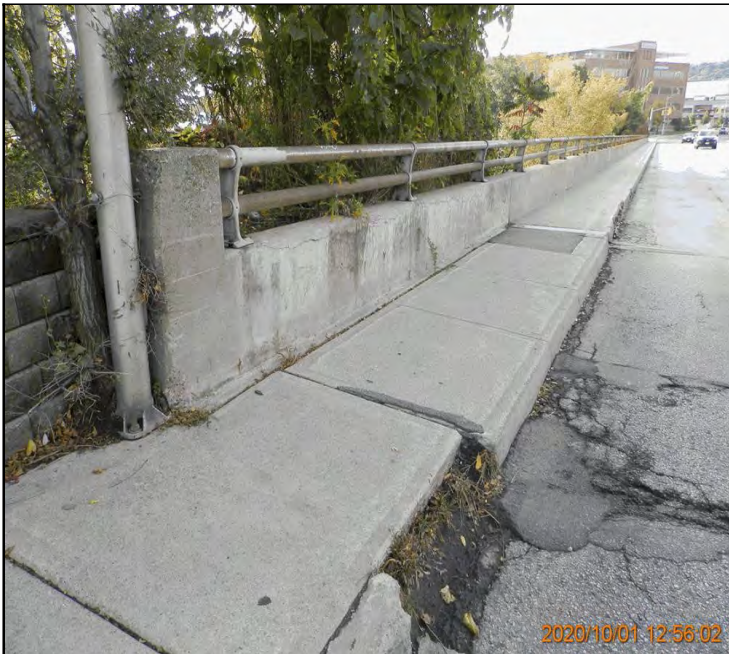
Description
East Parapet Wall and Sidewalk, Looking South. Note: Very severe delamination along top section of barrier wall.

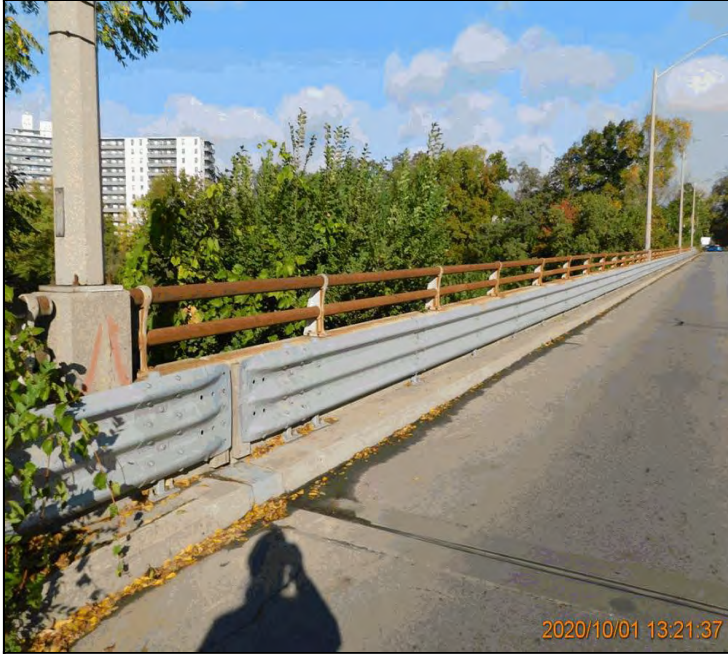
Description West Parapet Wall, Looking North. Note: Local areas of light to medium scaling.	
Elem Grp/Class	Barriers/Barrier/Parapet Walls
Elem Type	Parapet Wall with two rails
Sub Element	Interior
Material Type	Cast-in-place concrete
Locator	General
Defect Descript1	Fair condition
Defect Descript2	
Defect	Scaling
Other

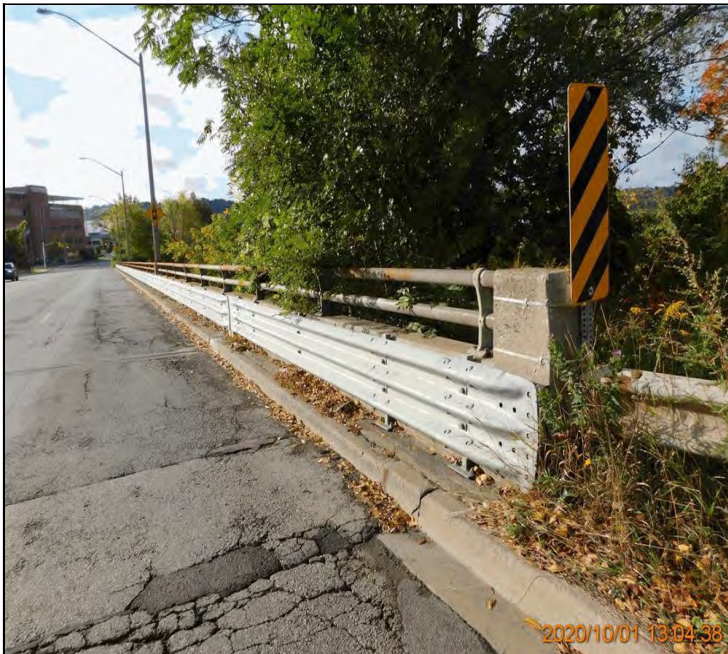
Description West Parapet Wall, Looking South. Note: Wide crack on curb face at end of approach slab.	
Elem Grp/Class	Barriers/Barrier/Parapet Walls
Elem Type	Parapet Wall with two rails
Sub Element	Interior
Material Type	Cast-in-place concrete
Locator	General
Defect Descript1	Poor condition
Defect Descript2	
Defect	Cracks
Other

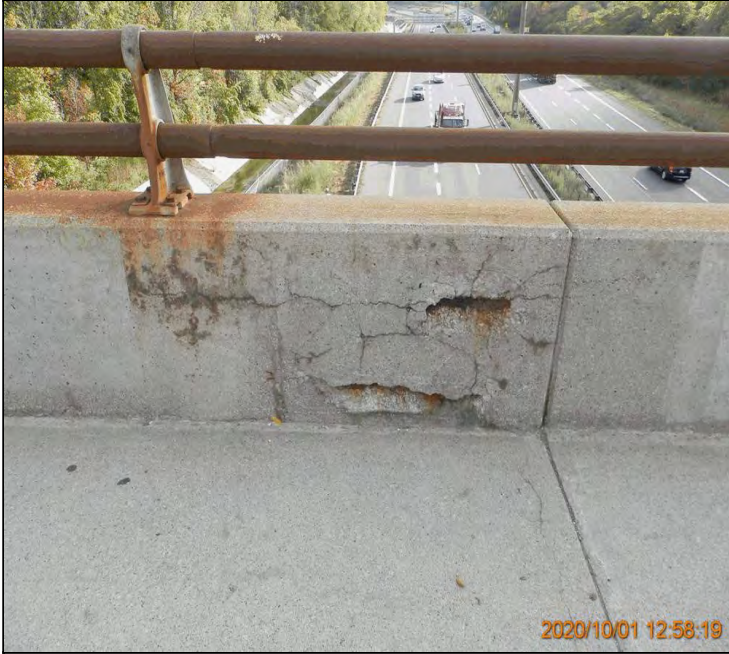
Description Severe Spall and Delam on East Wall in North Section of Span 3	
Elem Grp/Class	Barriers/Barrier/Parapet Walls
Elem Type	Parapet Wall with two rails
Sub Element	Interior
Material Type	Cast-in-place concrete
Locator	
Defect Descript1	Poor condition
Defect Descript2	
Defect	Spalling
Other

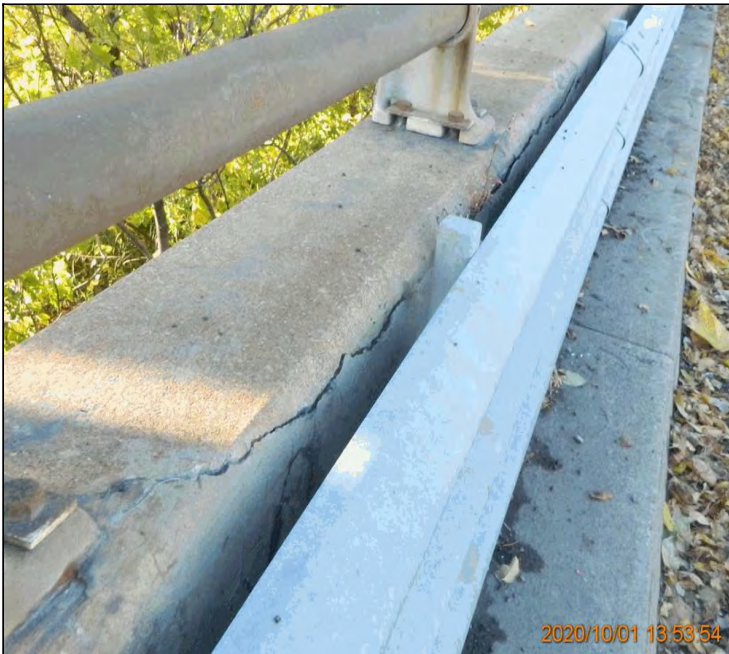
Description Delam on W Wall behind Thrie-Beam @ S Section of N Span 7 (TYP)	
Elem Grp/Class	Barriers/Barrier/Parapet Walls
Elem Type	Parapet Wall with two rails
Sub Element	Interior
Material Type	Cast-in-place concrete
Locator	
Defect Descript1	Poor condition
Defect Descript2	
Defect	Delamination
Other

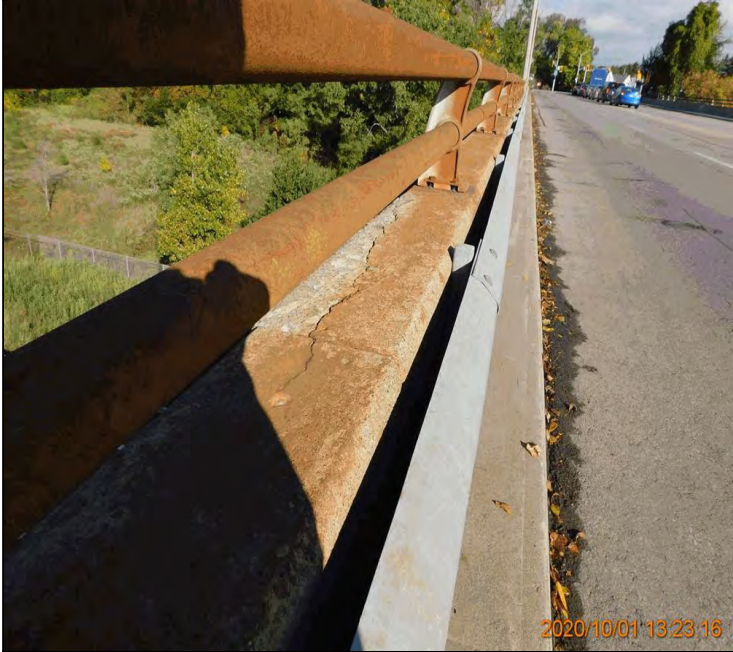
Description Wide Crack on Top Face of West Wall Over Hwy 403 WB		
	Elem Grp/Class Elem Type Sub Element Material Type Locator Defect Descript1 Defect Descript2 Defect Other	Barriers/Barrier/Parapet Walls Parapet Wall with two rails Interior Cast-in-place concrete Poor condition Cracks	
File Name	38 Wide Crack on Top Face of West Wall Over Hwy 403 WB.JPG

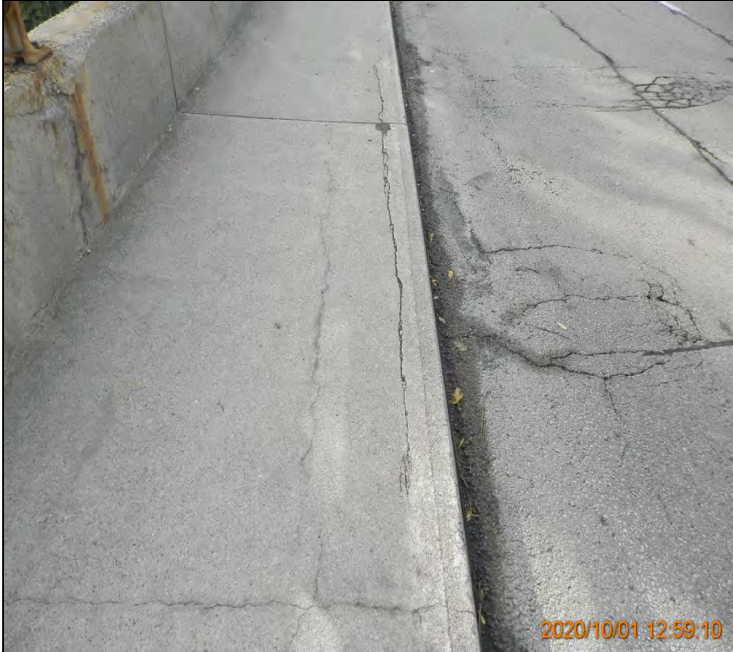
Description Wide Longitudinal Crack on East Sidewalk near South End of Deck (TYP)		
	Elem Grp/Class Elem Type Sub Element Material Type Locator Defect Descript1 Defect Descript2 Defect Other	Sidewalks/curbs/Sidewalk and Cast-in-place concrete Typical Poor condition Cracks	
File Name	39 Wide Longitudinal Crack on East Sidewalk near South End of Deck (TYP).JPG

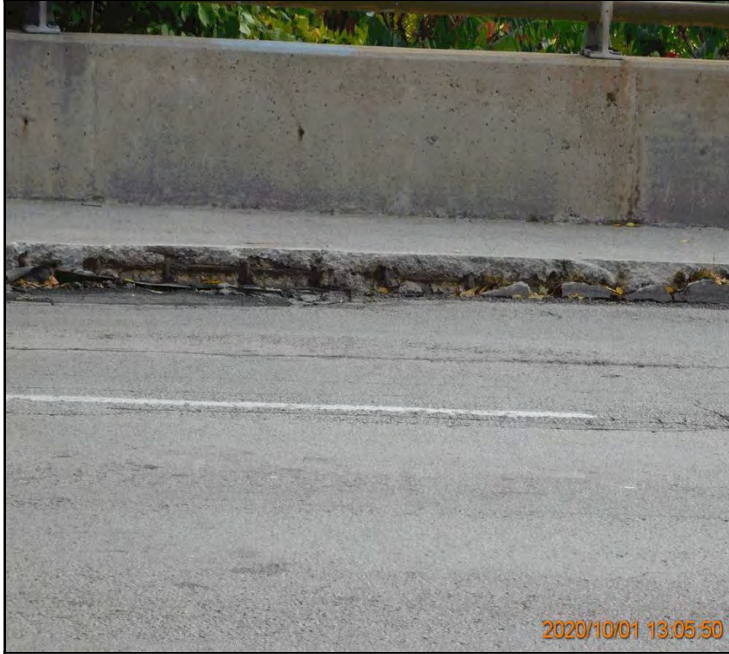
Description Very Severe Spall & Delam on East Curb @ North End of Deck	
Elem Grp/Class	Sidewalks/curbs/Sidewalk and
Elem Type	
Sub Element	
Material Type	Cast-in-place concrete
Locator	
Defect Descript1	Poor condition
Defect Descript2	
Defect	Spalling
Other

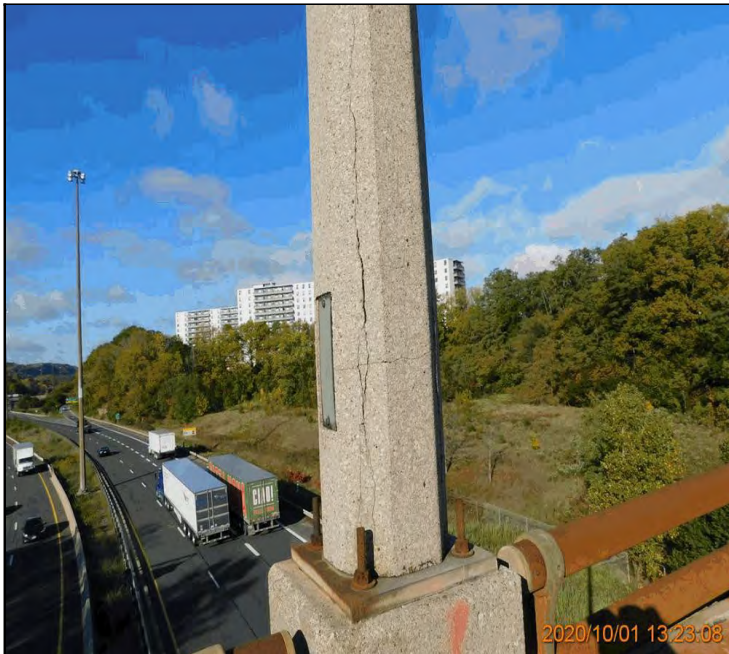
Multiple N-M vertical cracks on both barrier walls. Wide vertical cracks at bottom of light pole. Few patched areas on west wall over Hwy 403 median. (Ref Photo: #41).

Description Wide Vertical Cracks on Bottom of Light Pole over Hwy 403 Median	
Elem Grp/Class	Barriers/Barrier/Parapet Walls
Elem Type	Parapet Wall with two rails
Sub Element	Exterior
Material Type	Cast-in-place concrete
Locator	
Defect Descript1	Poor condition
Defect Descript2	
Defect	Cracks
Other

Recommended Work	Category	Timing	Quantity	Unit Cost	Total Cost (\$)
CO301 Rehab Concrete (sqm)	Major Rehab	1 - 5 year	7.000	650	4550

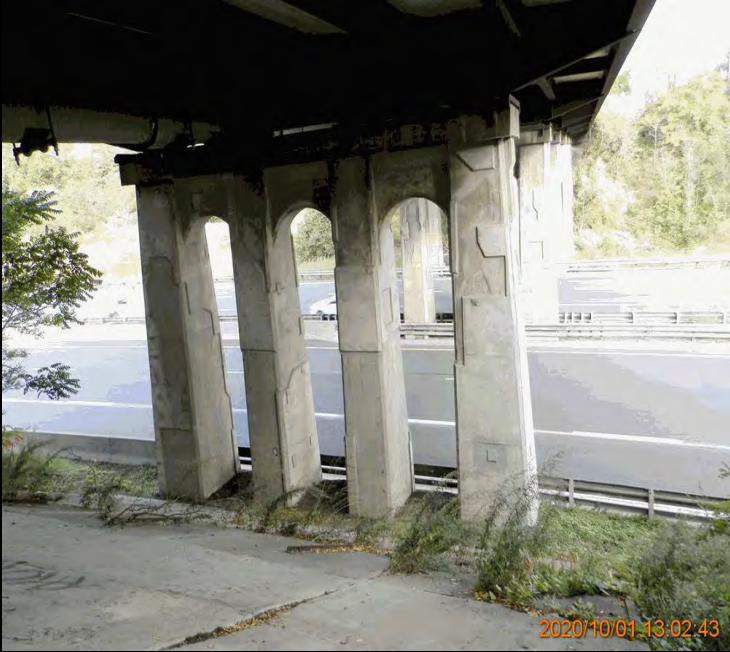
Description South Elevation of Pier 1. Note: Narrow stained shrinkage cracks on patch repairs.		
	Elem Grp/Class Elem Type Sub Element Material Type Locator Defect Descript1 Defect Descript2 Defect Other	Piers/Shfts/columns/Pile Bent Conc rectangular columns with Cast-in-place concrete General Fair condition Cracks	
File Name	42 South Elevation of Pier 1.JPG

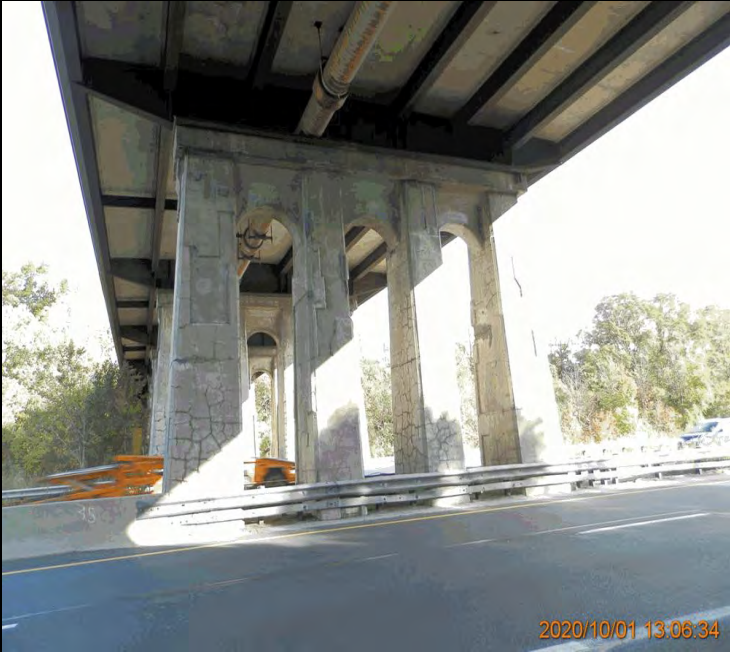
Description South Elevation of Pier 2. Note: Narrow stained shrinkage cracks.		
	Elem Grp/Class Elem Type Sub Element Material Type Locator Defect Descript1 Defect Descript2 Defect Other	Piers/Shfts/columns/Pile Bent Conc rectangular columns with Cast-in-place concrete General Fair condition Cracks	
File Name	43 South Elevation of Pier 2.JPG

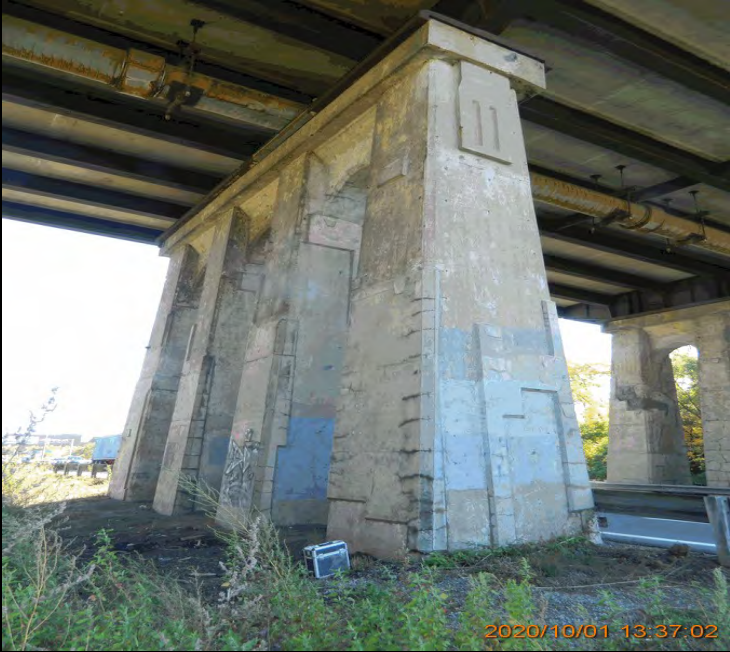
<p style="text-align: right; color: orange; font-size: small;">2020/10/01 13:37:02</p>		Description North Elevation of Pier 3. Note: Narrow stained shrinkage cracks on patch repairs.	
		Elem Grp/Class Elem Type Sub Element Material Type Locator Defect Descript1 Defect Descript2 Defect Other	Piers/Shfts/columns/Pile Bent Conc rectangular columns with Cast-in-place concrete General Fair condition Cracks
File Name		44 North Elevation of Pier 3.JPG

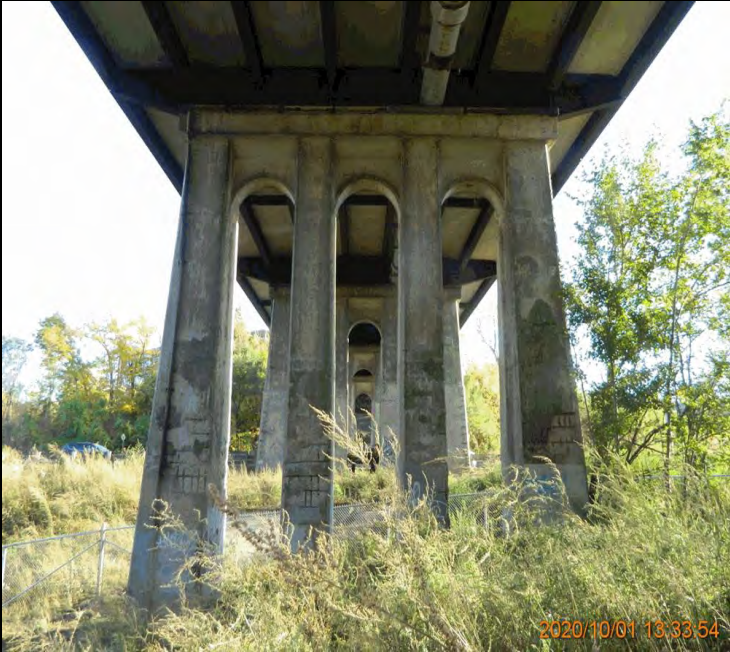
<p style="text-align: right; color: orange; font-size: small;">2020/10/01 13:33:54</p>		Description North Elevation of Pier 4. Note: Very severe spalls on pier column.	
		Elem Grp/Class Elem Type Sub Element Material Type Locator Defect Descript1 Defect Descript2 Defect Other	Piers/Shfts/columns/Pile Bent Conc rectangular columns with Cast-in-place concrete General Poor condition Spalling
File Name		45 North Elevation of Pier 4.JPG

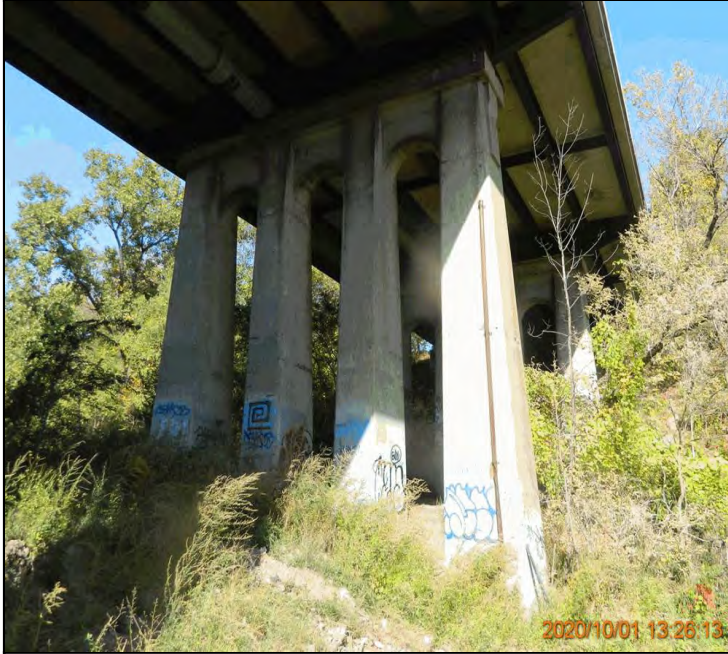
Description South Elevation of Pier 5. Note: Local severe spall on 2nd column from west.	
Elem Grp/Class	Piers/Shfts/columns/Pile Bent
Elem Type	Conc rectangular columns with
Sub Element	
Material Type	Cast-in-place concrete
Locator	General
Defect Descript1	Poor condition
Defect Descript2	
Defect	Spalling
Other

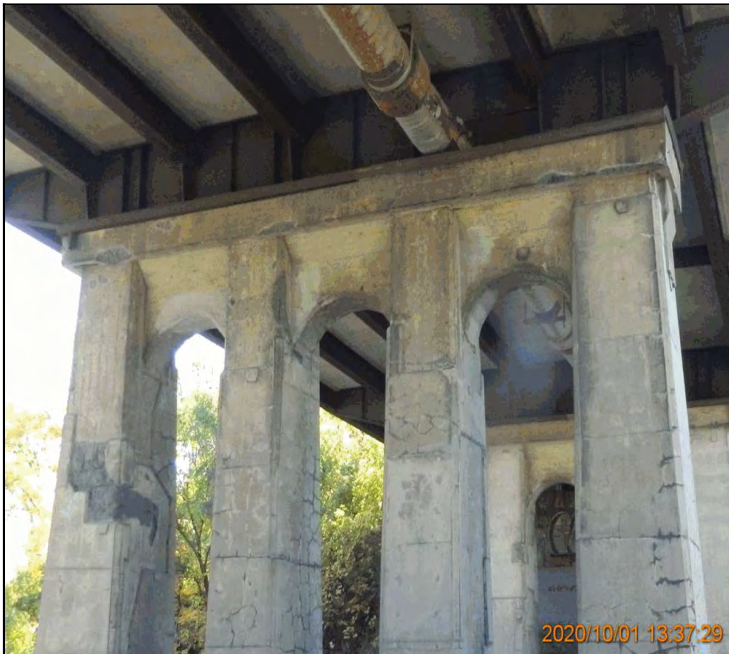
Description Severe Spalls on N Face of Pier 2 Columns and Cap	
Elem Grp/Class	Piers/Caps
Elem Type	
Sub Element	
Material Type	Cast-in-place concrete
Locator	
Defect Descript1	Poor condition
Defect Descript2	
Defect	Spalling
Other

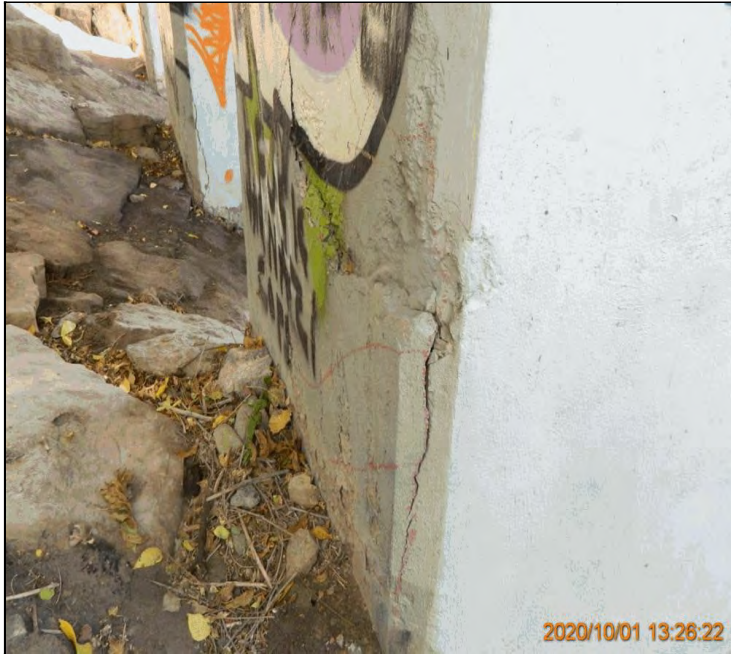
Description Severe Delam on North Face of Column 2 From West @ Pier P6	
Elem Grp/Class	Piers/Shfts/columns/Pile Bent
Elem Type	Conc rectangular columns with
Sub Element	
Material Type	Cast-in-place concrete
Locator	
Defect Descript1	Poor condition
Defect Descript2	
Defect	Delamination
Other

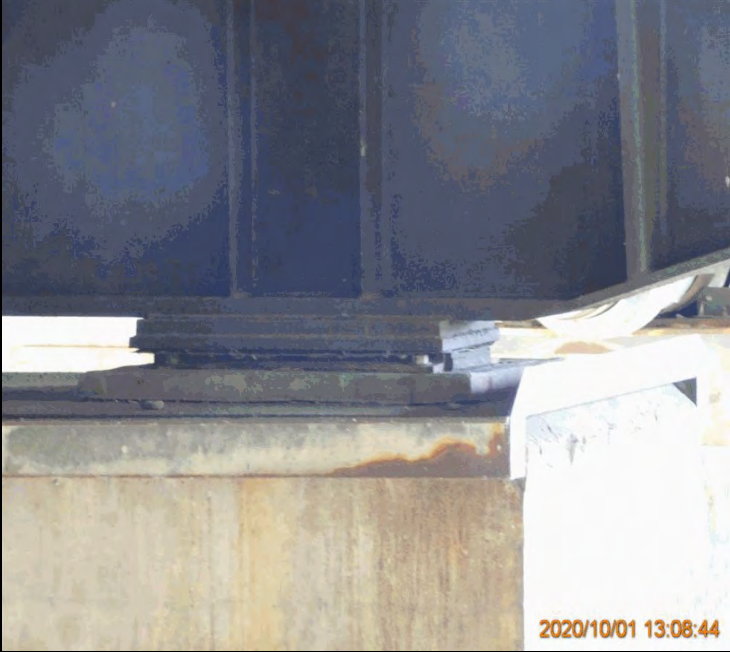
Description Typical Expansion Bearing, Pier 6 Bearing Shown. Note: Narrow to medium cracks in grout pad.

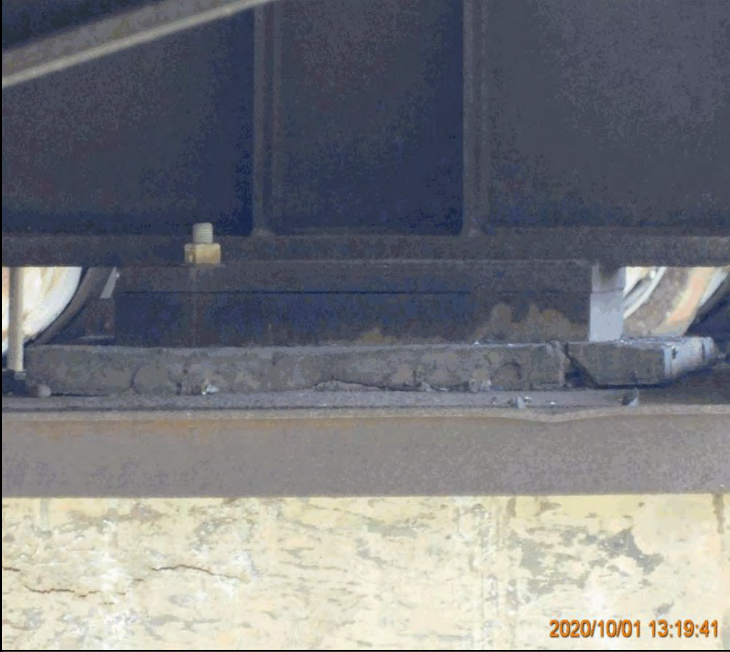
Description Typical Fixed Bearing at Pier 4. Note: Wide cracks in grout pad.

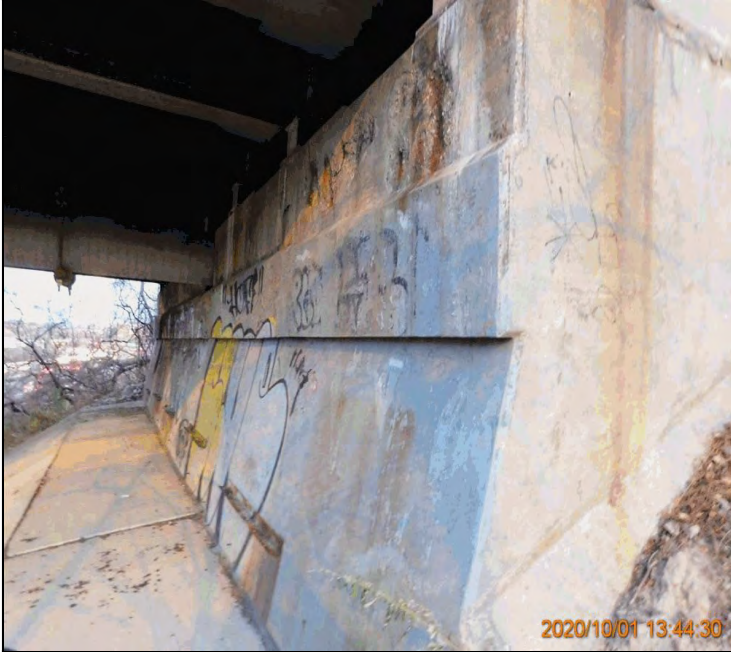
<p style="text-align: right; color: orange; font-size: small;">2020/10/01 13:44:30</p>	<p>Description South Abutment, Looking East. Note: Severe spalls on top section of abutment.</p>

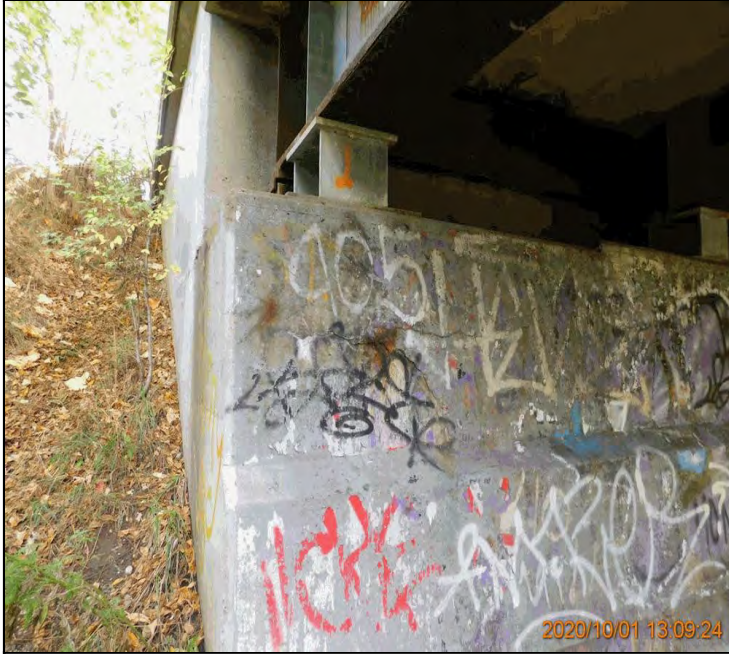
Description Severe Delam @ West End of North Abutment.	
Elem Grp/Class	Abutments/Abutment walls
Elem Type	Conventional closed
Sub Element	
Material Type	Cast-in-place concrete
Locator	
Defect Descript1	Poor condition
Defect Descript2	
Defect	Delamination
Other

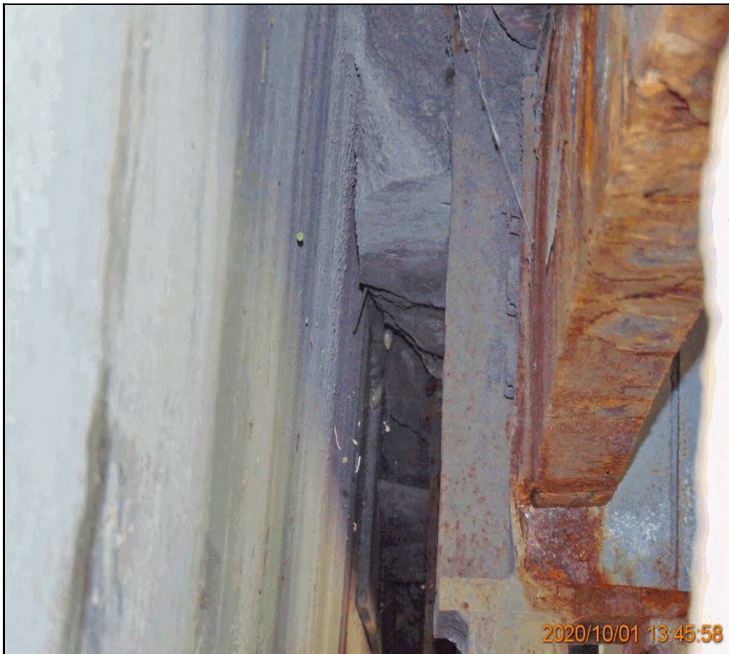
Description Wooden Form on South Ballast Wall & Spalls on Soffit below EJ	
Elem Grp/Class	Decks/Soffit - Thin Slab
Elem Type	
Sub Element	End
Material Type	Cast-in-place concrete
Locator	
Defect Descript1	Poor condition
Defect Descript2	
Defect	Spalling
Other

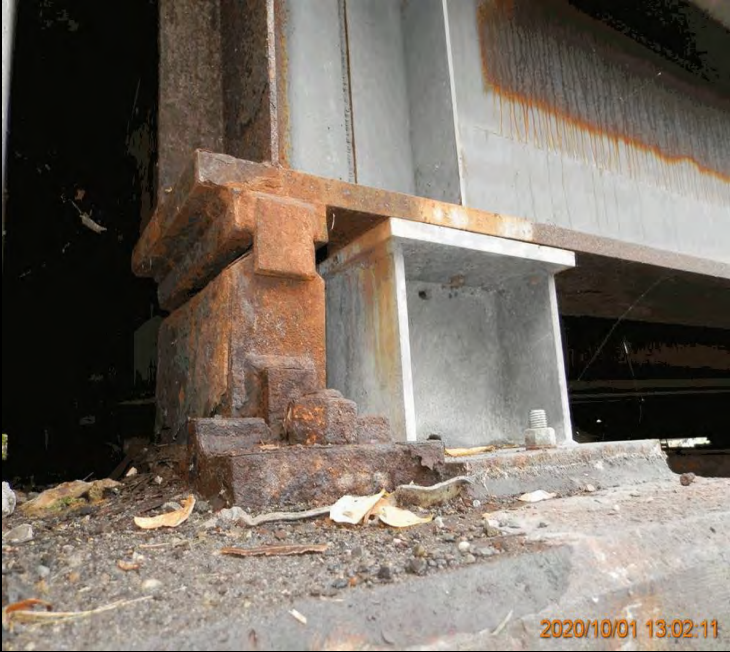
<p style="text-align: right; color: orange; font-size: small;">2020/10/01 13:02:11</p>	Description		
	South Abutment Bearing (East Bearing Shown). Note: Light to medium surface corrosion on original bearing.		
	Elem Grp/Class Elem Type Sub Element Material Type Locator Defect Descript1 Defect Descript2 Defect Other	Abutments/Bearings Rocker General Fair condition Corrosion	
File Name	63 South Abutment Bearing (East Bearing Shown).JPG

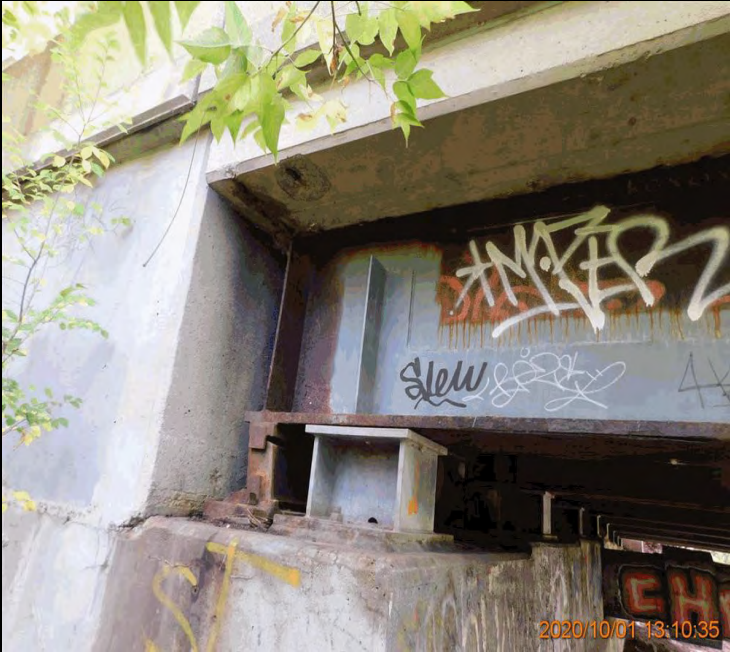
<p style="text-align: right; color: orange; font-size: small;">2020/10/01 13:10:35</p>	Description		
	North Abutment Bearing (West Bearing Shown). Note: L-M surface corrosion on original bearing, reinforced girder ends and graffiti markings.		
	Elem Grp/Class Elem Type Sub Element Material Type Locator Defect Descript1 Defect Descript2 Defect Other	Abutments/Bearings Rocker General Fair condition Corrosion	
File Name	64 North Abutment Bearing (West Bearing Shown).JPG

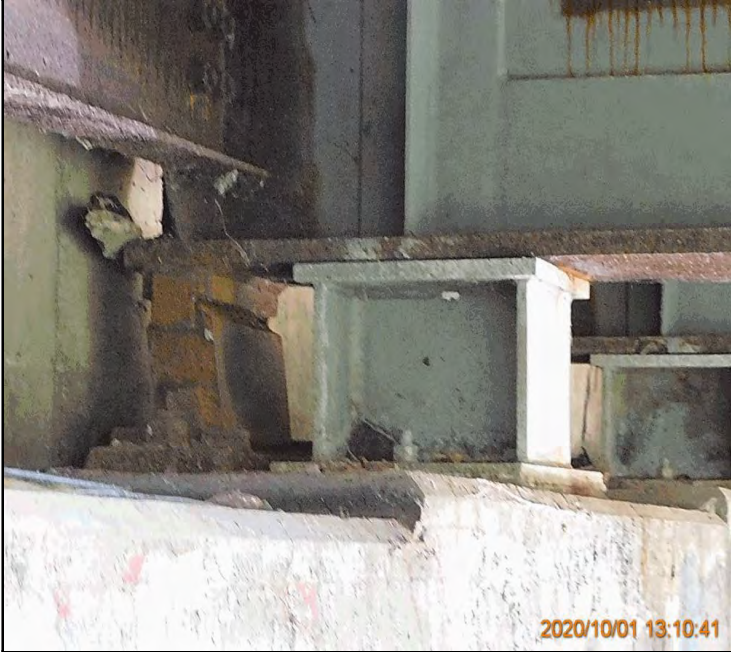
<p>Description Tilting of Orig Rocker Bearing @ Girder 2 from W @ N Abut(TYP)</p>
<p>Elem Grp/Class Elem Type Sub Element Material Type Locator Defect Descript1 Defect Descript2 Defect Other</p>	<p>Abutments/Bearings Rocker Fair condition</p>
<p>File Name 65 Tilting of Orig Rocker Bearing @ Girder 2 from W @ N Abut(TYP).JPG</p>

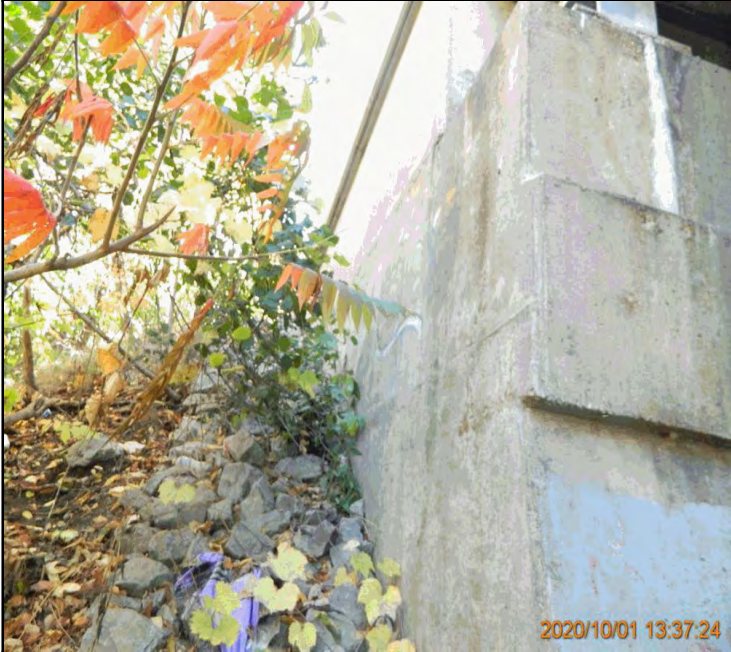
Comments CR = 3
 Local wet staining and few narrow to medium stained vertical cracks on wingwalls. (Ref Photos: #66-68).

<p>Description Southeast Wingwall. Note: Wet staining.</p>
<p>Elem Grp/Class Elem Type Sub Element Material Type Locator Defect Descript1 Defect Descript2 Defect Other</p>	<p>Abutments/Wingwalls Reinforced concrete Cast-in-place concrete General Fair condition Staining</p>
<p>File Name 66 Southeast Wingwall.JPG</p>

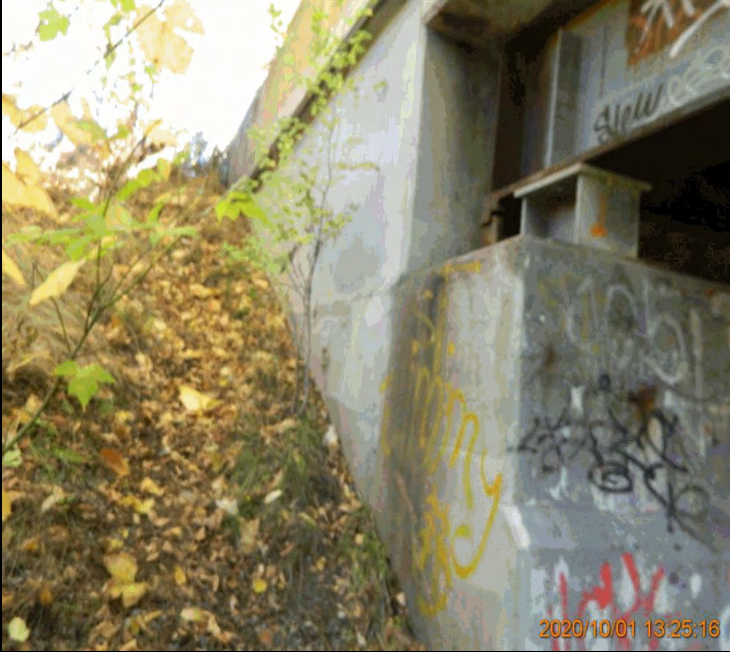
Description Northwest Wingwall. Note: Wet staining and graffiti markings.		
	Elem Grp/Class Elem Type Sub Element Material Type Locator Defect Descript1 Defect Descript2 Defect Other	Abutments/Wingwalls Reinforced concrete Cast-in-place concrete General Fair condition Staining	
File Name	67 Northwest Wingwall.JPG

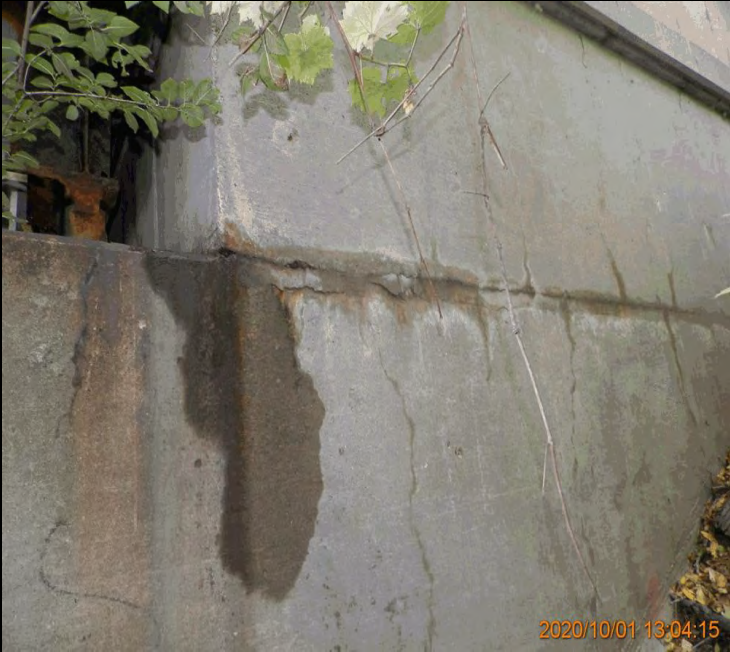
Description Narrow Wet Stained Vertical Cracks and Wet Staining on SW Wingwall		
	Elem Grp/Class Elem Type Sub Element Material Type Locator Defect Descript1 Defect Descript2 Defect Other	Abutments/Wingwalls Reinforced concrete Cast-in-place concrete Fair condition Cracks	
File Name	68 Narrow Wet Stained Cracks and Wet Staining on SW Wingwall.JPG
