COMMUNICATION UPDATE

TO:	Mayor and Members City Council
DATE:	February 1, 2024
SUBJECT:	Longwood Road Bridge (Bridge 282) Upcoming Reconstruction (ENG24001) (City Wide)
WARD(S) AFFECTED:	City Wide
SUBMITTED BY:	Jackie Kennedy Director, Engineering Services Public Works Department
SIGNATURE:

Appendix "A" to Communication Update ENG24001: BRIDGE 282_2020_OSIM

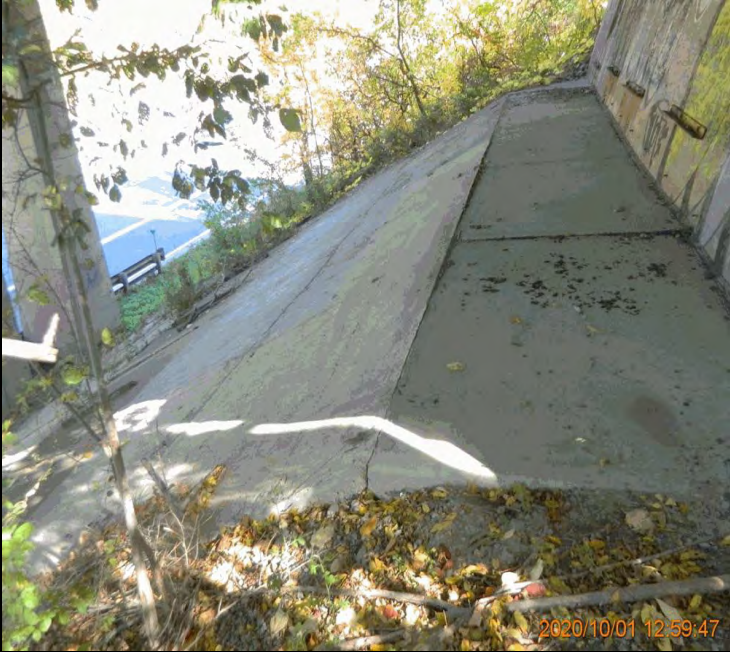
Description		
	Concrete Slope Paving on South Embankment. Note: Few medium cracks.		
	Elem Grp/Class	Embankments & Streams/Slop	
	Elem Type	Other	
	Sub Element		
	Material Type		
	Locator	General	
	Defect Descript1	Good condition	
	Defect Descript2		
	Defect	Cracks	
	Other		
File Name	69 Concrete Slope Paving on South Embankment.JPG

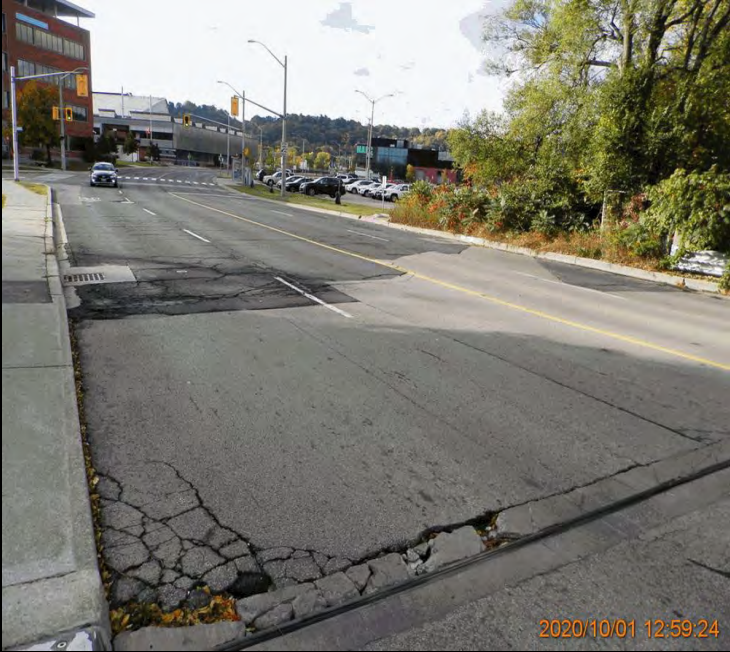
Severe pattern cracks on south approach, adjacent to east end of south expansion joint. Few medium to severe longitudinal and transverse cracks on both approaches. (Ref Photos: #71 and 72).

Description		
	South Approach. Note: M-S Pattern and longitudinal cracks. Severe spalling of end dam.		
Elem Grp/Class		Approaches/Wearing surface	
Elem Type			
Sub Element			
Material Type		Asphalt	
Locator		General	
Defect Descript1		Poor condition	
Defect Descript2			
Defect		Cracks	
Other			
File Name	71 South Approach.JPG

Recommended Work	Category	Timing	Quantity	Unit Cost	Total Cost (\$)
AS400 Replace Asphalt w/s Approaches (sq.m)	Replacement	1 - 5 year	173.000	98	16868

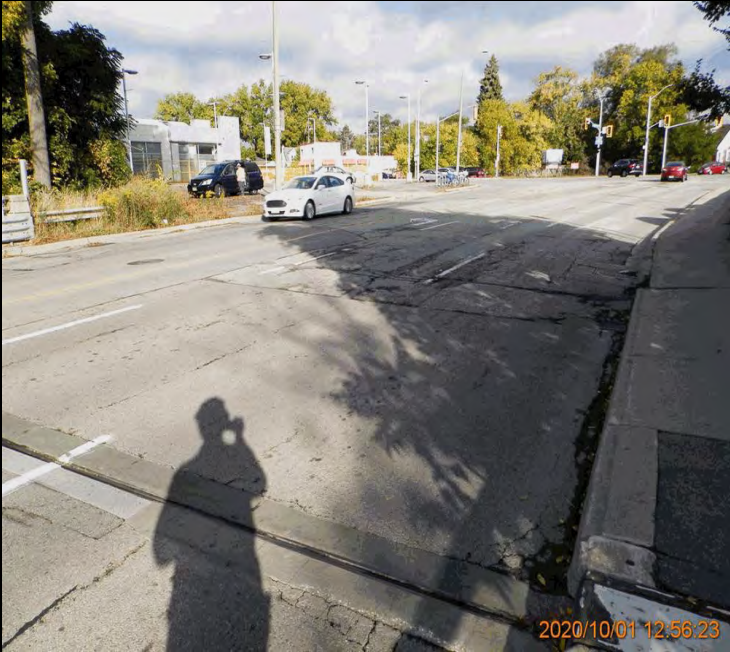
Description		
	North Approach. Note: M-S longitudinal cracks on wearing surface.		
Elem Grp/Class		Approaches/Wearing surface	
Elem Type			
Sub Element			
Material Type		Asphalt	
Locator		General	
Defect Descript1		Poor condition	
Defect Descript2			
Defect		Cracks	
Other			
File Name	72 North Approach.JPG

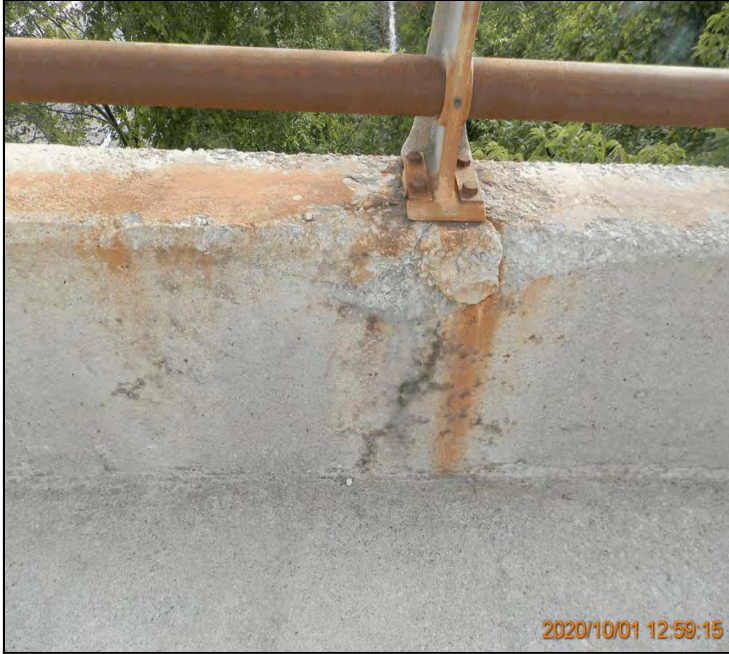
Description L-M Scaling on East Wall Near South End of Deck	
Elem Grp/Class	Barriers/Barrier/Parapet Walls
Elem Type	Parapet Wall with two rails
Sub Element	Interior
Material Type	Cast-in-place concrete
Locator	
Defect Descript1	Fair condition
Defect Descript2	
Defect	Scaling
Other
