Documentation and Salvage Report

1694 Upper James Street, City of Hamilton

Prepared for Royal Living Developments Ltd.

CP# 2023-004 February 2024

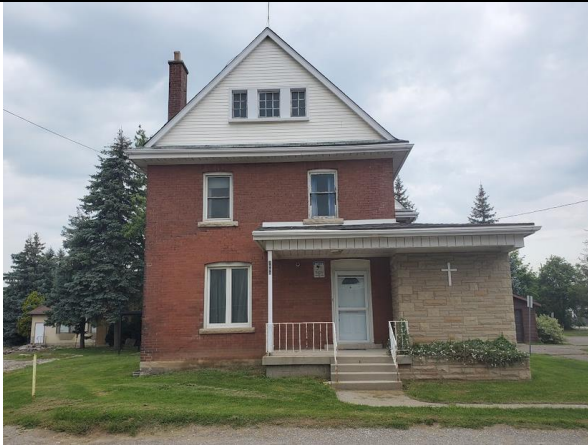
The front façade features a main single doorway, a double side by side pane window on the ground floor and two single sash windows on the upper story. Each window frame features a carved stone sill. The 3rd storey features a Colonial style triple window set with a larger nine paned window in the centre flanked by two six paned windows. The 3rd storey is faced with modern siding. The original porch has been removed along with all soffits, fascia and gutters and has been replaced with a modern wrap-around porch accessed by a 3 step concrete stairs. The porch itself is composed of concrete blocks with a single metal pillar and a metal railing. The original front door has been replaced. The north side of the ground floor features a modern addition faced with stone masonry, and featuring a cross and a garden box at porch floor height also faced with stone masonry. These renovations have significantly compromised the Edwardian character of the main façade.

1. Front (east) façade and grounds

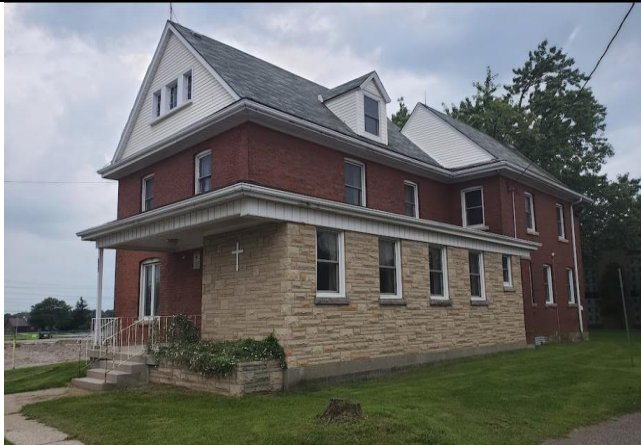
compromised by the modern addition on the northeast corner and along the northern façade of the building which superseded the original veranda and resulted in its removal.

2. Northeast corner

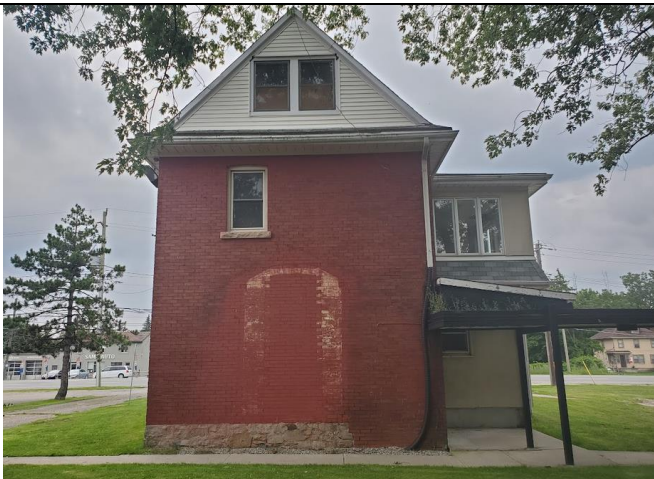
The rear façade evinces a former rear entrance that was bricked over. The rubble foundation is missing from the southwest corner and the brick wall here extends from ground level to the roofline. A small framed portico or porch may have provided shelter over this entry and wrapped around to the south side explaining the masonry in this area. A single sash window on the second storey, offset to the north and a double attic window are located above. The attic façade, like the one on the opposite side is faced with siding in a cream colour. Trim is modern and painted white and brown. The southern side of this façade features the framed sun porch and modern covered walkway that joins the rectory to the church building. The walkway cover is constructed of wooden posts supporting a metal roof and lighting. On its western face the ground floor of the sun porch features a single sash window now partially obscured by the metal roof of the walkway. The second storey features a modern triple window. Between the ground floor and second storeys, an asphalt shingled mansard style overhang provides shelter for the ground floor wall.

5. Rear (west) façade

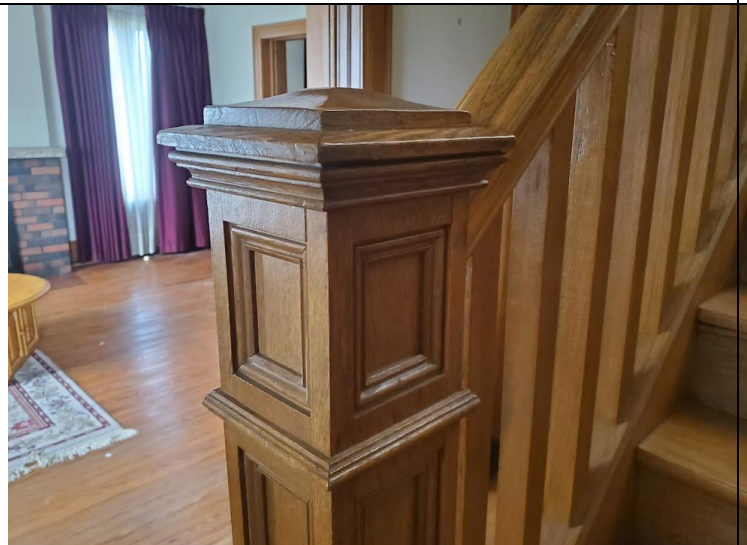
28. Newel post detail

These stair components are in good condition and could be re-used for stair construction.

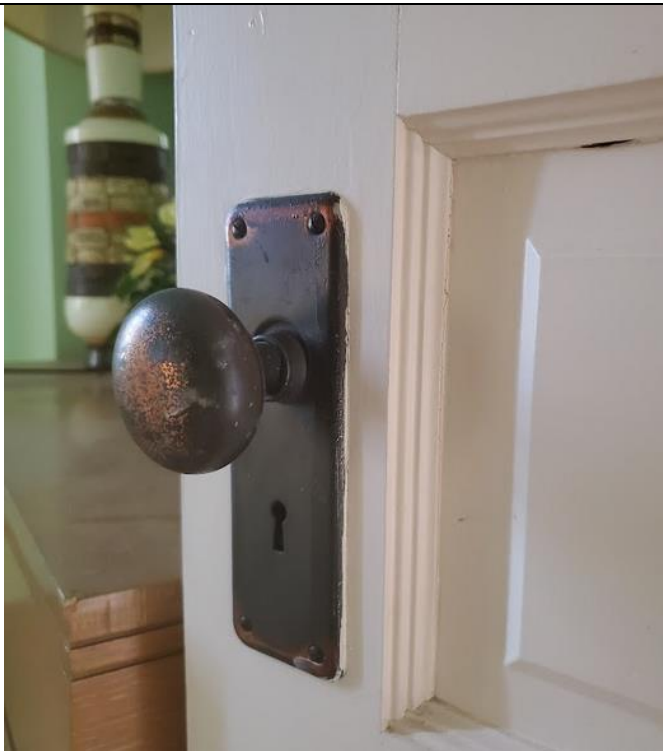
37. Original door knob detail
