<b>TO:</b>	Mayor and Members City Council
<b>DATE:</b>	January 22, 2026
<b>SUBJECT:</b>	Dundas Driving Park Stair Assessment (City Wide)
<b>WARD(S) AFFECTED:</b>	City Wide
<b>SUBMITTED BY:</b>	Cynthia Graham Director, Environmental Services Public Works Department
<b>SIGNATURE:</b>	A handwritten signature in black ink that reads 'C. Graham'.

**DUNDAS DRIVING PARK  
STAIRS**

**RE: Structural Assessment of Wood Stair System @  
71 Cross St., Dundas, ON L9H 2R5  
Our Project No. 2025-JPS-131**

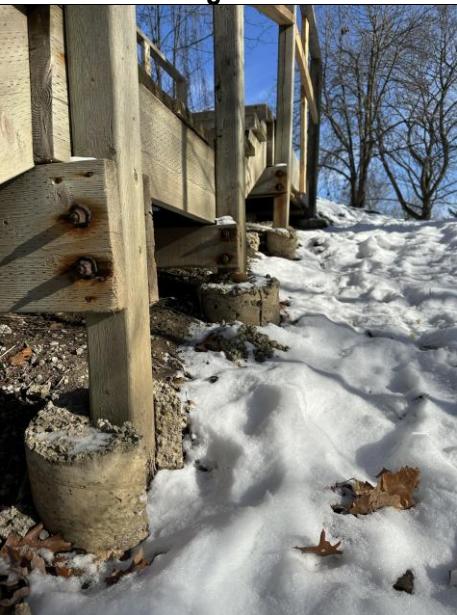
<p>On the south side, the concrete piers were incorrectly positioned during the original installation. Their misalignment relative to the posts prevents proper load transfer and eliminates the possibility of realigning the stair structure.</p>

- Close access to the stairway due to unsafe structural conditions.
- Remove all deteriorated wood components and unsafe sections of the stair.
- Concrete piers must be demolished and replaced, as they were incorrectly installed and cannot support a properly aligned stair.
- Install new frost-protected sonotube piers at correct structural spacing and height c/w galvanized post base connector.
- Add 2 additional side rails, one above and one below existing.
- Replace all corroded bolts with new galvanized bolts c/w large washers.
- Add minimum of two vertical bracing at the high bays.

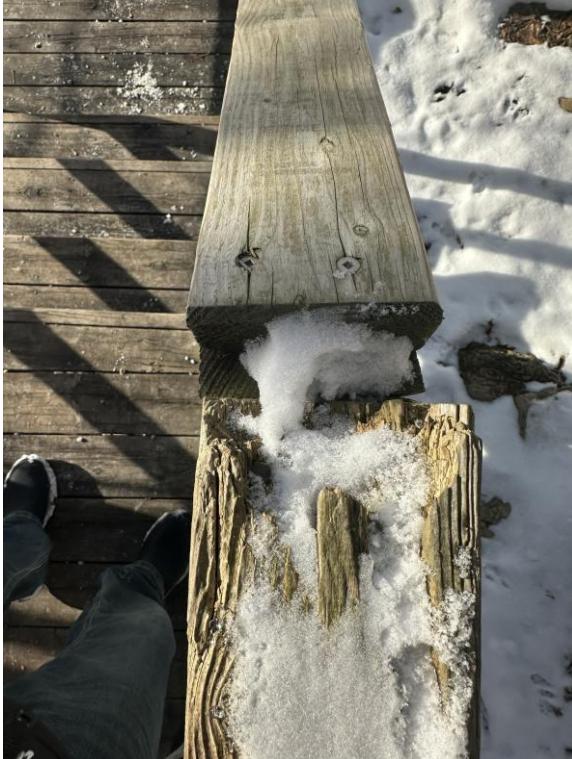
10

<p>At this location, the top guardrail member exhibits significant deterioration. Warping, splitting, and material loss have reduced its structural capacity and present a safety concern.</p>
11

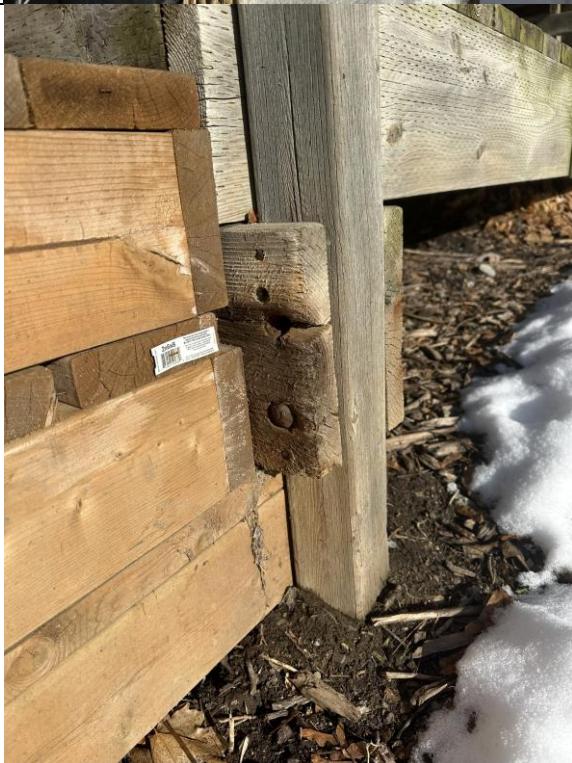
<p>At this location, the beam-to-post connection is severely damaged, with cracking, splitting, and one bolt missing. These issues prevent proper vertical and lateral load transfer. The post bottom is also buried below finished grade, which will trap moisture and accelerate further deterioration.</p>
