Summary of Interior Conditions

The former Church has been unused for over 20 years and as a result has suffered extensively within the interior. Renovating the Church will require restoration and rehabilitation of the interior spaces and will require new services such as bathroom facilities and mechanical equipment that is in keeping with today's standards.

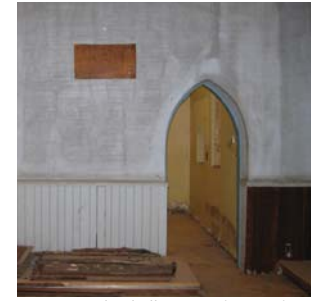
3. Damaged plaster due to damaged roof and soffits

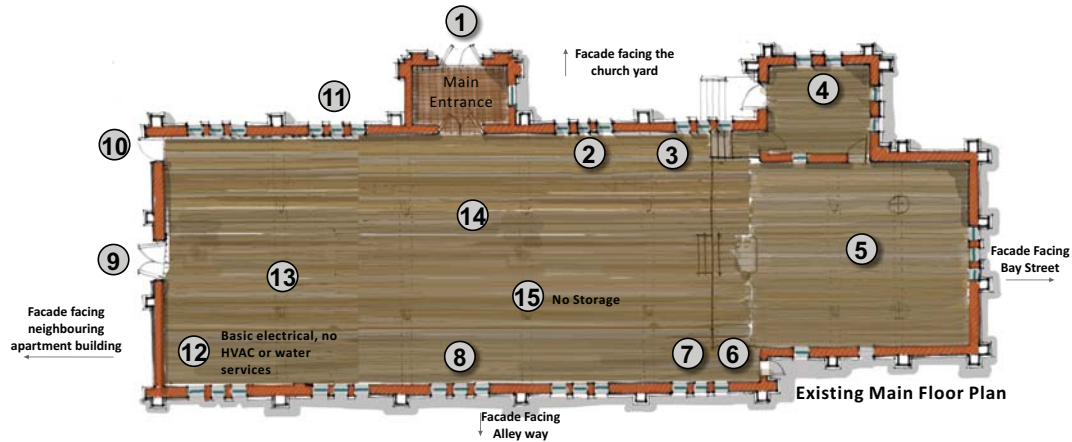
14. Main space features wide wood plank flooring and cast metal grates
