Upper West Side Secondary Plan Area Fluvial Geomorphological Assessment And Natural Channel Design

Twenty Road West, City of Hamilton

November 20, 2023
PN23079

Report Title: Upper West Side Secondary Plan Area
Fluvial Geomorphological Assessment and Natural
Channel Design

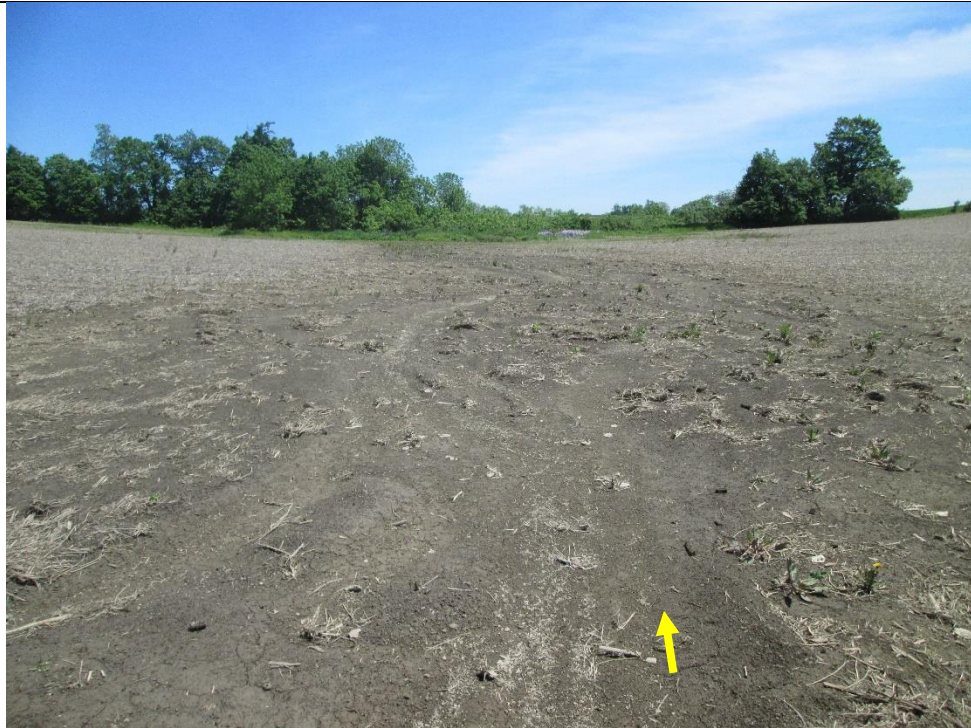
Photo 2
Tributary of Twenty Mile Creek: Visit 2
Reach TTCM2-9

No riparian or aquatic vegetation was observed within or adjacent to the feature. Notably, the feature's substrate was equivalent to that of the surrounding fields.

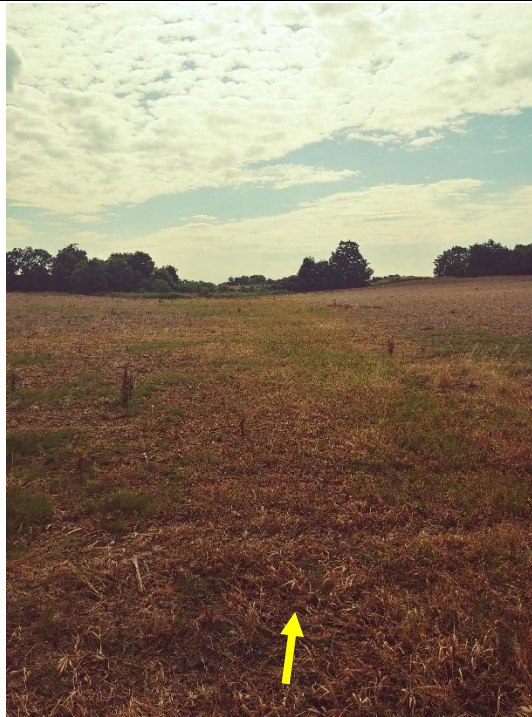
Photo 3
Tributary of Twenty Mile Creek: Visit 3
Reach TTCM2-9

The feature was indistinguishable from the surrounding landscape during the summer, with no channel formation or hydrophilic vegetation observed.

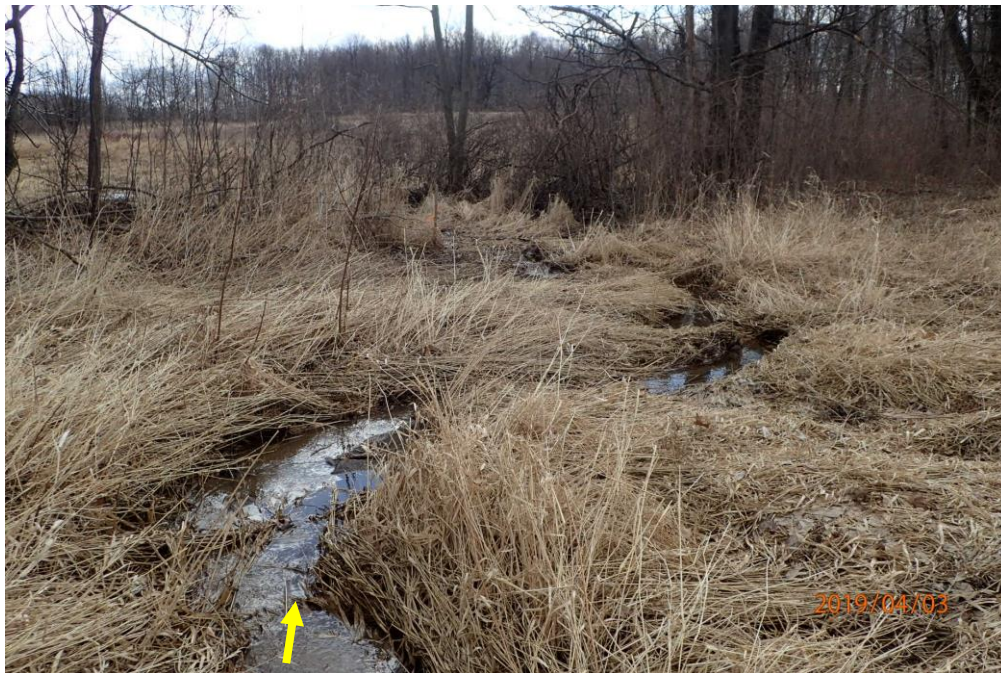
Photo 4
Tributary of Twenty Mile Creek: Visit 1
Reach TTM2-10

The feature was a poorly-defined channel with substantial water flowing through an agricultural field and a hedgerow during the spring visit.

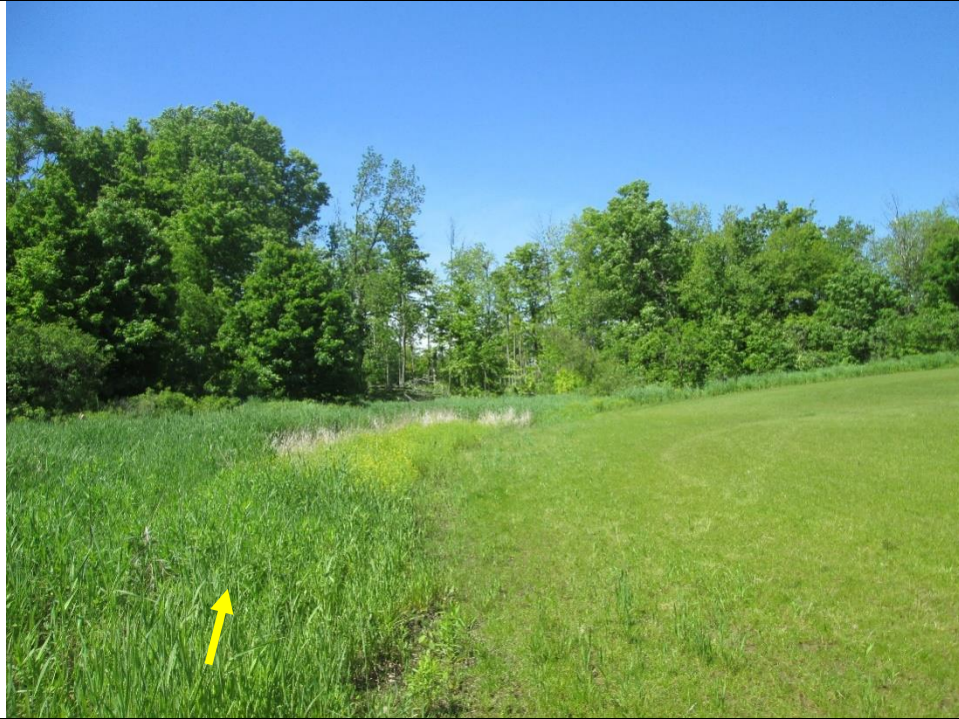
Photo 5
Tributary of Twenty Mile Creek: Visit 2
Reach TTM2-10

Herbaceous and grass vegetation were observed within and adjacent to the channel. Bed materials were equivalent to the surrounding fields.

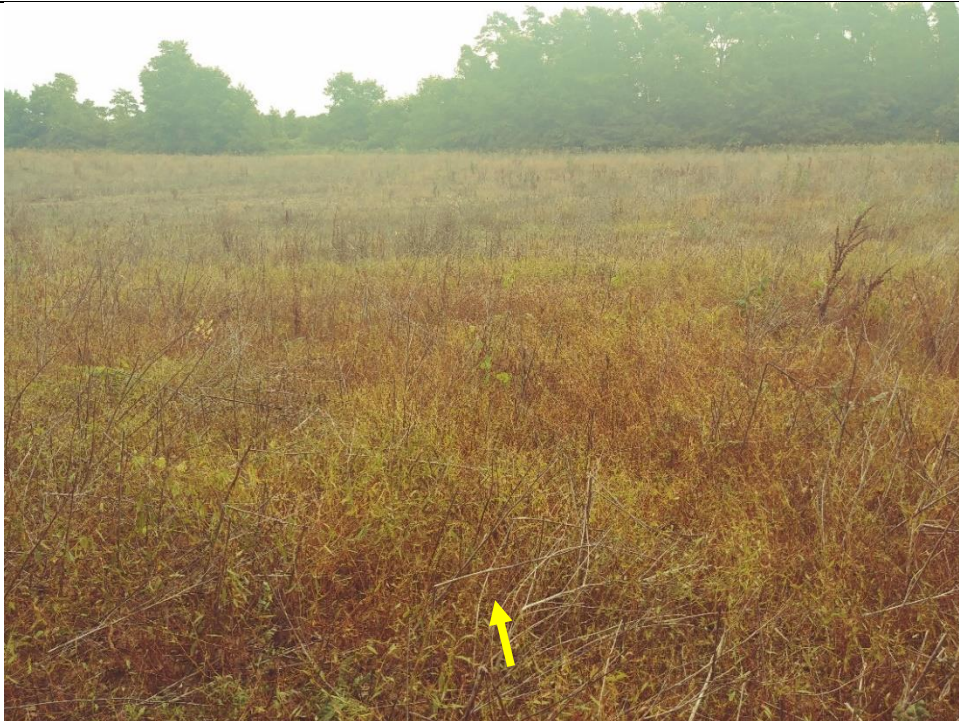
Photo 6
Tributary of Twenty Mile Creek: Visit 3
Reach TTM2-10

The feature was dry and indistinguishable from the surrounding fields during the summer, with no channel formation or hydrophilic vegetation observed.

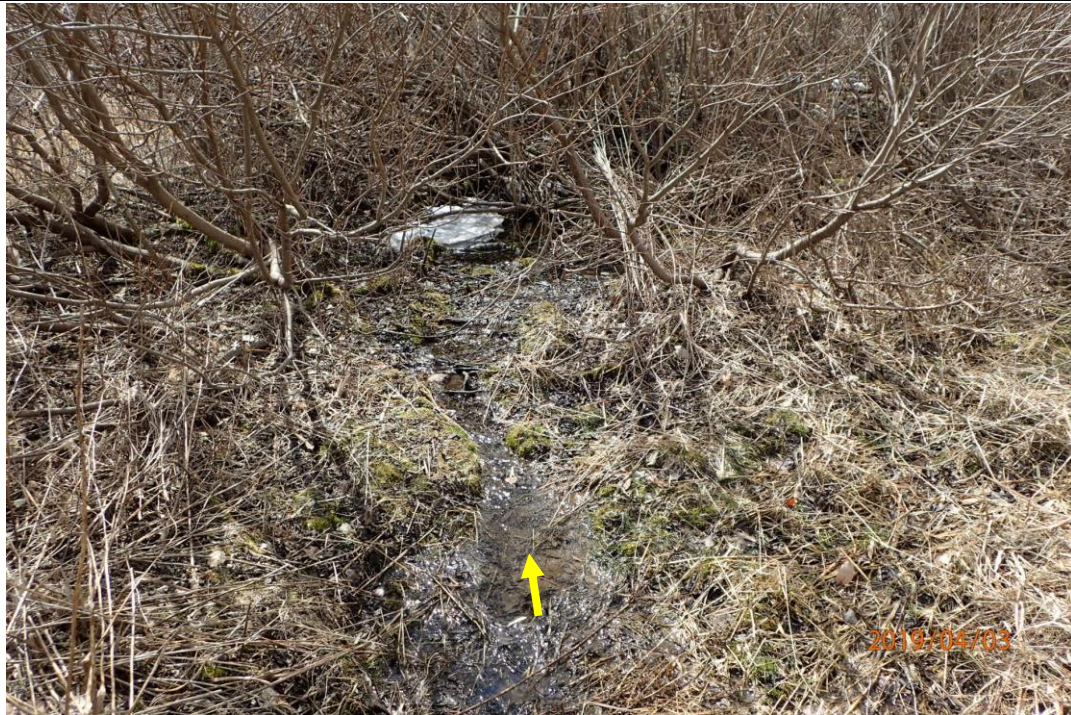
Photo 7
Tributary of Twenty Mile Creek: Visit 1
Reach TTMC2-10-1

The feature lacked defined bed and banks and conveyed minimal flow through an agricultural field and a hedgerow during the spring visit.

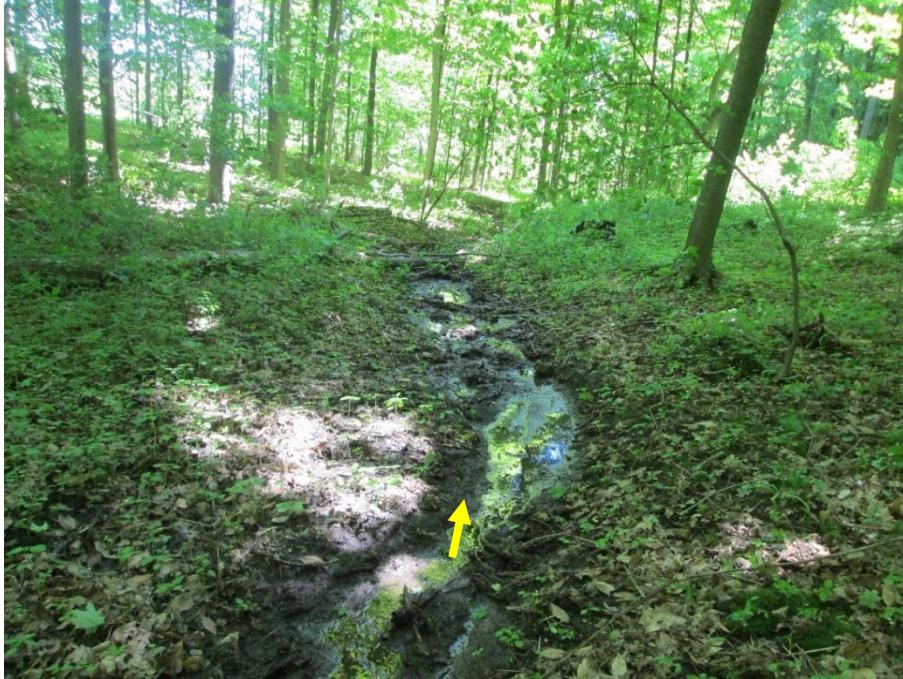
Photo 11
Tributary of Twenty Mile Creek: Visit 2
Reach **TTMC2-10-2**

Deciduous tree species were observed adjacent to the channel and minimal flow was present during the second visit.

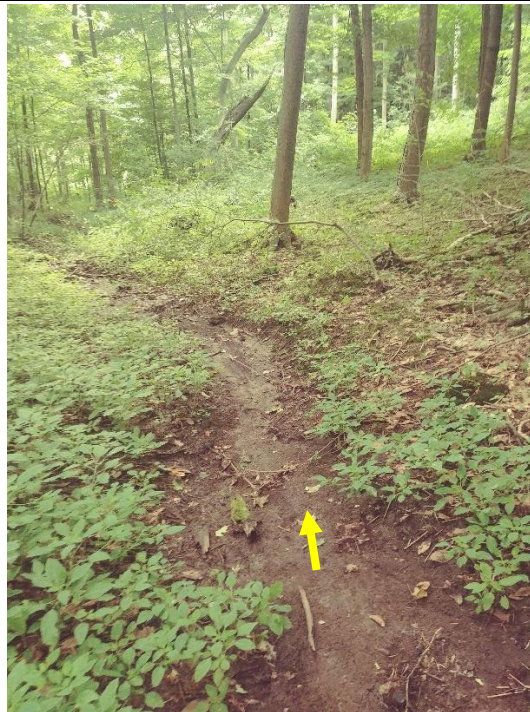
Photo 12
Tributary of Twenty Mile Creek: Visit 3
Reach **TTMC2-10-2**

Feature was dry but distinguishable from the surrounding landscape during the third visit. Bed materials consisted predominantly of silt and clay.

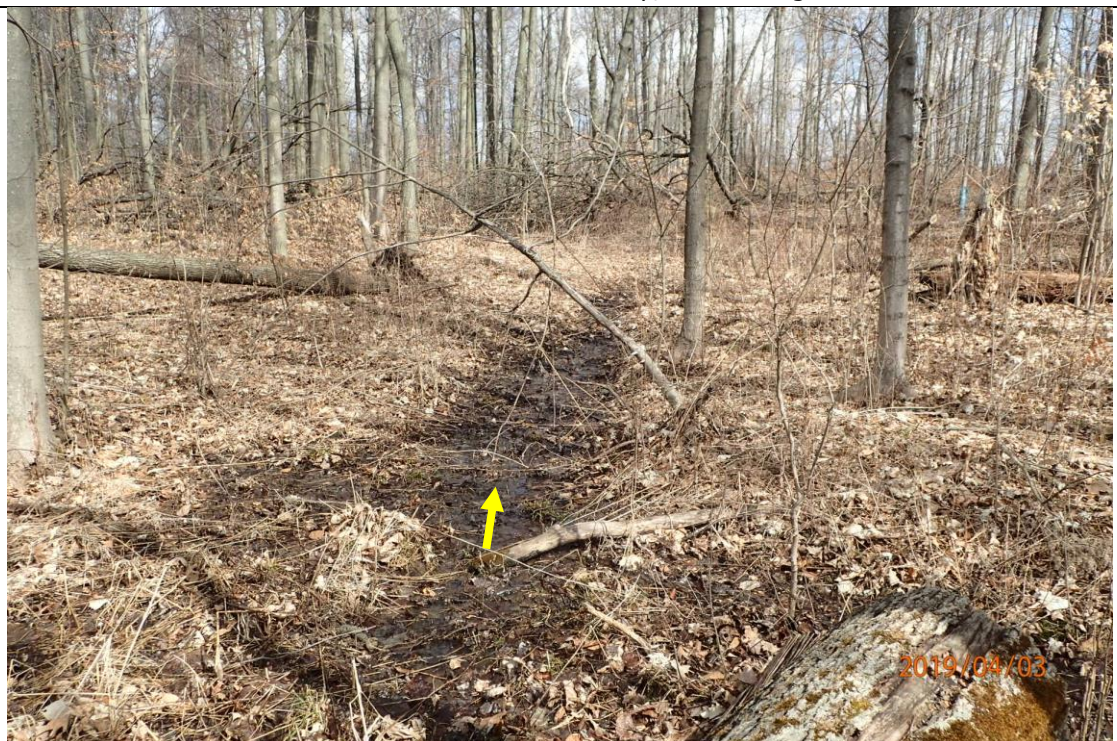
Photo 22
Tributary of Twenty Mile Creek: Visit 1
Reach TTM2-12-1b

The feature was a low gradient swale conveying minimal flow through a woodlot. No bed or bank definition were observed.

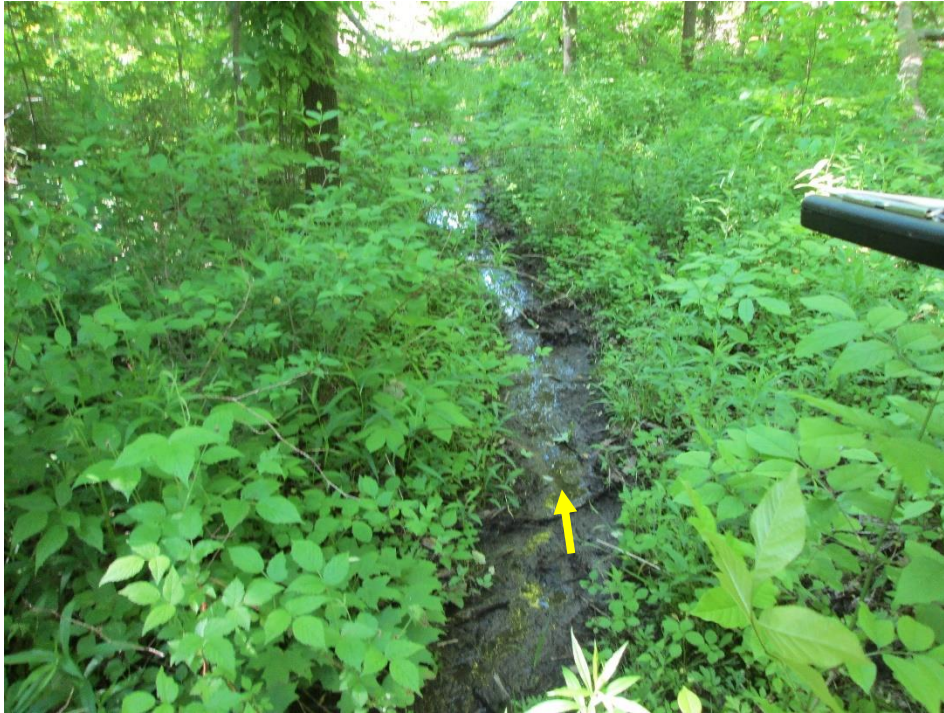
Photo 23
Tributary of Twenty Mile Creek: Visit 2
Reach TTM C2-12-1b

Riparian vegetation consisted of herbaceous vegetation and deciduous tree species. Standing water was observed during the second visit.

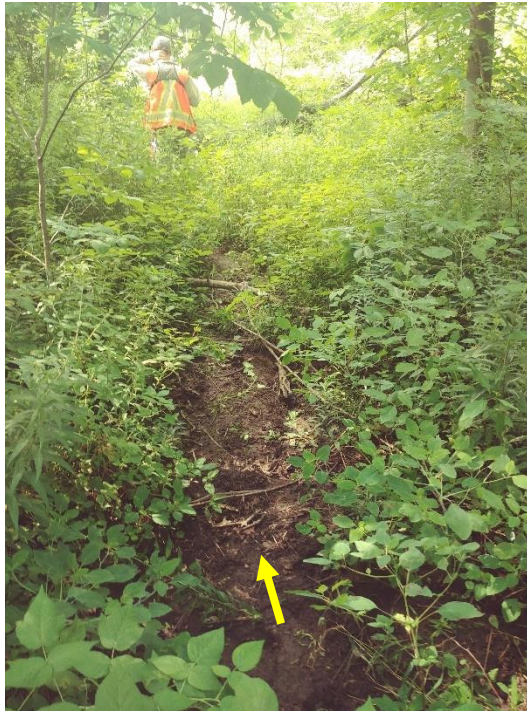
Photo 24
Tributary of Twenty Mile Creek: Visit 3
Reach TTM C2-12-1b

The feature was dry during the summer visit but distinguishable from the surrounding woodlot. Bed materials consisted of sand, silt and organic matter

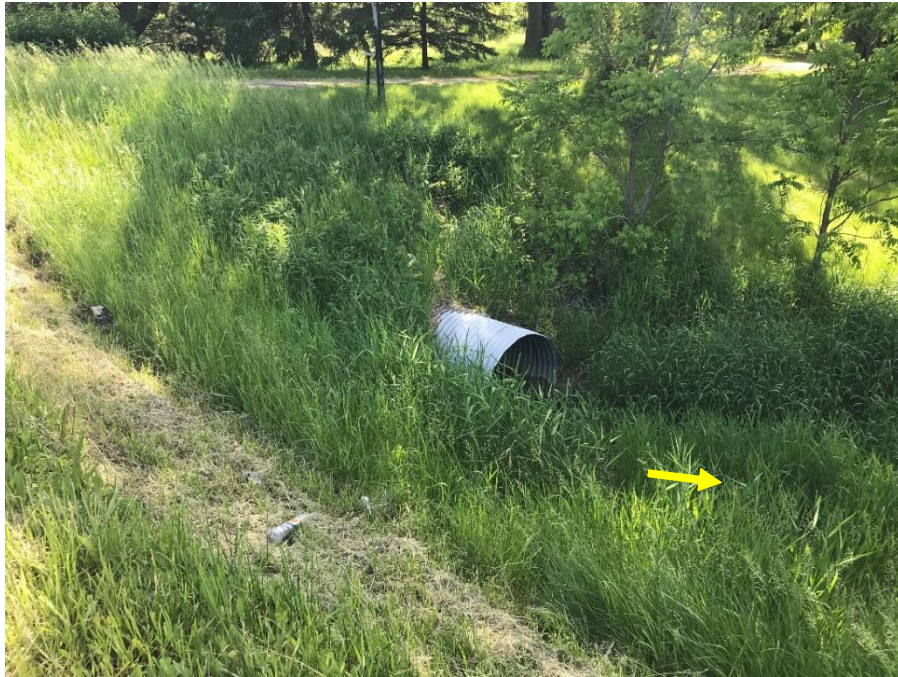
Photo 27
Tributary of Twenty Mile Creek: Visit 2
Reach TTMC3-1

A culvert discharged flows into the feature near its downstream extent. No water was observed within the pipe during the second visit.

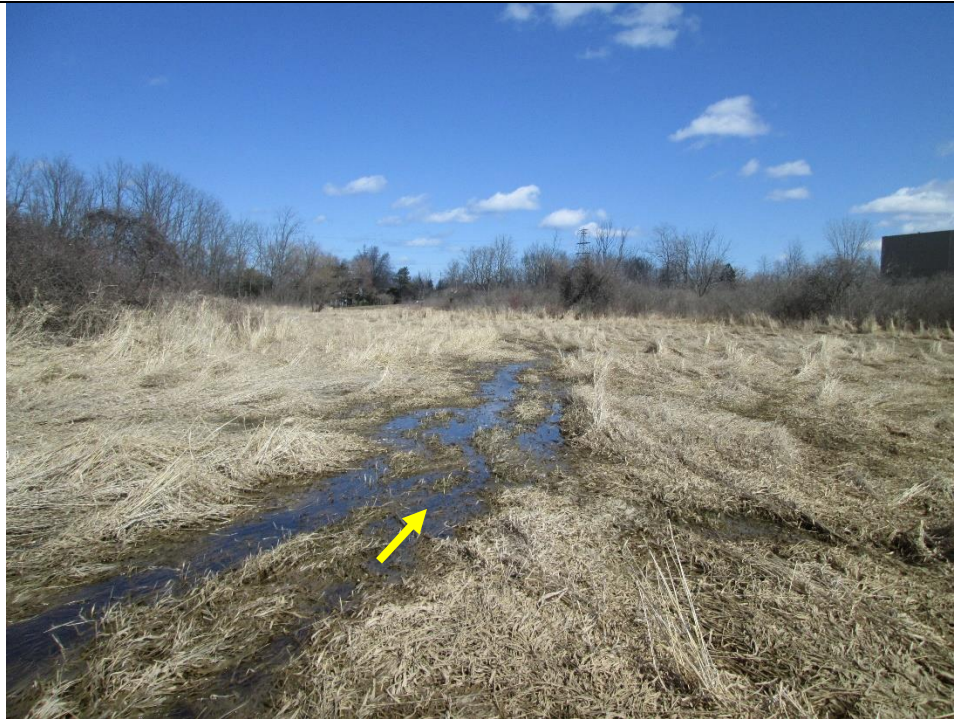
Photo 28
Tributary of Twenty Mile Creek: Visit 1
Reach TTMC3-2

The feature had no discernible banks, and occupied a wide grassy corridor characterized as a provincially significant wetland (PSW).

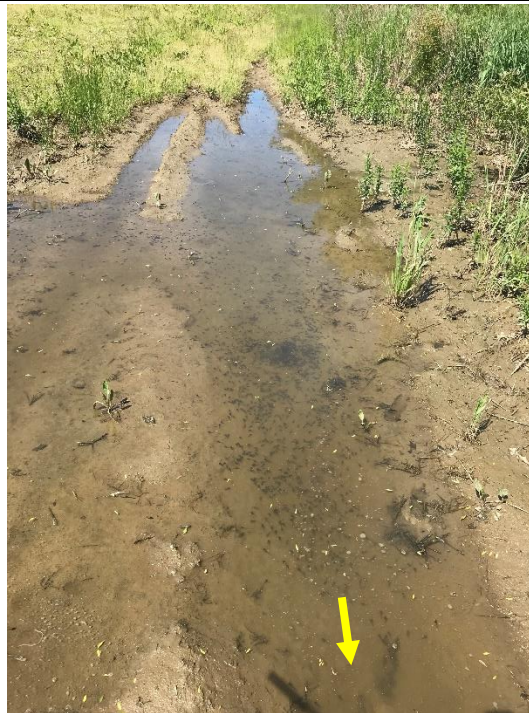
Photo 30
Tributary of Twenty Mile Creek: Visit 3
Reach TTMC3-2

Tadpoles were observed within an isolated pool. Substrate consisted of clay, silt and organic materials.

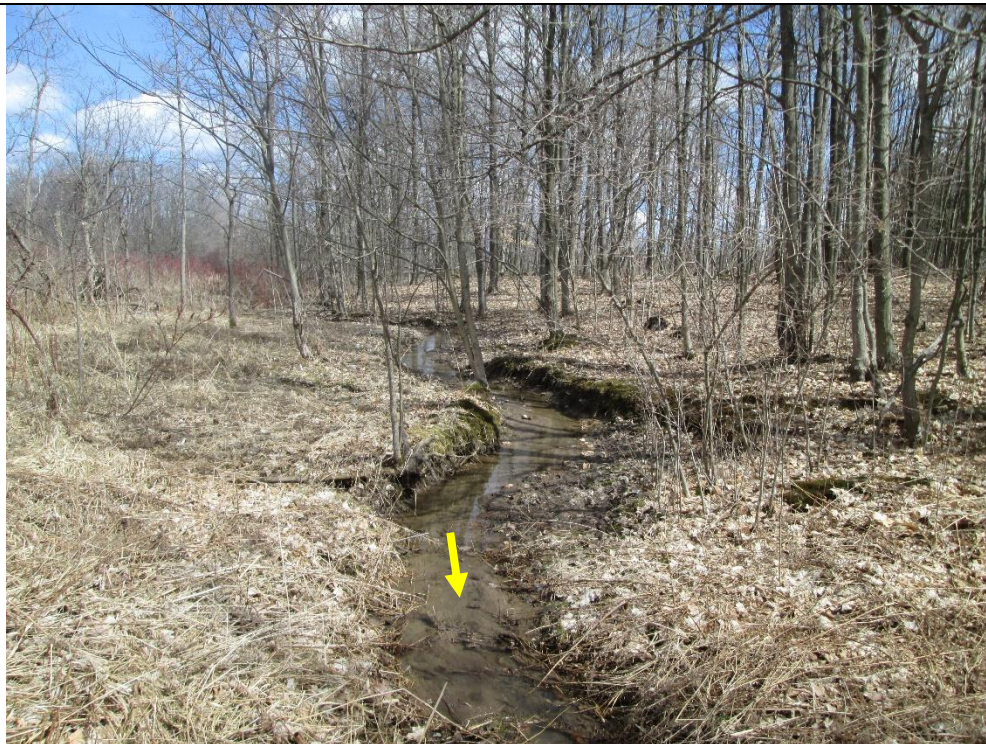
Photo 31
Tributary of Twenty Mile Creek: Visit 1
Reach **TTMC3-2-1**

The feature was a defined channel which conveyed flows through a woodlot.

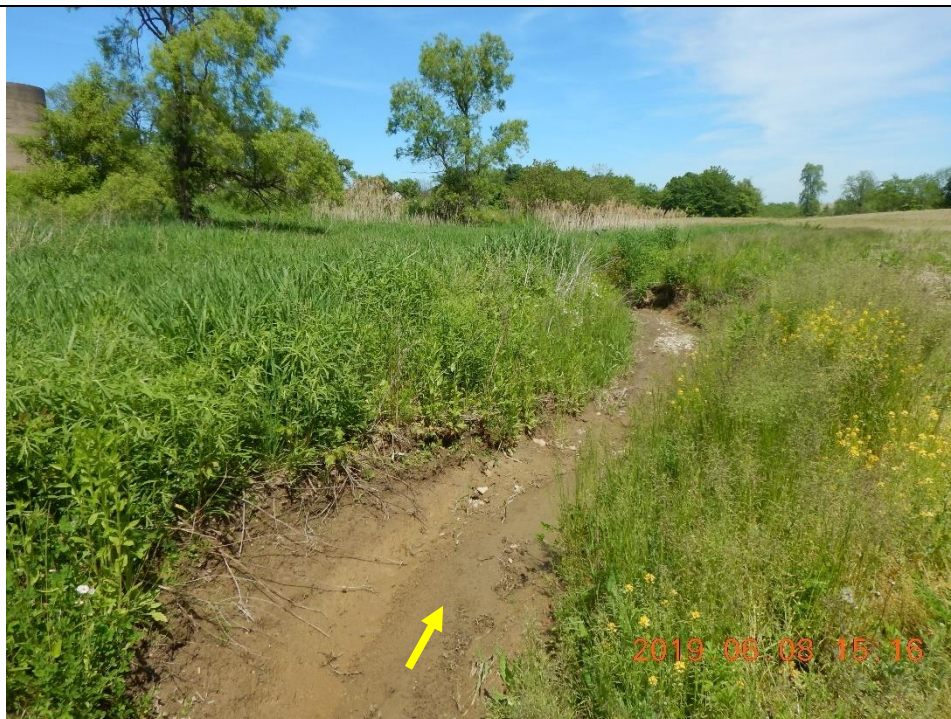
Photo 41
Tributary of Twenty Mile Creek: Visit 2
Reach TTM3-4

The riparian buffer consisted predominantly of herbaceous species, with some agricultural crops noted on the south side of the channel further downstream.

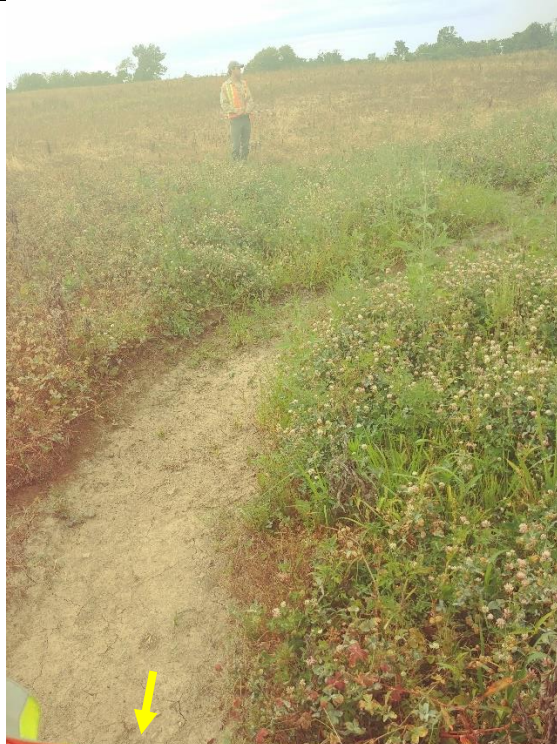
Photo 42
Tributary of Twenty Mile Creek: Visit 3
Reach TTM3-4

The channel bed was predominantly composed of clay and gravel and was dry during the summer visit.

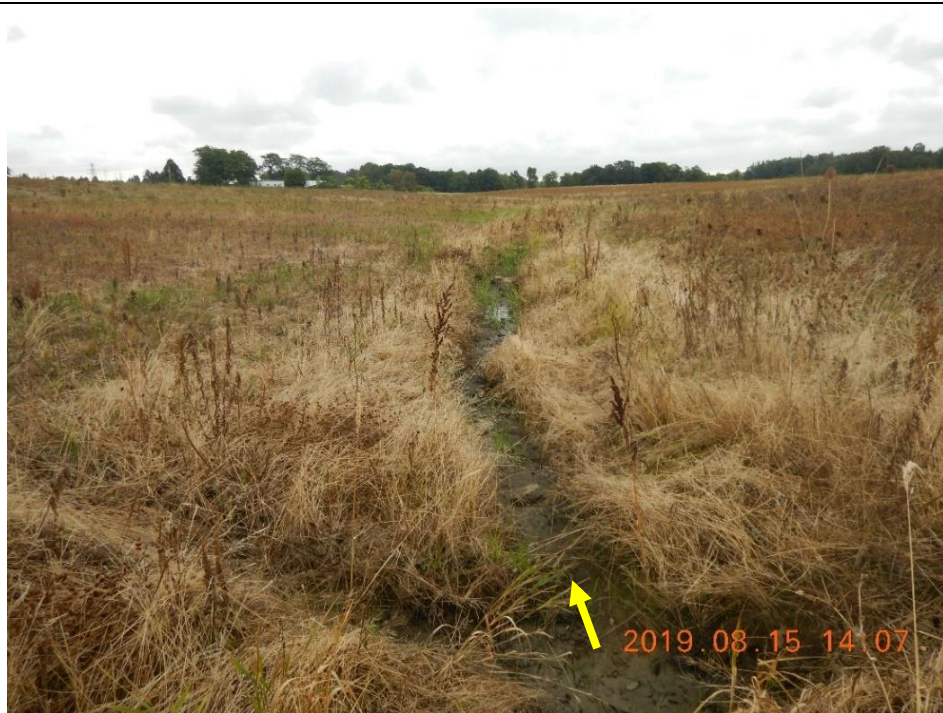
Photo 45
Tributary of Twenty Mile Creek: Visit 3
Reach **TTMC3-5**

The dominant substrate was clay and silt, but some sand, gravel and, cobbles were also observed. The channel was mainly dry with some isolated stagnant pools.

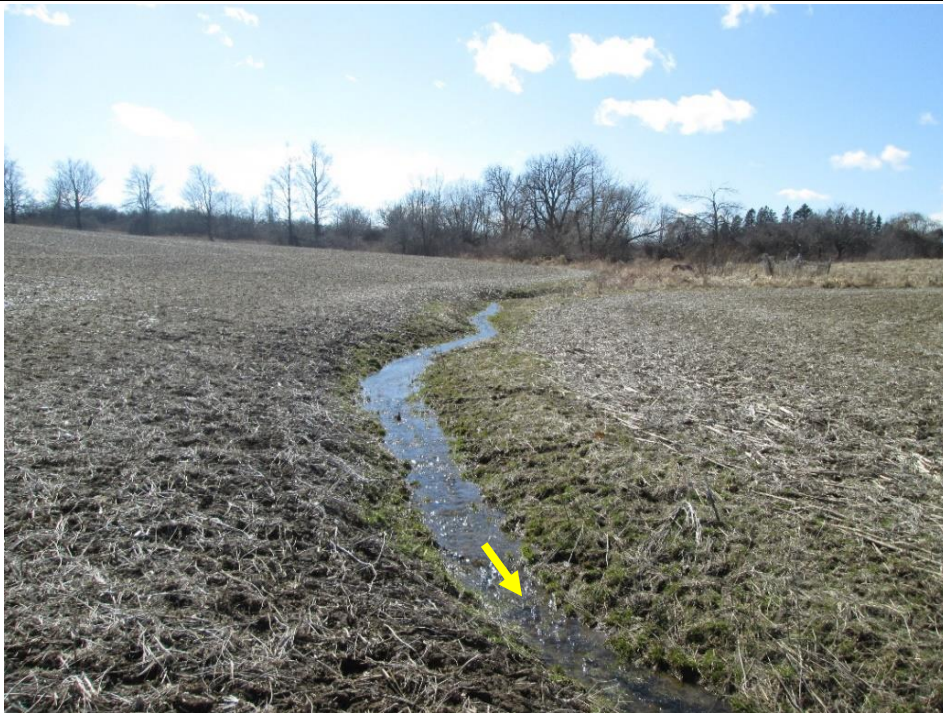
Photo 46
Tributary of Twenty Mile Creek: Visit 1
Reach **TTMC3-6**

The feature conveyed flows through an agricultural field, with water present during the spring visit.

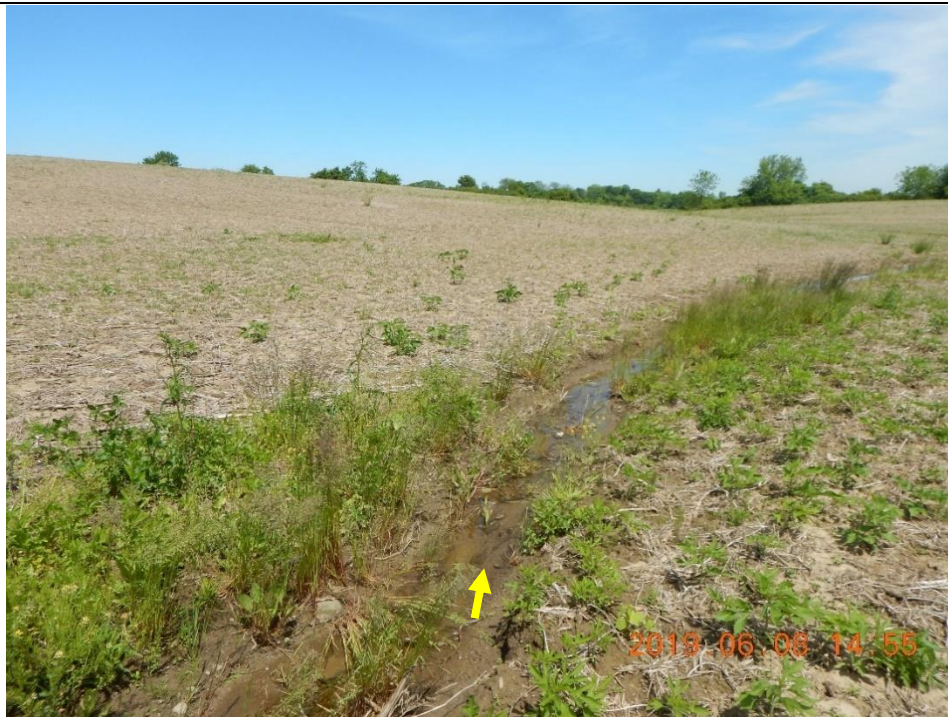
Photo 47
Tributary of Twenty Mile Creek: Visit 2
Reach TTM3-6

Riparian vegetation was predominantly agricultural crops, with some herbaceous and grass species also observed.

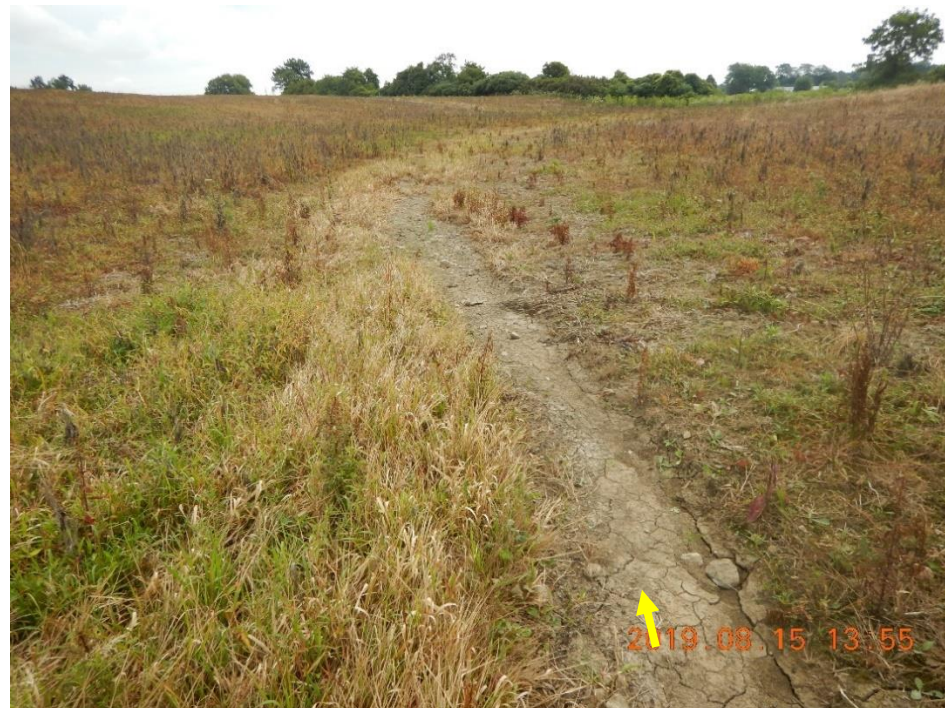
Photo 48
Tributary of Twenty Mile Creek: Visit 3
Reach TTM3-6

Bed and banks were mostly composed of the same material as the agricultural fields, a clay, silt, sand mixture, although some cobbles were present.

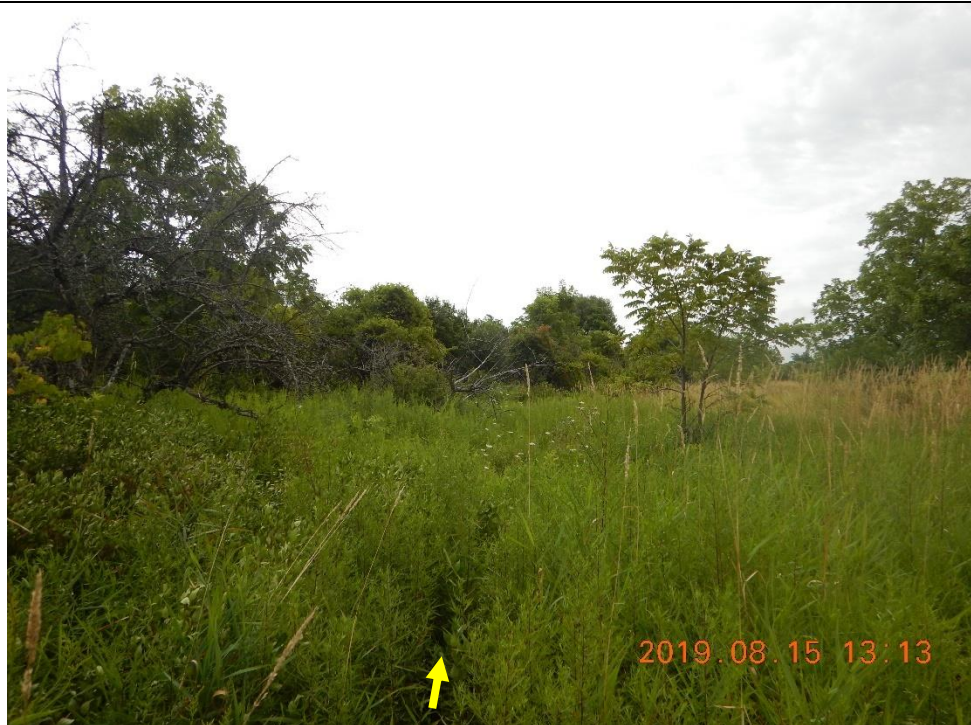
Photo 59
Tributary of Twenty Mile Creek: Visit 3
Reach TTM3-10

The substrate within the reach was clay, silt and sand. No flows were observed during the summer visit.

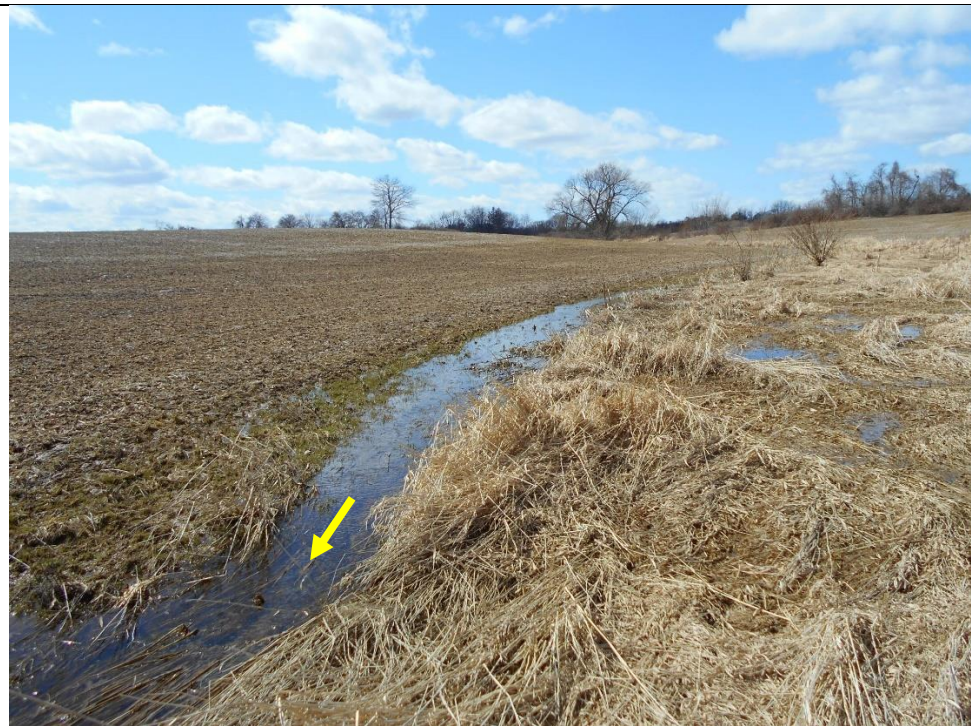
Photo 60
Tributary of Twenty Mile Creek: Visit 1
Reach TTM5-4

The feature had poor channel definition and conveyed flows through an agriculture field.

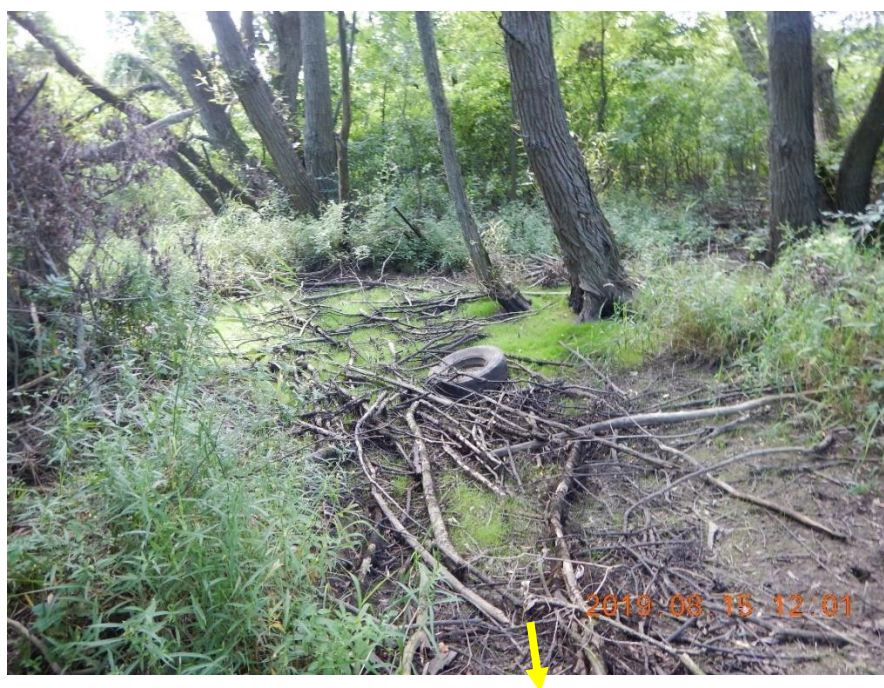
Photo 68
Tributary of Twenty Mile Creek: Visit 3
Reach TTMCS-6

The substrate within the channel was predominantly clay, silt and sand. No water was observed during the summer visit.

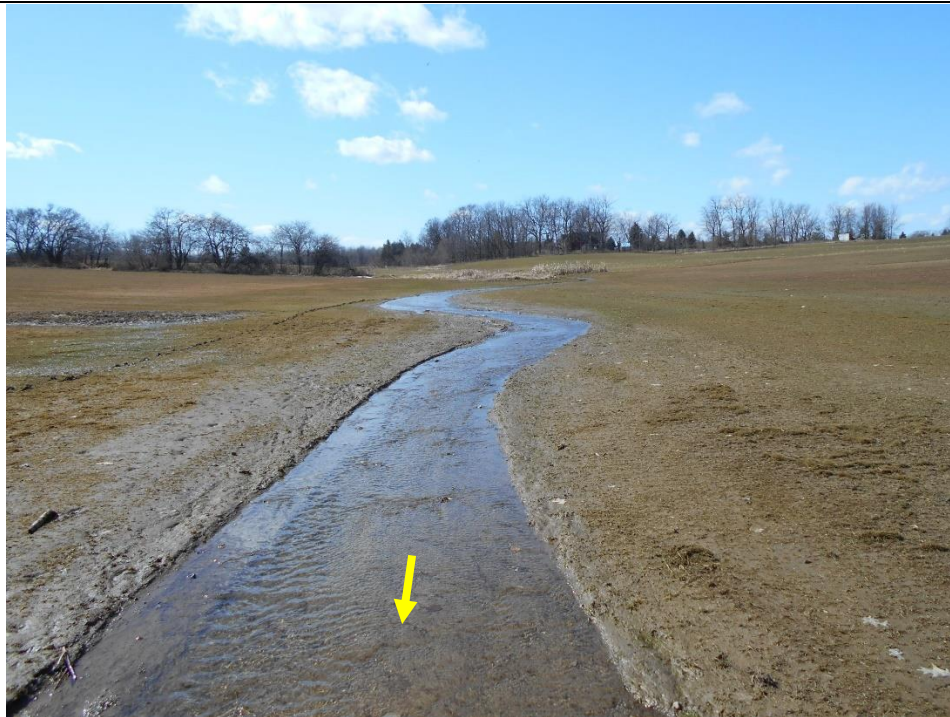
Photo 69
Tributary of Twenty Mile Creek: Visit 1
Reach TTMCS-7

The feature had some bed and bank definition during the spring as it conveyed flows through an agricultural field.

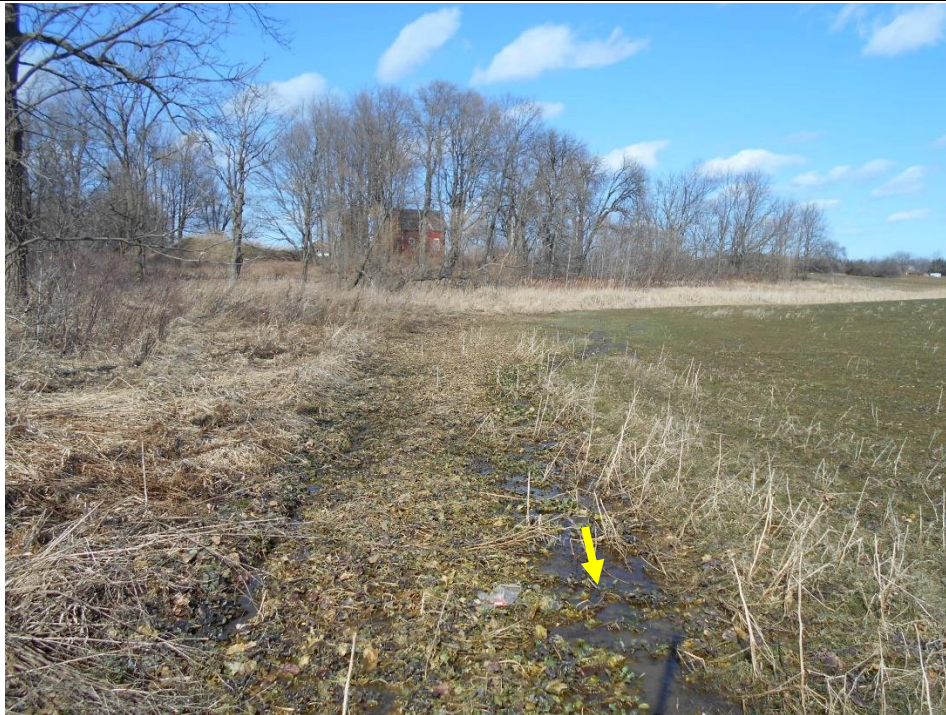
Photo 75
Tributary of Twenty Mile Creek: Visit 1
Reach TTM5-8-1

The feature had poorly defined banks, but a discernible channel was observed. Water was flowing during the spring visit.

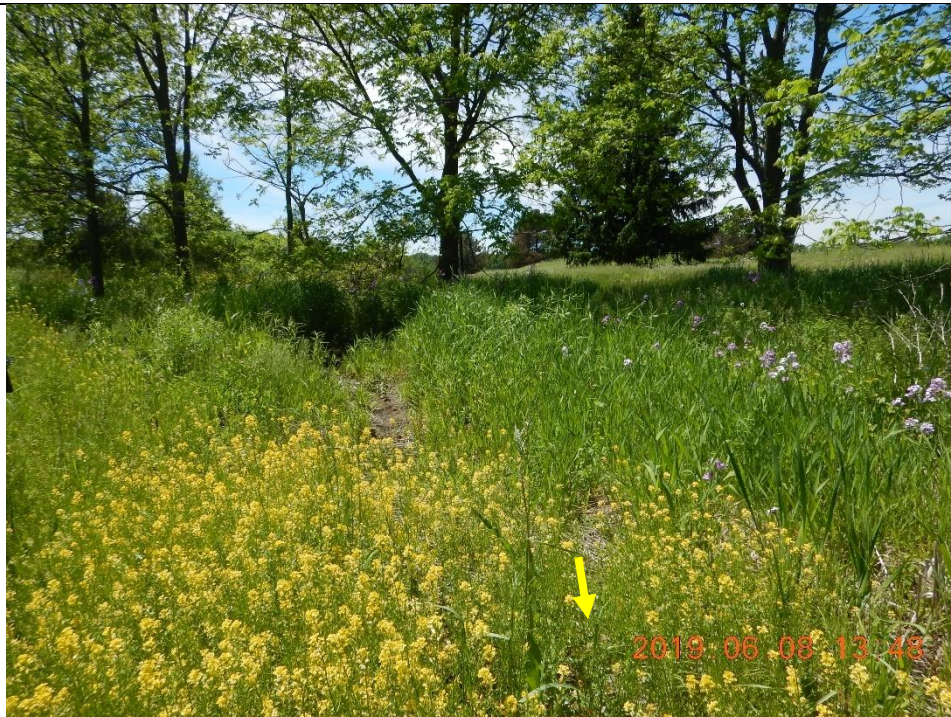
Photo 76
Tributary of Twenty Mile Creek: Visit 2
Reach TTM5-8-1

Riparian vegetation consisted of herbaceous vegetation and grasses. The channel was dry during the second visit.

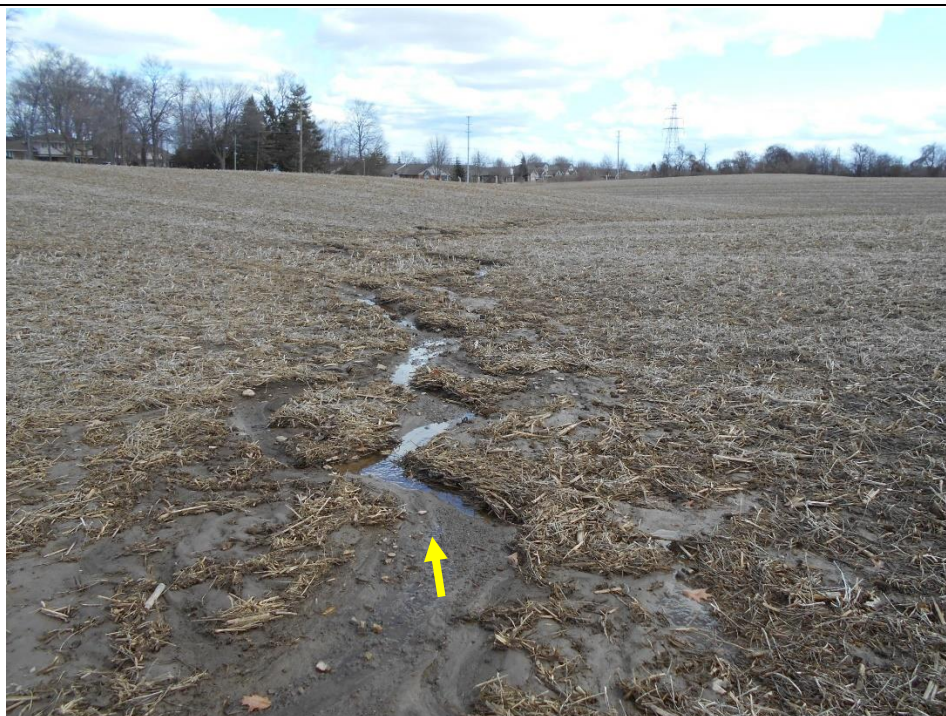
Photo 80
Tributary of Twenty Mile Creek: Visit 1
Reach TTM6-1

The feature lacked defined bed and banks, and minimal flow was observed during the spring site visit.

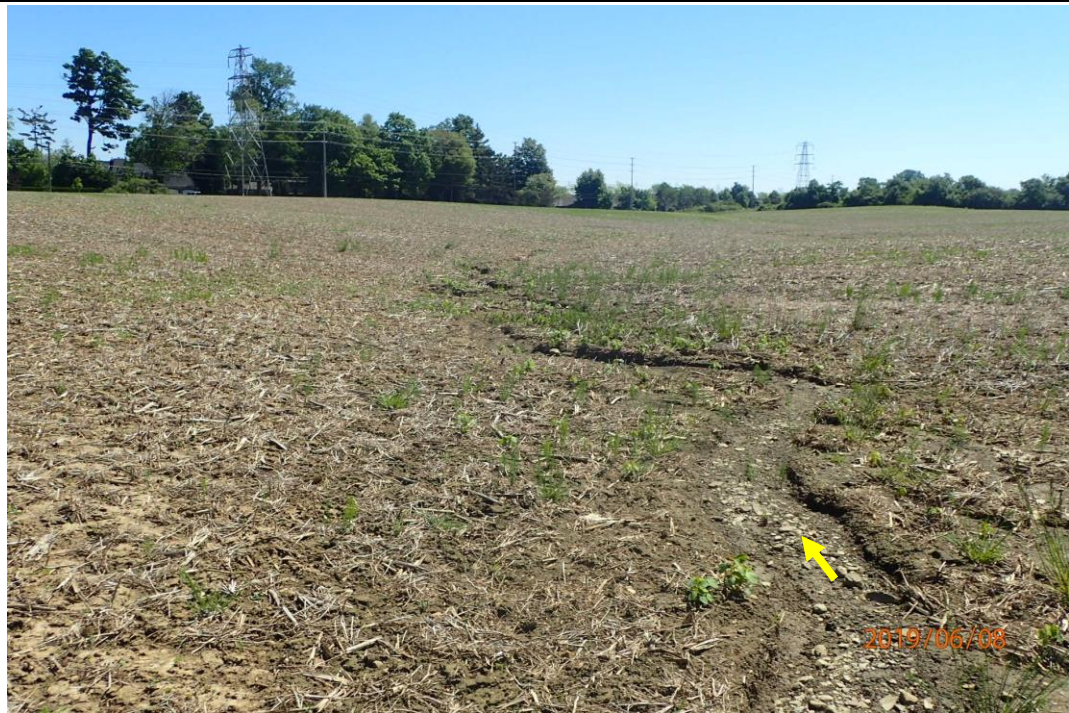
Photo 81
Tributary of Twenty Mile Creek: Visit 2
Reach TTM6-1

The channel was dry during the 2nd visit and the substrate was predominantly clay, silt, and sand. Some gravel and cobbles were also observed.

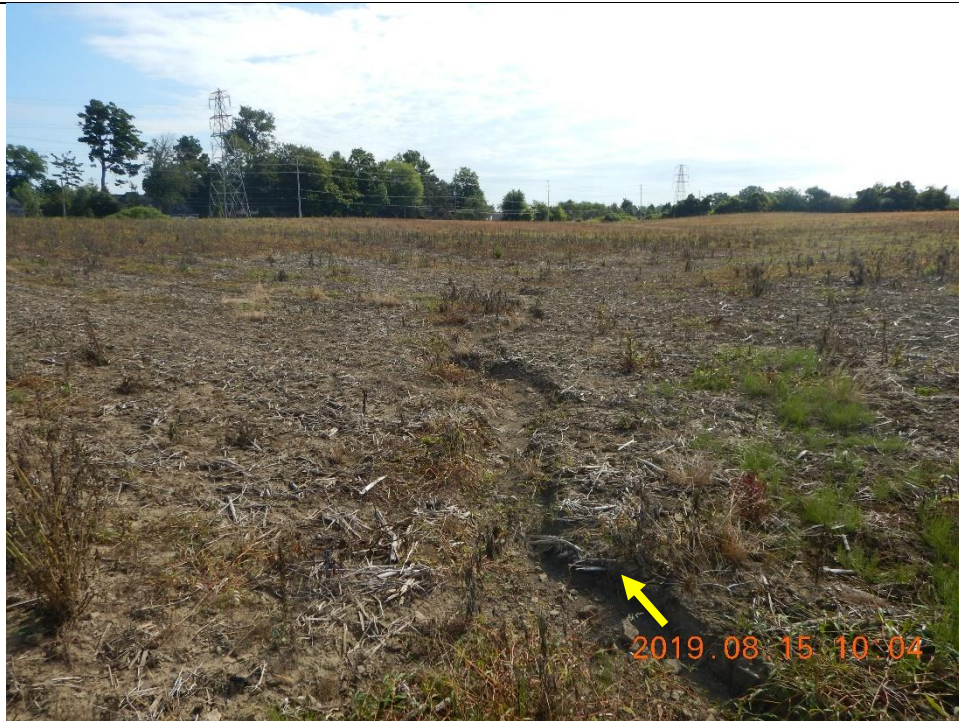
Photo 82
Tributary of Twenty Mile Creek: Visit 3
Reach TTM6-1

Vegetation within the feature was predominantly composed of the crops which occupied the adjacent fields, with sparse aquatic vegetation was infrequently observed.

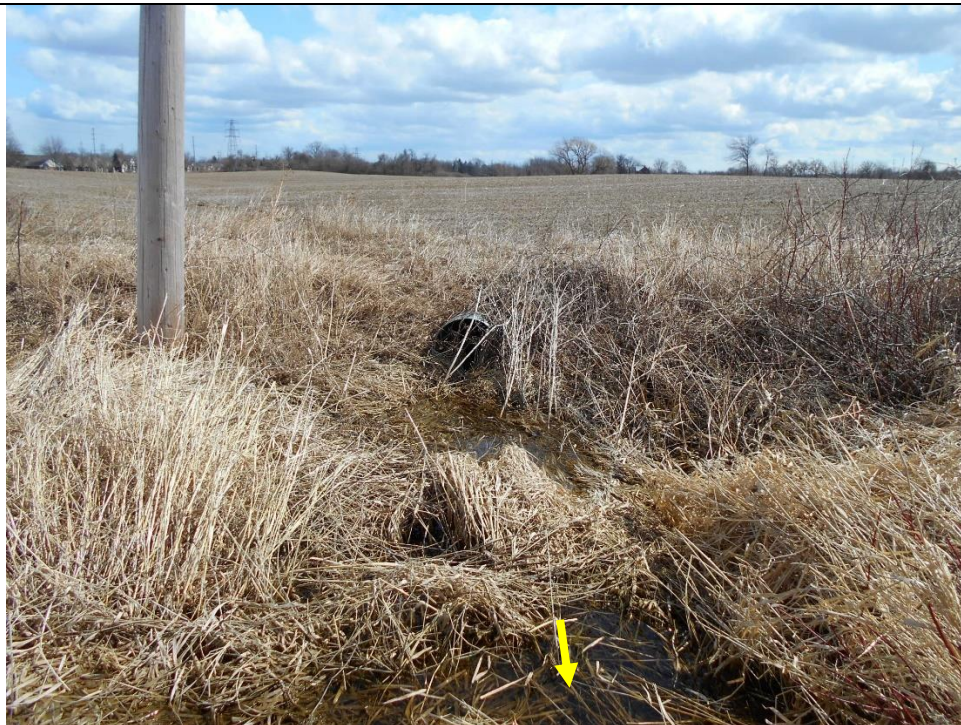
Photo 83
Tributary of Twenty Mile Creek: Visit 1
Reach TTM6-2

The feature had poor channel definition and originated at a culvert. The reach conveyed flows within the fallow orchard.

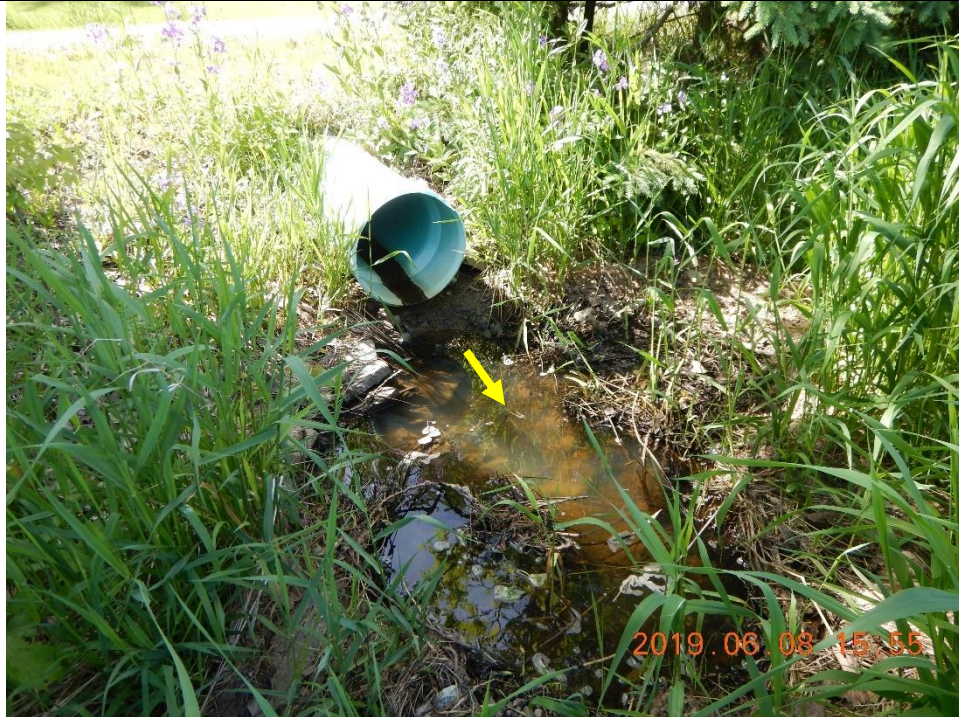
Photo 93
Tributary of Twenty Mile Creek: Visit 2
Reach TTM7-1

The feature was surrounded by meadow and grass species and some standing water was observed during the second visit.

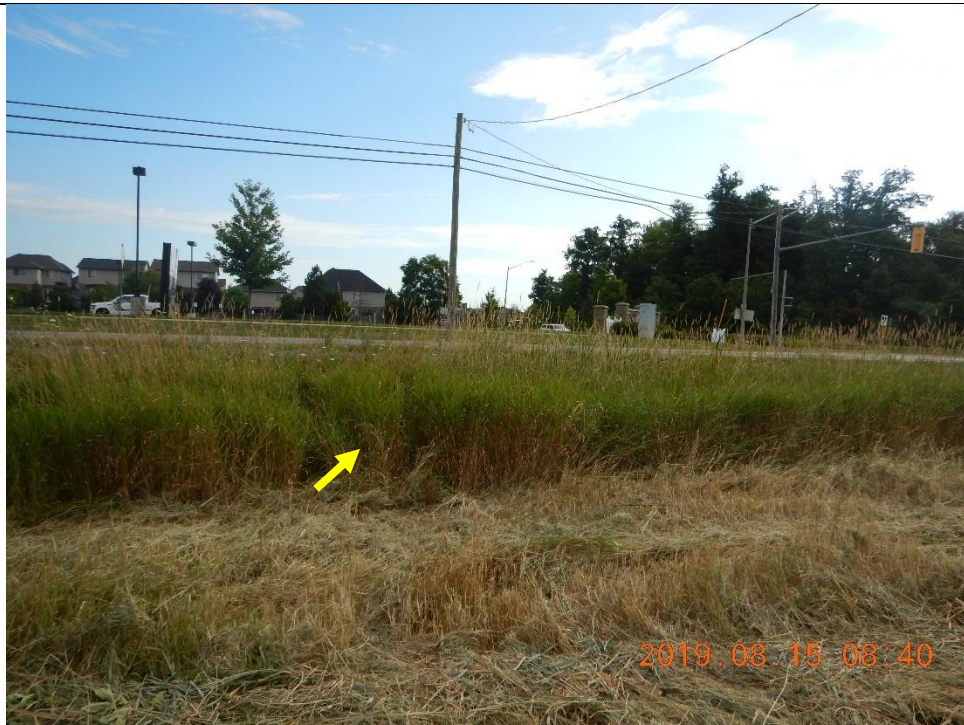
Photo 94
Tributary of Twenty Mile Creek: Visit 3
Reach TTM7-1

Bed material for the reach was predominantly clay, silt and sand. No water was present within the reach during the third visit.
