Upper West Side Secondary Plan Area Fluvial Geomorphological Assessment And Natural Channel Design

Twenty Road West, City of Hamilton

November 20, 2023
PN23079

Report Title: Upper West Side Secondary Plan Area
Fluvial Geomorphological Assessment and Natural
Channel Design

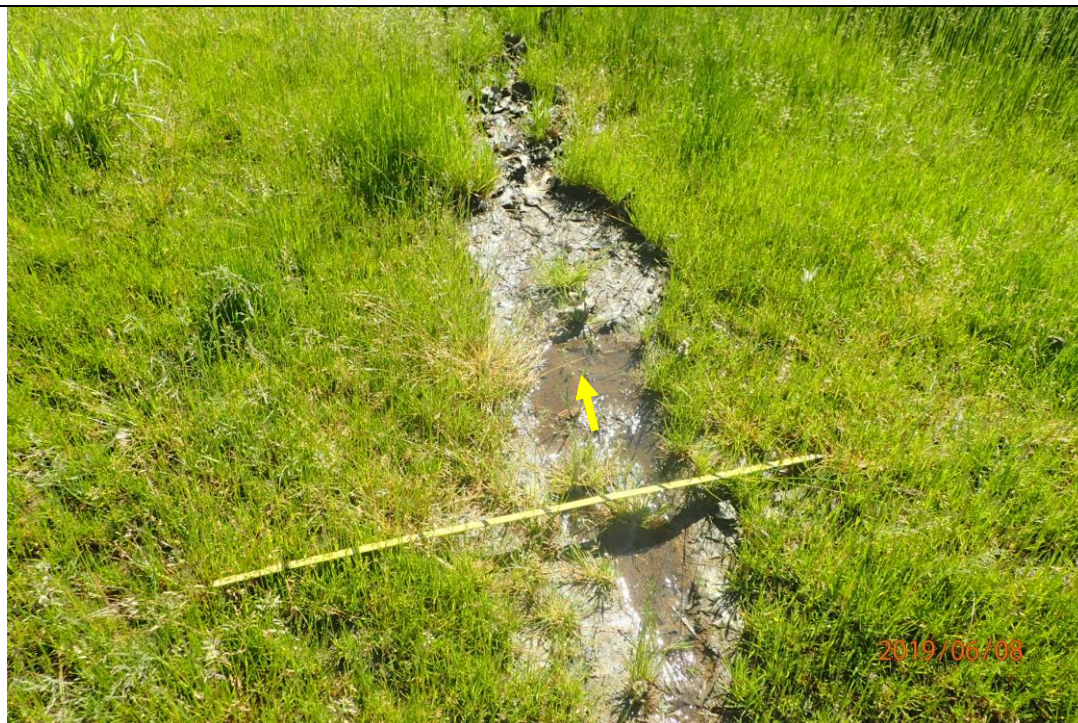
Photo 103
Tributary of Twenty Mile Creek: Visit 2
Reach TTMC8-9-1

The feature lacked definition and conveyed flows through an agricultural field. Standing water was observed during the 2nd visit.

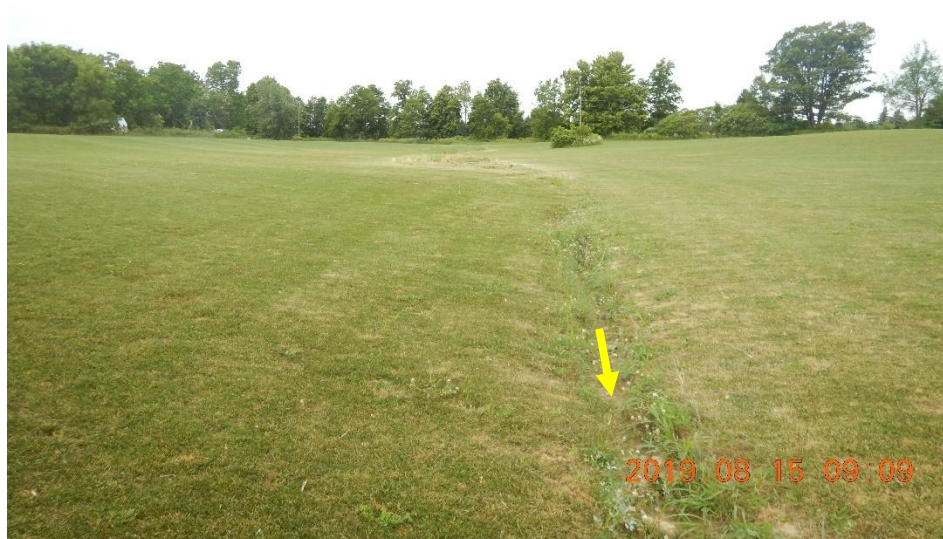
Photo 104
Tributary of Twenty Mile Creek: Visit 3
Reach TTMC 8-9-1

Bed composition was predominantly clay, silt and sand. The feature was dry during the summer visit.

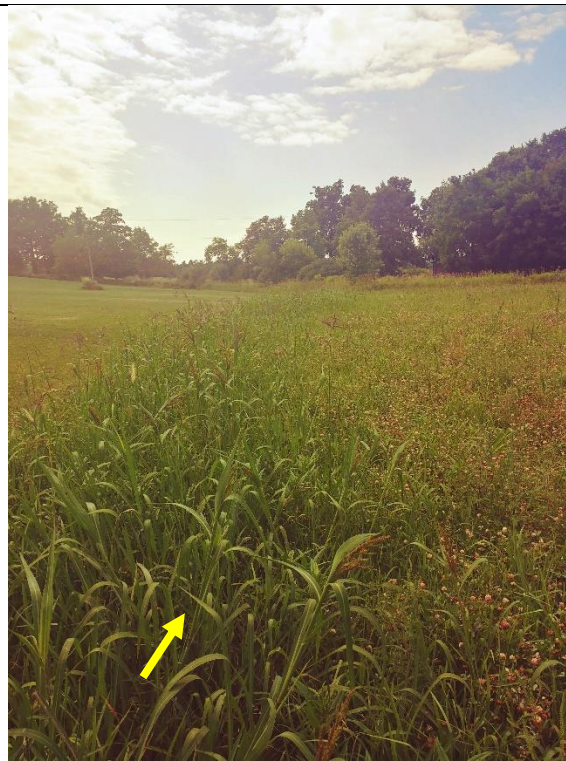
Photo 108
Tributary of Twenty Mile Creek: Visit 3
Reach TTMC8-3-3

Substrate within the intermittent feature was predominantly clay, silt, and sand. No water was observed during the 3rd visit.

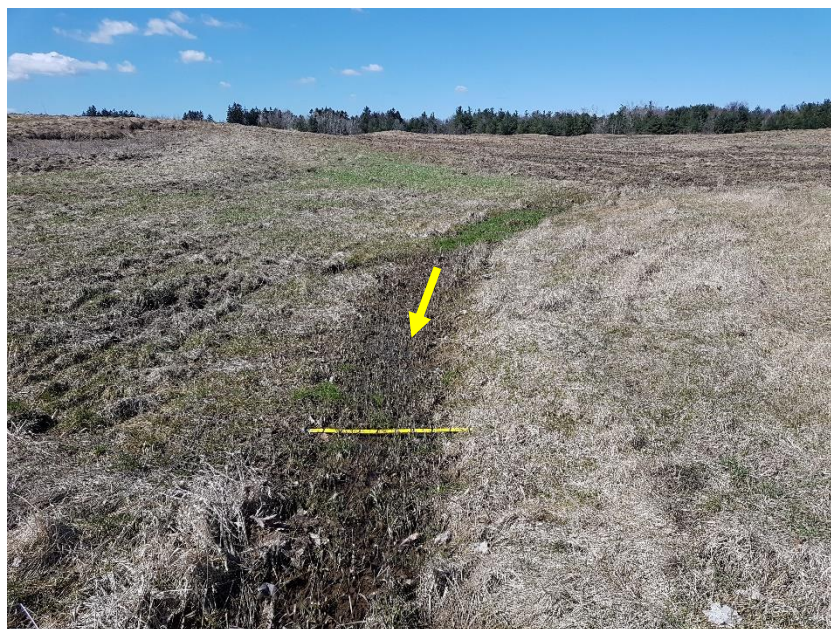
Photo 109
Tributary of Twenty Mile Creek: Visit 1
Reach TTMC8-3-4

The feature lacked channel definition and contained limited water during first round visit.

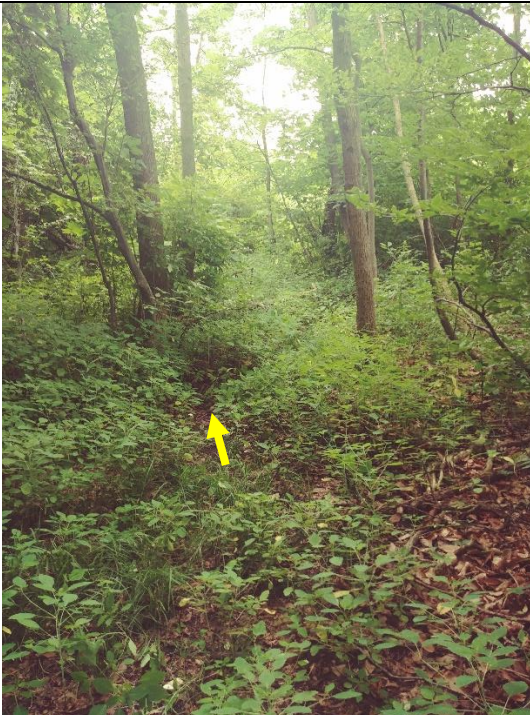
Photo 112
Tributary of Twenty Mile Creek: Visit 3
Reach TTM9-1

The low gradient feature's substrate was predominantly composed of decomposing organic matter and silt. Water was not observed during the 3rd visit.

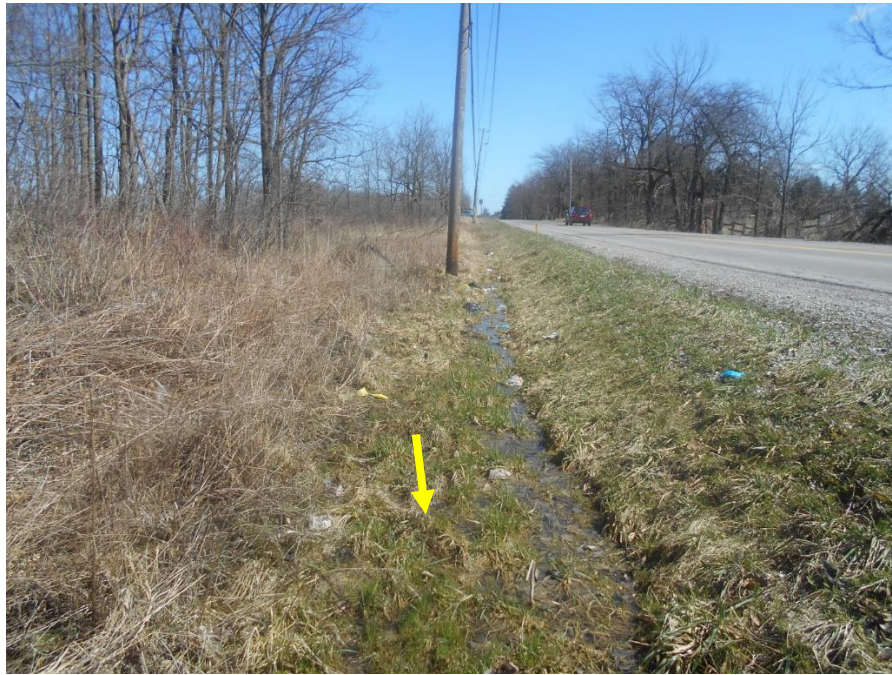
Photo 113
Tributary of Twenty Mile Creek: Visit 1
Reach TTMC9-1a

The feature ran parallel to a road and a woodlot with water present during visit 1.
