Fluvial Geomorphology Study Fruitland-Winona Block 1 Servicing Strategy City of Hamilton, Ontario

March 8, 2024
PN21043

Report Title: Fluvial Geomorphology Study - Fruitland-Winona Block 1
Servicing Strategy

Project Number: PN21043

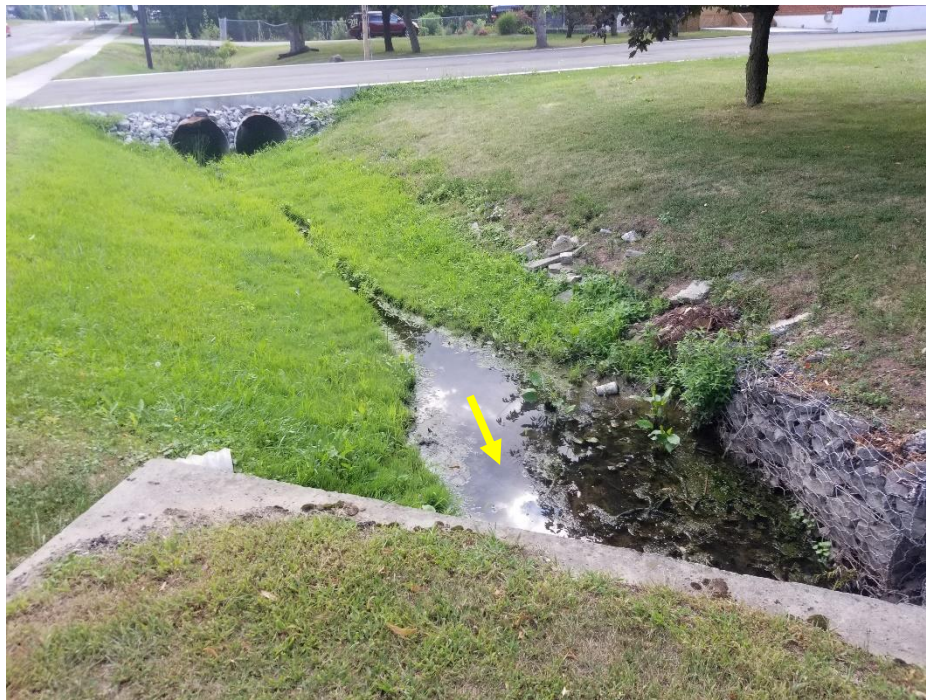
Photo 1
Reach **WC5**

Flows enter reach **WC5** through a concrete box culvert passing under Fruitland Road. No erosion concerns were noted. Yellow arrow denotes flow direction.

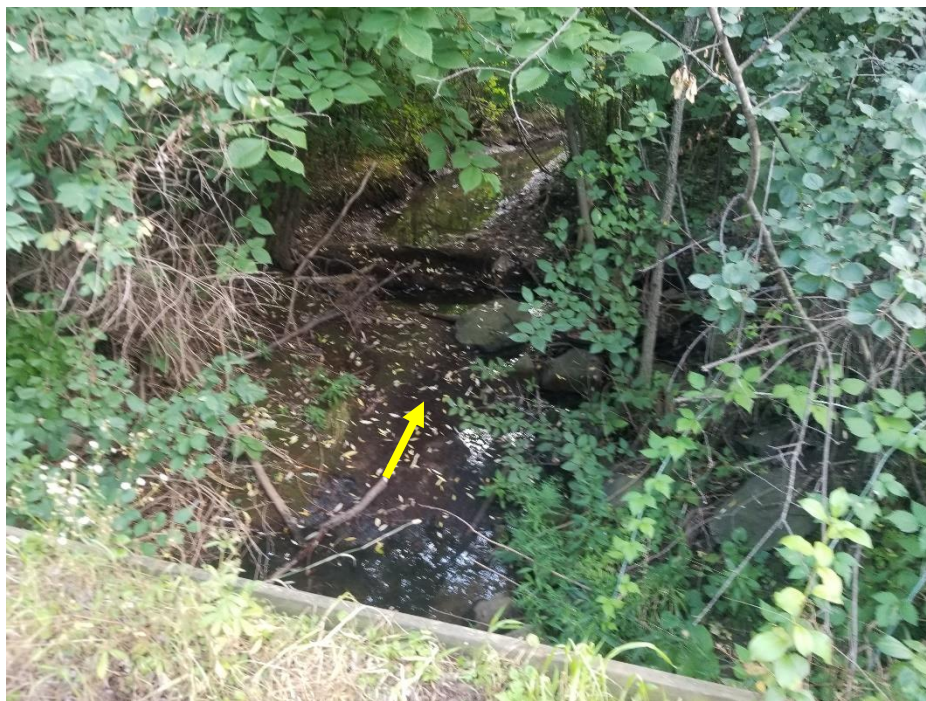
Photo 2
Reach **WC5**

No bed scour was noted downstream of the Fruitland Road culvert.

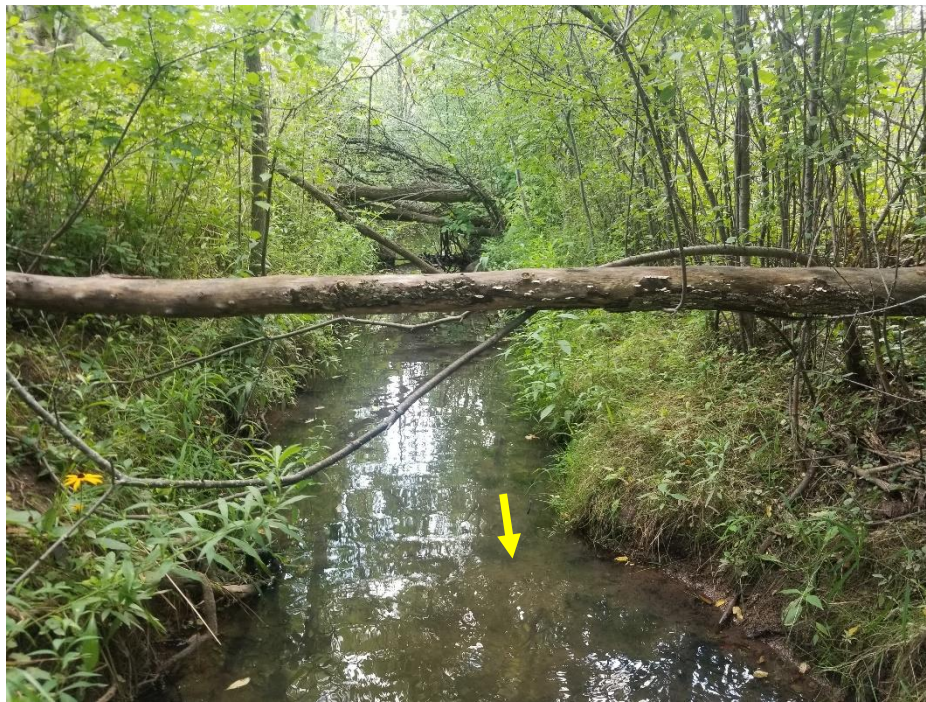
Photo 3
Reach **WC5**

Reach **WC5** has a predominantly trapezoidal channel shape throughout the study area. Minimal flow velocities were observed during the assessment.

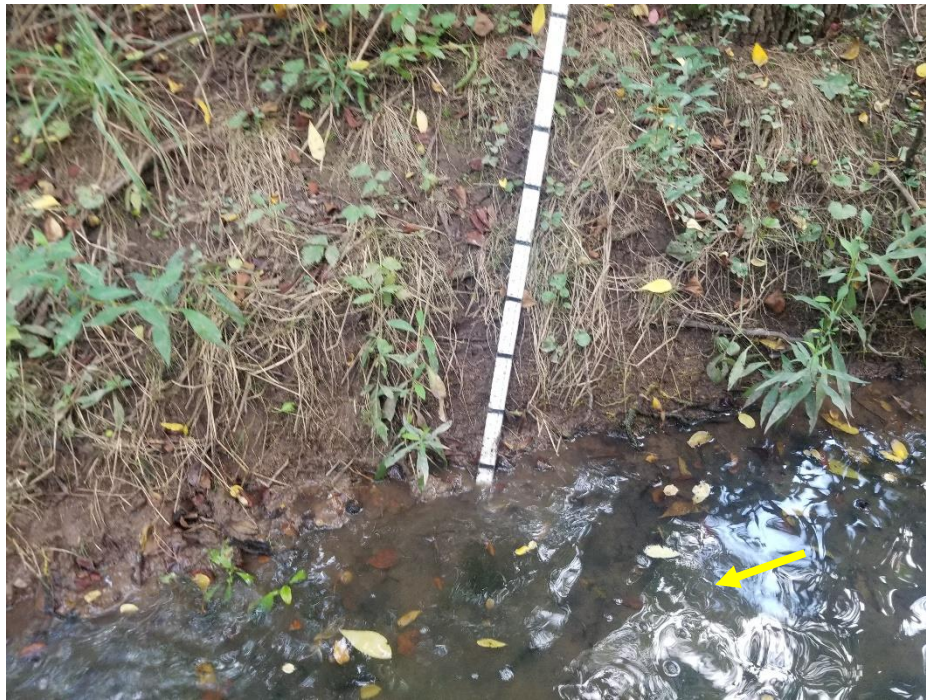
Photo 4
Reach **WC5**

Bank materials across the entire reach are characterized by silty clay. Occasional tree roots were observed, but the bottom third of the bank is typically exposed.

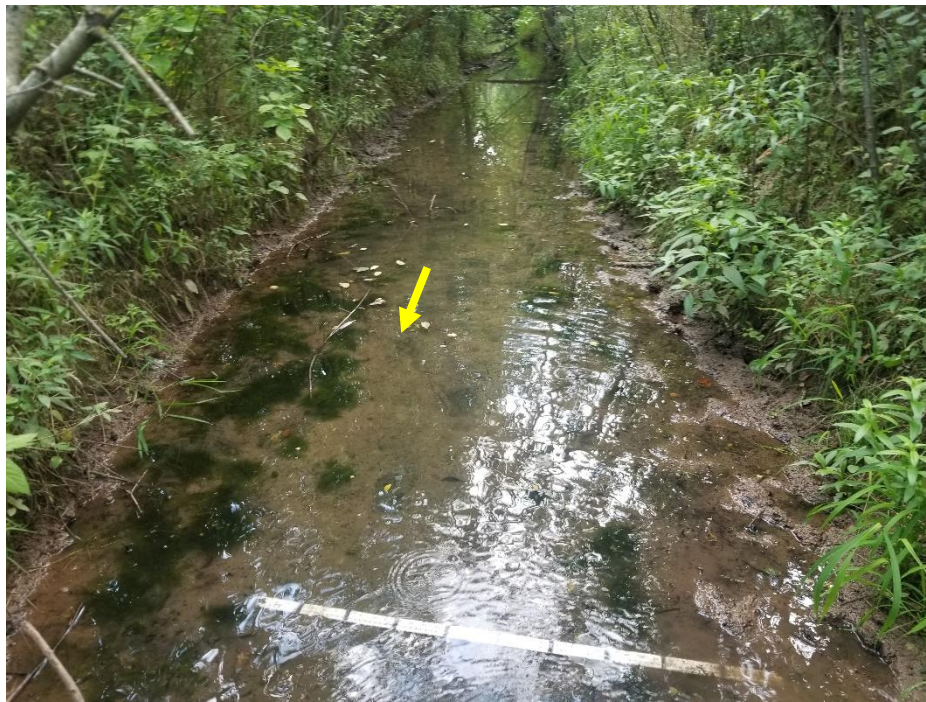
Photo 5
Reach **WC5**

Bed materials are consistent with the bank materials but are much less compact. Algae is abundant throughout the reach.

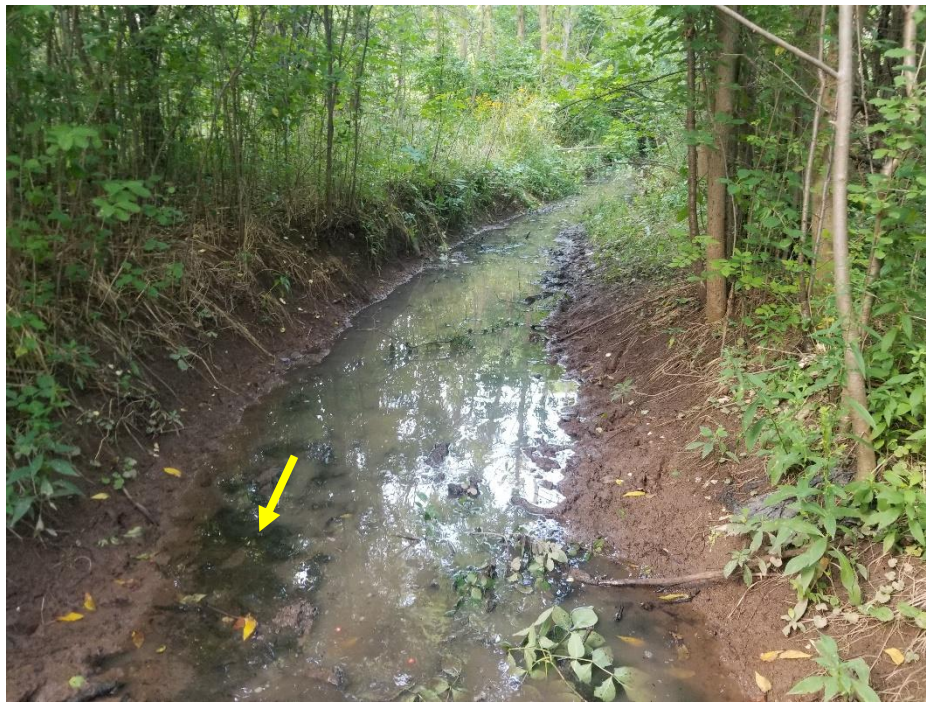
Photo 6
Reach **WC5**

Exposed material is common at toe of bank. Riparian vegetation provides some level of stabilization, but roots are typically small and immature.

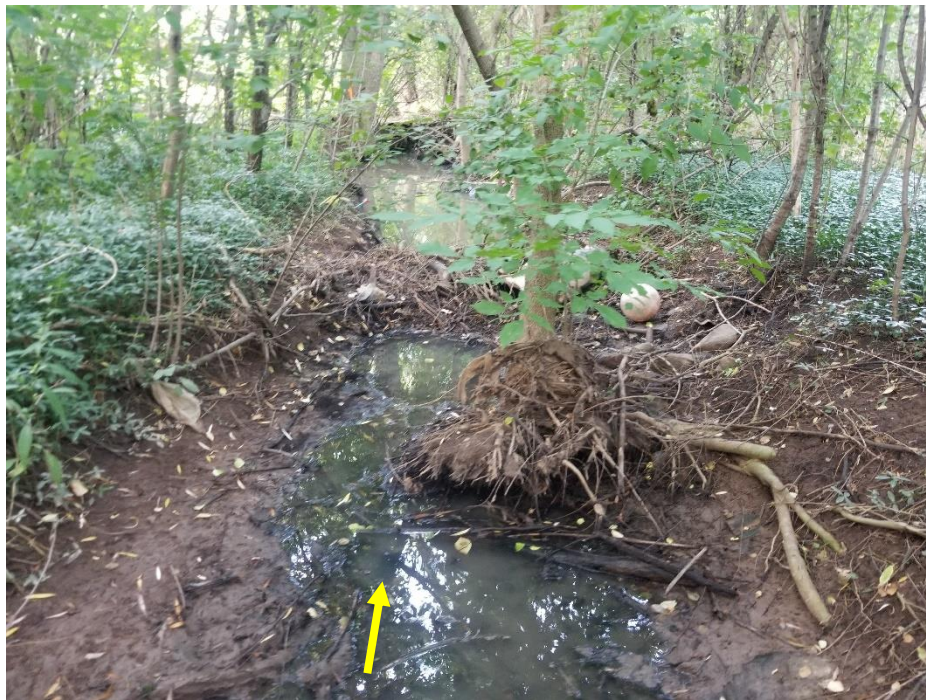
Photo 9
Reach **WC5**

Downstream of the footbridge, debris marks are visible on several flow-impeding trees, indicating the approximate bankfull flow stage.

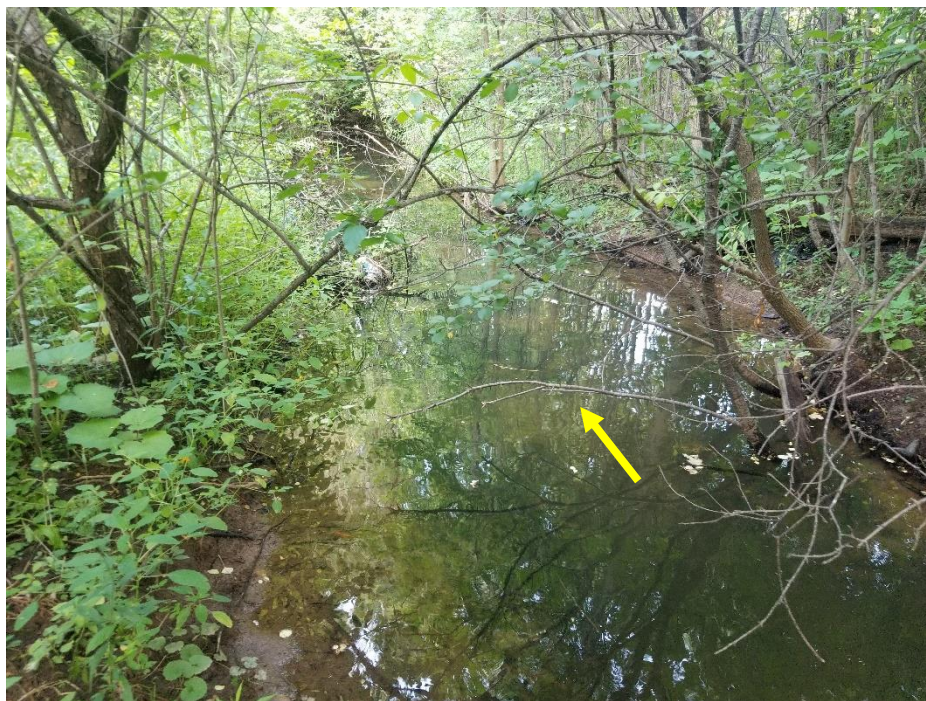
Photo 12
Reach **WC5**

Evidence of erosion largely subsides near the downstream extent, as the channel exhibits more depositional tendencies, indicated by siltation on the bed.
