Hunter Street West

Summary of Existing Conditions

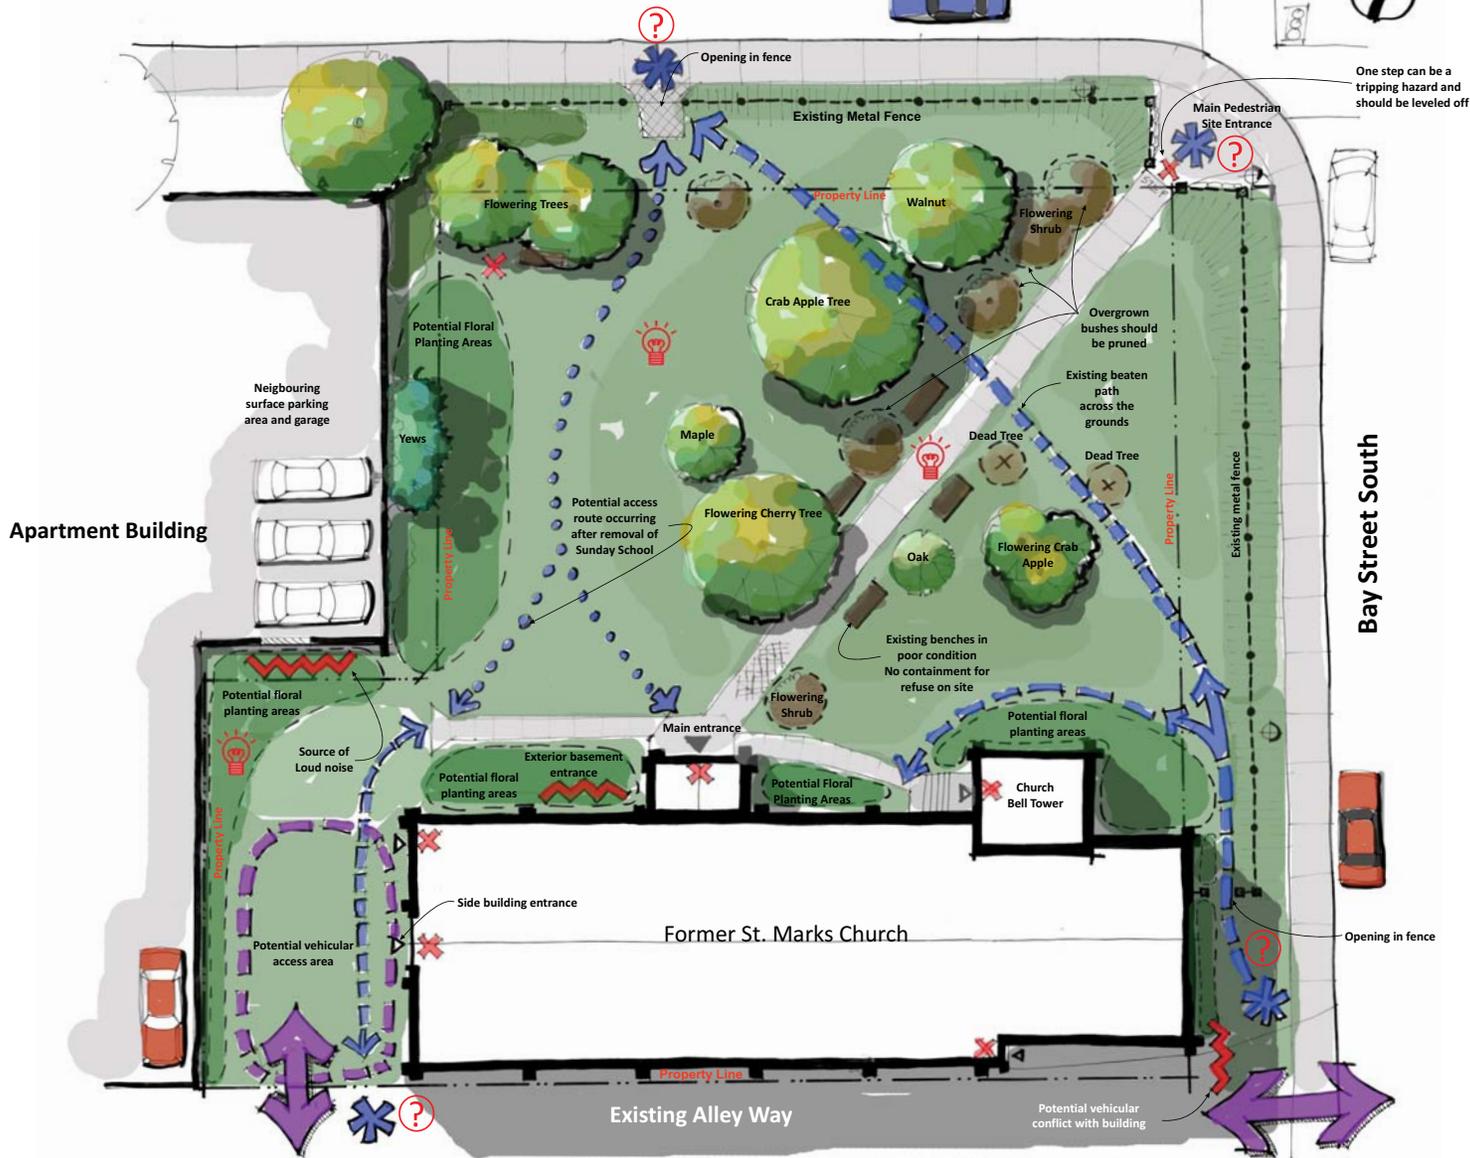
The former Church yard is not properly accessible. There are a number of trees and shrubs that require care and/or replacement. There are also areas of the church yard that are concealed from the street which contributes to an uninviting outdoor space. At night time, there are areas that are not well lit which, for many, can contribute to poor security and diminished sense of personal safety. The overall quality of the site furniture is not adequate, benches are placed too close and without good visibility to the street.

There are a few trees and flowering shrubs that are in good condition and that provide shade and visual interest.
