City of Hamilton

Red Hill Valley Parkway Detailed Safety Analysis

November 2015

CIMA
Partners in excellence

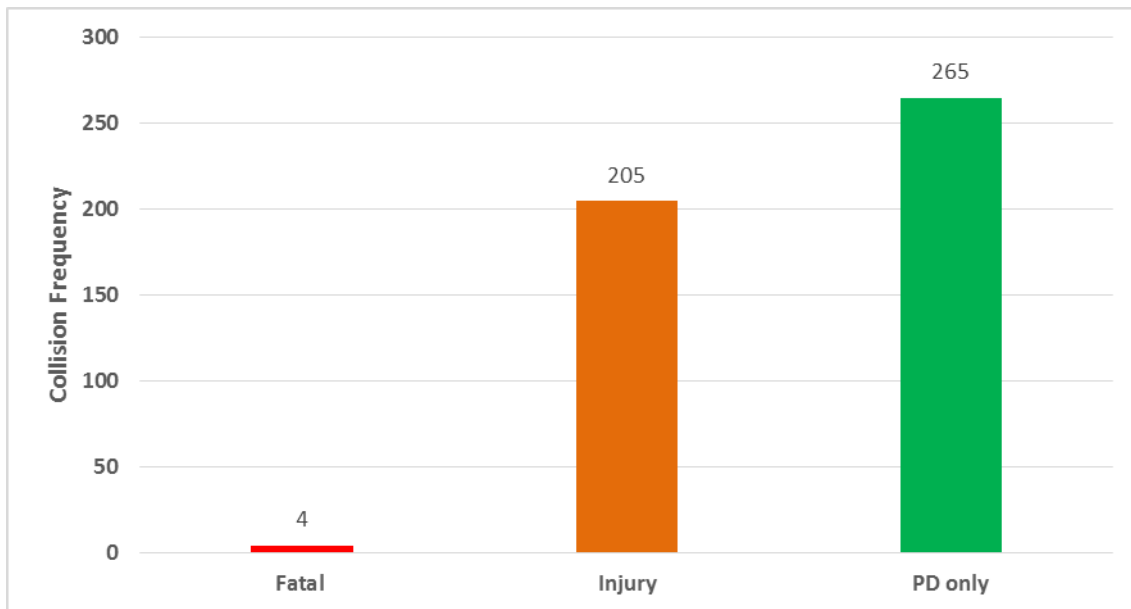
Figure 2: Collision severity

The study area experienced a total of 474 collisions during the period from January 1, 2008 to July 23, 2015. The data, broken down by collision severity, is summarized in **Figure 2**. There were 4 fatal collisions (resulting in 5 fatalities), 205 injury collisions, and 265 Property Damage Only (PDO) collisions.

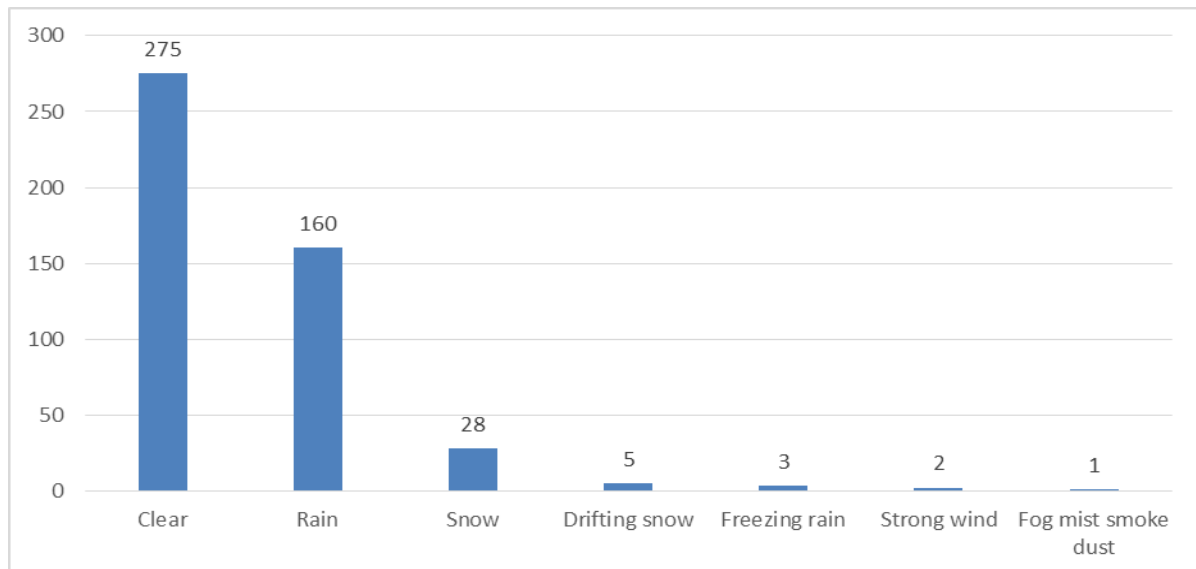
Figure 4: Collisions by environment condition

With respect to environment condition, 275 out of 474 collisions (58.0%) occurred with clear weather; 160 (33.7%) with rainy weather, and the remaining collisions with other weather conditions, including snow, drifting snow, freezing rain, strong wind, and fog/mist/smoke/dust. Compared to the Provincial average of 10.9%³ and the overall City of Hamilton average of 13.4%⁴, and based on a Chi-Square statistical test, the proportion of collisions under rainy weather is significantly higher. Details about the statistical test can be found in **Appendix A**.

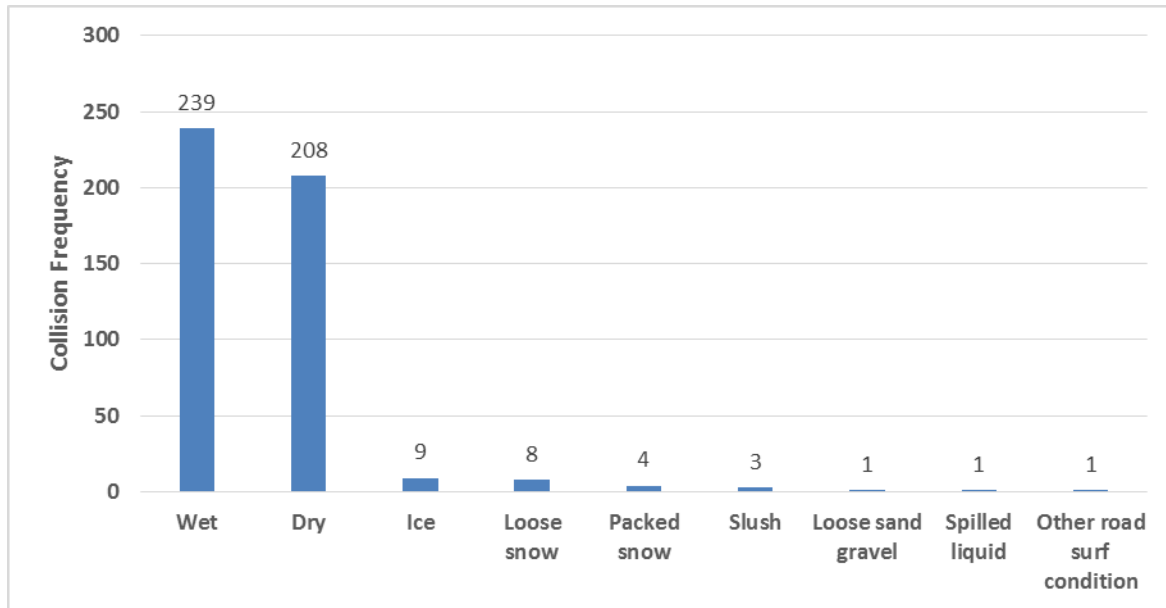
Figure 5: Collisions by road surface condition

Wet surface collisions make up the majority of collisions in the study area, with 50.4% (239 out of 474), followed by dry surface with 43.9% (208 out of 474). When compared to the Provincial average of 17.6% and the City of Hamilton average of 22%, and based on a Chi-Square statistical test, the proportion of collisions under wet road surface is significantly higher. Details about the statistical test can be found in **Appendix A**.

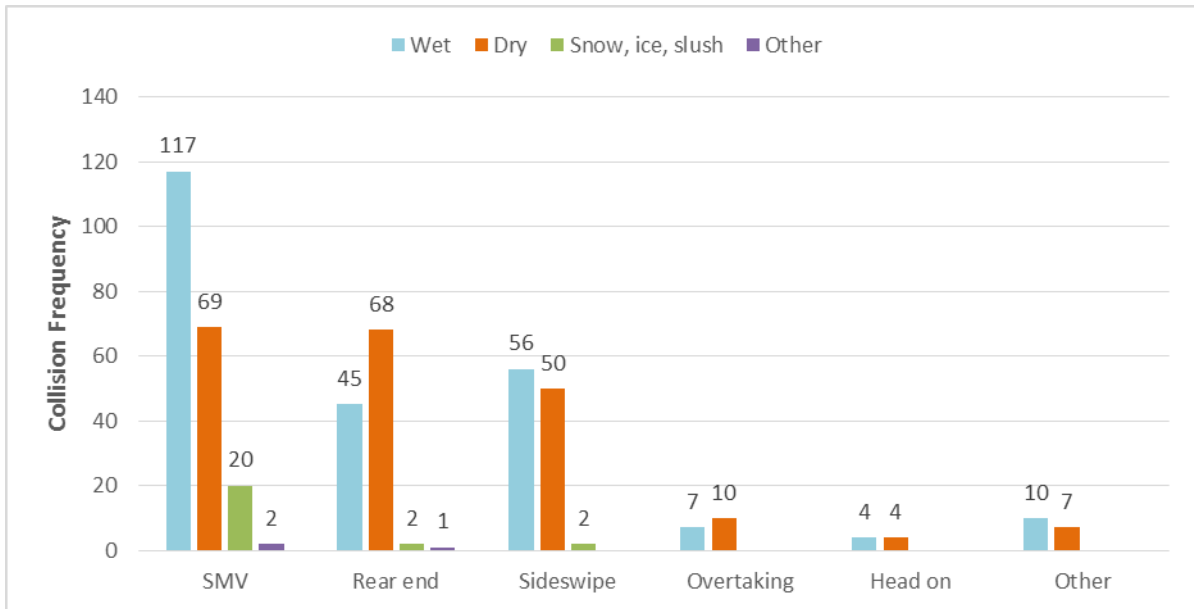
Figure 6: Collisions by impact type and roadway surface condition

Figure 6 summarizes collisions by impact type and by roadway surface condition.⁵ Single motor vehicle collisions (SMV) collisions are the most prevalent collision type with 208 incidents of a total of 474 collisions (44%). Rear end and sideswipe collisions with 116 (24%) and 108 (23%) incidents, respectively, were the next most common collision types.

Out of the 208 SMV collisions, 117 (56.3%) occurred under wet surface conditions, as well as 45 out of 116 rear end collisions (38.8%) and 56 out of 108 sideswipe collisions (51.9%).

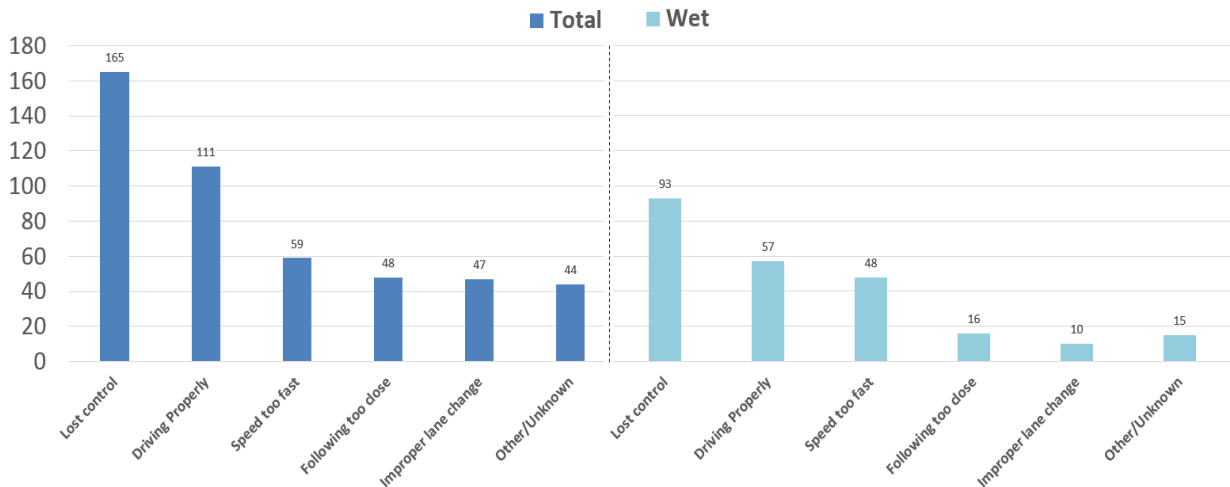
Figure 7: Apparent driver action

Figure 7 summarizes the collisions in the study area according to the apparent driver action, including total collisions and wet surface collisions. The most frequent apparent driver action reported is “lost control”, with 165 out of 474 collisions (34.8%), followed by “driving properly” (23.4%), “speed too fast” (12.4%), “following too close” (10.1%), and “improper lane change” (9.9%).

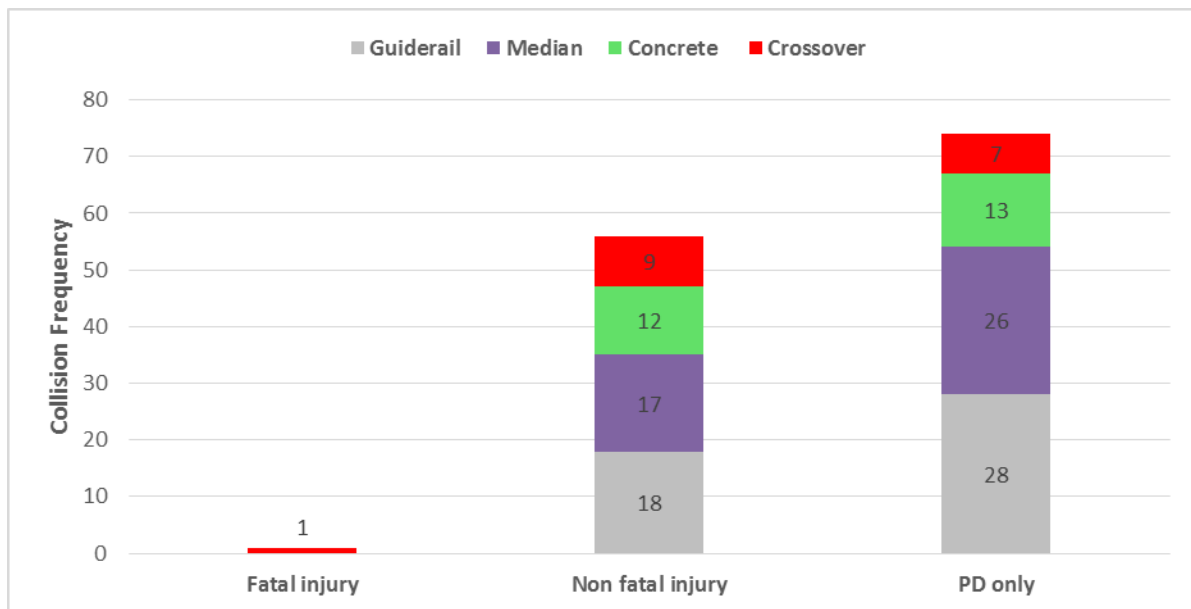
Figure 10: Summary of median related collisions

- + 1 fatal collision (crossing over the median; 2 fatalities);
- + 56 injury collisions (9 crossing over the median, 17 resting on the median, and 30 involving guide rail/concrete barrier); and
- + 74 PDO collisions (7 crossing over the median, 26 resting on the median and 41 involving guide rail/concrete barrier).

As can be seen in **Figure 10**, 59% (10 out of 17) of the crossover collisions are severe, a higher proportion than median collisions (17 out of 43 or 40%), concrete barrier collisions (12 out of 25 or 48%), and guide rail collisions (18 out of 46 or 39%). As a result, the need for a median barrier will be investigated in this study.

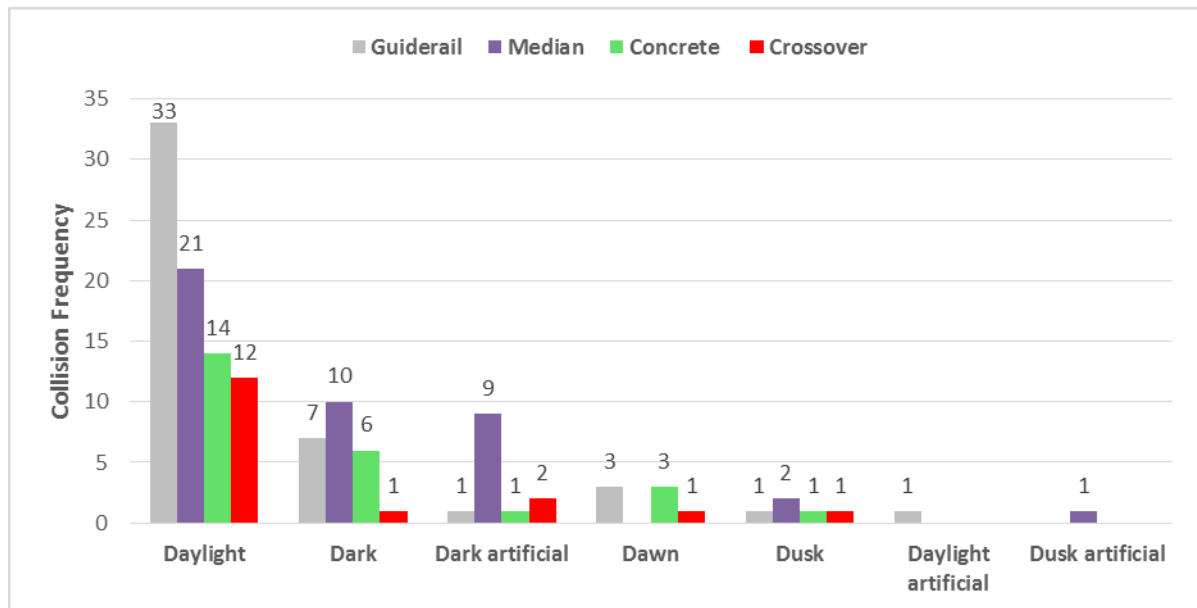
Figure 11: Median related collisions by light condition

The majority of collisions occurred under daylight/daylight artificial conditions, with a total of 81 out of 131 collisions (62%), with the remaining 50 (38%) collisions occurring during non-daylight conditions, which include dark/dark artificial, dusk/dusk artificial, and dawn/dawn artificial. These proportions are very similar to the proportions for all collisions (**Section 4.1.1**).

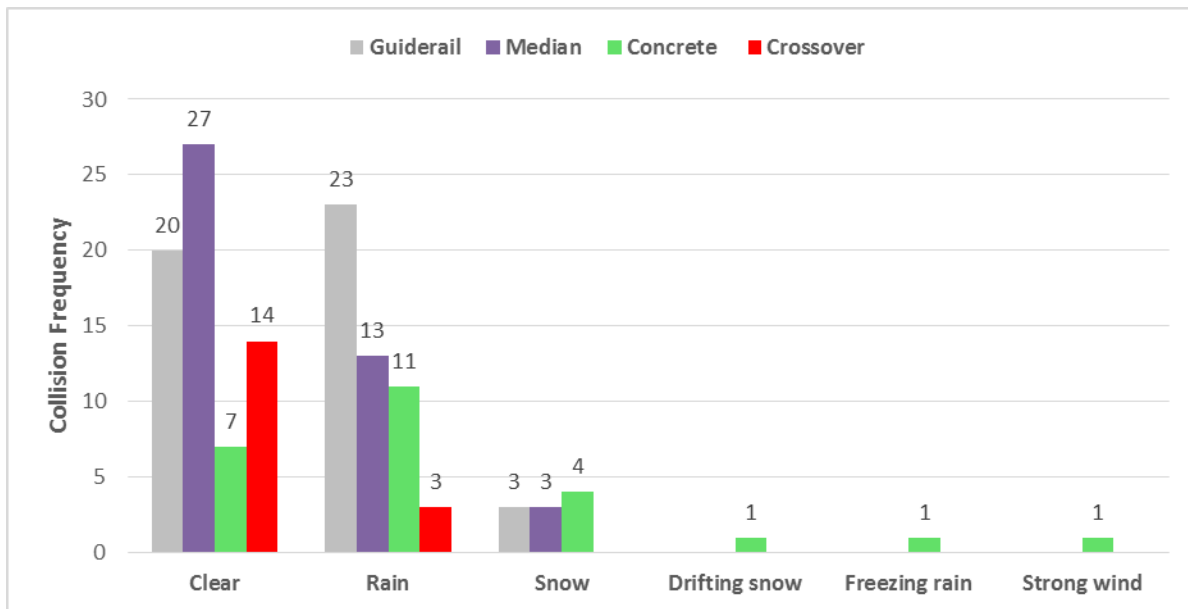
Figure 12: Median related collisions by environment condition

With respect to environment condition, 68 out of 131 collisions (52%) occurred with clear weather; 50 (38%) with rainy weather, and the remaining collisions with other weather conditions, including snow, drifting snow, freezing rain, strong wind, and fog/mist/smoke/dust. These proportions are somewhat similar to the proportions for all collisions (**Section 4.1.1**), although non-clear weather conditions are slightly higher for median related collisions than for overall collisions (48% and 42%, respectively).

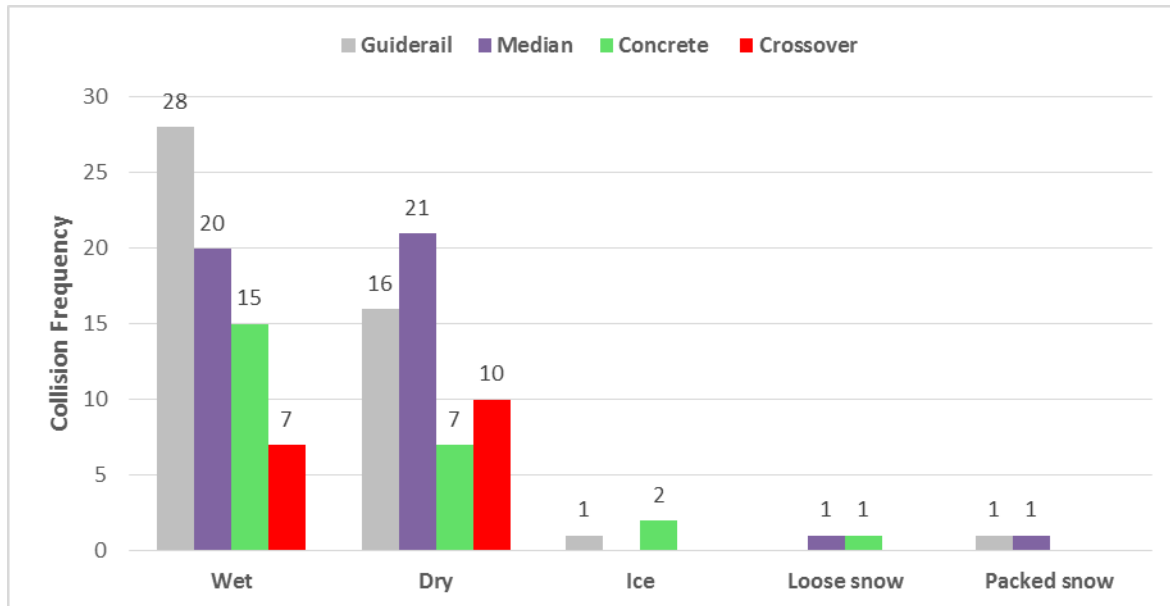
Figure 13: Median related collisions by roadway surface condition

Wet surface collisions make up the majority of median related collisions in the study area, with 53% (70 out of 131), followed by dry surface with 41% (54 out of 131). These proportions are somewhat similar to the proportions for all collisions (**Section 4.1.1**).

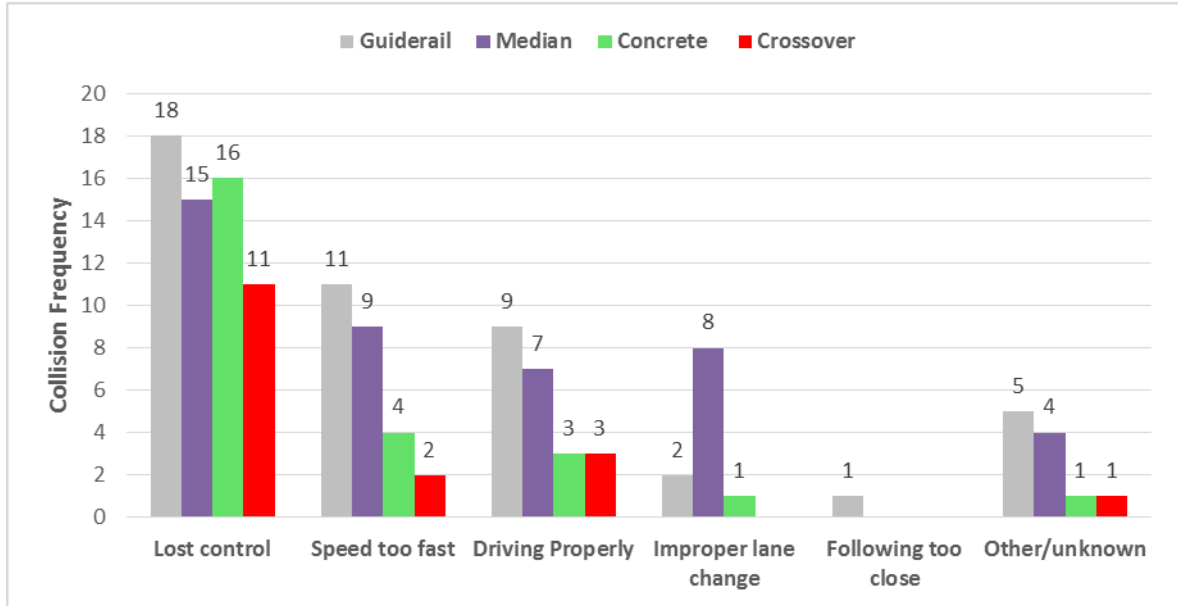
Figure 14: Median related collisions by apparent driver action

collisions (46%), followed by “speed too fast” (18%), “driving properly” (17%), and “improper lane change” (8%). The proportions of “lost control” and “speed too fast” are 11 and 6 percent points higher than for all collisions (as shown in **Section 4.1.3**). Additionally, 43.5% of median related, wet surface collisions involved “lost control” driver action, as well as 29% “speed too fast”.

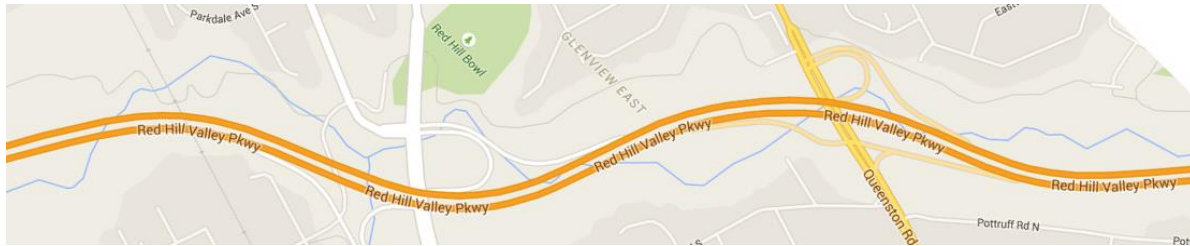
Figure 16: Critical collision locations

- In the northbound direction, a 600-metre section around the King Street interchange (31% of northbound collisions over 7.5% of the RHVP length); and
- In the southbound direction, 100-metre sections near the on-ramps of the Queenston Road, Barton Street and King Street (combined, approximately 30% of southbound collisions over 3.7% of the RHVP length).
- All locations with the highest collision frequencies are located within, on approach to, or leaving horizontal curves (**Figure 16**).

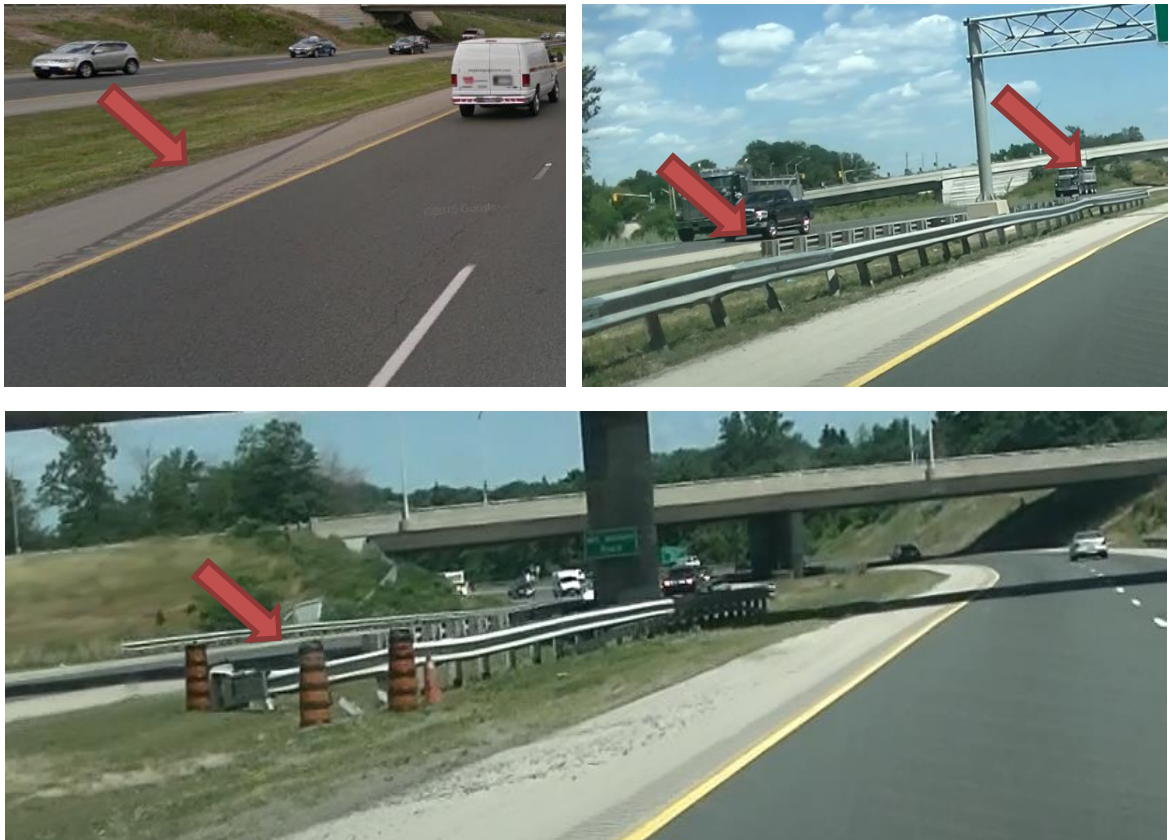
Figure 17: Evidence of loss of control towards the median / collisions with guide rails

The review of collision history revealed a large number of median related collisions including one fatal collision. During the field investigation, evidence of vehicles losing control towards the median was found, including skid marks and damage to guide rails, as illustrated in **Figure 17**. With the exception of the 1,100 m section between Mud Street West and Greenhill Avenue, the median does not have a continuous barrier to protect against median cross-over collisions. The study area was further evaluated regarding the benefits and drawbacks of providing a median barrier. Findings are provided in **Section 7**.

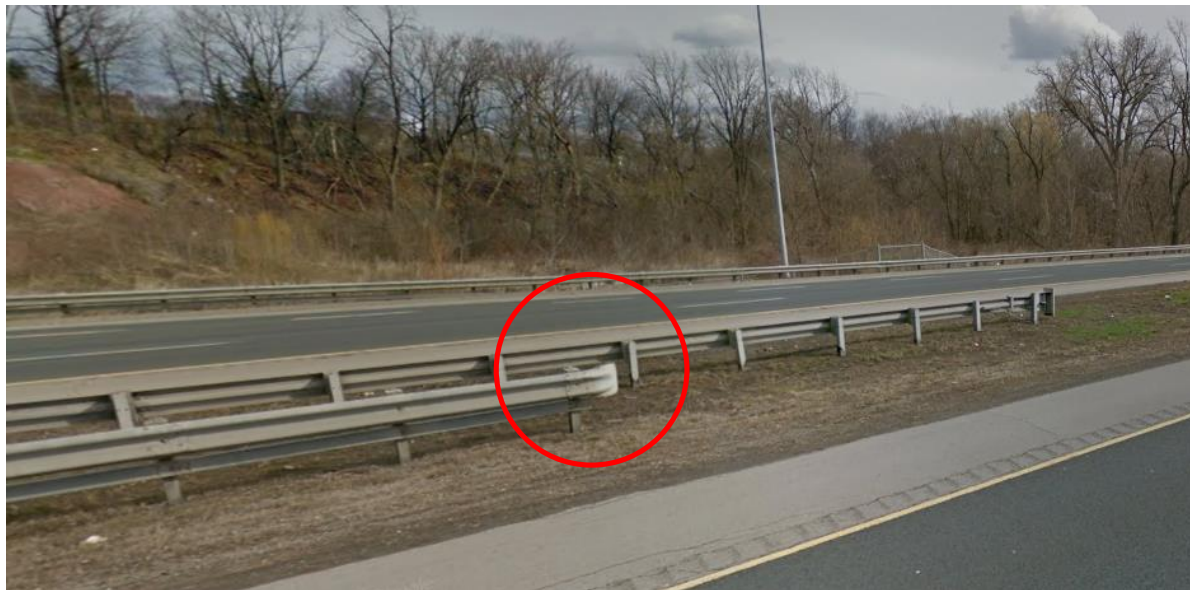
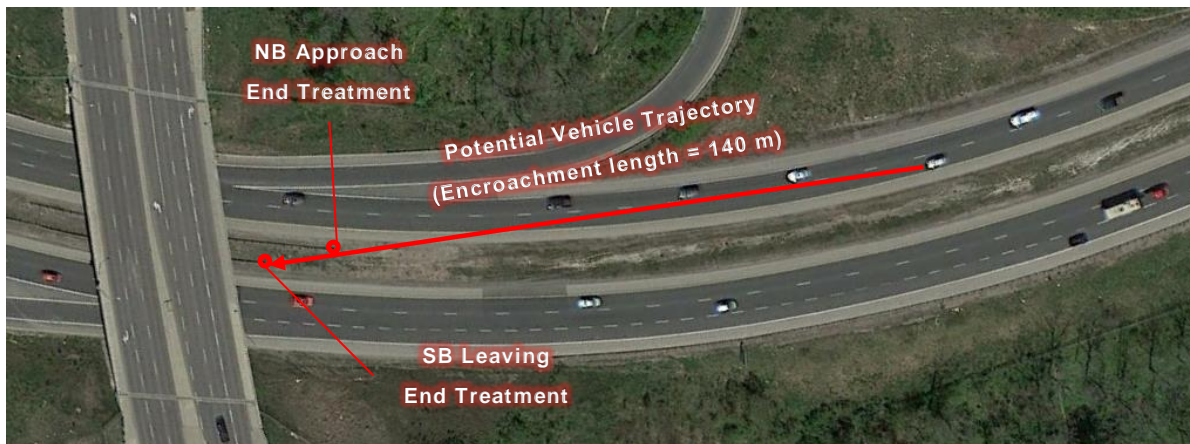
It was also noted that some “fishtail” leaving end treatments at some guide rails protecting bridge structures are located within the clear zone of the opposite direction of traffic (**Figure 18**). When this is the case, the guide rails at the opposite direction do not provide the required length of need to protect the end treatment (**Figure 19**). This type of end treatment can represent a spearing hazard in the event of a frontal collision and should be protected when located within the clear zone.

Figure 18: RHVP typical guide rail leaving end treatment

Figure 19: Potential trajectory of a vehicle towards fishtail end treatment

As highlighted in **Section 5.1**, “fishtail” leaving end treatments at some guide rails protecting bridge structures are located within the clear zone of the opposite direction of traffic, and the approaching end treatment in the opposite direction does not provide the required length of need, exposing vehicle occupants to a spearing hazard. The City should consider replacing the existing extruder and “fishtail” end treatments with CAT-350 attenuators at bridge structures, which is the recommended end treatment according to the RSM. The City may also choose similar options such as the SMART crash cushion (OPSD 923.483). The estimated cost is \$7,000 per unit.

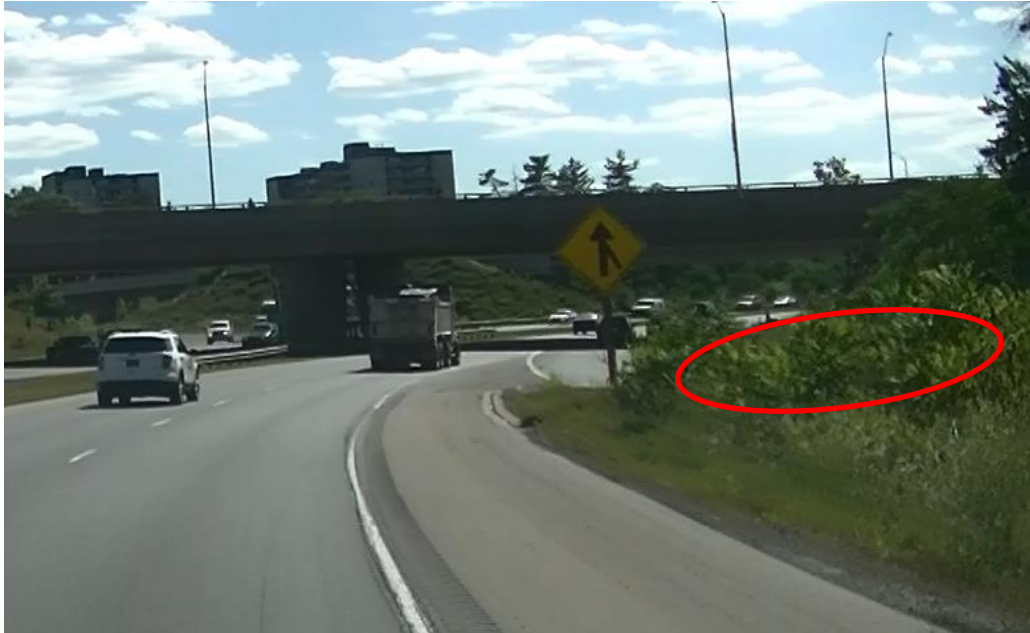
Figure 20: Vegetation obscuring view of vehicles approaching from on-ramp

The RHVP is mostly used by commuter traffic, meaning drivers are expected to be familiar with the road. During the field investigation, it was noted that, occasionally, drivers entering the RHVP from an on-ramp tend to do so in a somewhat aggressive fashion, merging onto the mainline as soon as they reach the dashed line at the acceleration lane. This may be due to a potential perception by drivers that some acceleration lanes along the RHVP are too short (especially considering the high operating speeds as shown in **Section 5.2.1**), and may contribute to sideswipe and SMV collisions (as drivers on the mainline swerve to avoid a sideswipe collision with a merging vehicle). Additionally, some on-ramps in the study area present relatively high vegetation that may restrict visibility, to drivers on the mainline, of approaching vehicles from the ramps (**Figure 20**), which has the potential to violate drivers' expectancy related to merging traffic.

Section 5.4.3 discusses the application of MERGE warning signs on the RHVP, used to alert drivers of unfavorable merging conditions.

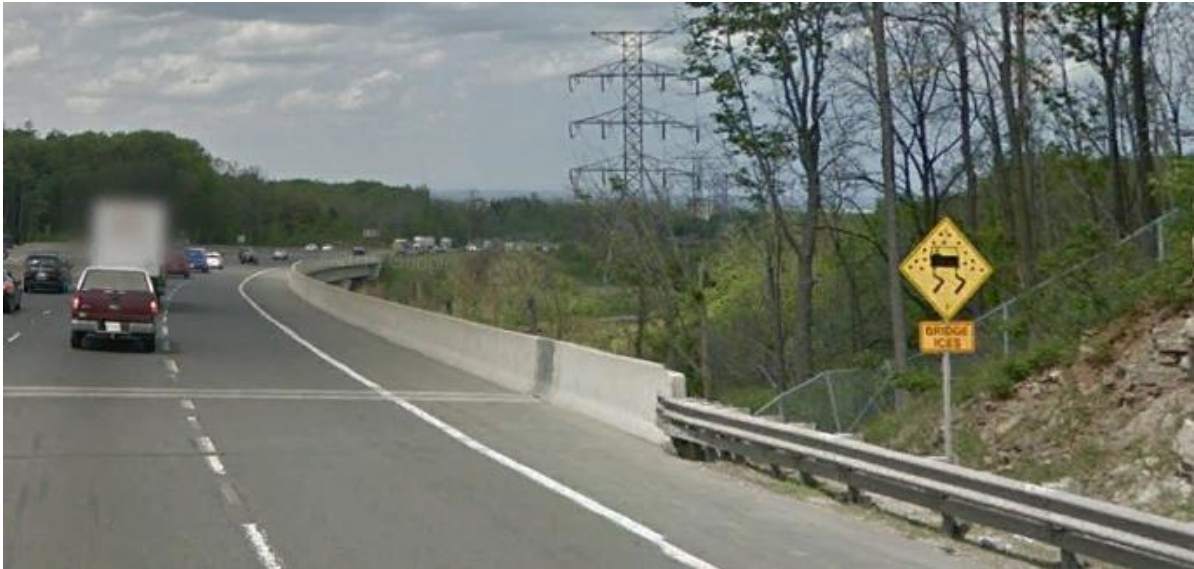
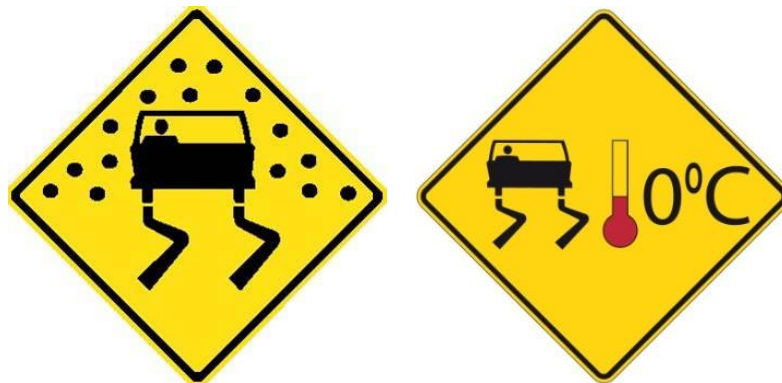
Given the existing proportion of wet pavement collisions (50%), oversized SLIPPERY WHEN WET signs (Wc-105) should be used in the study area. Four of these signs are installed along the RHVP, however they are placed immediately in advance of two bridges (one between Mud Street and Greenhill Avenue, and one between Barton Street and the north end of the study area) and combined with BRIDGE ICES tab signs (**Figure 22**). This tab sign is not part of the current version of OTM Book 6, although it will be included in the updated version, expected to be published in 2015. However, this tab will be recommended for use with the new BRIDGE/ROAD ICES sign, which will have the same design as the WC-23 “Bridge Ices” sign from the Manual of Uniform Traffic Control Devices for Canada (MUTCDC). **Figure 23** illustrates the two different signs.

Figure 22: SLIPPERY WHEN WET sign + BRIDGE ICES tab sign

Figure 23: SLIPPERY WHEN WET sign (left) and BRIDGE/ROAD ICES sign (right)

Because these two signs are intended to convey different messages, the use of the SLIPPERY WHEN WET sign to represent both “slippery when wet” and “bridge ices” conditions is not recommended, as this may create confusion for drivers (although the tab helps clarify the different conditions). This is especially important on the RHVP, since both conditions are possible and should be signed accordingly.

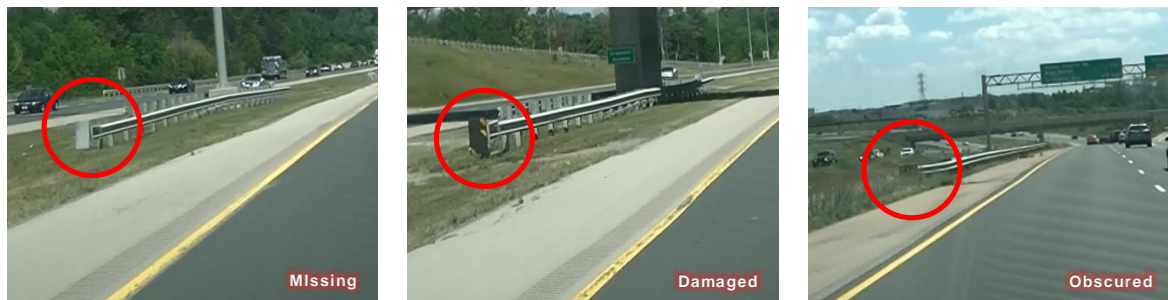
Figure 24: Examples of Missing, Damaged and Obscured Object Marker Signs

Several guide rail approach end treatments were found to have missing, damaged, or obscured OBJECT MARKER signs (Wa-33). **Table 7** provides a list of all identified locations, and **Figure 24** illustrates these three conditions.

Direction	Location	Side	Issue
EB	Upstream of Dartnall interchange	Left	Obscured by vegetation
EB	Upstream of Stone Church/Mud interchange	Left	Obscured by vegetation
NB	Underneath Mud overpass	Left	Obscured by vegetation
NB	Downstream of Mud interchange	Left	Obscured by vegetation
NB	Downstream of Mud interchange	Right	Missing
NB	Underneath Greenhill overpass	Left	Damaged
NB	Downstream of Greenhill interchange	Left	Missing
NB	Underneath railway overpass btwn Greenhill and King	Left	Damaged
SB	Downstream of Barton interchange	Left	Missing
SB	Underneath Mud overpass	Left	Obscured by vegetation
SB	Underneath Pritchard overpass	Left	Damaged / Obscured by vegetation
SB	Downstream of Pritchard overpass	Left	Missing

Additionally, as identified in **Section 5.4.2**, **Table 7**, several guide rail approach end treatments were found to have missing, damaged, or obscured OBJECT MARKER signs (Wa-33). These signs should be installed, replaced, or made visible by trimming the vegetation, respectively. The estimated cost is approximately \$500 per sign.

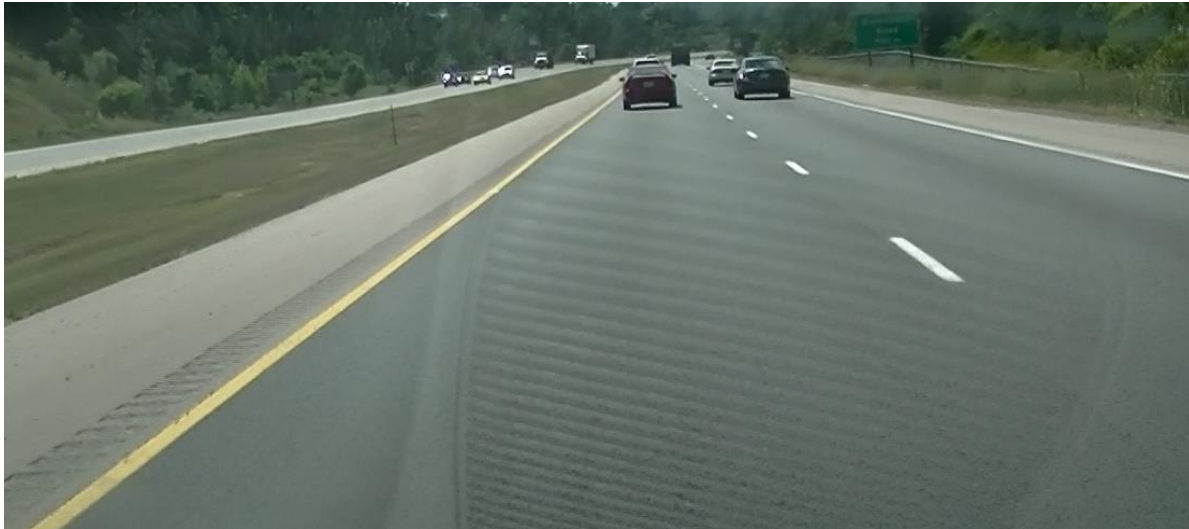
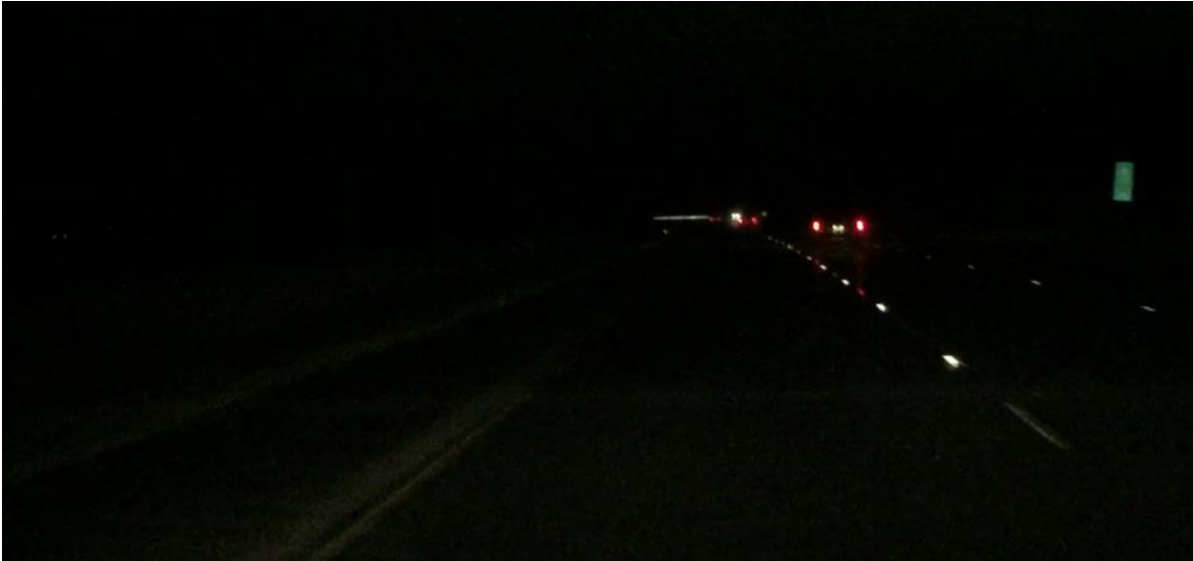
It was also observed that, where present, guide rails or concrete barriers on the median are not visible due to the lack of delineation along these devices.

Figure 25: Pavement markings during daytime condition

Figure 26: Pavement markings during nighttime condition (without PRPMs)

Figure 27: Pavement markings during nighttime condition (with PRPMs)

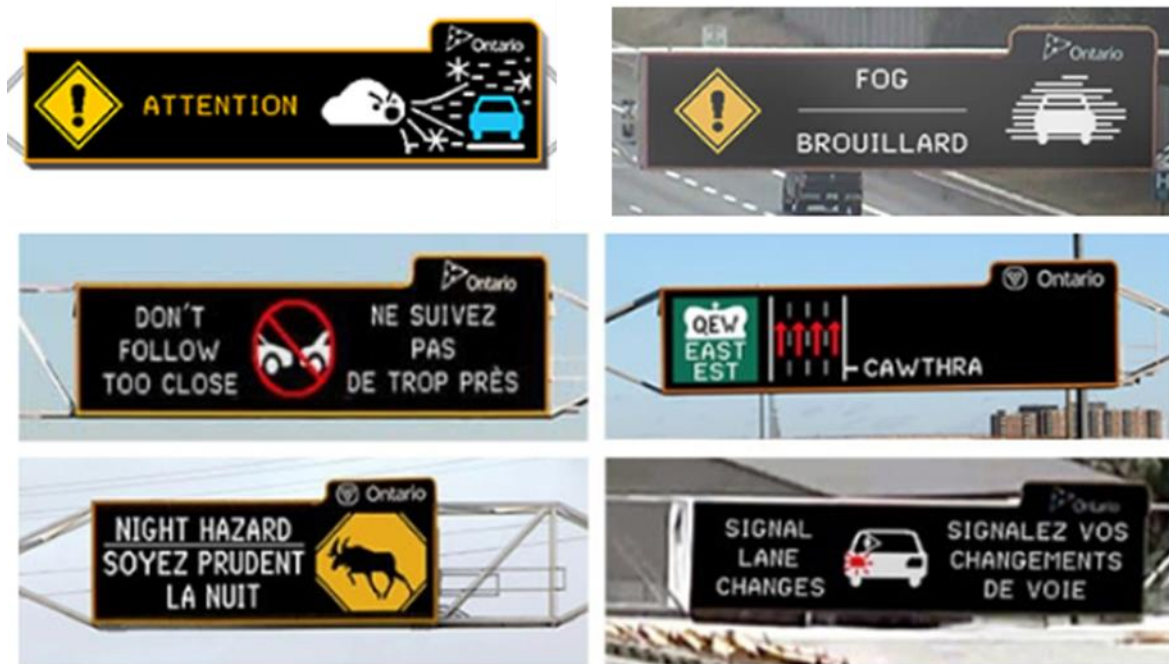
Figure 28: Examples of Dynamic Message Signs

Another alternative is to display messages related to road and environment conditions using Dynamic Message Signs (DMS) that can be implemented as part of the City's planned Advanced Traffic Management System (ATMS) project, consisting of an Intelligent Transportation System (ITS) Freeway Traffic Management System (FTMS) inclusive of the entire Linc and RHVP freeway system from Hwy 403 to the QEW. **Figure 28** provides examples of DMSs used on Ontario Highways under MTO's jurisdiction.²⁴

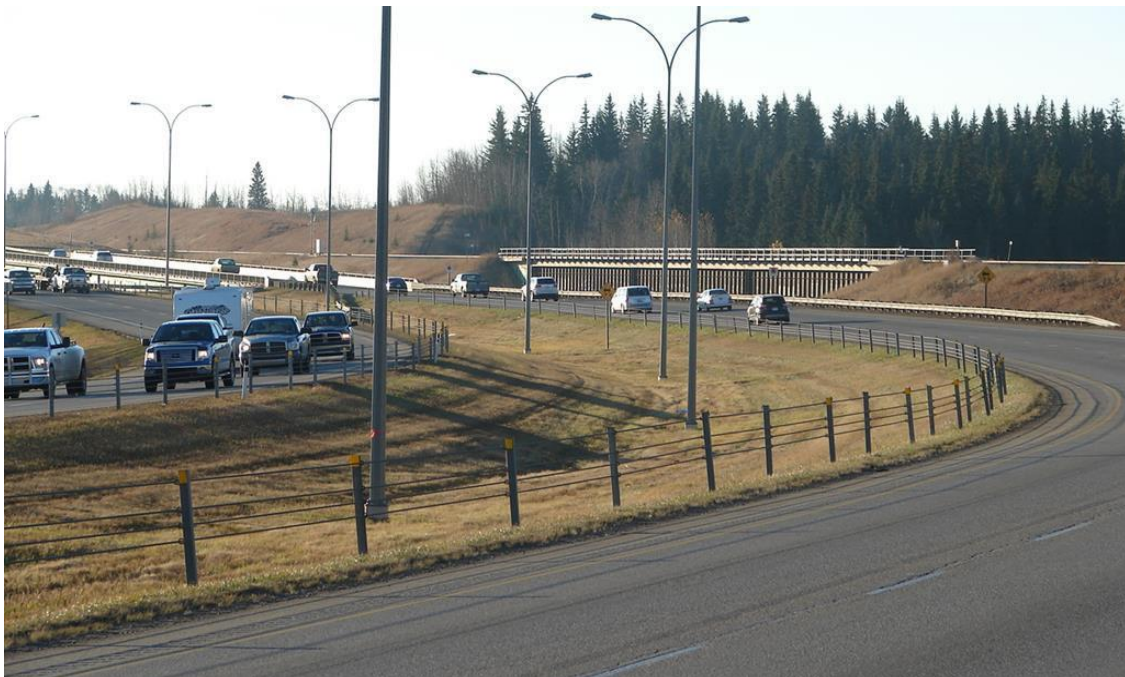
Figure 31: Example of high tension cable barrier

Provide High-Tension Cable Barrier on both sides of the median. An example of High Tension Cable Barrier installed on both sides of a median location on Highway 2 in Alberta is demonstrated in Figure 31.

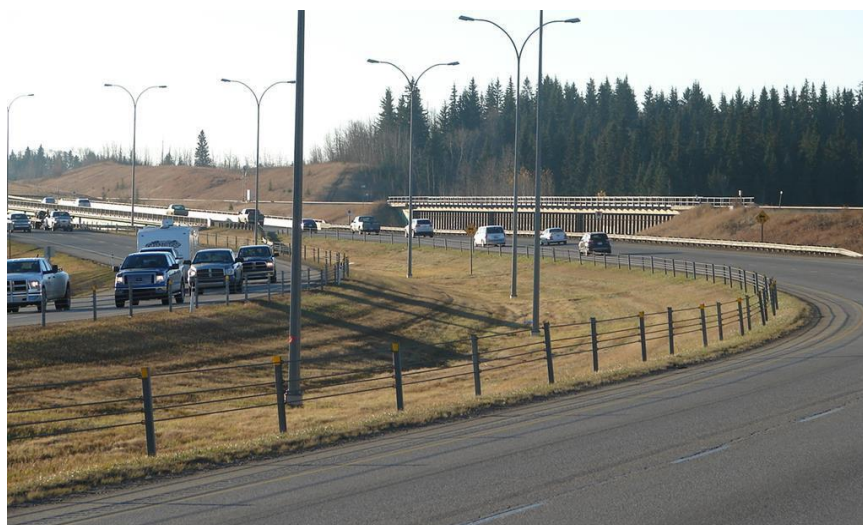
Figure 2 : An Example High Tension Cable Barrier

Provide High-Tension Cable Barrier on both sides of the median. An example of High Tension Cable Barrier installed on both sides of a median location on Highway 2 in Alberta is demonstrated in Figure 2.
