Submitted to:
City of Hamilton

Elfrida Subwatershed Study

Final Phase 1 Report

Aquafor Beech Limited

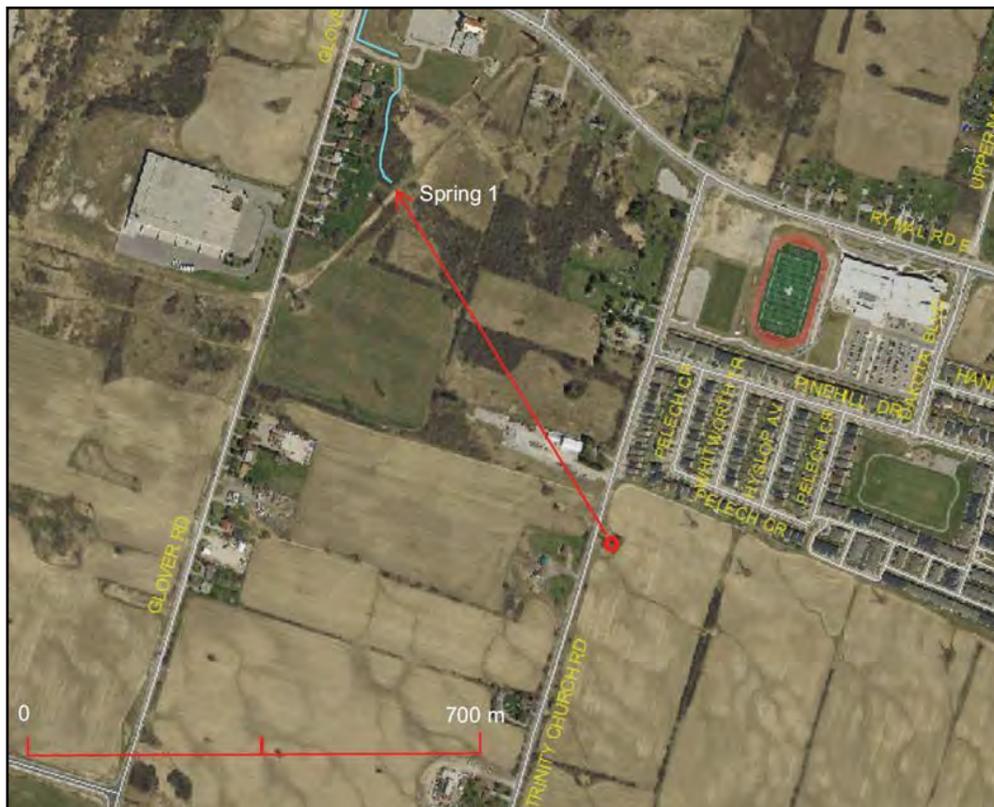
Figure 3.9: Location of Sinkhole

A sinkhole is present in the northwest corner of the Elfrida study area within the Hannon Creek subwatershed. It is located in the eastern ditch of Trinity Church Road near the electrical transmission lines, as illustrated in **Figure 3.9**. This sinkhole was subject to a groundwater dye tracing study on March 28, 2016. Approximately 20 grams of Rhodamine WT dye was injected into the sinkhole at 12:00 hours (12 noon) on March 28, 2016 at a flow rate of approximately 0.4 Litres/second. The dye discharged approximately 650 m away at Spring 1 from approximately 3:40 to 6:15 hours after dye injection (**Figure 3.10**). The peak dye detection occurred 4:06 hours after injection indicating a dye travel time of approximately 160 m/hr. Spring 1 was flowing at approximately 5 Litres/second. A YSI 600 OMS data logger equipped with a Rhodamine WT fluorometer was used to detect the rhodamine WT at Spring 1. This sinkhole and spring were originally mapped by Terra-Dynamics (2001).

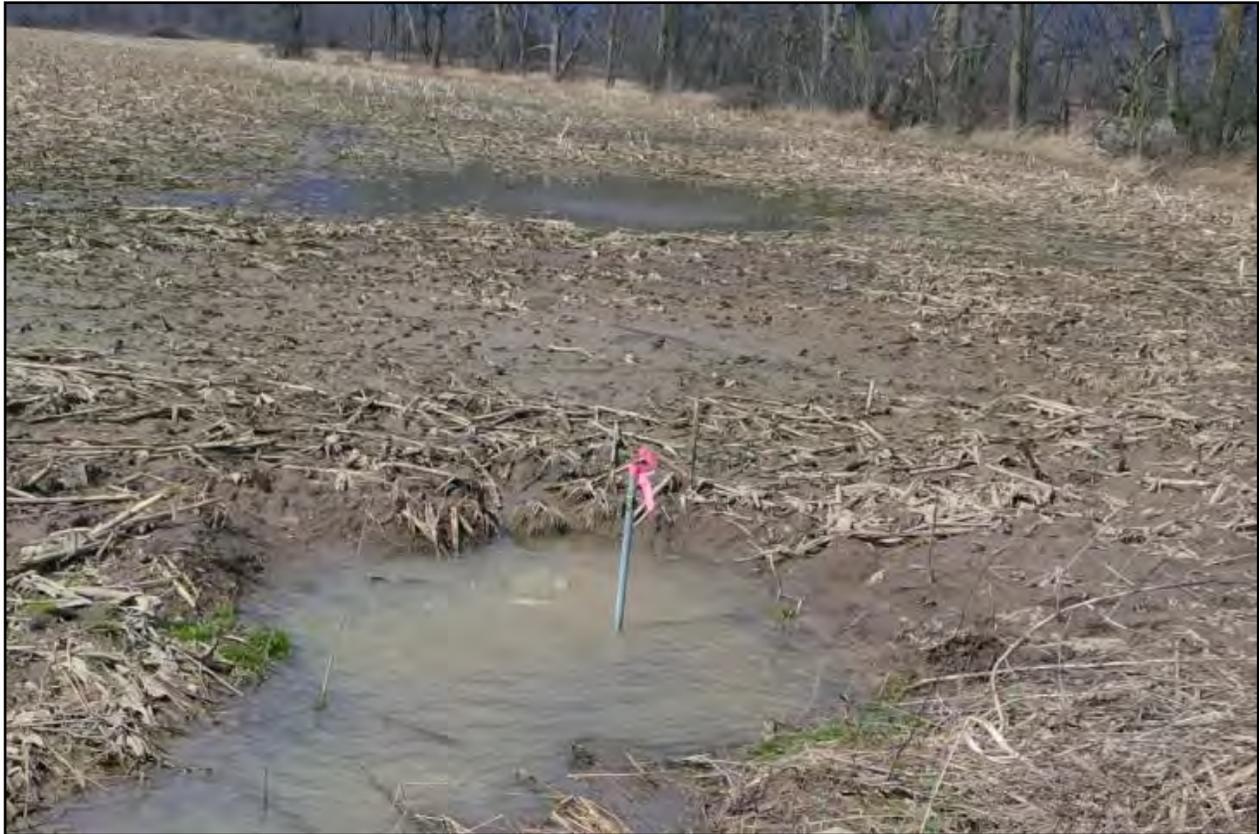
Figure 3.15: Groundwater bubbling up at GW3

At most locations, piezometer readings indicate that the groundwater table is located below the stream bed or ground elevation and therefore does not supply any significant baseflow to the streams. This is supported by observations of intermittent flow. At monitoring sites GW3 (**Figure 3.15**), GW5, and GW8, the groundwater level was found to be located near or above the ground surface on select dates, indicating the potential for seasonal groundwater discharge at these locations in the Twenty Mile Creek watershed. Piezometer readings at these same locations indicated a groundwater level below the ground surface at other times of the year.

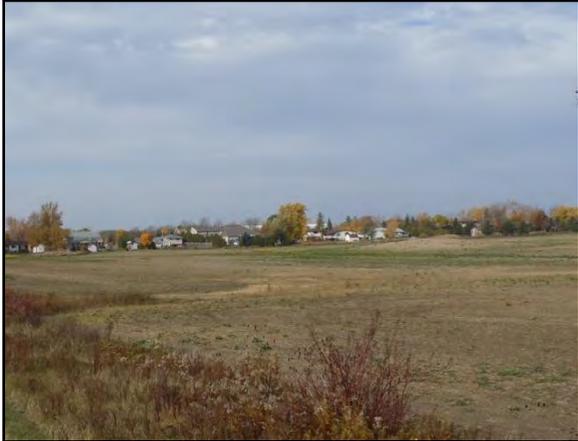
Photo 1: Agricultural swale Reach TM2-R1

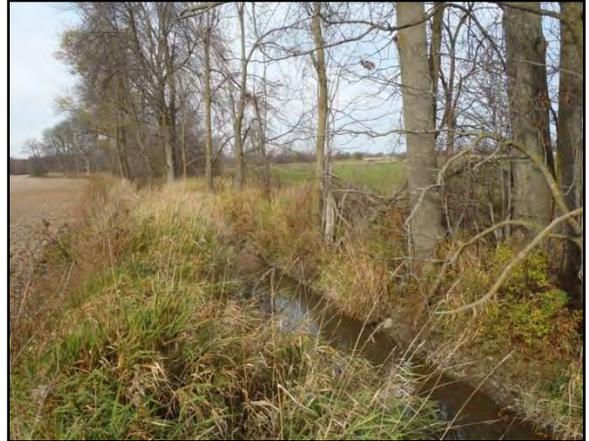
Photo 2: Agricultural ditch Reach TM1-R2

- **Twenty Mile Creek** – three main tributaries documented as TM1, TM2, and TM3. Agricultural fields and isolated woodlots include a patchwork of ephemeral swales and channelized ditches in the upper reaches of TM1-R1 and TM2-R1 (**Photo 1**). Lower reaches are more consistently channelized as agricultural ditches (TM1-R2) and roadside ditches (TM1-R3 and TM3-R1) flanked by narrow hedgerows of riparian trees and shrubs in some sections (**Photos 2, 3, and 4**).

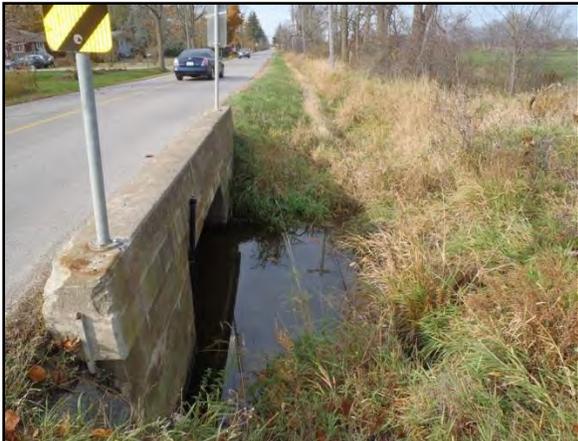
Photo 3: Roadside ditch Reach TM1-R3

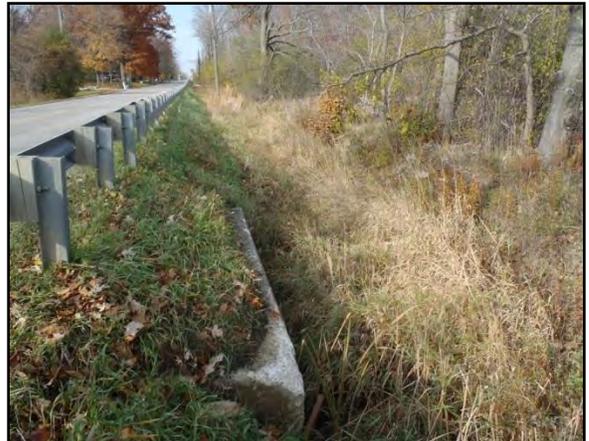
Photo 4: Roadside ditch Reach TM3-R1

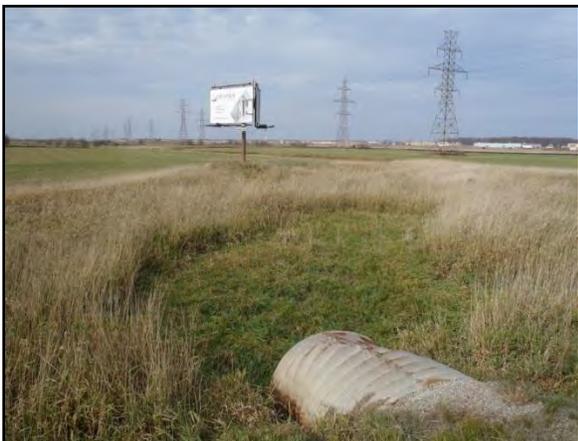
Photo 5: Agricultural swale Reach SI3-H1B

- **Sinkhole Creek** – three main tributaries documented as SI1, SI2, and SI3. For the upper reaches, agricultural swales and ditches (**Photo 5**) vary between cultivated and perennial vegetation with the degree of agricultural activity and history of channel modification within individual property lots (SI1-R1, SI2-R1, SI3-H2). Broad topographic depressions within tributary reach SI2-R1 sustain a widened stream corridor of marsh and meadow vegetation in some sections (**Photo 6**). The lower reach of SI1-R2 (3rd order) is also highly modified as a straightened agricultural ditch, aligned upstream between local hedgerows and downstream across a broad agricultural field (**Photo 7**).

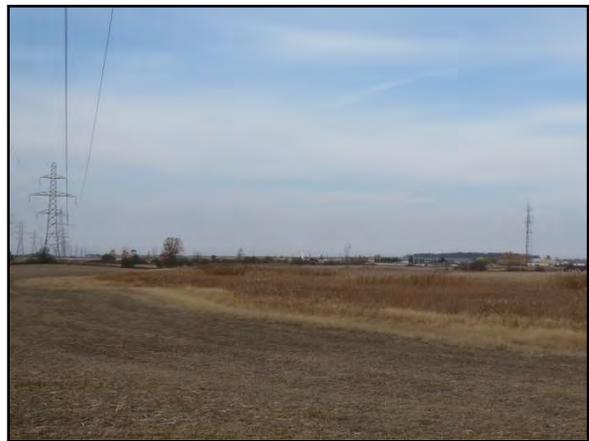
Photo 6: Swale marsh Reach SI2-R1

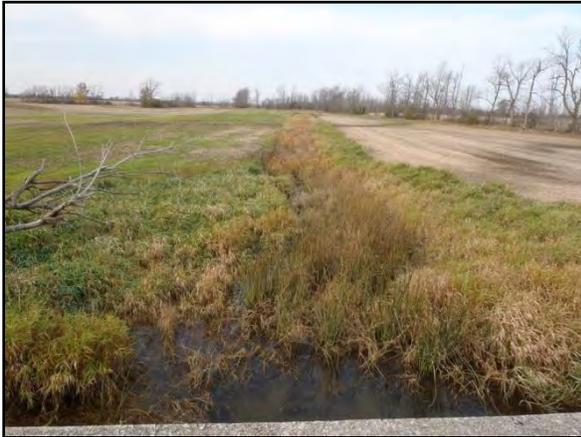
Photo 7: Agricultural ditch S11-R2

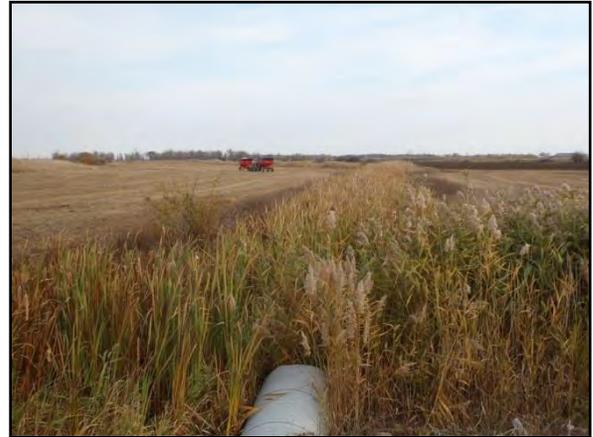
Photo 8: Swale marsh ST1-H2

- **Stoney Creek** – two main tributaries documented as ST1 and ST2. Upper reaches of ST1-H2 are straightened agricultural channels with marsh and cattail vegetation (**Photo 8**). The middle reaches of tributary ST1 have been channelized within an old golf course (**Photo 9**, ST1-R1, including ponds and side channels,) and as a ditch along the south side of Mud Street East (ST1-R2) (**Photo 10**). Under existing conditions, there is also drainage from the west side of Upper Centennial Road (Hwy 20) that enters a ditch

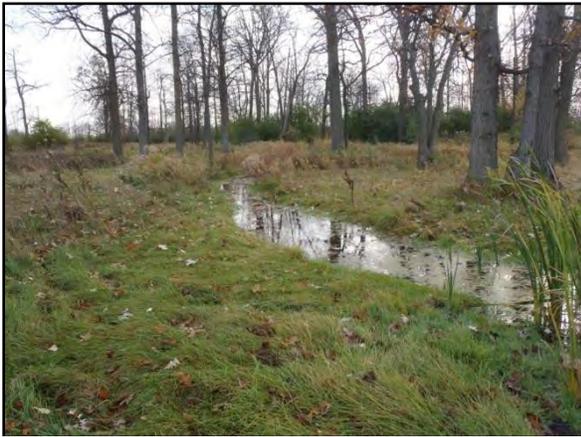
Photo 9: Golf course channel Reach ST1-R1

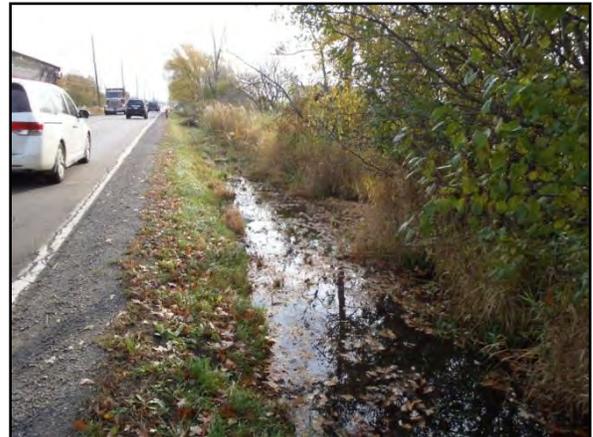
Photo 10: Roadside ditch Reach ST1-R2

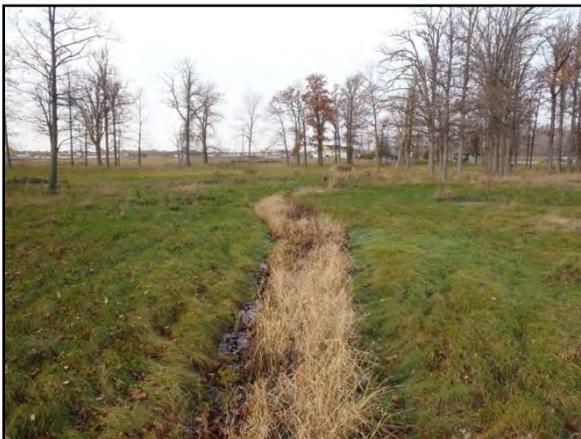
Photo 11: Golf course channel, drainage connection restoration opportunity from Hwy 20 looking upstream to the west (right)

on east side of the highway and flows north and then east along Mud Street East to join the main branch of Stoney Creek (roadside ditch of ST1-R2). For future development, this ditch drainage should be reconnected through a restored natural corridor (**Photo 11**, see restoration opportunities). The lower reaches of Stoney Creek are channelized ditches within agricultural fields (ST1-R4) (**Photo 12**), with some sections locally flanked by narrow hedgerows of riparian trees and shrubs (ST1-R3).

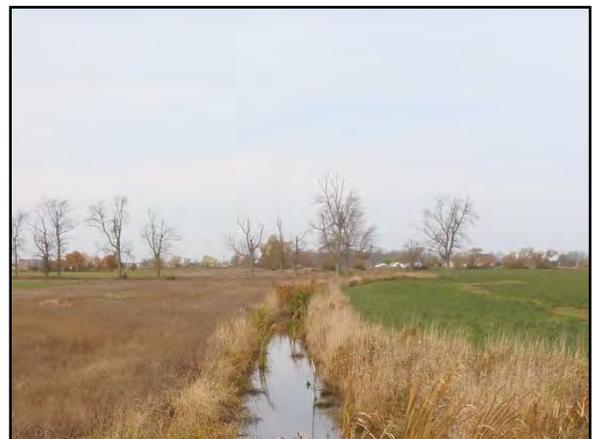
Photo 12: Agricultural ditch Reach ST1-R4

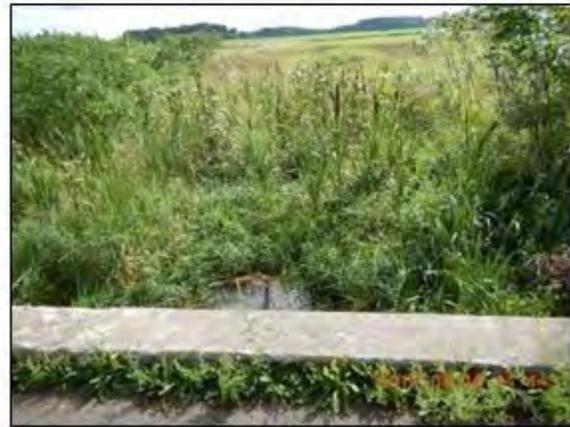
Twenty Mile Creek (Site 3) – Summer

Figure 3.33: Variable Conditions at Stream Monitoring Sites

Collectively, the above difficulties prevented a consistent and accurate estimate of the rating curves and consequentially, the runoff hydrographs. Due to these inconsistencies, the monitoring data was not carried forward at this time for use in the hydrologic modeling component of the study.

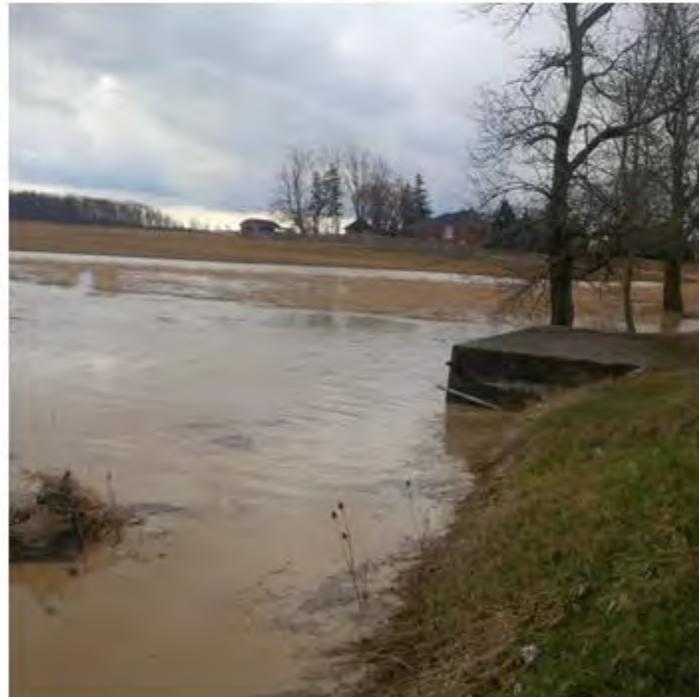
Sinkhole Creek at Hendershot Road – spring 2016

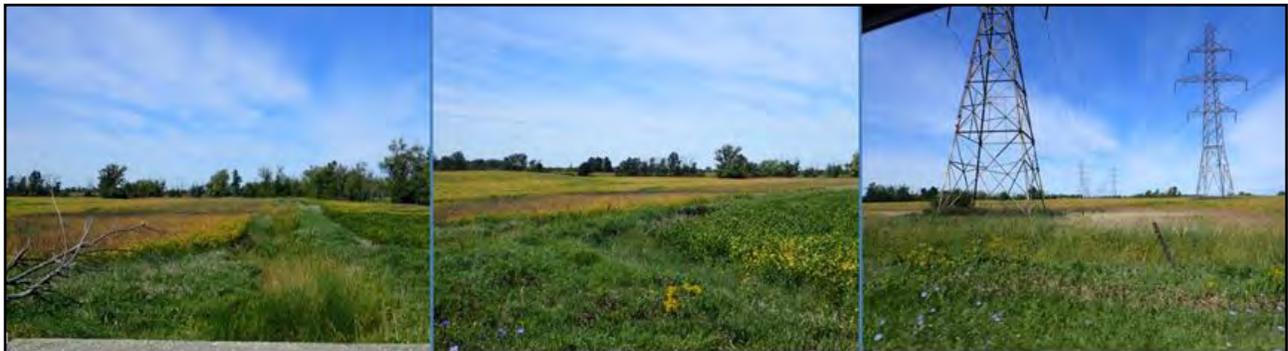
Figure 3.44: Lands North of the Sinkhole Creek Crossing of Hendershot Road (centre & right), and at the Hendershot Road Crossing (left) have been converted to Agriculture

It is important to note that significant portions of the Sinkhole Creek Provincially Significant Wetland (e.g. lands adjacent to Hendershot Road) were converted into agriculture in 2016 (**Figure 3.44**). The revised boundaries of this feature are included in the NHS and associated development limitations mapping within this report.

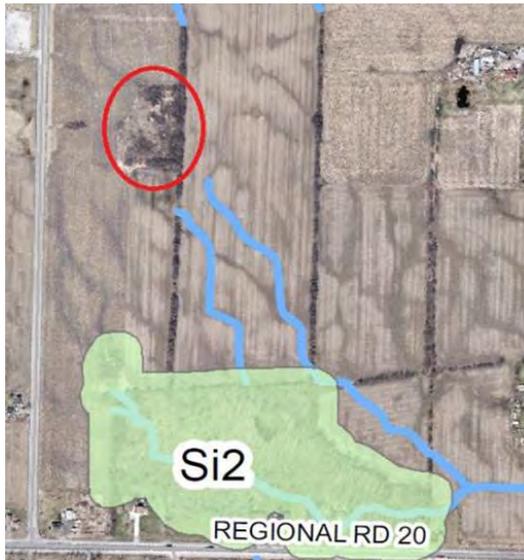
Figure 3.65: Potential Seepage/Headwater Area (circled in red)

In addition, a wooded area approximately 350 m north of Si2 is located at the headwaters of a tributary/HDF to Sinkhole Creek (**Figure 3.65**). This area, which is surrounded by agricultural fields, was not visited during field surveys due to lack of land access permissions. It is evident from air photos that the area is seasonally wet, and spring peeper was recorded calling from this area on May 25th, 2016. Accordingly, it is possible that this is an area of groundwater seepage and therefore it should be considered candidate SWH subject to confirmation through further study.

Sand barrens, savannah, and tallgrass prairies	Sand barrens, savannah, and tallgrass prairies were not recorded within the study area.
	Alvars	Alvars are not present within the study area.	
	Key Hydrologic Features	Permanent and Intermittent streams	Permanent and intermittent watercourses are primarily considered under <i>Key Natural Heritage Features: Fish Habitat</i> , above. Additional features within the study area which qualify as intermittent streams include HDFs classified as Protection, Conservation, or Mitigation. HDFs that were not visited as part of the study due to lack of access permissions are shown in the Core Areas and Linkages map (Figure 3.70) for reference only; the status of these HDFs will be determined through future study.
		Lakes (and their littoral zones)	Lakes are not present within the study area.
		Seepage areas and springs	Two seepage areas were confirmed within the study area: one in NHA Tw4 and another at Groundwater Monitoring Station #3. As the former is within a significant woodland and the latter within the floodplain and minimum Vegetation Protection Zone associated with Twenty Mile Creek, these features are included within the NHS. The presence of seepage areas on lands north of NHA Si2 (see Figure 3.65) will be confirmed through further study.

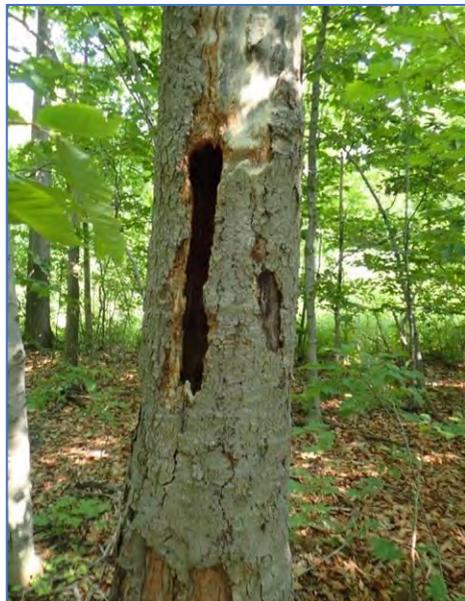
Figure 3.66: Beech snag with cavity, NHA Si2

Potentially suitable bat maternity colony habitat is present within NHAs St1, St2 (this NHA contains many cavity trees and snags, **Figure 3.66**), St3, St4, Si1, Si2, Si3, Si5, Si8, Tw1, Tw2, Tw3, Tw4, and Tw5. Bats were observed foraging in NHAs St1 and Si2 during amphibian calling surveys. Cavity trees and snags are prevalent in NHA Si2, as were mature shagbark hickory (*Carya ovata*) trees; cavity trees were not observed in NHA Si7. Furthermore, NHAs Si3, Si5, Si8, St2, St3, St4, Tw2, Tw3, and Tw5 were not included in field surveys due to lack of land access permissions. As bat surveys were not completed as part of this study, it is recommended that surveys be completed a subsequent planning stage.

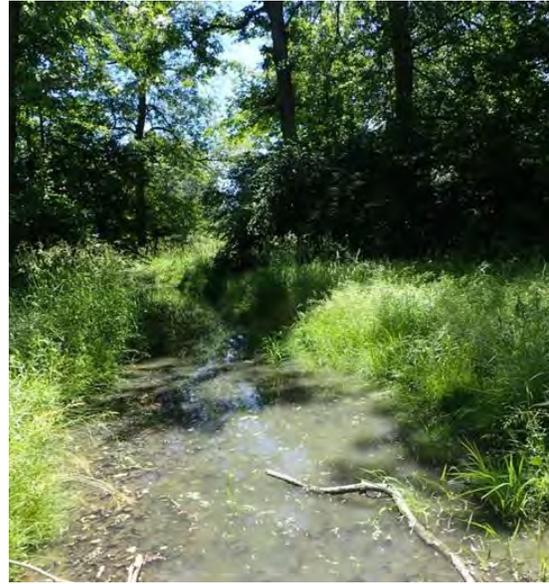
Figure 3.67: Bur Oak Mineral Deciduous Swamp in NHA St1

One (1) provincially and globally rare vegetation community type was identified within the study area during vegetation community assessments (**Section 3.3.2.5**). This remnant Bur Oak Mineral Deciduous Swamp community is located within NHA St1 (ELC polygon 3). This community contains clay soils and has scattered low spots that hold water seasonally. This community has been significantly influenced by human activity; exotic species are commonplace, portions of the community have been cleared, and a channelized watercourse, which connects a series of permanent ponds built as part of a now-defunct golf course, runs through the swamp (**Figure 3.67**).

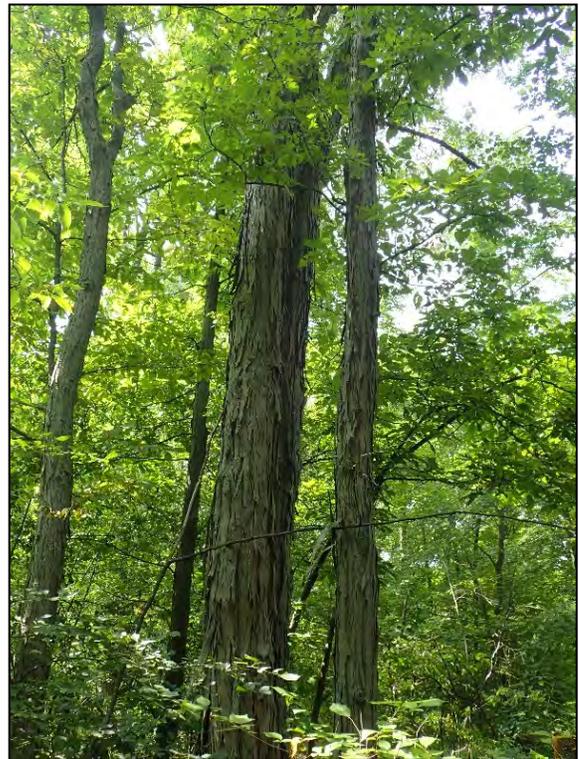
Figure 3.71: Shagbark hickory (*Carya ovata*) trees in NHA Si2

There are eight (8) species of bat known to occur in Niagara and Hamilton. Of these, four (4) are considered at-risk. As mentioned in **Section 3.3.5**, actively foraging bats were incidentally observed in NHA Si2. In addition, many cavity trees, trees with loose bark, as well as large-diameter oak and maple trees which could provide roosting habitat for bats are present within the NHA (, **Figure 3.71**, and **Figure 3.72**). Bats were also observed foraging over standing water adjacent to the northern portion of the forest. Acoustic surveys and comprehensive surveys for potential roosting habitat were both outside of the scope of work for this study and as such were not completed. Such studies are recommended at a subsequent planning stage.

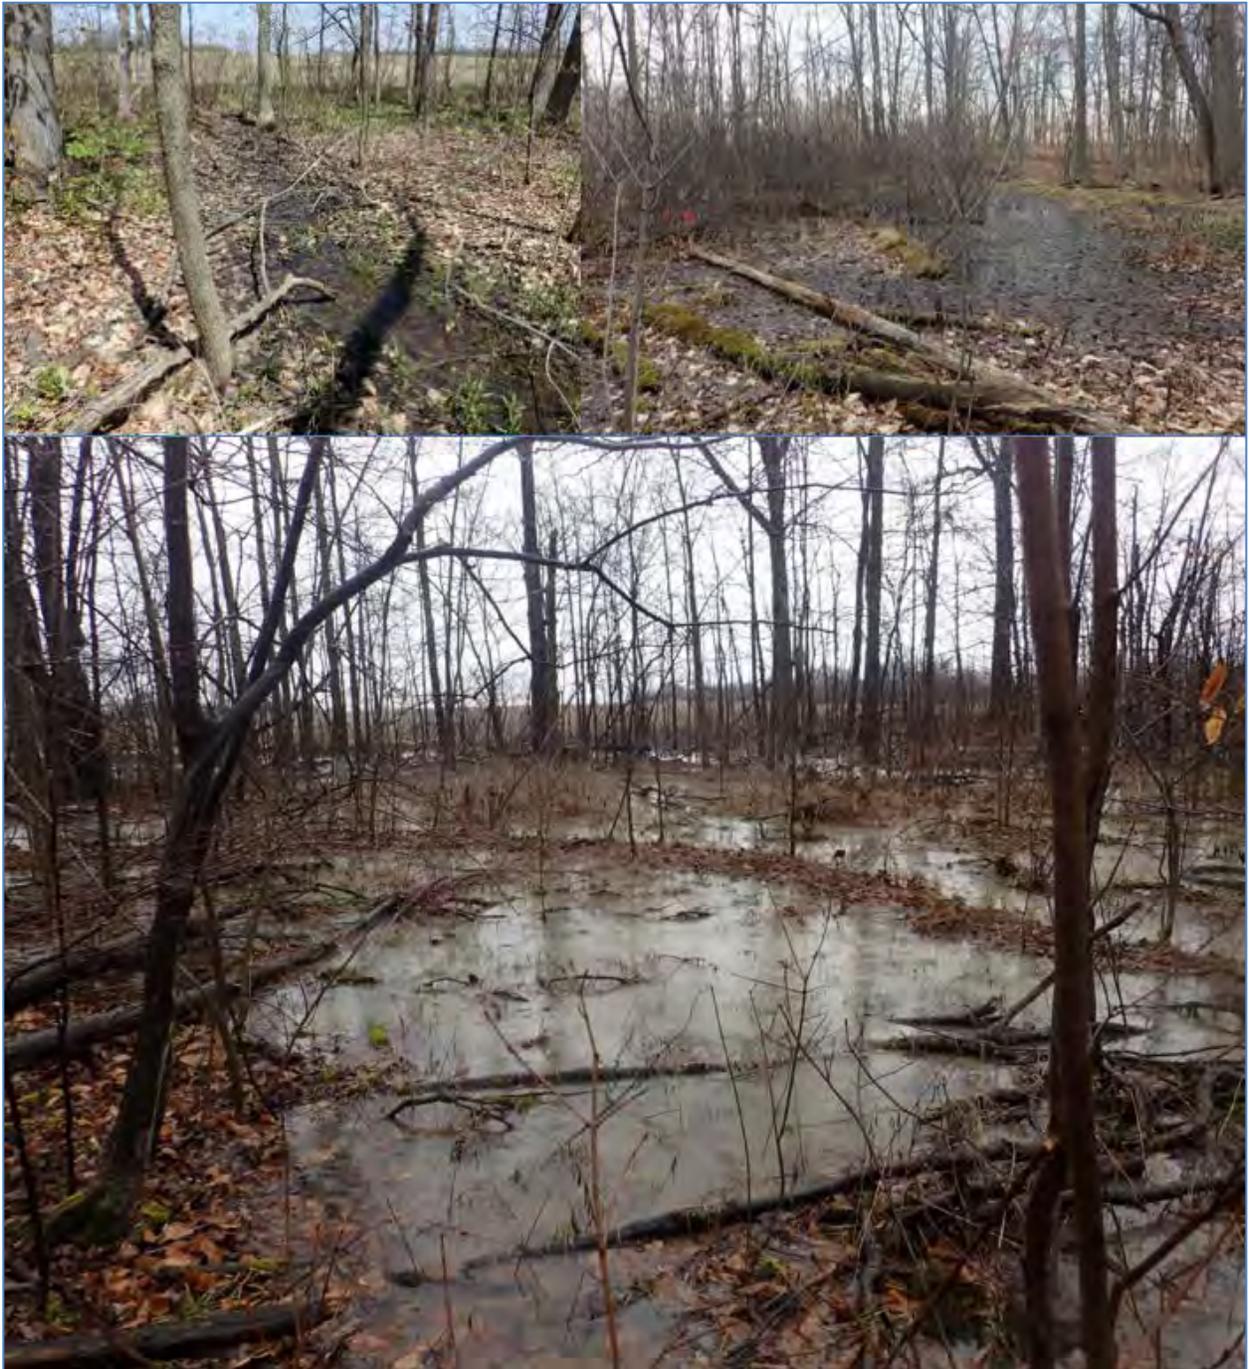
Figure 3.73: Hydrologic inputs from fields to the north into NHA Si2

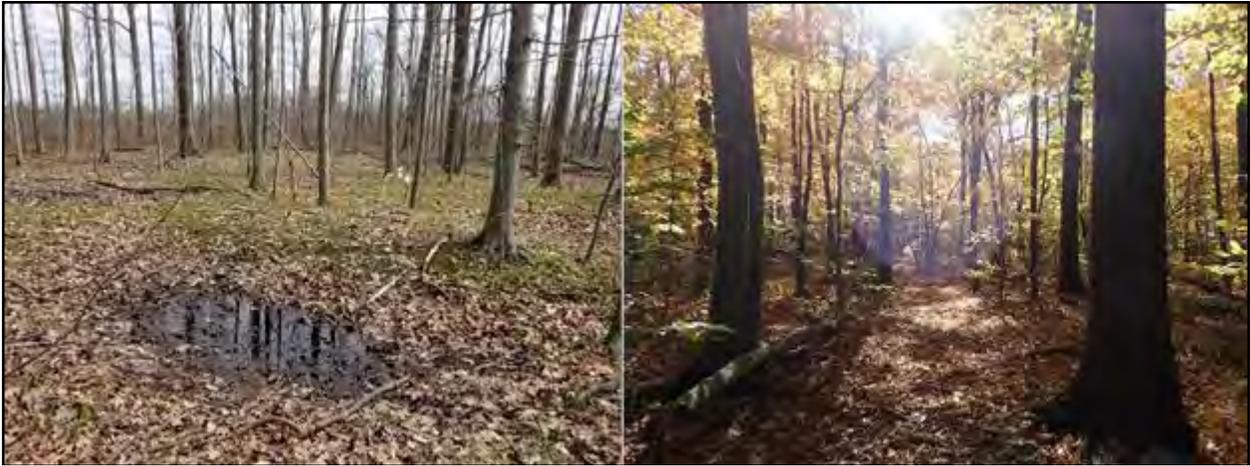
Figure 3.74: Deciduous forest within NHA Tw1, spring (left) and autumn (right)

The main block of NHA Tw1 is currently an isolated natural area which contains thicket swamp, treed swamp, and deciduous forest communities (**Figure 3.74**). It is one of the higher-quality forested habitats within the study area (second only to NHA Si2) and contains vernal pools, locally rare flora, flora with narrow habitat tolerances (i.e. those with CC values ≥ 7), and variable topography. Natural heritage designations applicable to the feature include significant woodland, several categories of significant wildlife habitat, and wetlands. Tributaries of Twenty Mile Creek are located north and south of the feature before confluenting in the east. In the case of the former, the tributary passes through the thicket swamp at the northern end of the feature. Additionally, on the south end of the feature, HDF #TM2-H2 forms a hydrologic connection between the sloughs within the southeast portion of the forest to a tributary of Twenty Mile Creek to the south.

Lands recommended for forest restoration and enhancements include lands between the south end of the deciduous forest and the southern tributary of Twenty Mile Creek and its associated floodplain. These lands contain HDF #TM2-H2. Lands directly east of the feature, landlocked by virtue of their location between two tributaries of Twenty Mile Creek, are also a prime candidate for forest restoration efforts. Restoration and enhancement of these two aforementioned areas will likely positively influence the ecologic function of the feature and will complement the connections and other ecologic functions gain from nearby watercourse and floodplain restoration efforts. It is recommended that future upgrades to Golf Club Road consider the incorporation of traffic calming and wildlife passages between the restored areas north of Golf Club Road and the extant orchard to the south, as applicable.

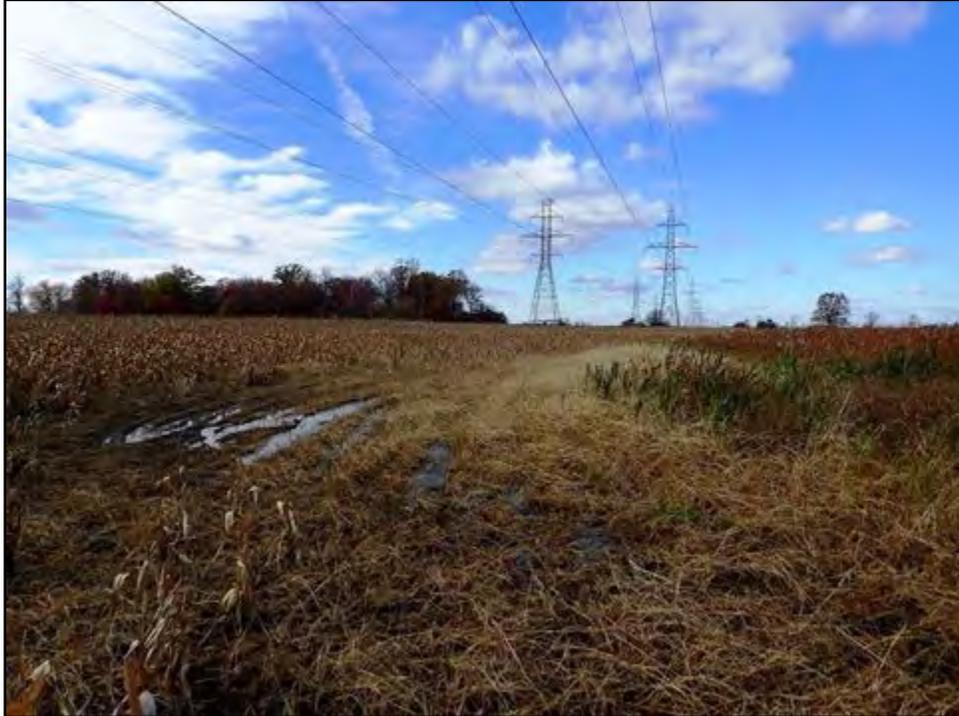
Figure 3.75: Restoration area located between NHA Si5 (left) and NHA Si6 (right)

Landlocked areas located between the tributaries of Sinkhole Creek, their associated floodplain, and NHAs Si5 and Si6 (**Figure 3.75**) represent an opportunity to enhance the aforementioned NHAs and the Stoney Creek tributaries by creating an ecologically functional connection between them. As the majority of these landlocked areas are within the hydro corridor, it is recommended that restoration efforts consider the maintenance regime and height restrictions imposed within the hydro corridor. Outside of the corridor, it is recommended that opportunities for wetland creation be explored.

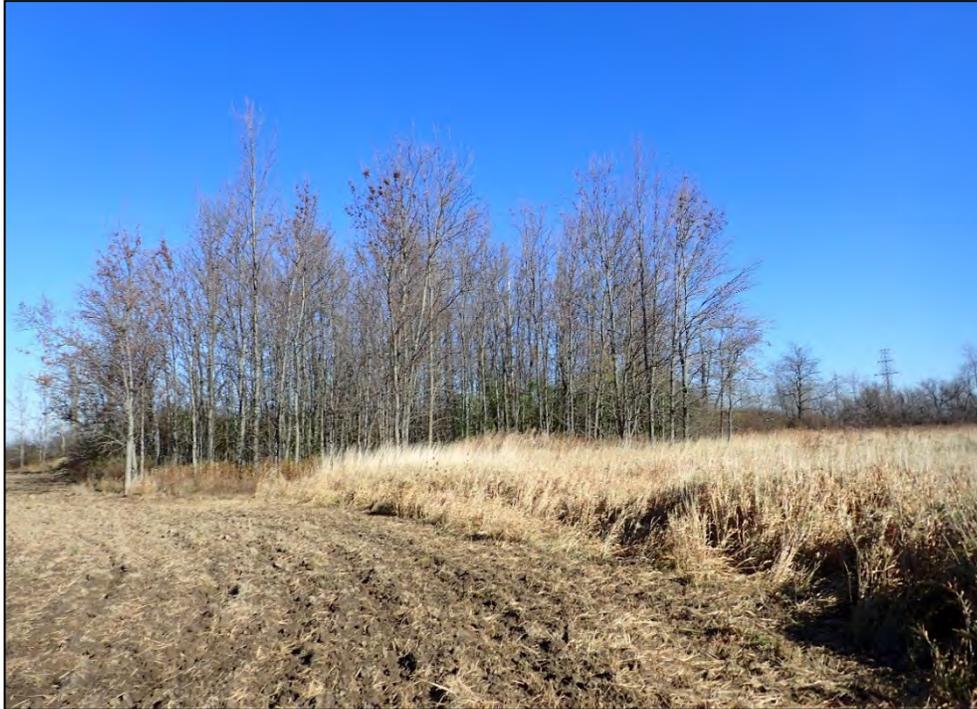
Figure 3.76: NHS Si7

NHA Si7 is an ash (*Fraxinus*) dominated woodland and a cultural meadow within and surrounded by the floodplain of Sinkhole creek, which borders the NHA to the north and south (**Figure 3.76**). Forest restoration in this area would not only mitigate the impacts of emerald ash borer (*Agrilus planipennis*), but also increase the ecologic function of the woodland and Sinkhole Creek.

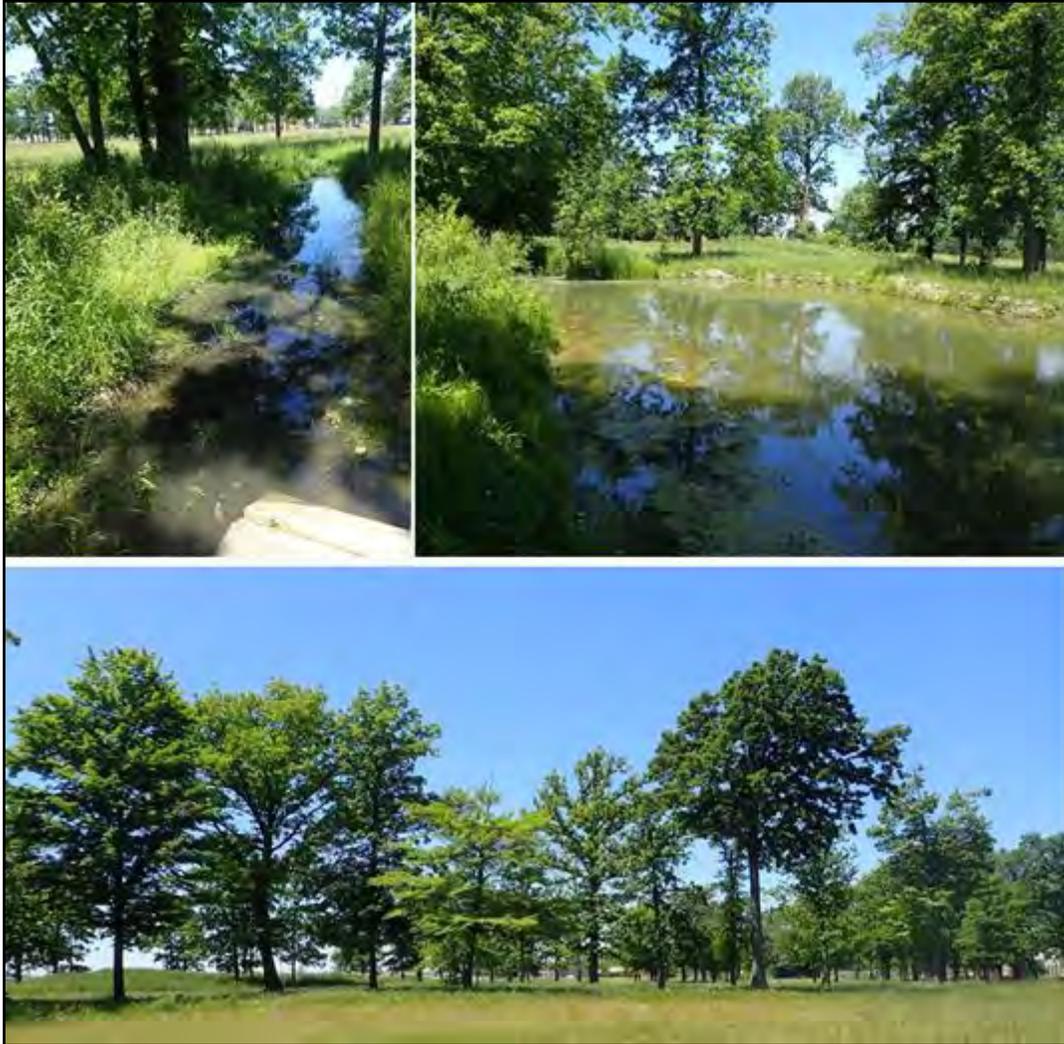
Figure 3.77: Wetland and cultural savannah communities within the northern portion of NHA St1

The northern portion of NHA St1 (**Figure 3.77**) occupies the site of a former 9-hole golf course that, judging by the remnant vegetation communities present, was likely built within moist forest and swamp. This feature is separated from nearby forested communities by roads but retains a hydrologic connection with a wetland/pond to the east and the treed swamp west of Upper Centennial Parkway (NHA St2). Vegetation communities within this feature include cultural savannah and various wetland communities including meadow marsh, ponds, and the globally and provincially rare Bur oak Mineral Deciduous Swamp. Wetland communities within this feature are part of a larger wetland which extends along Stoney Creek from Highland Road to the pond east of NHA St1, near Mud Street. A species of Special Concern, the Eastern wood-pewee, has been confirmed within this feature. Other natural heritage designations applicable to this feature include significant woodlands, wetlands, several categories of significant wildlife habitat, fish habitat, and watercourses (Stoney Creek).

As a way to potentially enhance water quality within Stoney Creek, the wetlands, and fish habitat; it is recommended that the floodplain associated with the branch of Stoney Creek that extends from Upper Centennial Parkway and joins with another tributary of Stoney Creek be actively restored to an open woodland community. This restoration will have the added benefit of providing potentially suitable habitat for wildlife, including and not limited to Eastern wood-pewee.
