Cherry Beach Shoreline Protection Environmental Assessment Project

Coastal Technical Report

July 2014

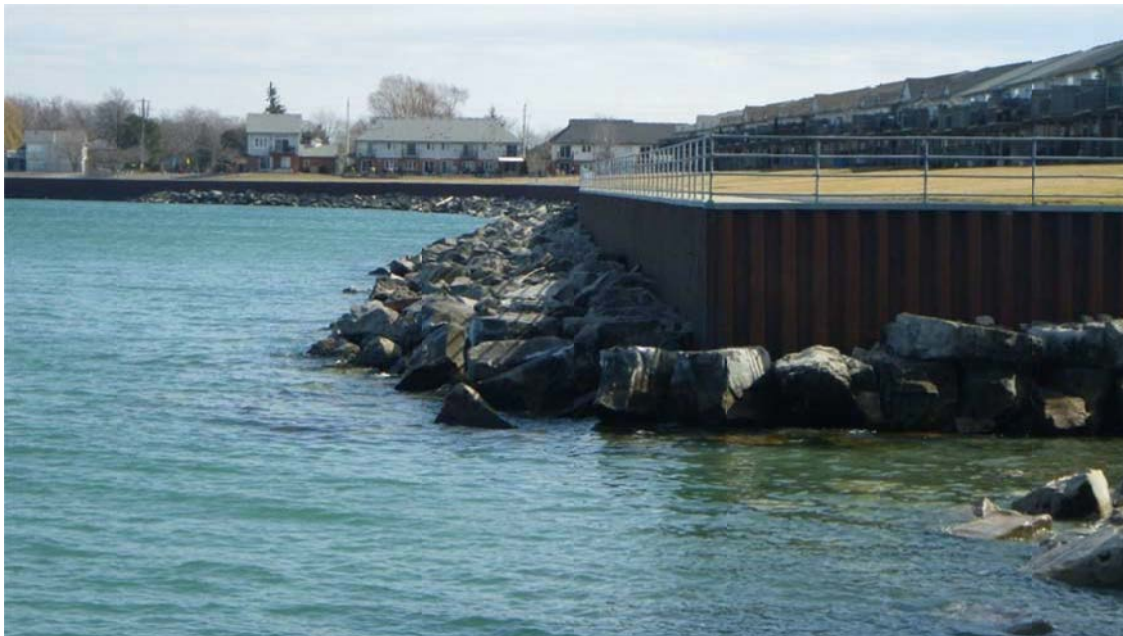
Figure 2.1: View of Shoreline to East of Site

A concrete lined channel runs along the east property line and discharges into Lake Ontario. The shoreline to the east of the channel is protected with a steel sheet pile wall with a wide low armour stone revetment along the front of the wall. Figure 2.1 shows the shore protection to the east of the study area.

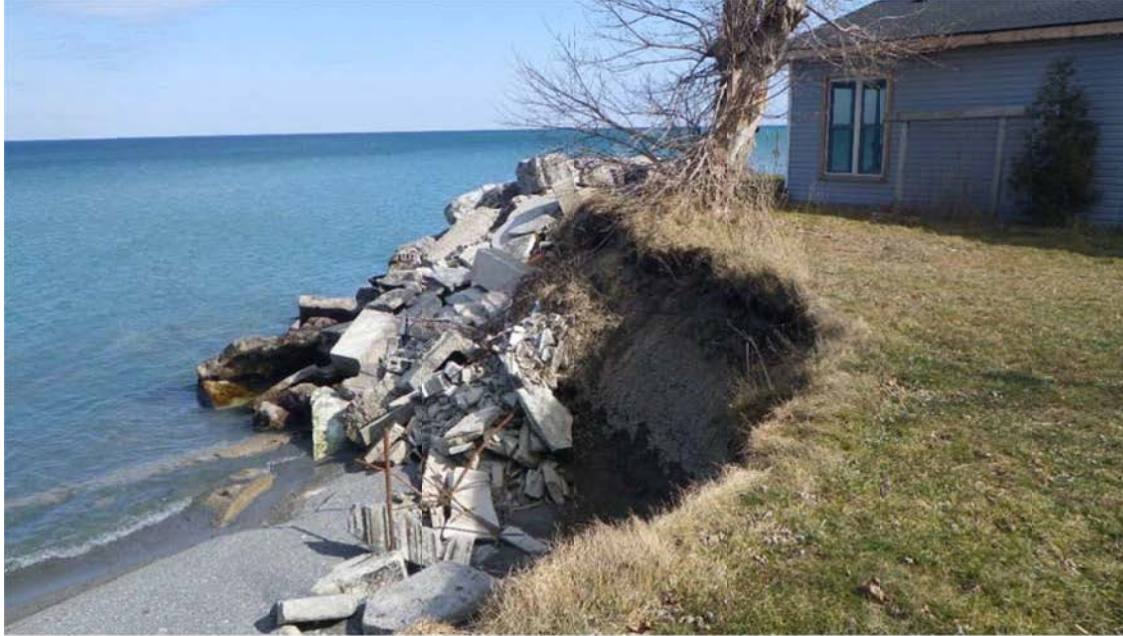
Figure 2.2: View of Headland at East End of Study Area

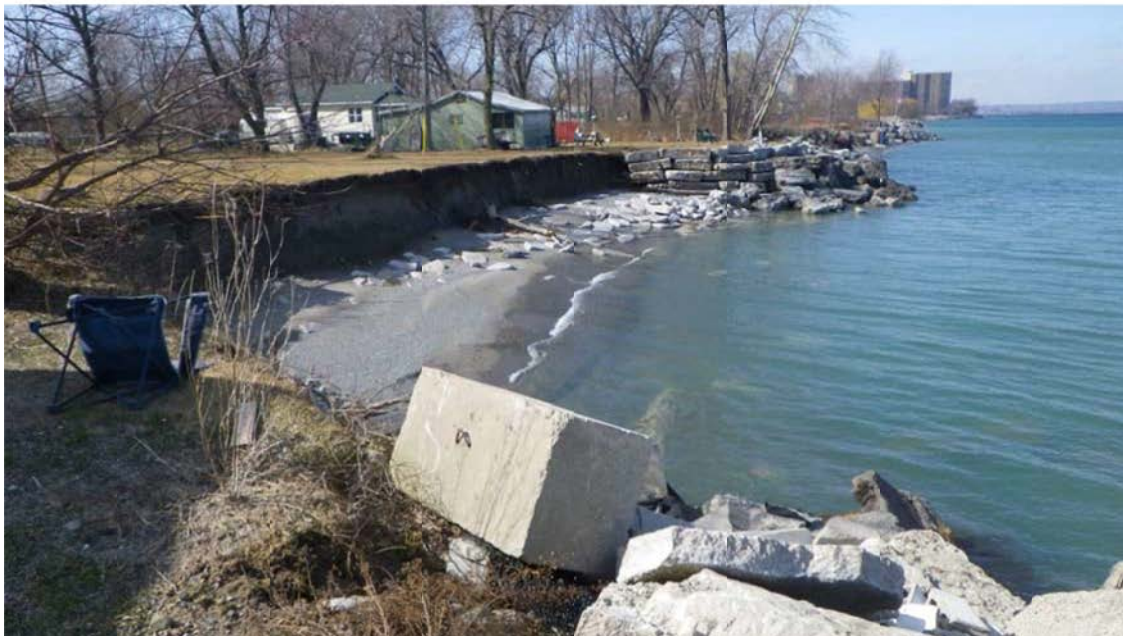
Figure 2.3: View of Bank in Eastern Part of Site Looking West

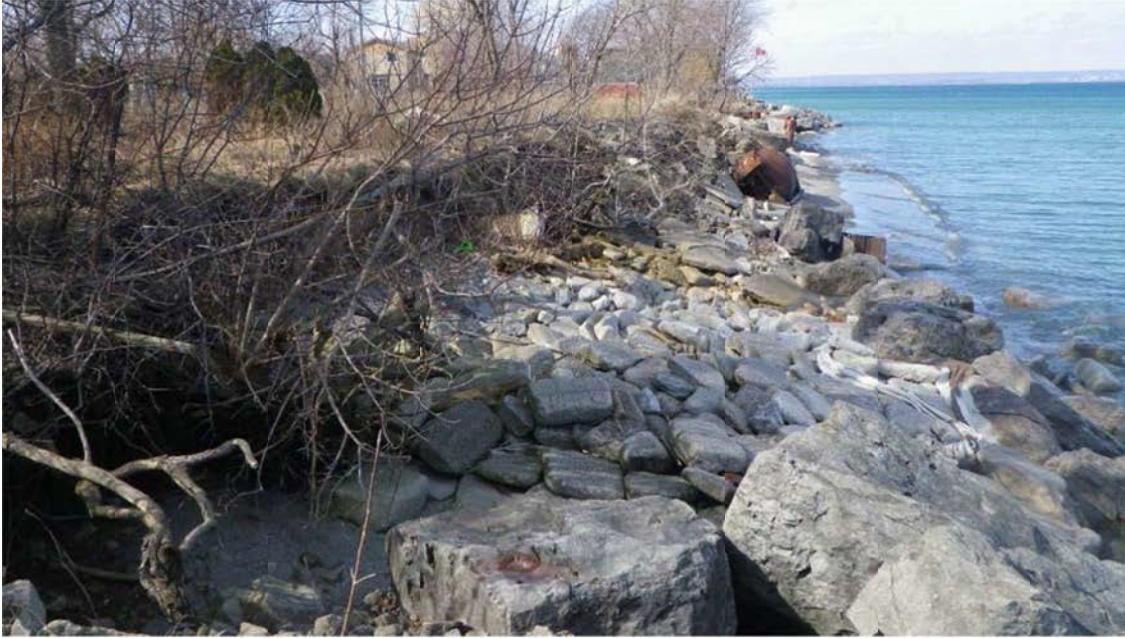
Figure 2.4: View of Rubble and Armour Stone in Central Part of Site, Looking West

Most structures along the shoreline of the site appear to be conglomerate structures constructed over years as reinforcement was required. Rubble is scattered along the shore and is visible in the nearshore. This may originate from collapsed structures or is the remains of rubble dumped along the shore. The portions of the shoreline that are unprotected have an exposed low till bank, which has a near vertical slope. The bank is actively eroding in these areas. The unprotected, eroding shoreline is up to 10 m back (south) of the adjacent protected shoreline. This section of shoreline is shown in Figure 2.2 and Figure 2.3. The shoreline near the centre of the study site is shown on Figure 2.4. This photograph shows the mix of armour stone and rubble used to protect the shoreline along most of the study site.

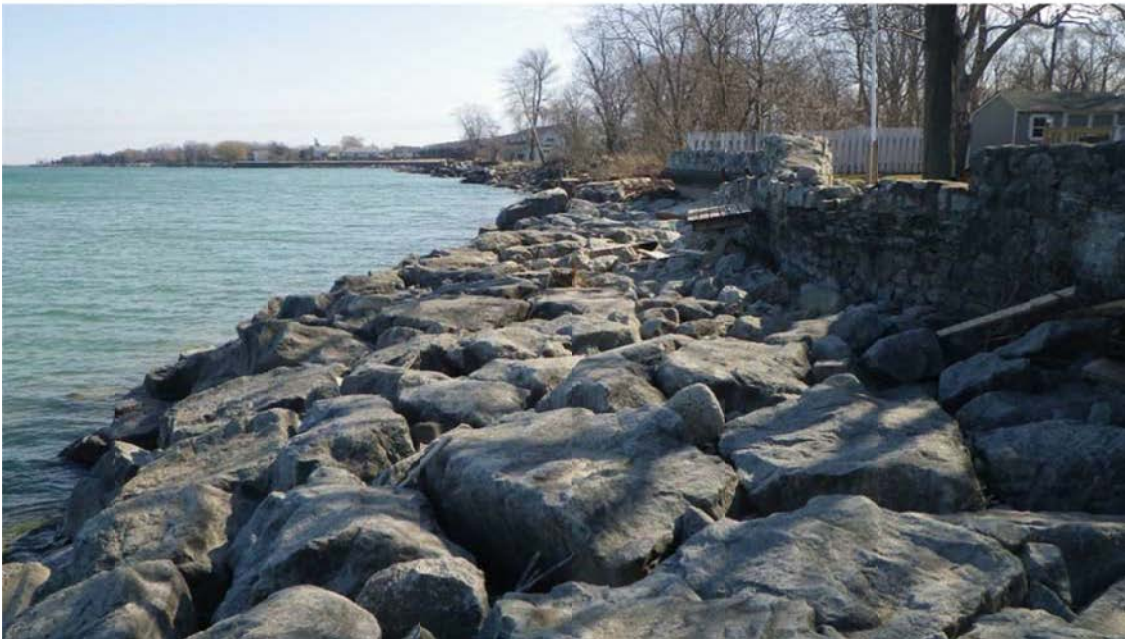
Figure 2.5: View from Adjacent Property to the West, Looking East

The shoreline on the adjacent property to the west is protected with an armour stone revetment with a stone and mortar wall. The armour stone revetment has a wide low crest, with an approximate

elevation of 77.0 m IGLD. The top of the stone and mortar wall varies but is approximately 2 m above the revetment. Figure 2.5 and Figure 2.6 show the shoreline to the west of the study area.

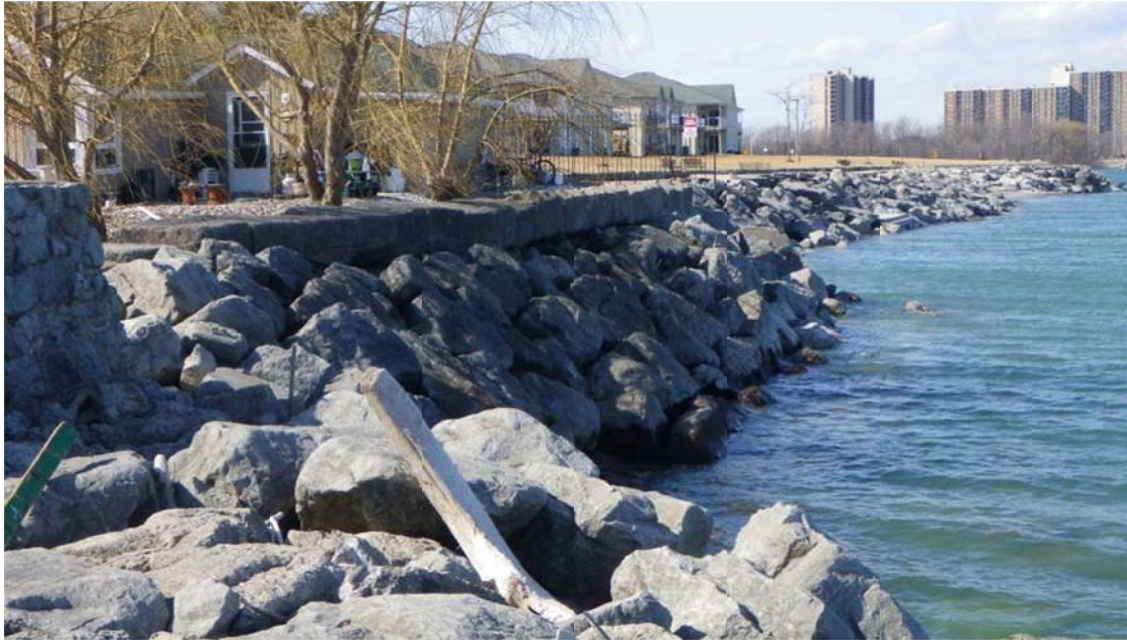
Figure 2.6: View of Adjacent Property to the West, Looking West

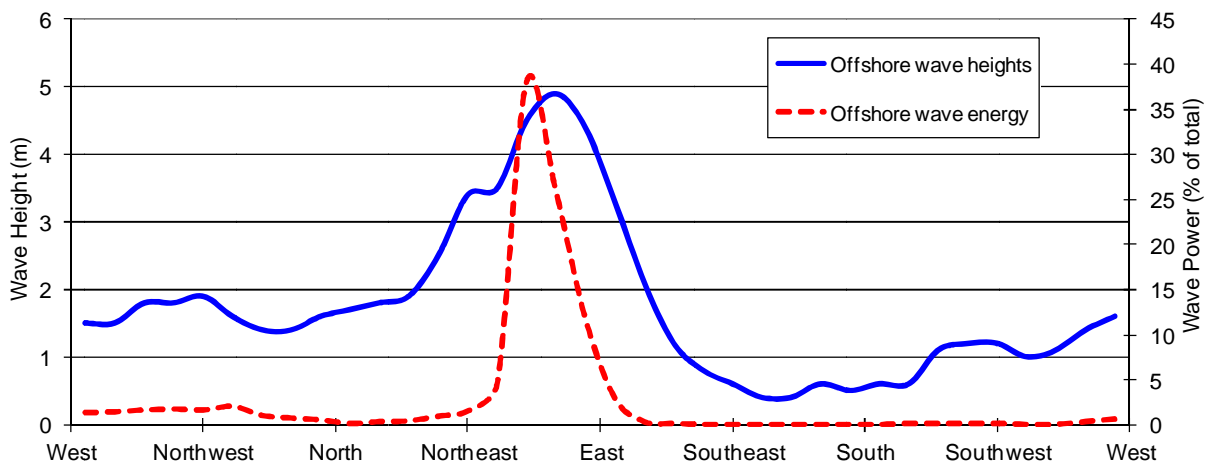
Figure 2.8: Distribution of Offshore Wave Heights and Wave Energy

Figure 2.8 shows the highest hindcast wave heights and total wave energy distribution by direction for the 36 year hindcast. It can be seen from Figure 2.8 that the largest offshore wave heights come from the east. The wave energy distribution shows a large peak from the north-northeast and a much smaller one from north-northwest. There are larger wave heights coming from the east than the northwest due to the longer overwater fetches to the east. The small energy peak from north-northwest is due to the frequency of winds that come from the western quadrant, blowing over the relatively short fetch from Burlington Beach.

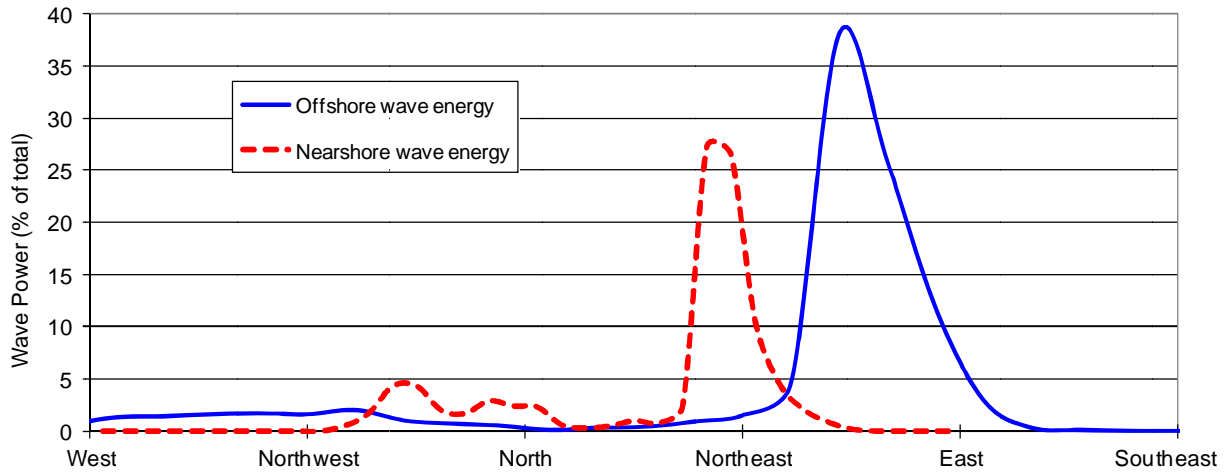
Figure 2.11: Comparison of Offshore and Nearshore Wave Energy Distributions

A nearshore wave climate was produced by determining nearshore waves for a number of representative offshore wave conditions. Those results were used to establish interpolation limits for transferring each wave from the 36-year hourly hindcast data set. This produced a 36-year data set of hourly estimates of zero-moment wave height, peak wave period and mean wave direction for a nearshore node in front of the site. Figure 2.11 shows a comparison of the offshore and nearshore wave energy distributions. The two peaks have moved closer together in the nearshore and the easterly peak still dominates.

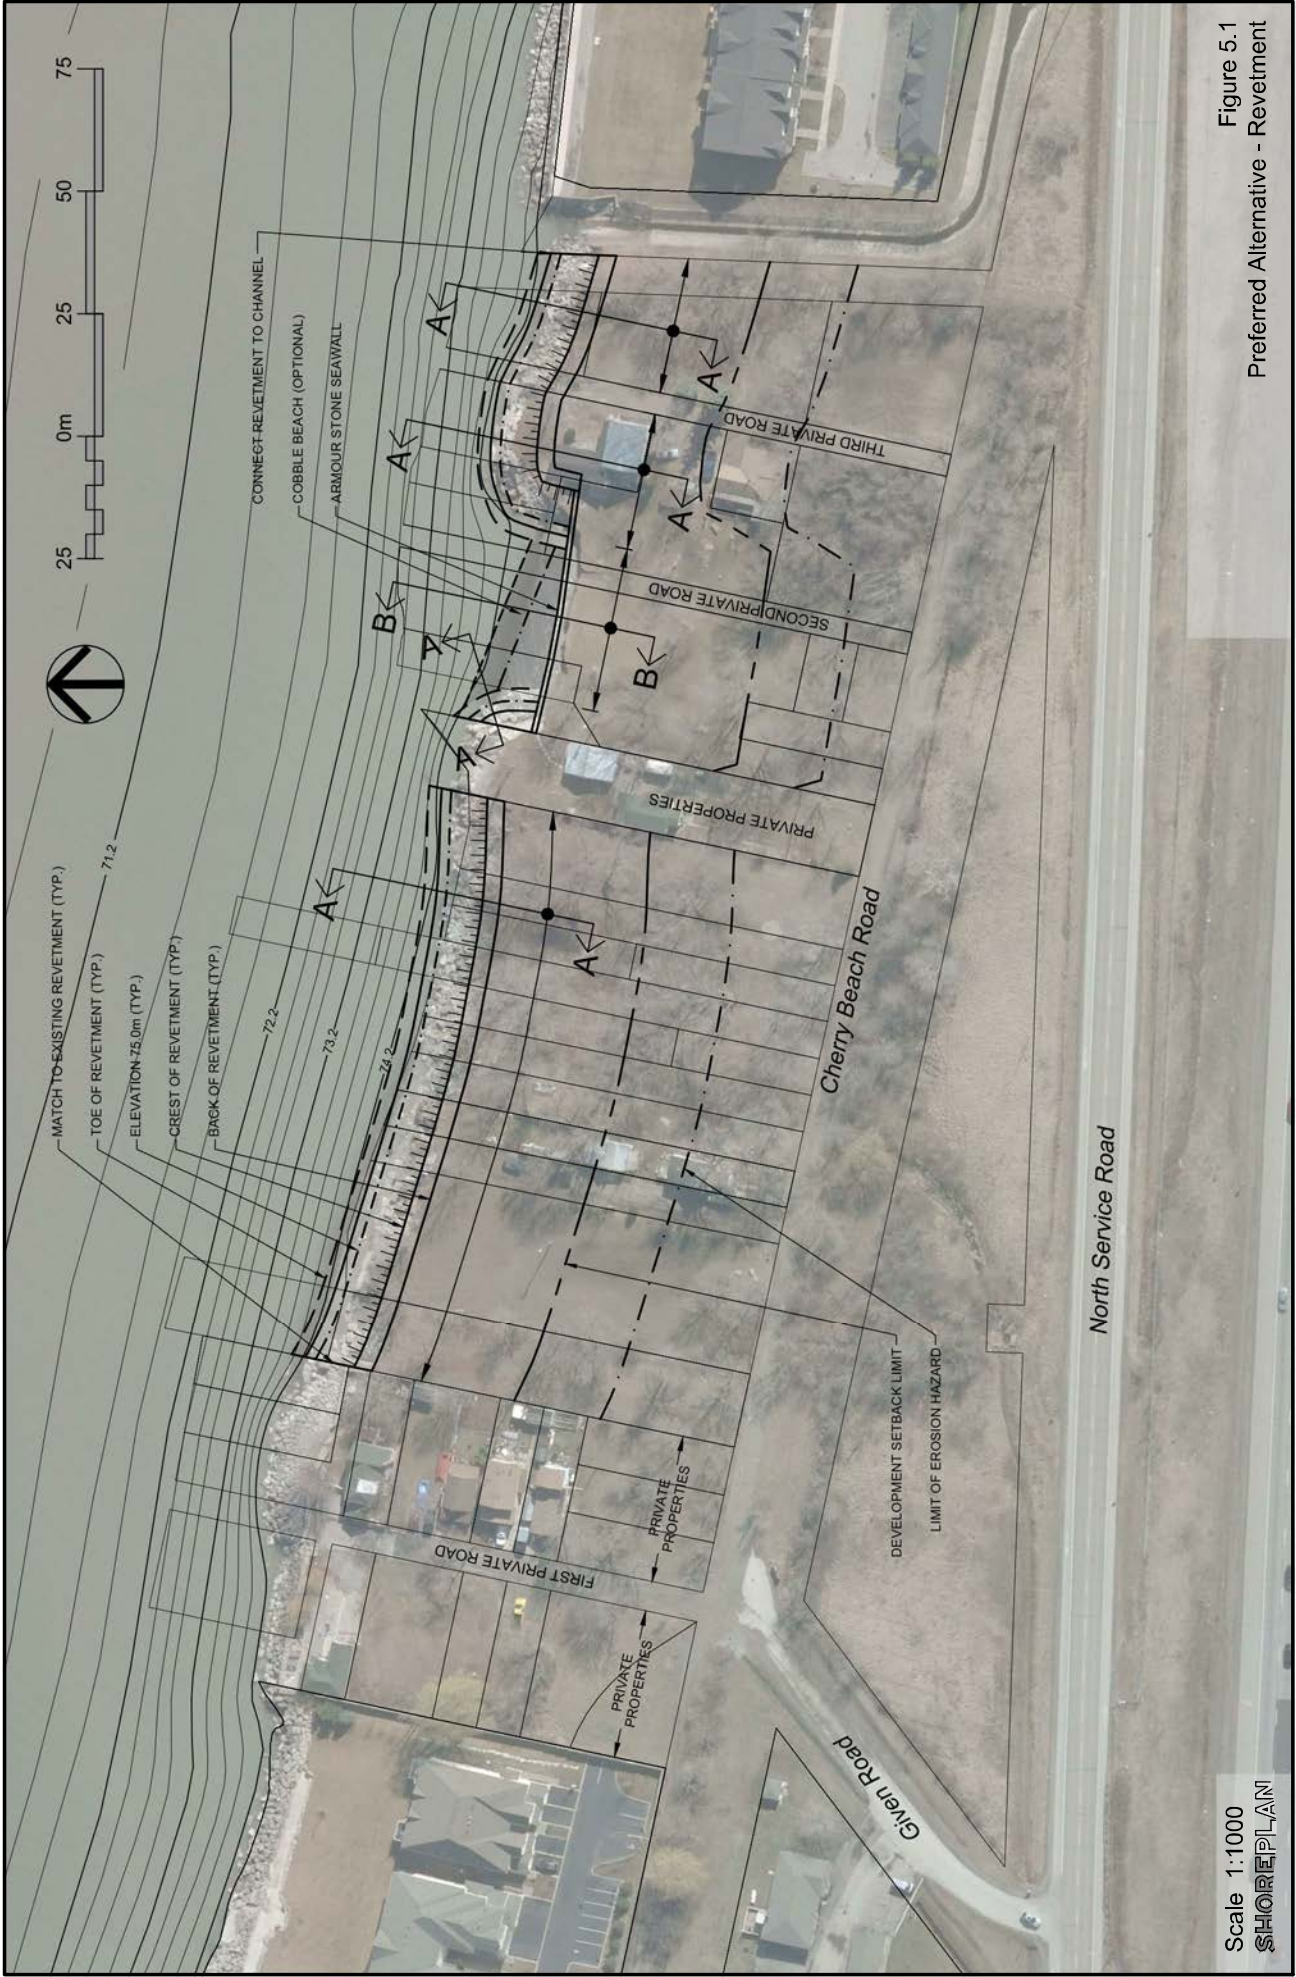
Figure 5.1
 Preferred Alternative - Revetment

Two alternate designs of the revetment are proposed at the preliminary design stage. Both alternate designs will be founded on firm till at an elevation of approximately 72.0 m and have an estimated crest elevation of approximately 78.75 m. The first alternate section is shown in Section A on Figure 3.2. The structure slope is composed of two layers of randomly placed armour stone. The armour stone overlays a layer of rip rap placed on a geotextile. The toe stones will be specially placed on firm till below the scour and nearshore downcutting depth. The crest will consist of specially placed cap stones. Behind the structure, the ground elevation steps down to match existing grade. The second alternate section is shown on Figure 3.3. The structure slopes are composed of a bottom layer of specially placed armour

The average lake bottom elevation at the toe of the proposed structure is approximately 74.2 m. This means that at the DHWL (76.0 m IGLD 1985), the water depth at the toe of the structure will be approximately 1.8 m. The crest elevation is estimated to be high enough to prevent wave overtopping under most conditions but minor overtopping is expected to occur during the design high water level and design storm conditions. The toe depth of the structure is designed to be below the nearshore level at the end of the design life. Typical design life is approximately 35 years, but can extend to approximately 50 years with relatively minor movement of the toe.

The revetment structure breaks at the location of the existing shingle pocket beach. The existing concrete rubble will be removed and the beach will be nourished with cobble beach material. The cobble beach material will consist of approximately 50 to 150 mm diameter washed cobble stone. The material will be placed in a berm with a natural angle of repose and be allowed to be reshaped by wave action. The beach slope will adjust to varying water levels and wave conditions. The beach is expected to establish a slope of approximately 3h:1v above the water line and a slope of approximately 6h:1v below the water line.

An armour stone seawall will be constructed at the back of the cobble beach, directly in front of the existing exposed bank. The wall is expected to have a double toe stone founded on firm till at an elevation of approximately 73.0 m. Armour stone will be stacked to a crest elevation of approximately 77.5 m to match backshore grades. The armour stone will be backed by a layer of rip rap and geotextile.
