Cherry Beach Shoreline Protection Class Environmental Assessment

City of Hamilton

Project File Final Report

September 2014

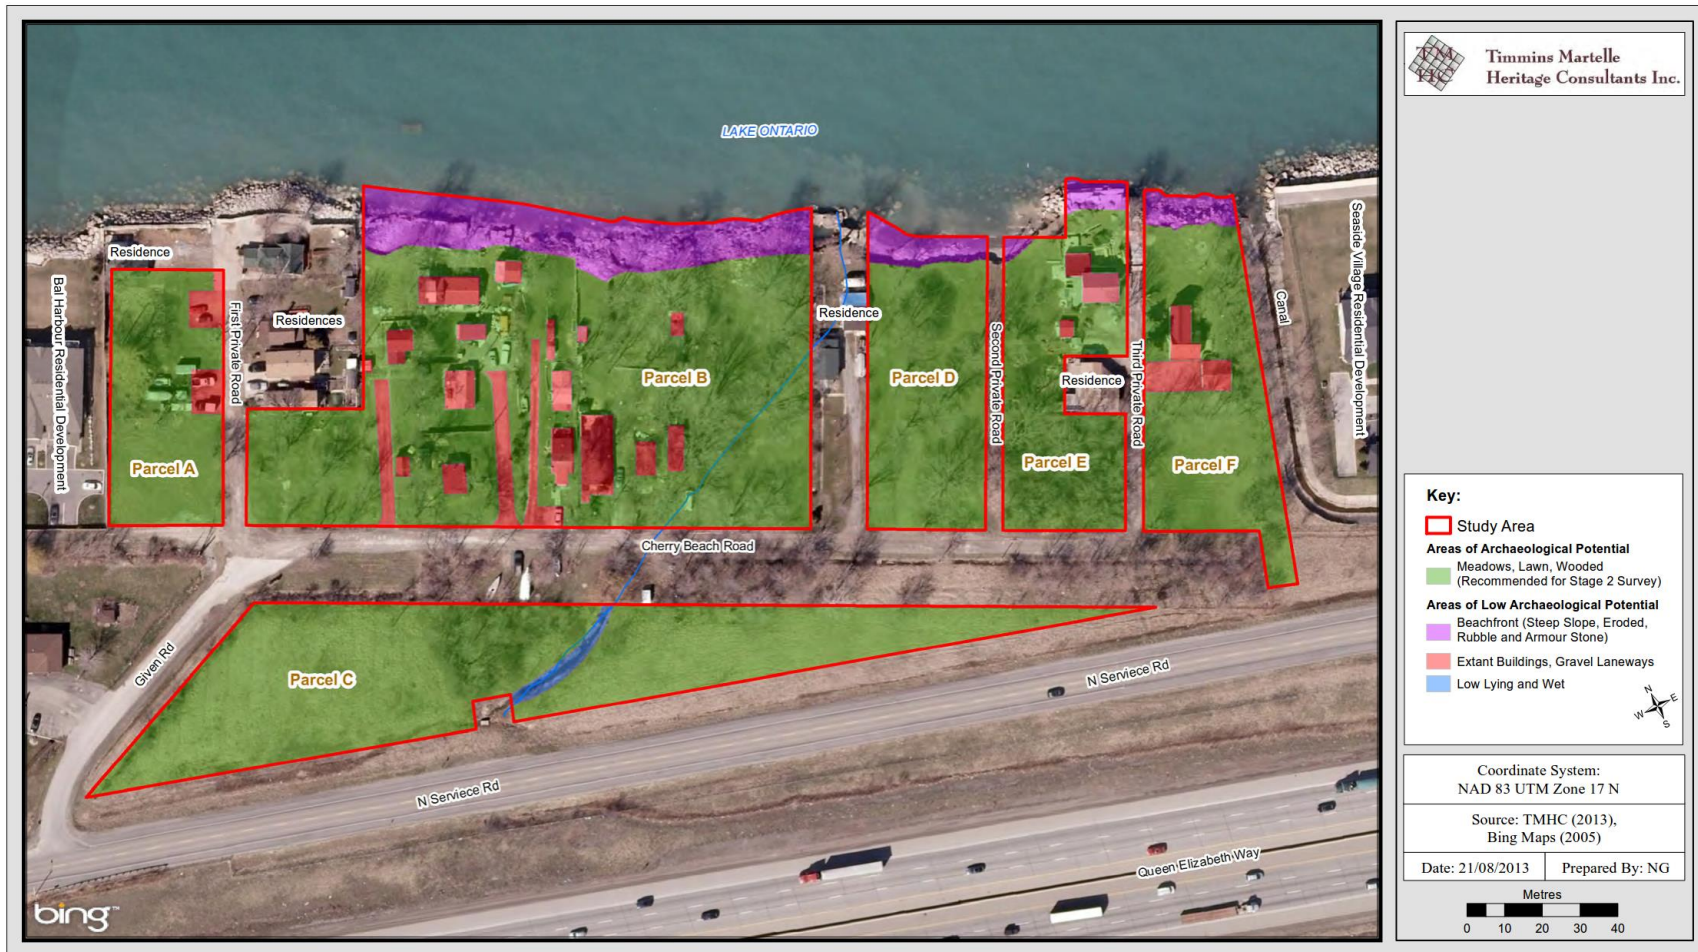
Figure 9: Study Area for Stage 1 and 2 Archaeological Assessment, Cherry Beach Road
 (Source: Timmins Martelle Heritage Consultants Inc., 2013)

The Stage 1 assessment revealed that the Study Area had potential for archaeological resources. Potential for the discovery of First Peoples sites is indicated by the proximity (within 300 m) of a primary water source (Lake Ontario) and a glacial shoreline of Lake Iroquois. The potential for the discovery of historic era sites is demonstrated by proximity (within 300 m) to a primary water source (Lake Ontario) and its potential association with early settlers on the area (Henry Utter and the Carpenter family).

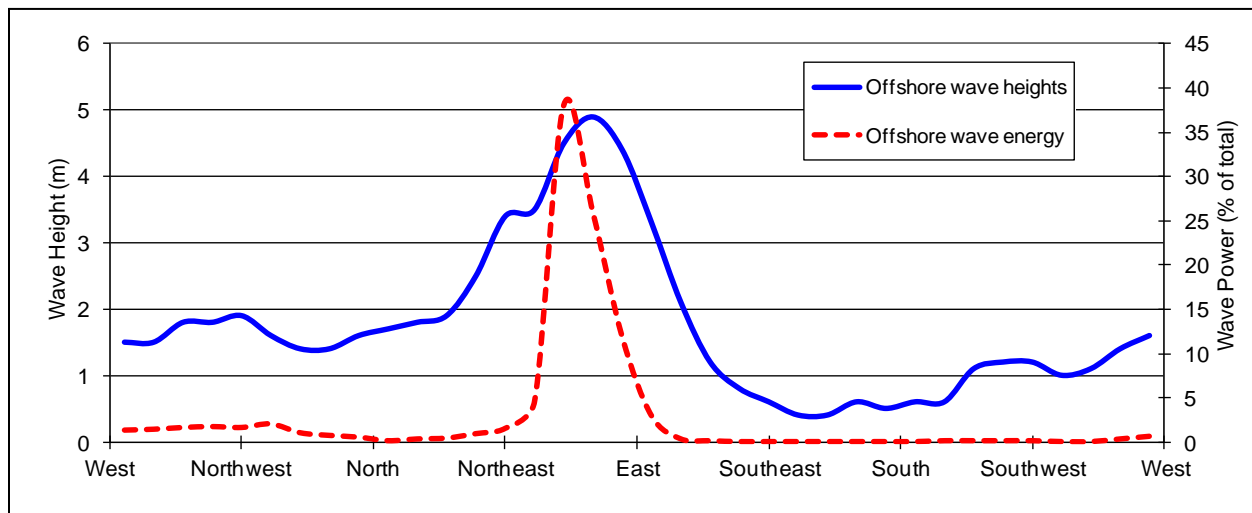
Figure 11: Distribution of Offshore Wave Heights and Wave Energy

Figure 11 shows the highest hindcast wave heights and total wave energy distribution by direction for the 36 year hindcast. As shown on **Figure 11**, the largest offshore wave heights come from the east. The wave energy distribution shows a large peak from the north-northeast and a much smaller one from north-northwest. There are larger wave heights coming from the east than the northwest due to the longer overwater fetches to the east. The small energy peak from north-northwest is due to the frequency of winds that come from the western quadrant, blowing over the relatively short fetch from Burlington Beach.

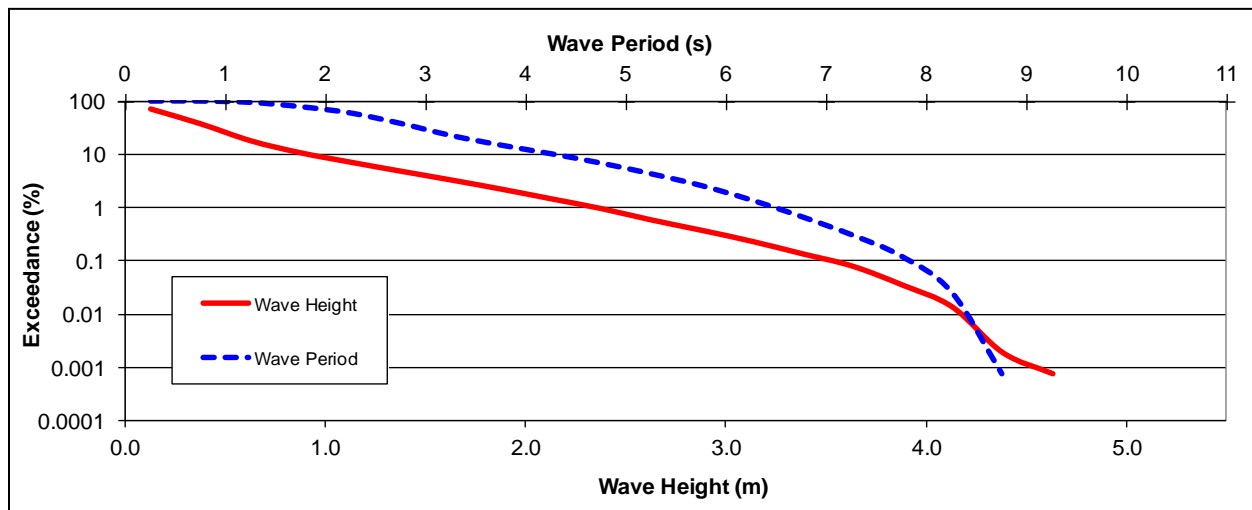
Figure 12: Wave Height and Period Exceedance Curves

Figure 12 shows wave height and period exceedance curves for the hindcast data set. These plots show the percentage of time that a given wave height or period are exceeded.

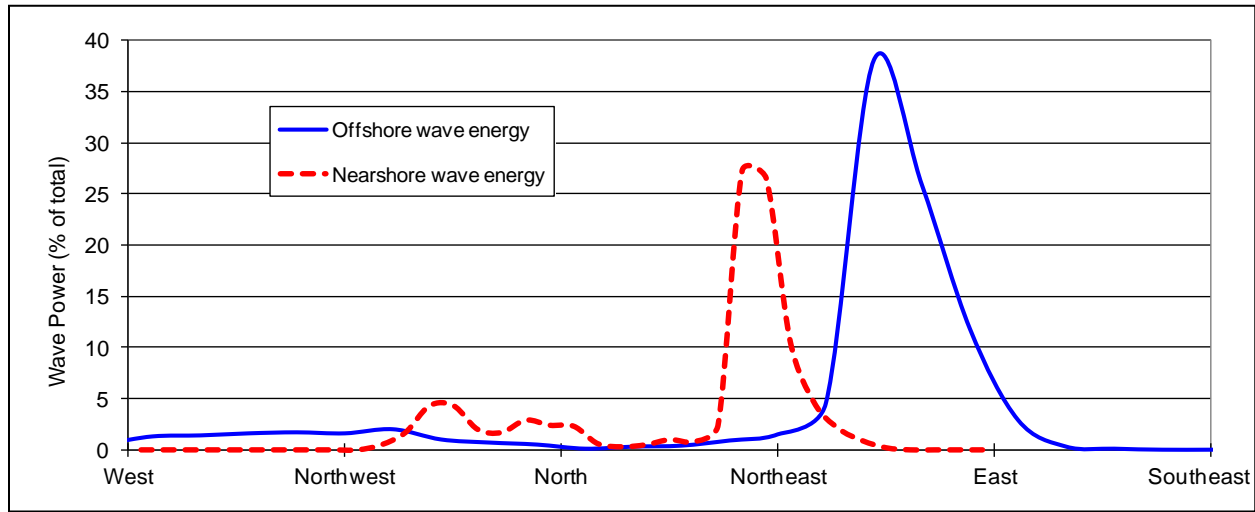
Figure 14: Comparison of Offshore and Nearshore Wave Energy Distributions

A nearshore wave climate was produced by determining nearshore waves for a number of representative offshore wave conditions. Those results were used to establish interpolation limits for transferring each wave from the 36-year hourly hindcast data set. This produced a 36-year data set of hourly estimates of zero-moment wave height, peak wave period and mean wave direction for a nearshore node in front of the site. **Figure 14** shows a comparison of the offshore and nearshore wave energy distributions. The two peaks have moved closer together in the nearshore and the easterly peak still dominates.

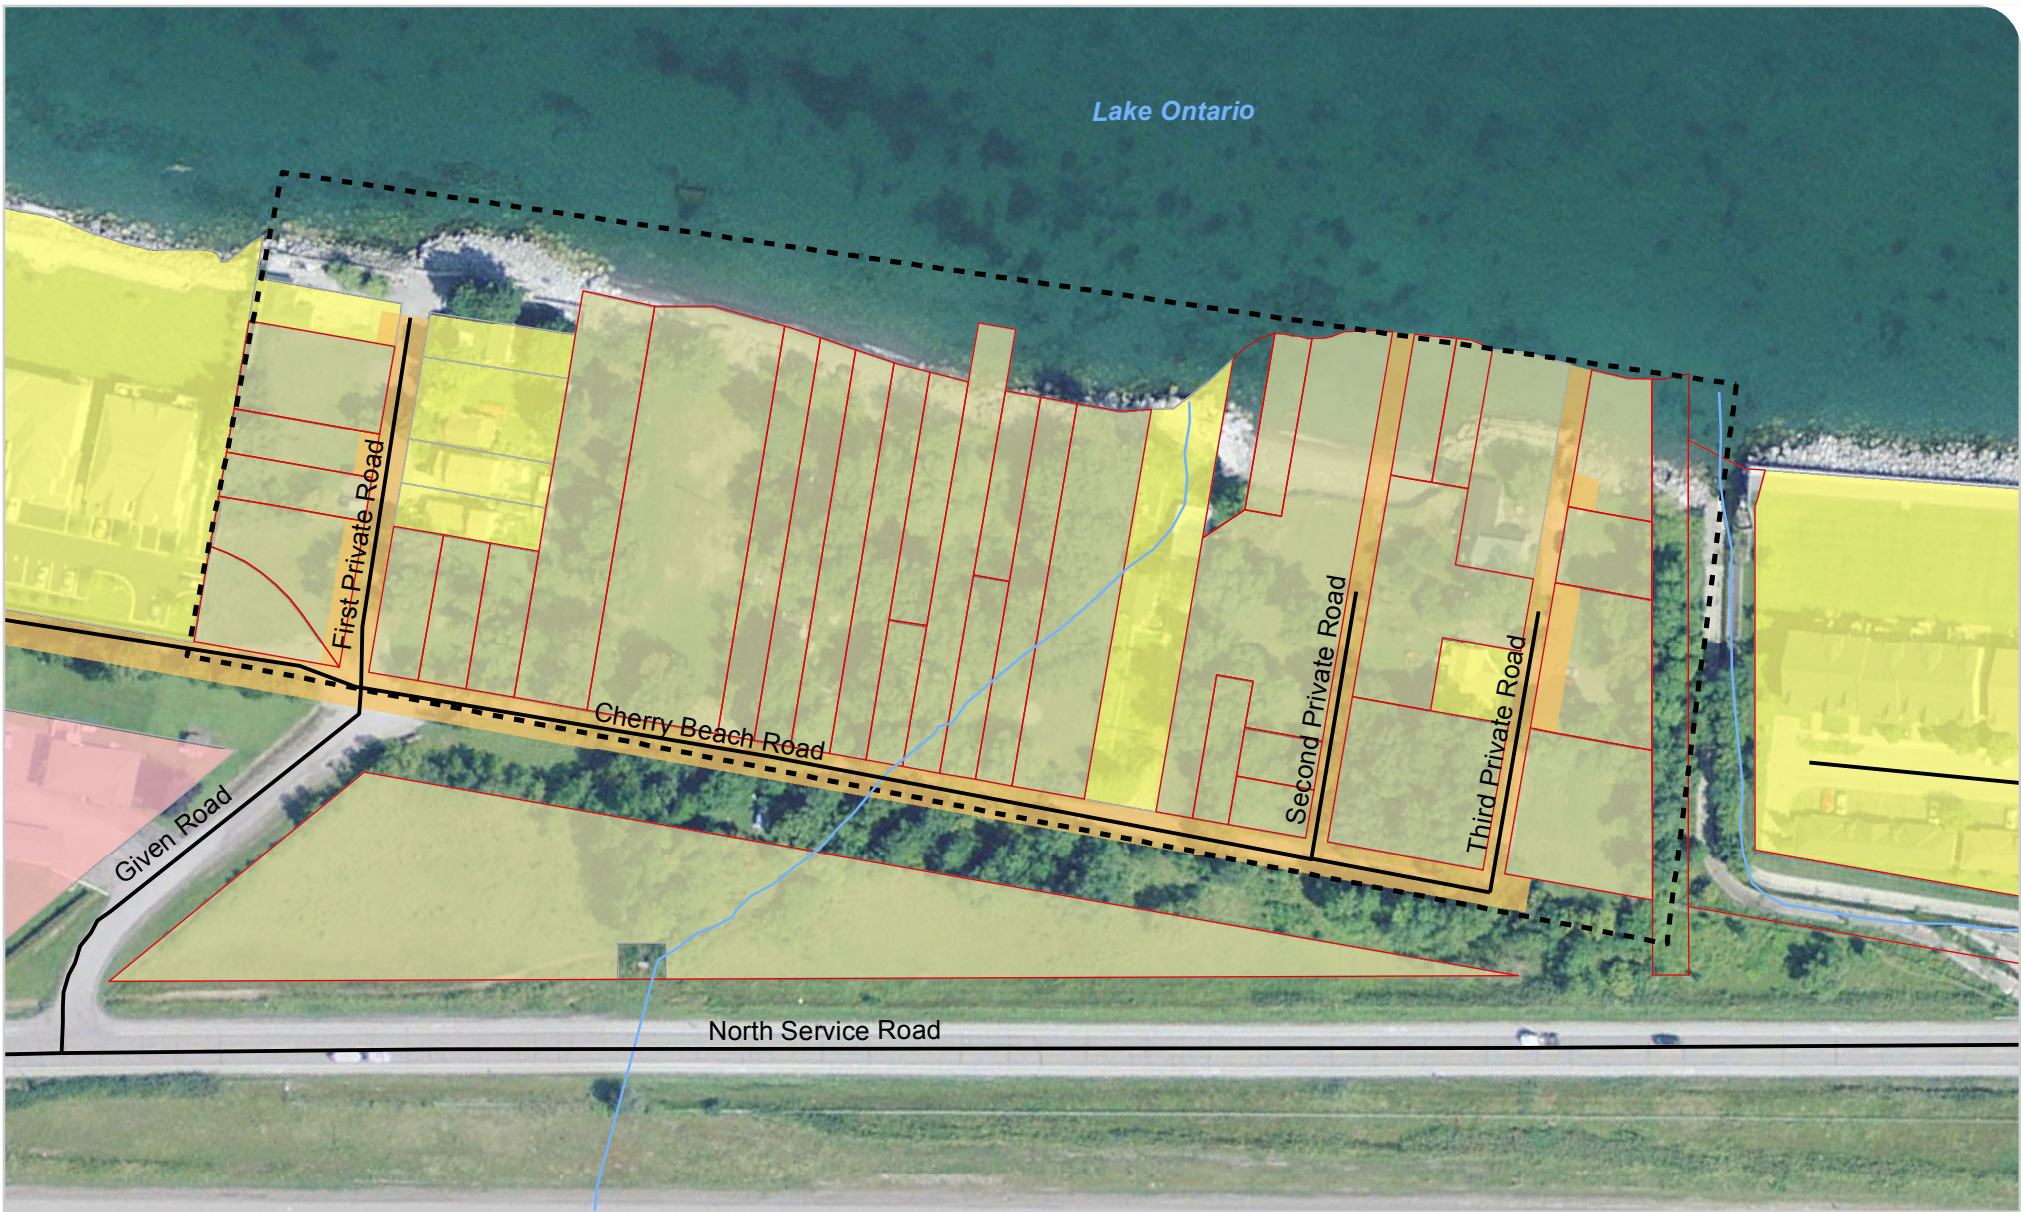
Figure 15: Existing Land Uses

The Study Area is an old lakefront area enclave which contains City owned properties, many of which were former cottage sites. As shown on **Figure 15**, the area consists of vacant land containing meadow, manicured lawn and deciduous woodland. Existing views and vistas will be closely maintained.
