This Cultural Heritage Impact Assessment ("CHIA") has been prepared by ERA Architects Inc. ("ERA") for the proposed redevelopment of the property known municipally as 1284 Main Street East, in Hamilton (the "Site").

CONDITION ASSESSMENT PREPARED BY ERA ARCHITECTS INC, DATED MAY, 2022

PROPOSED RESIDENTIAL DEVELOPMENT

1284 MAIN STREET EAST - DELTA

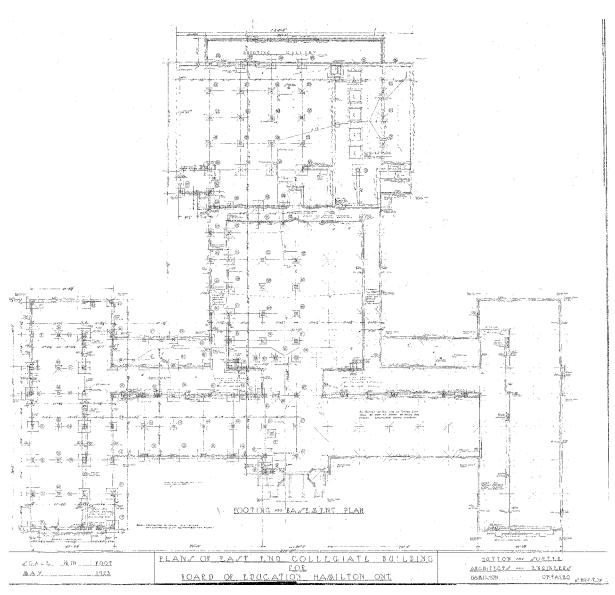
1923 foundation plan (Hutton and Souter).

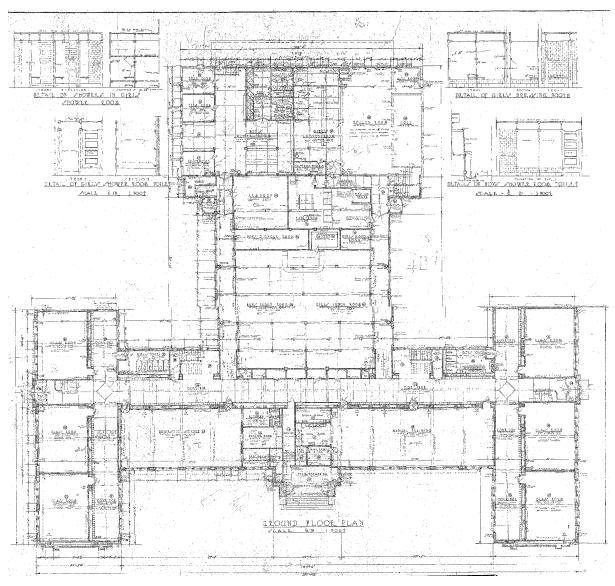
1923 ground floor plan (Hutton and Souter).
