PHASE 1 ENVIRONMENTAL SITE ASSESSMENT REPORT

Area 1: Tower Park Phase 1 ESA Report

Phase I Environmental Site Assessment (ESA)

42-46 Woodend Drive, Carlisle, Hamilton, ON

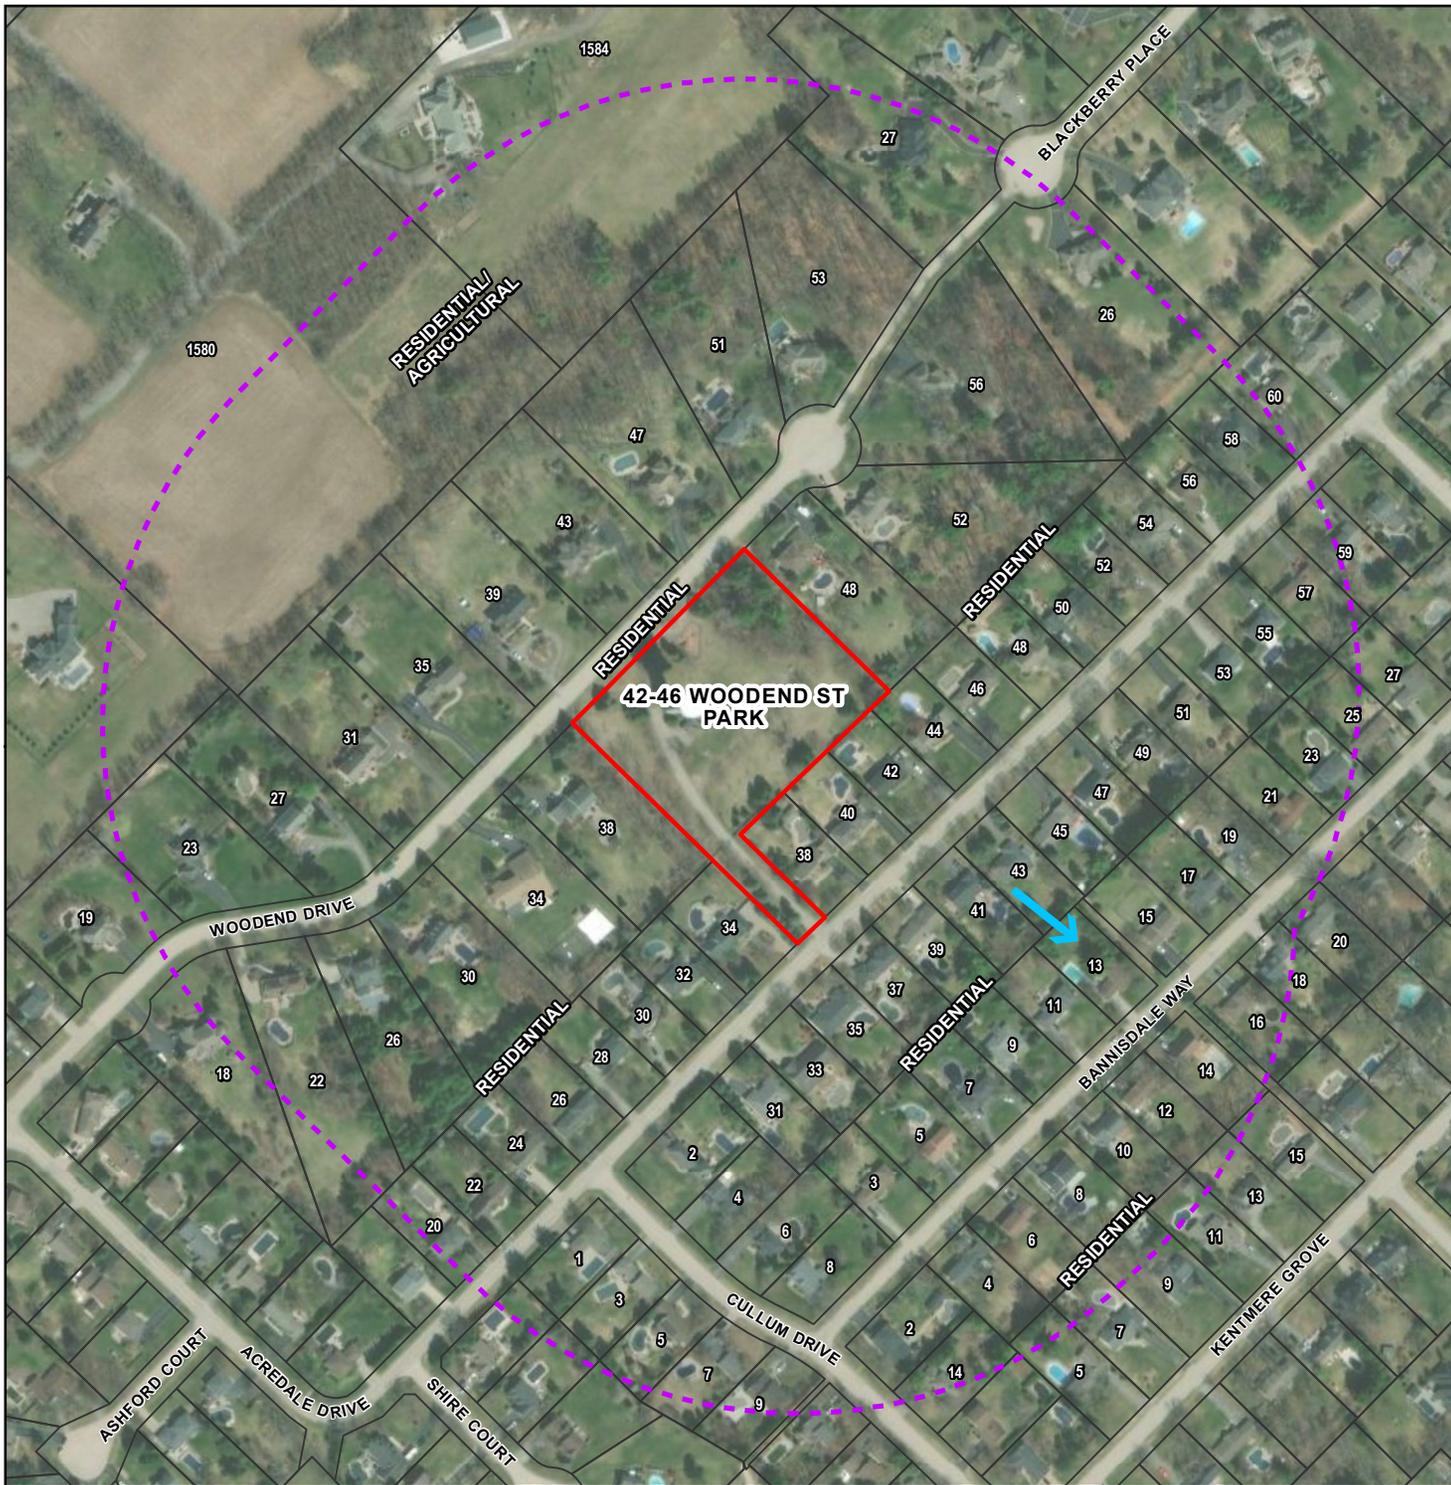
PART OF SLR	REF. NO. 2108704-MR-202-1
Figure 2

The surrounding area was surveyed within a 250 m radius and all occupants of neighboring properties were noted and are developed with residential land uses, as shown in **Figure 2**.

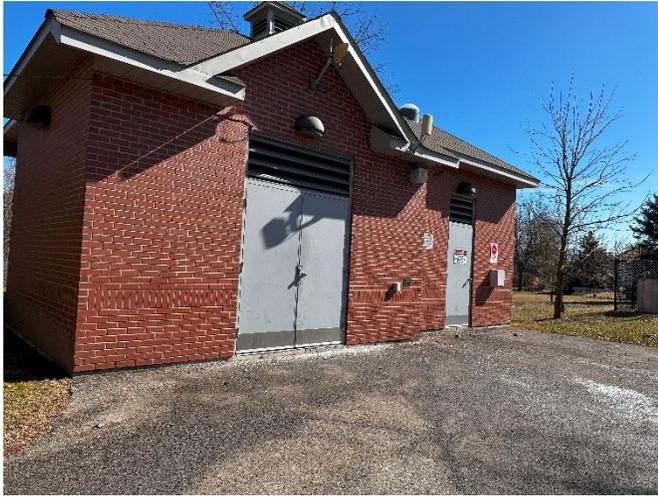
Photograph 5

Photo depicts front facing view of the storage building on the Site.

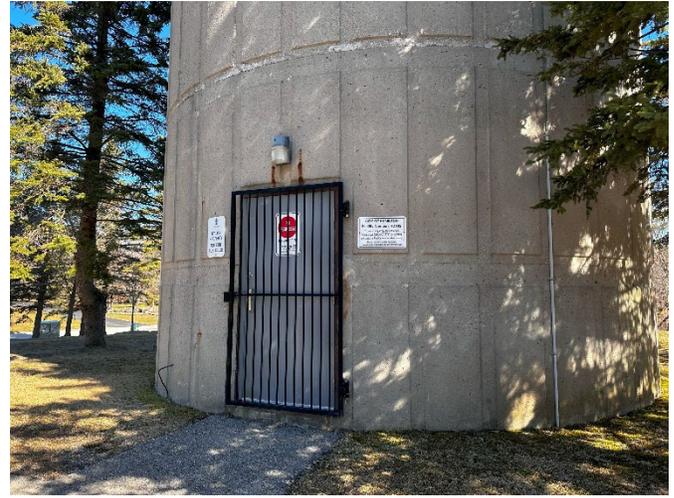
Photograph 6

Photo depicts the front facing view of the water tower building on the Site.

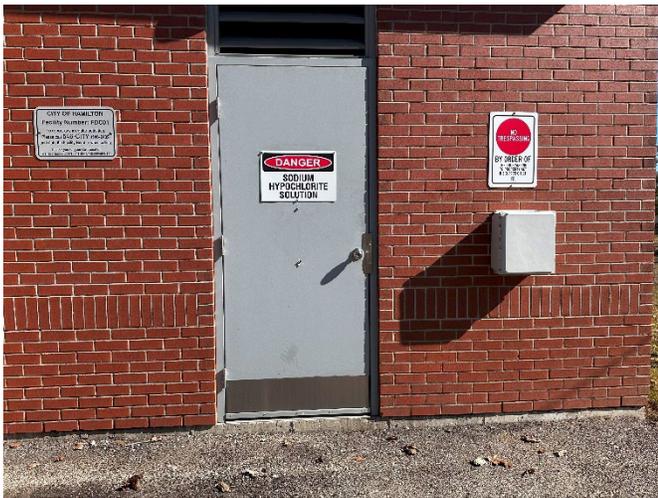
Photograph 7

SITE OBSERVATIONS		
DESCRIPTION	REPORTED/ OBSERVED ON-SITE Y/N	COMMENTS
Hazardous Substances and Petroleum Products	Y	On the front of the storage building a sign indicated that Sodium Hypochlorite solution was present within the building. This product is not considered to pose an environmental concern to the Site, as it is used for water treatment and a known disinfecting agent. In addition, no visible evidence of spills and/or leaks were associated in the vicinity of the Site buildings.
UST(s)	N	Palmer did not observe fill pipes, vent pipes or other evidence of UST(s). Palmer did not observe operations and/or equipment that are typically associated with significant fuel or chemical storage that typically utilizes USTs.
AST(s)	N	Palmer did not observe fill pipes, vent pipes or other evidence of AST(s). Palmer did not observe operations and/or equipment that are typically associated with fuel or chemical storage that typically utilizes ASTs.

Photo depicts sign located at the front of the storage building indicating the use of Sodium Hypochlorite solution.

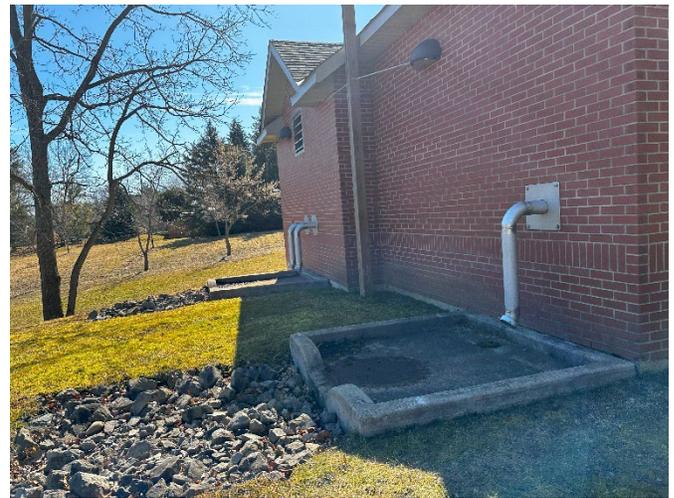
Photograph 8

- Site Exterior
 - Drainage pipes were observed along the rear of the storage building. Use of this area is reportedly unknown. Based on Palmer's site reconnaissance, this area is associated with treating potable water;
 - The northeast portion of the Site has a playground and is used for recreational purposes;
 - An asphalt-paved walkway runs throughout the Site from north to south and the rest of the site consists of landscaped grassed areas and trees.
- Storage Facility
 - No access to the interior of the building.
- Water Tower
 - No access to the interior of the structure.

Photo depicts drainage pipes and catch basins located at the rear of the storage building on the Site.

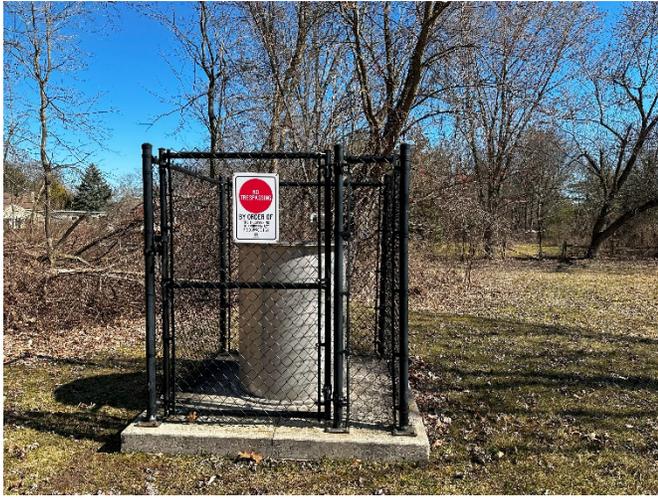
Photograph 9

One (1) ground water monitoring well was observed on the east side of the property and two (2) municipal wells were also observed on the Site beside the storage building and to the east.

Photo depicts steel well located on the east portion of the Site.

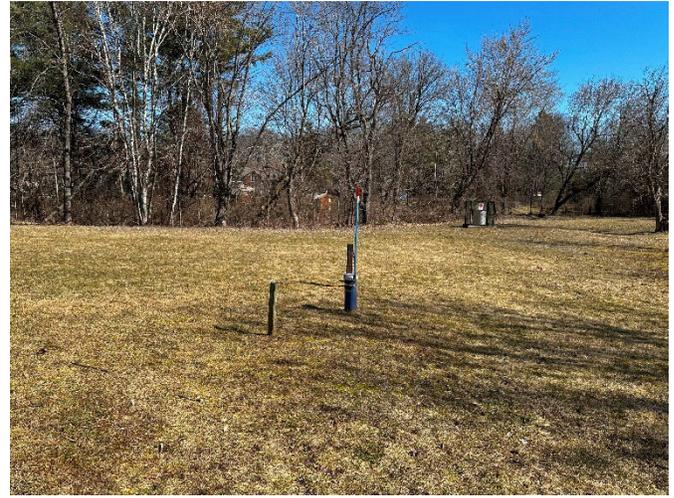
Photograph 10

Photo depicts previously installed monitoring well located on the east portion of the Site.

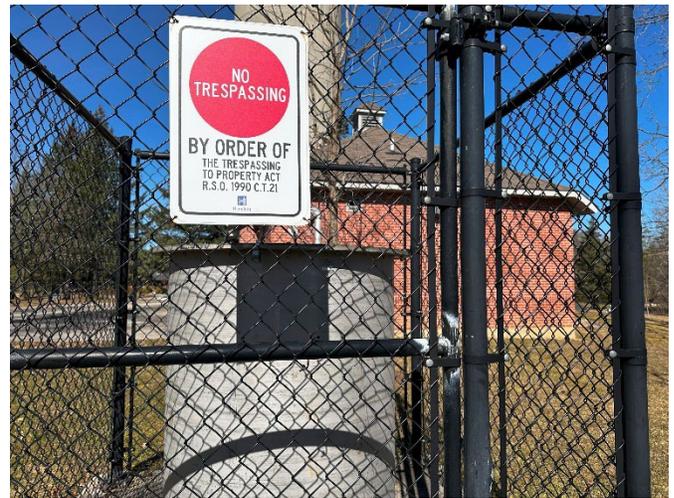
Photograph 12

Photo depicts second steel well located to the south of the storage building.
