FINAL REPORT

Cultural Heritage Impact Assessment

Upper West Side Secondary Plan in Glanbrook, City of Hamilton, Ontario

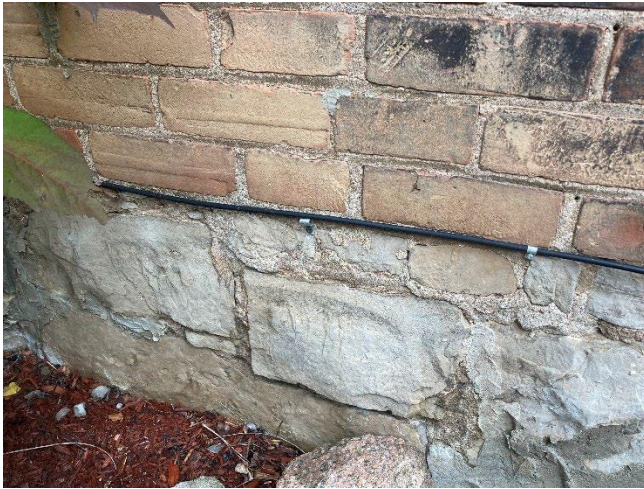
Plate 36: Coursed rubble foundation on east elevation

The main block of the residence at 9575 Twenty Road West is a three-bay, L-shaped Gothic Revival farmhouse set on coursed rubble stone foundation with red brick walling and water table and with buff brick diamond quoins (Plate 36 to Plate 37). Buff brick is also used to decorate beneath the two bay windows and upper second storey window on the west elevation, as diamond detailing in the gable centre on all elevations, and as a staggered Flemish bond border at the east and north gables (Plate 38 to Plate 39).

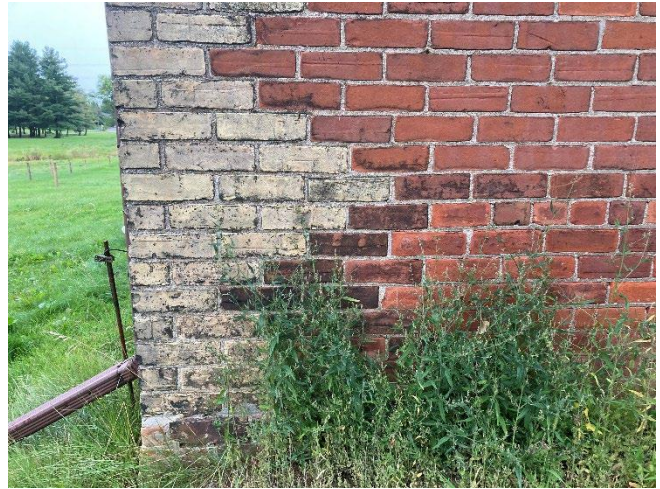
Plate 37: Buff brick diamond quoin and water table on south elevation

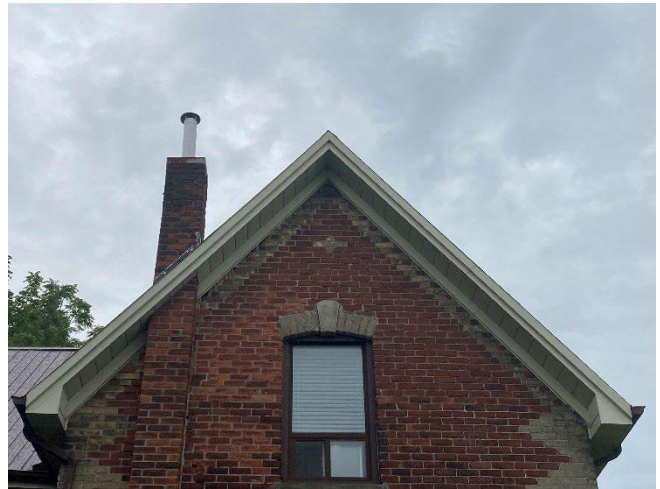
Plate 39: Buff brick staggered Flemish bond border and detailing in the north elevation gable

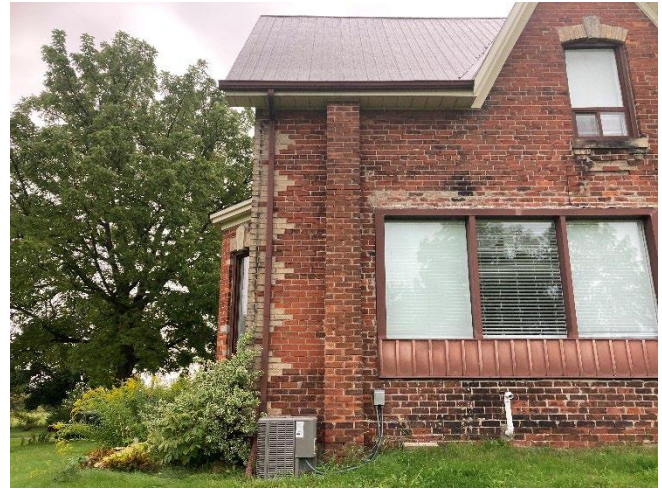
Plate 41: Remnants of a second brick chimney on the west elevation. Large breach on west elevation to accommodate new window.

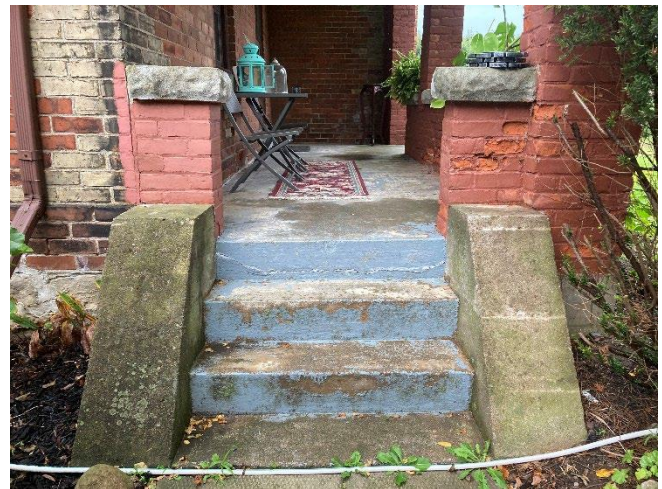
Plate 43: Access to veranda from east

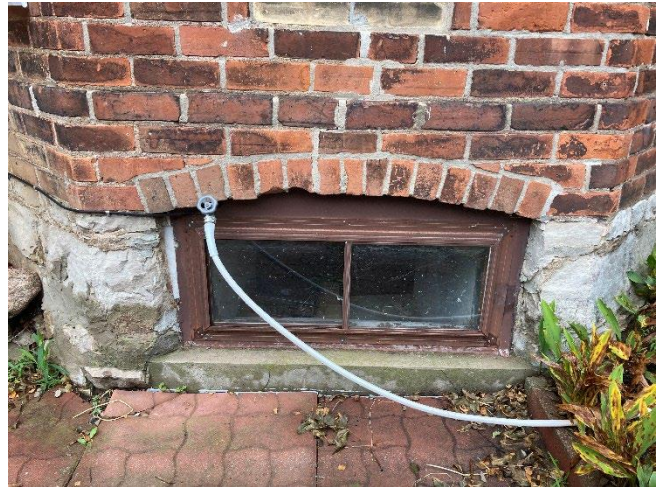
Plate 45: Basement window opening on front façade

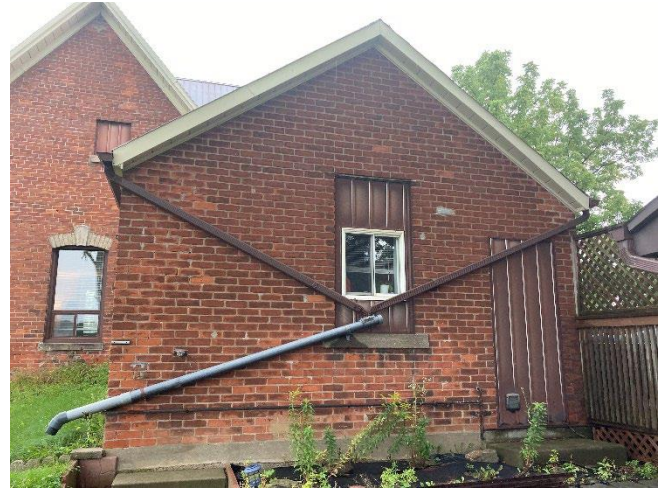
Plate 49: Blind entrance of rear addition

The main entrance is beneath the partially enclosed veranda on the north elevation (Plate 47). Another entrance is on the southern addition, accessible via the wooden porch. A blinded entrance is on the south-most elevation of the addition and now covered over by aluminium siding (Plate 48 to Plate 49).

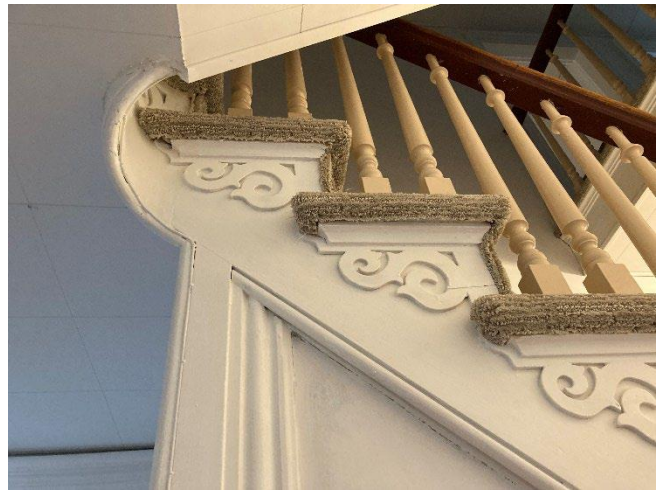
Plate 63: Turned wood balustrade and decorative trim

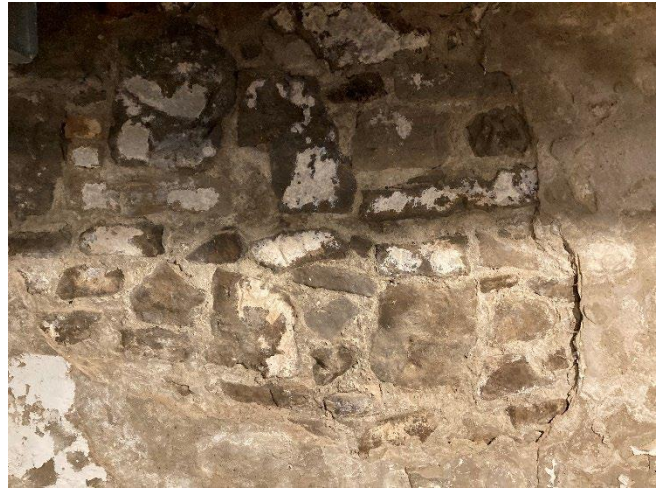
Plate 67: Course rubble foundation covered in plaster

Accessed from the first-floor central hallway, the basement features a rough concrete floor and the walls are parged coursed rubble (Plate 64 to Plate 68). Several blind windows are located throughout the basement and the floor joists for the ground floor are visible in the basement ceiling and are circular sawn (Plate 69 to Plate 73).

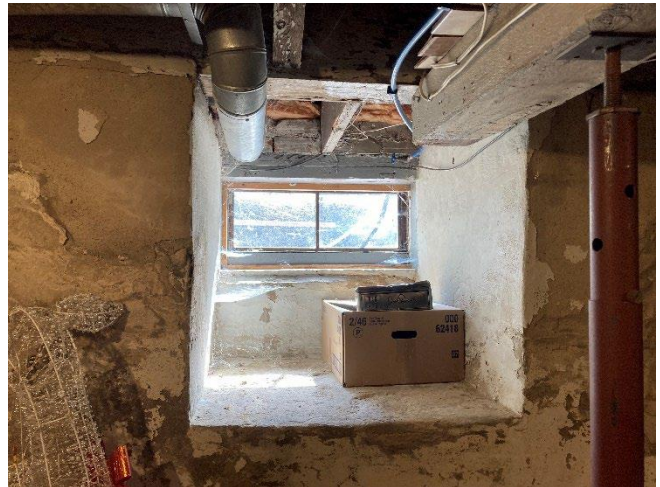
Plate 69: Original window frame located in the basement
