**Fluvial Geomorphology and Preliminary Channel Crossing Design
Fifty Creek (WC 12) & Lake Ontario Tributaries WC 5.0, 6.0, 7.0, & 7.1
Phases 3 & 4 Barton Street and Fifty Road Improvements
Municipal Class Environmental Assessment
City of Hamilton**

DRAFT May 28, 2021 / FINAL August 25, 2021

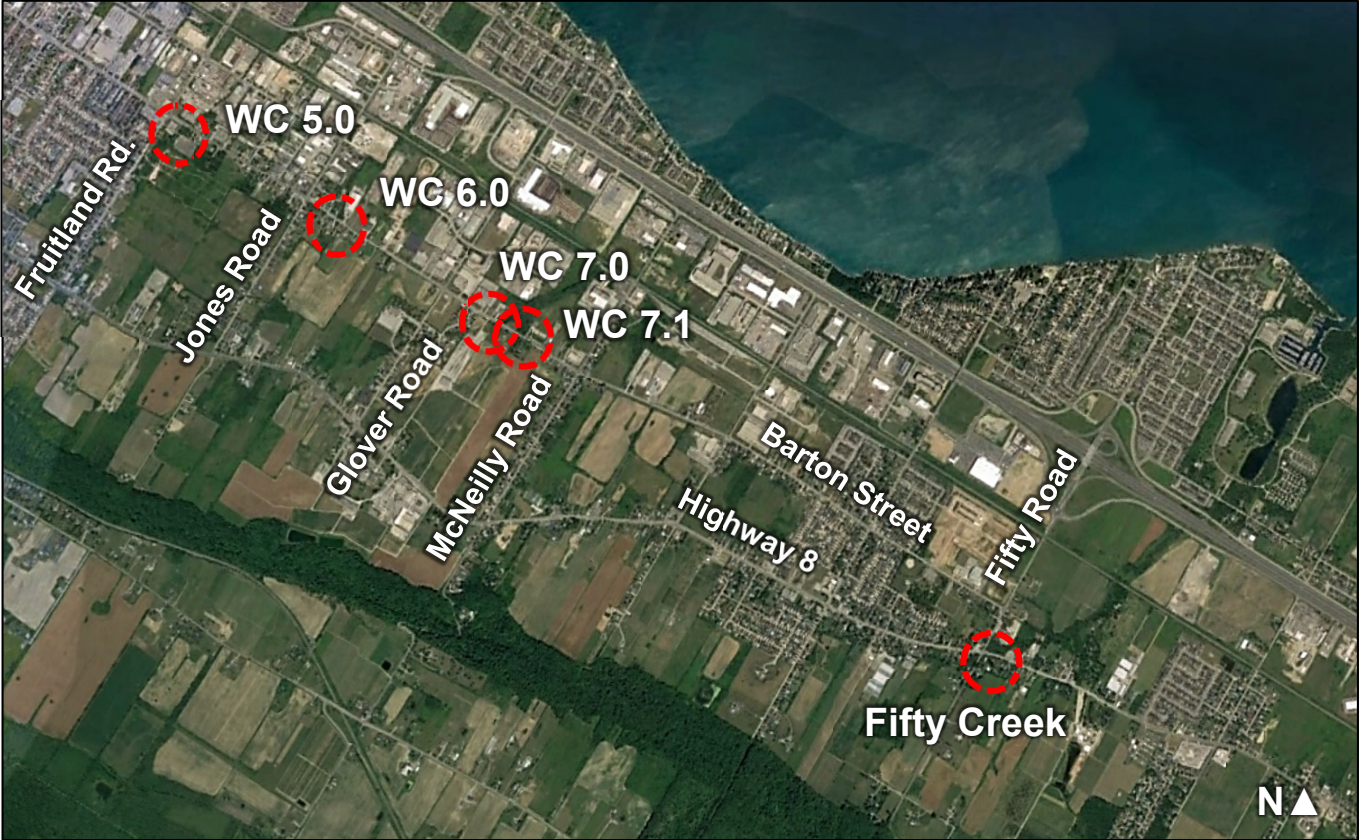
Study Area

Phases 3 & 4 Barton Street and Fifty Road Improvements
Municipal Class Environmental Assessment

Fifty Creek and Lake Ontario Tributaries WC 5.0, 6.0, 7.0 and 7.1 have been investigated based on fluvial geomorphic requirements for Fifty Road, Highway 8, and Barton Street crossings in the City of Hamilton. This study includes original reporting for Fifty Creek and WC 7.0 undertaken in 2018 and additional reporting for WC 5.0, 6.0, and 7.1 done in 2021. Scoping level characterization review including rapid assessments, summary of meander belt and erosion limits, recommendations for crossing geometry, and guidance recommendations for scour treatment and channel design have been undertaken. The study area crossing locations are shown on an appended figure.

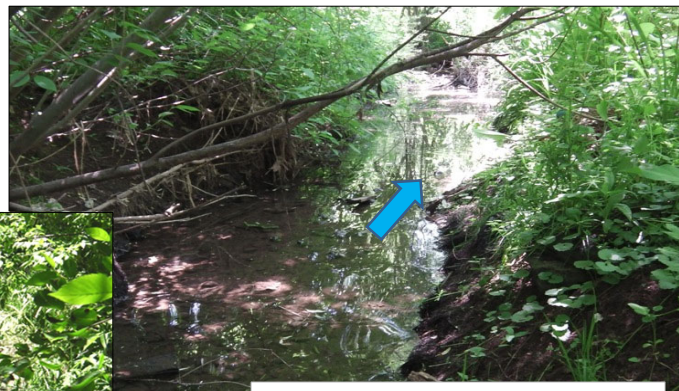
Looking downstream from crossing

Looking downstream below wetland pool

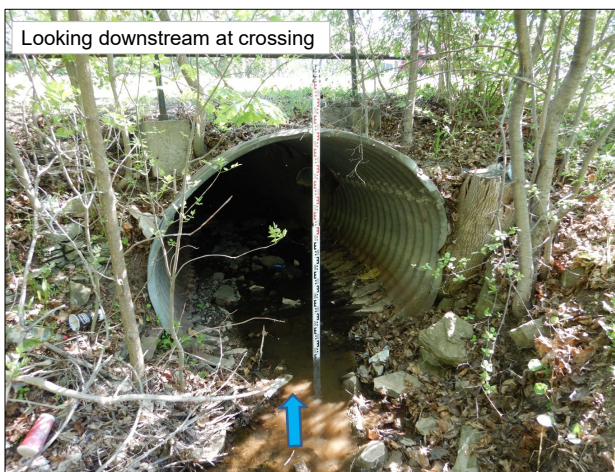
Looking downstream at crossing

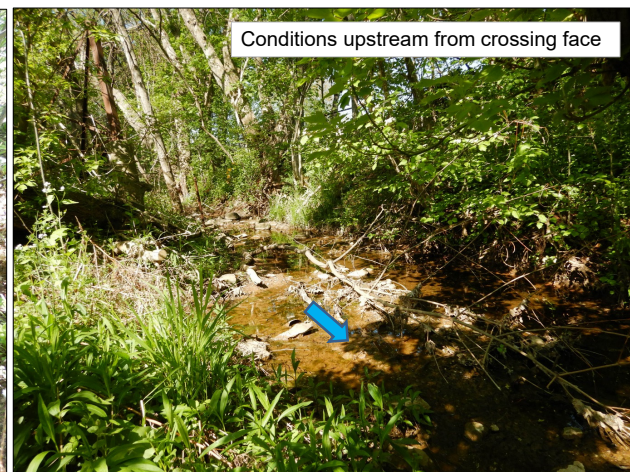
Conditions upstream from crossing face

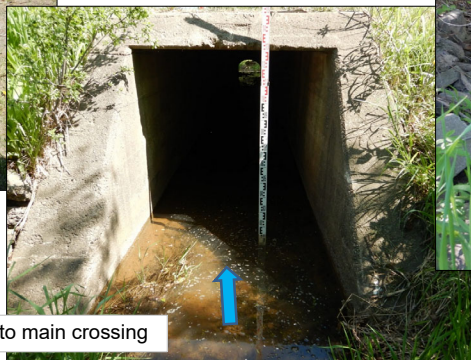
Looking downstream into main crossing

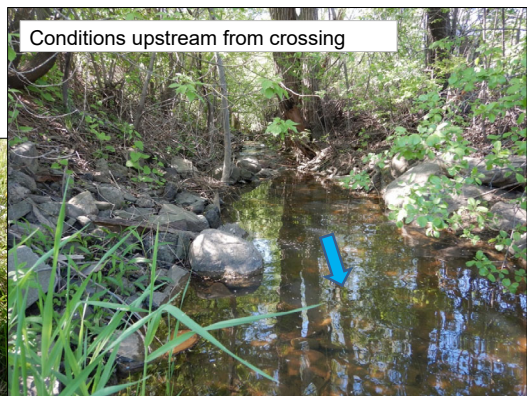
Conditions upstream from crossing

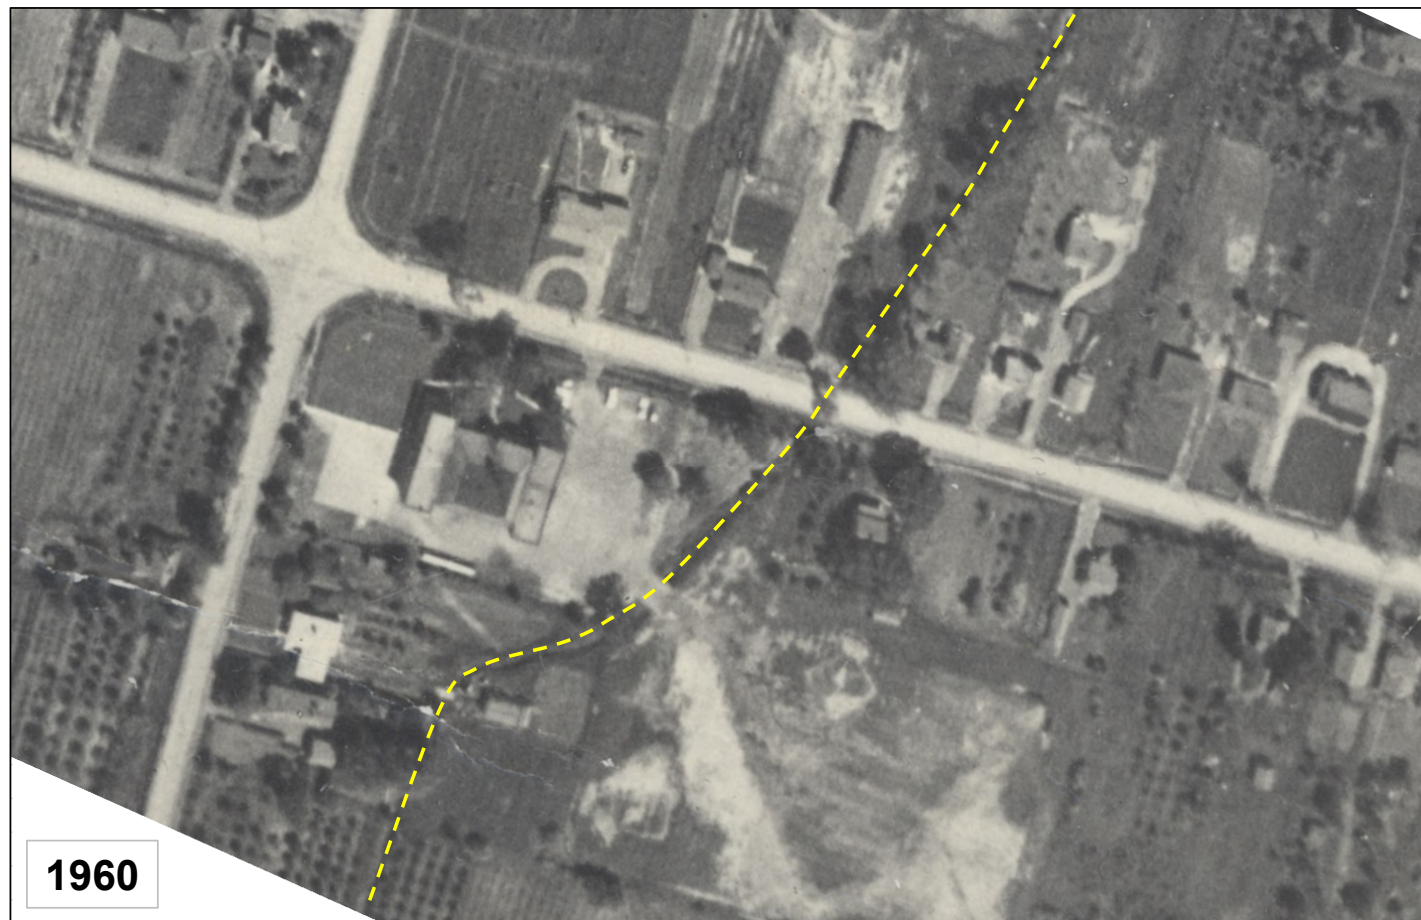
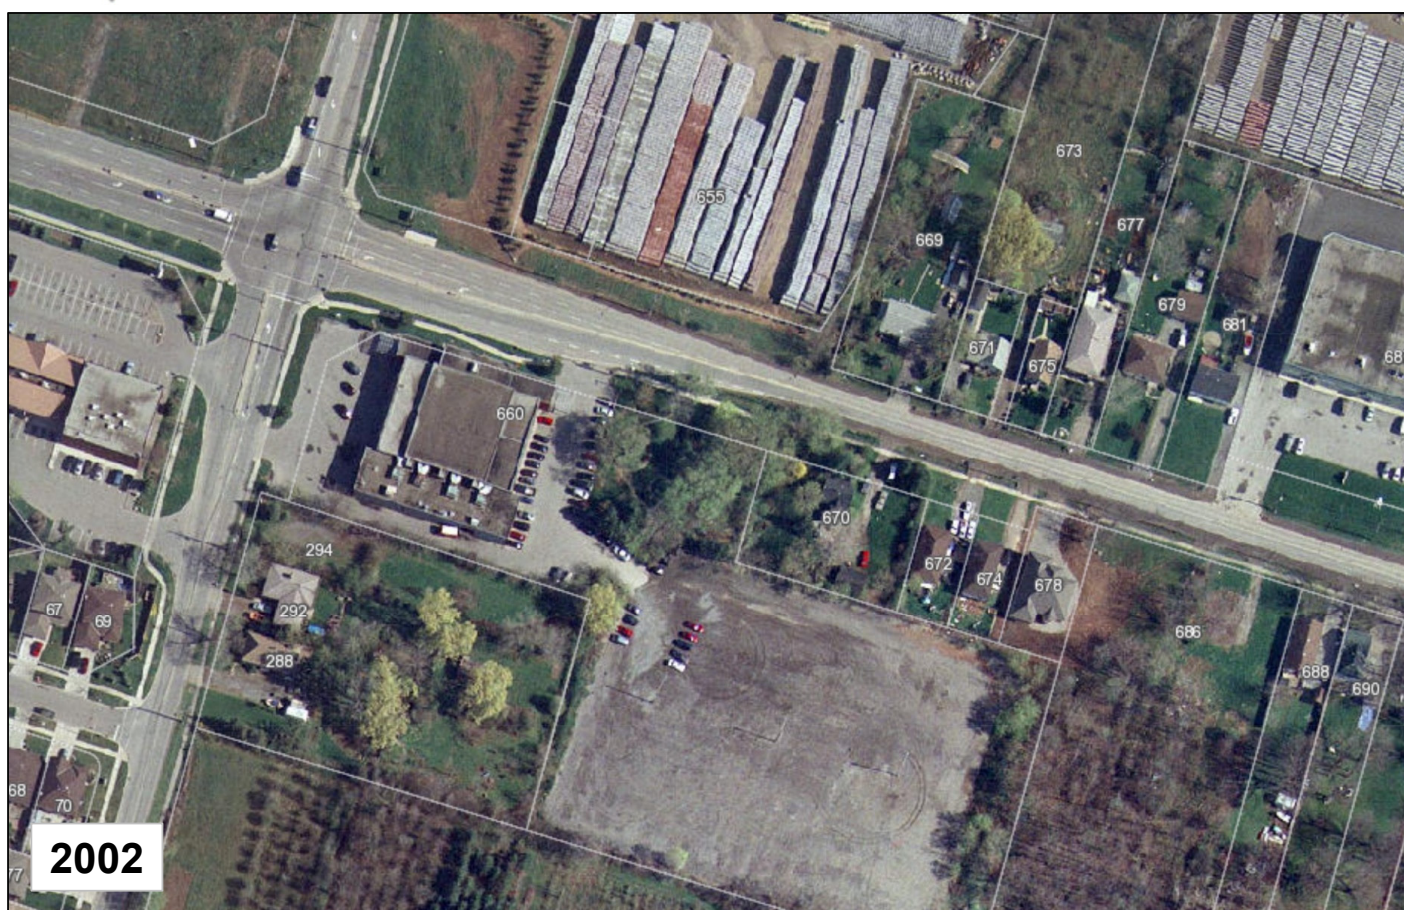
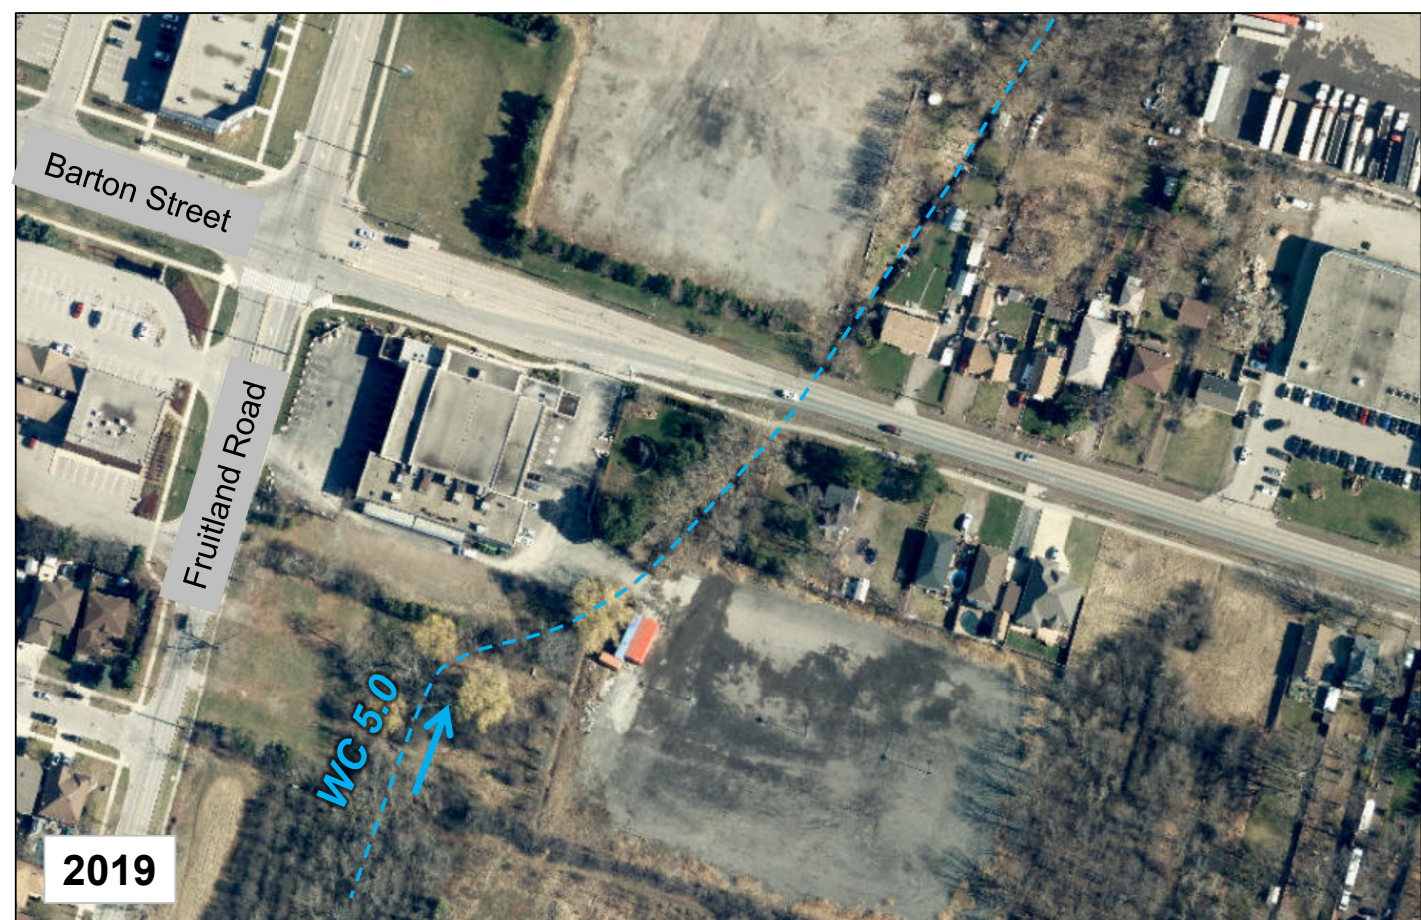
WC 6.0
Historic Planform Comparison

1960

2002

2019

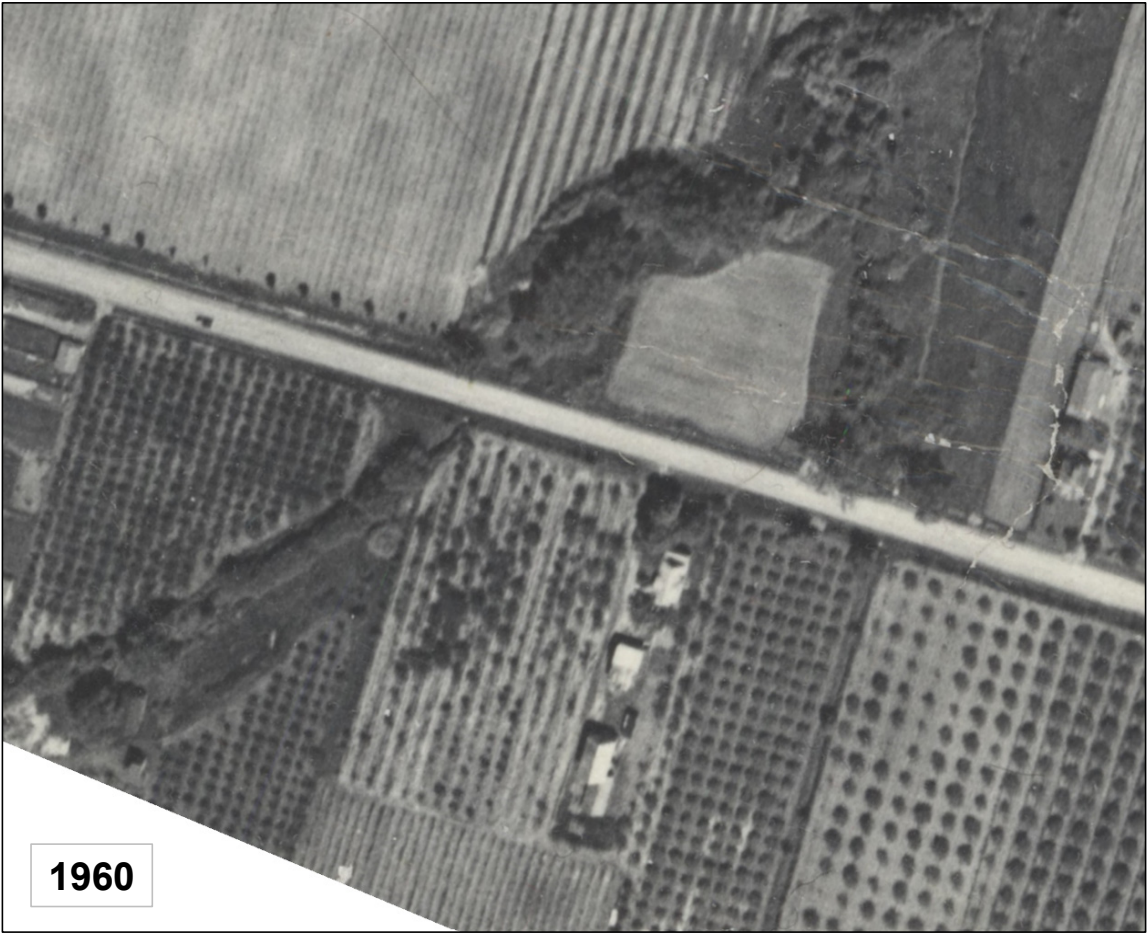
WC 7.0 & 7.1 Historic Planform Comparison

1960

2002

2019

natural channel realignment projects under construction on north side of Barton St.

The planform comparison on the upstream side of Barton Street confirms current observations and rapid assessment results identifying the features as stable. Conditions in the upstream appear to have persisted where erosion thresholds are not significantly exceeded over the long-term flow regime. There is no meso or macro scale development of a lateral or down corridor meander amplitude pattern from the upstream into either crossing location of WC 7.0 and 7.1.

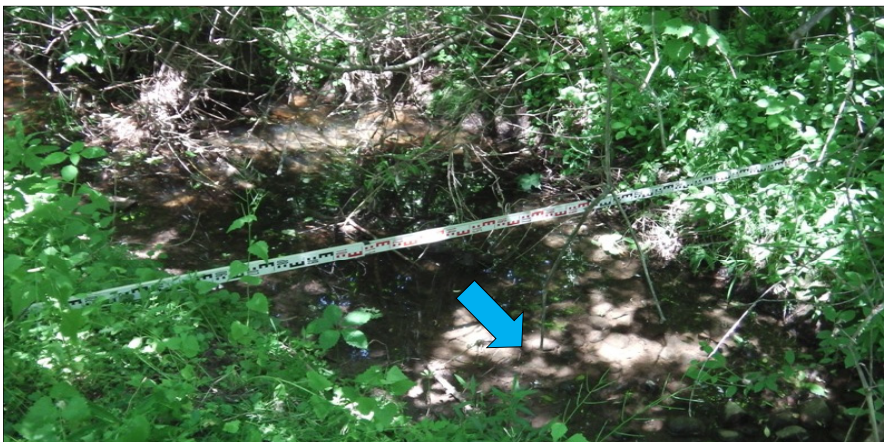
Morphology Type		Hydraulic Geometry	
cascade		A (m ²)	1.25
step		R (m)	0.36
riffle		TW (m)	3.00
run	•	WP (m)	3.43
glide		max d (m)	0.63
pool		mean d (m)	0.42
thalweg out of phase		E _s (Limerinos) (m) [+]	
Hydraulic Roughness		E _s (Strickler) (m) [+]	
rr R/D ₈₄	2.91	Hydraulic Ratios	
ff V mean/V*	5.71	ER max d	5.00
ff D ₈₄	5.81	r _c / TW	
ff mean	5.76	TW / L _f	1.71
ROUGH BED		TW/max d	4.8
		TW/mean d	7.2

Sediment Transport Mode				high	low		
		w_s (m s ⁻¹)	P	wash load	sus. load	sus. load	bedload
k	0.41	D ₃₀ 0.196	7.56	NO	NO	NO	NO
V_* (m s ⁻¹)	0.063	D ₅₀ 0.655	25.26	NO	NO	NO	NO
		D ₈₄ 1.641	63.25	NO	NO	NO	NO
Section Data							
ER _e (m)	0.63	ER stations L / R		-5.00	10.00	TW ck	
WS _e (m)	0.000	WS stations L / R		0.00	3.00	3.00	
L _f _e (m)	-0.450	Lf stations L / R		0.75	2.50		
W _{tp} (m)	15.00	E _s sta. (Limerinos) L / R					
r _c (m)		E _s sta. (Strickler) L / R					
Z		T _e (m)	T _{ols} (m)	-0.63	1.25		
E _g (m m ⁻¹)	0.0055						
Substrate Gradation		D ₁₅	D ₃₀	D ₅₀	D ₈₄	D ₁₀₀	
Existing Conditions (mm)		0.10	2.00	20.00	125.00	140.00	
Stability Design Targets (mm)

Geomorphic open channel flow models were created for each cross-section location. Each model required input of channel bed substrate data, cross-section dimensions, gradient, and bank geometry. Calibrated modeling tests were done for each cross-section to determine hydraulic geometry, erosion thresholds, and bankfull flow. The detailed modeling results for existing bankfull conditions are appended. The proposed design bankfull flow rates are summarized in **Table 3**.

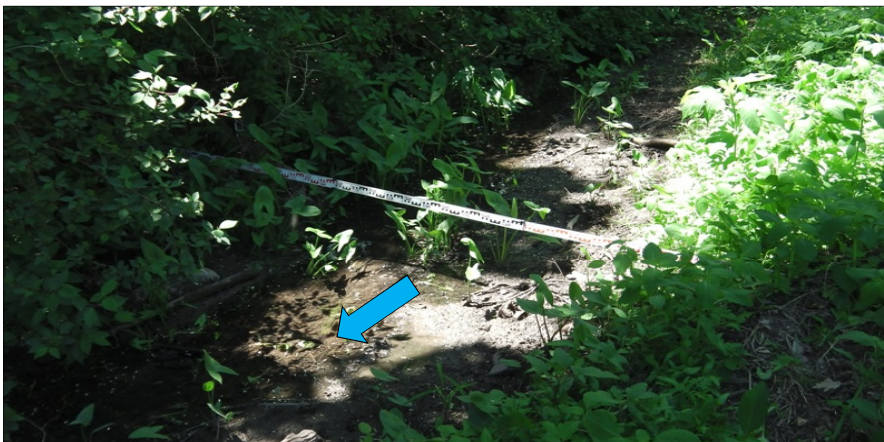
Morphology Type		Hydraulic Geometry	
cascade		A (m ²)	1.37
step		R (m)	0.34
riffle		TW (m)	3.70
run	●	WP (m)	4.02
glide		max d (m)	0.53
pool		mean d (m)	0.37
thalweg out of phase		E _s (Limerinos) (m) [±]	
Hydraulic Roughness		E _s (Strickler) (m) [±]	
rr R/D ₈₄	56.98	Hydraulic Ratios	
ff V mean/V*	9.20		
ff D ₈₄	13.04		
ff mean	11.12		
SMOOTH BED		ER max d	4.05
		r _c / TW	
		TW / L _f	2.31
		TW/max d	7.0
		TW/mean d	10.0

Sediment Transport Mode								ff V mean/V*		9.20		ER max d		4.05			
k		w_s (m s ⁻¹)		P	wash load	high sus. load	low sus. load	bedload	ff D_{84}	13.04		r_c / TW					
V_* (m s ⁻¹)		D_{30}		0.003	0.12	YES	YES	YES	YES	ff mean		11.12		TW / Lf _w			
		D_{50}		0.023	0.97	NO	YES	YES	YES					TW/max d			
		D_{84}		0.356	14.83	NO	NO	NO	NO	SMOOTH BED				TW/mean d			
Section Data								Bedload Transport Data									
ER _e (m)		0.53		ER stations L / R		-5.00		10.00		TW _{ck}		Strickler Q		Limerinos Q			
WS _e (m)		0.000		WS stations L / R		0.00		3.70		3.70		Rosgen		Q_{sb}			
Lf _e (m)		-0.450		Lf stations L / R		0.90		2.50				type		(kg sec ⁻¹)			
W _{fp} (m)		15.00		E_s sta. (Limerinos) L / R								B3		0.0019			
r_c (m)				E_s sta. (Strickler) L / R								C3		0.0003			
Z				T_e (m)		T_{ols} (m)		-0.53		1.75		C4		0.0063			
E_g (m m ⁻¹)		0.0050												0.0097			
Substrate Gradation				D_{15}		D_{30}		D_{50}		D_{84}		D_{100}

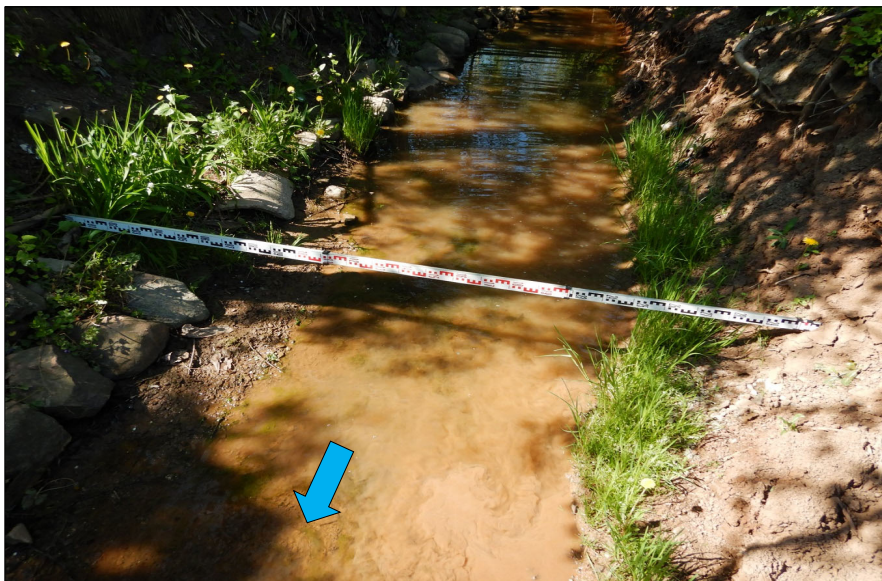
Morphology Type		Hydraulic Geometry	
cascade		A (m ²)	1.05
step		R (m)	0.32
riffle		TW (m)	3.00
run	●	WP (m)	3.33
glide		max d (m)	0.57
pool		mean d (m)	0.35
thalweg out of phase		E _s (Limerinos) (m) [+]	
Hydraulic Roughness		E _s (Strickler) (m) [+]	
rr R/D ₈₄	12.60	Hydraulic Ratios	
ff V mean/V*	8.49	ER max d	1.67
ff D ₈₄	9.36	T _c / TW	
ff mean	8.93	TW / L _f _w	1.94
SMOOTH BED		TW/max d	5.3
		TW/mean d	8.6

Sediment Transport Mode							
	w _s (m s ⁻¹)	P	wash load	high sus. load	low sus. load	bedload	
k	0.41	D ₃₀ 0.001	0.08	YES	YES	YES	YES
V _* (m s ⁻¹)	0.044	D ₅₀ 0.003	0.16	YES	YES	YES	YES
		D ₈₄ 0.733	40.44	NO	NO	NO	NO
Substrate Gradation							
ER _e (m)	0.57	ER stations L / R	-1.00	4.00	TW ck		
WS _e (m)	0.000	WS stations L / R	0.00	3.00	3.00		
L _f (m)	-0.450	L _f stations L / R	0.85	2.40			
W _{tp} (m)	5.00	E _s sta. (Limerinos) L / R					
r _c (m)		E _s sta. (Strickler) L / R					
Z		T _e (m)	T _{o/s} (m)	-0.57	1.75		
E _g (m m ⁻¹)	0.0031						
Bedload Transport Data							
Strickler Q		Limerinos Q		D ₃₀	D ₅₀	D ₈₄	
Rosgen	Q _{sb}	Q _{sb}					
type	(kg sec ⁻¹)	(kg sec ⁻¹)					
B3	0.0018	0.0019	salination	YES	YES	NO	
C3	0.0002	0.0003	rolling	YES	YES	NO	
C4	0.0057	0.0064	∅	NO	NO	YES	
Flow Regime				Flow Regime			
Strickler method				Limerinos method			
Q (cms)	0.771	Q (cms)		Q (cms)			
V (m s ⁻¹)	0.73	V (m s ⁻¹)		V (m s ⁻¹)

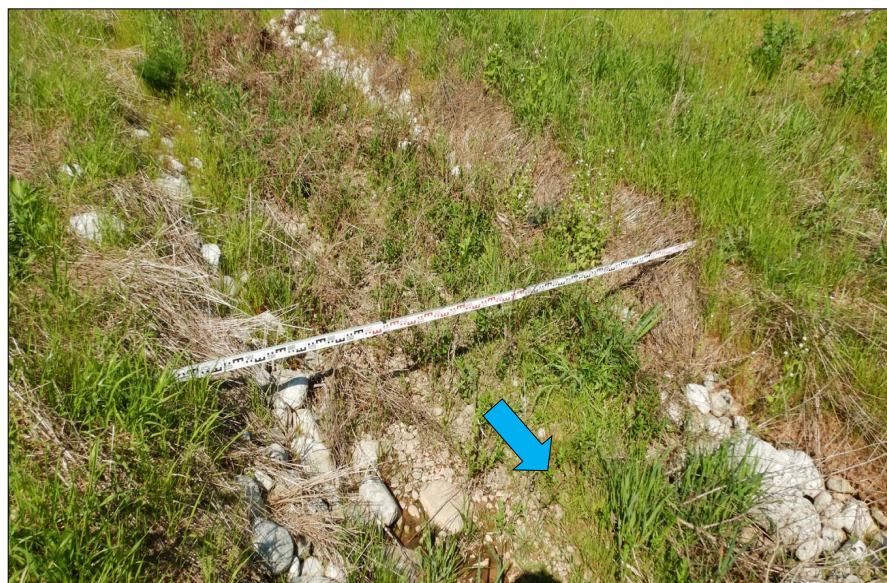
Morphology Type		Hydraulic Geometry	
cascade		A (m ²)	0.98
step		R (m)	0.30
riffle		TW (m)	3.00
run	●	WP (m)	3.22
glide		max d (m)	0.51
pool		mean d (m)	0.33
thalweg out of phase		E _s (Limerinos) (m) [+]	
Hydraulic Roughness		E _s (Strickler) (m) [+]	
rr R/D ₈₄	4.05	Hydraulic Ratios	
ff V mean/V*	6.26	ER max d	3.67
ff D ₈₄	6.47	T _c / TW	
ff mean	6.37	TW / L _f _w	
ROUGH BED		TW/max d	5.9
		TW/mean d	9.2

Sediment Transport Mode								Hydraulic Ratios			
		w_s (m s ⁻¹)	P	wash load	high sus. load	low sus. load	bedload	ff V mean/V*	6.26	ER max d	3.67
k	0.41	D ₃₀	0.023	1.03	NO	YES	YES	ff D ₈₄	6.47	T_c / TW	
V_* (m s ⁻¹)	0.055	D ₅₀	0.196	8.68	NO	NO	NO	ff mean	6.37	TW / Lf _w	
		D ₈₄	1.271	56.20	NO	NO	NO			TW/max d	5.9
									ROUGH BED	TW/mean d	9.2
Section Data								Bedload Transport Data			
ER _e (m)	0.51	ER stations L / R			-4.00	7.00	TW ck	Strickler Q	Limerinos Q		
WS _e (m)	0.000	WS stations L / R			0.00	3.00	3.00	Rosgen	Q _{sb}	Q _{sb}	D ₃₀ D ₅₀ D ₈₄
Lf _e (m)	-0.500	Lf stations L / R			1.50	1.50		type	(kg sec ⁻¹)	(kg sec ⁻¹)	T* 76.8 7.7 0.2
W _{fp} (m)	11.00	E _s sta. (Limerinos) L / R						B3	0.0017	0.0018	salination YES YES NO
r _c (m)		E _s sta. (Strickler) L / R						C3	0.0001	0.0002	rolling YES YES NO
Z		T _e (m)	T _{o/s} (m)	-0.50	1.50			C4	0.0055	0.0059	Ø NO NO YES
E _g (m m ⁻¹)	0.0050							Flow Regime		Flow Regime

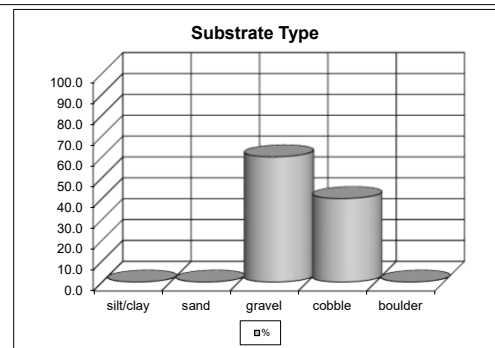
Morphology Type		Hydraulic Geometry	
cascade		$A \text{ (m}^2\text{)}$	0.99
step		$R \text{ (m)}$	0.30
riffle		$TW \text{ (m)}$	3.00
run	●	$WP \text{ (m)}$	3.29
glide		$\text{max } d \text{ (m)}$	0.60
pool		$\text{mean } d \text{ (m)}$	0.33
thalweg out of phase		$E_s \text{ (Limerinos)} \text{ (m)} \text{ [}^+\text{]}$	
		$E_s \text{ (Strickler)} \text{ (m)} \text{ [}^+\text{]}$	
Hydraulic Roughness		Hydraulic Ratios	
$rr \ R/D_{84}$	4.01	$ER \text{ max } d$	2.00
$ff \ V \text{ mean}/V^*$	6.62	r_c / TW	
$ff \ D_{84}$	6.50	TW / Lf_w	2.31
$ff \ \text{mean}$	6.56	$TW/\text{max } d$	5.0
ROUGH BED		$TW/\text{mean } d$	9.1

Sediment Transport Mode				high	low		
		w_s (m s ⁻¹)	P	wash load	sus. load	sus. load	bedload
k	0.41	D_{30}	0.733	32.60	NO	NO	NO
V_* (m s ⁻¹)	0.055	D_{50}	1.038	46.14	NO	NO	NO
		D_{84}	1.271	56.52	NO	NO	NO

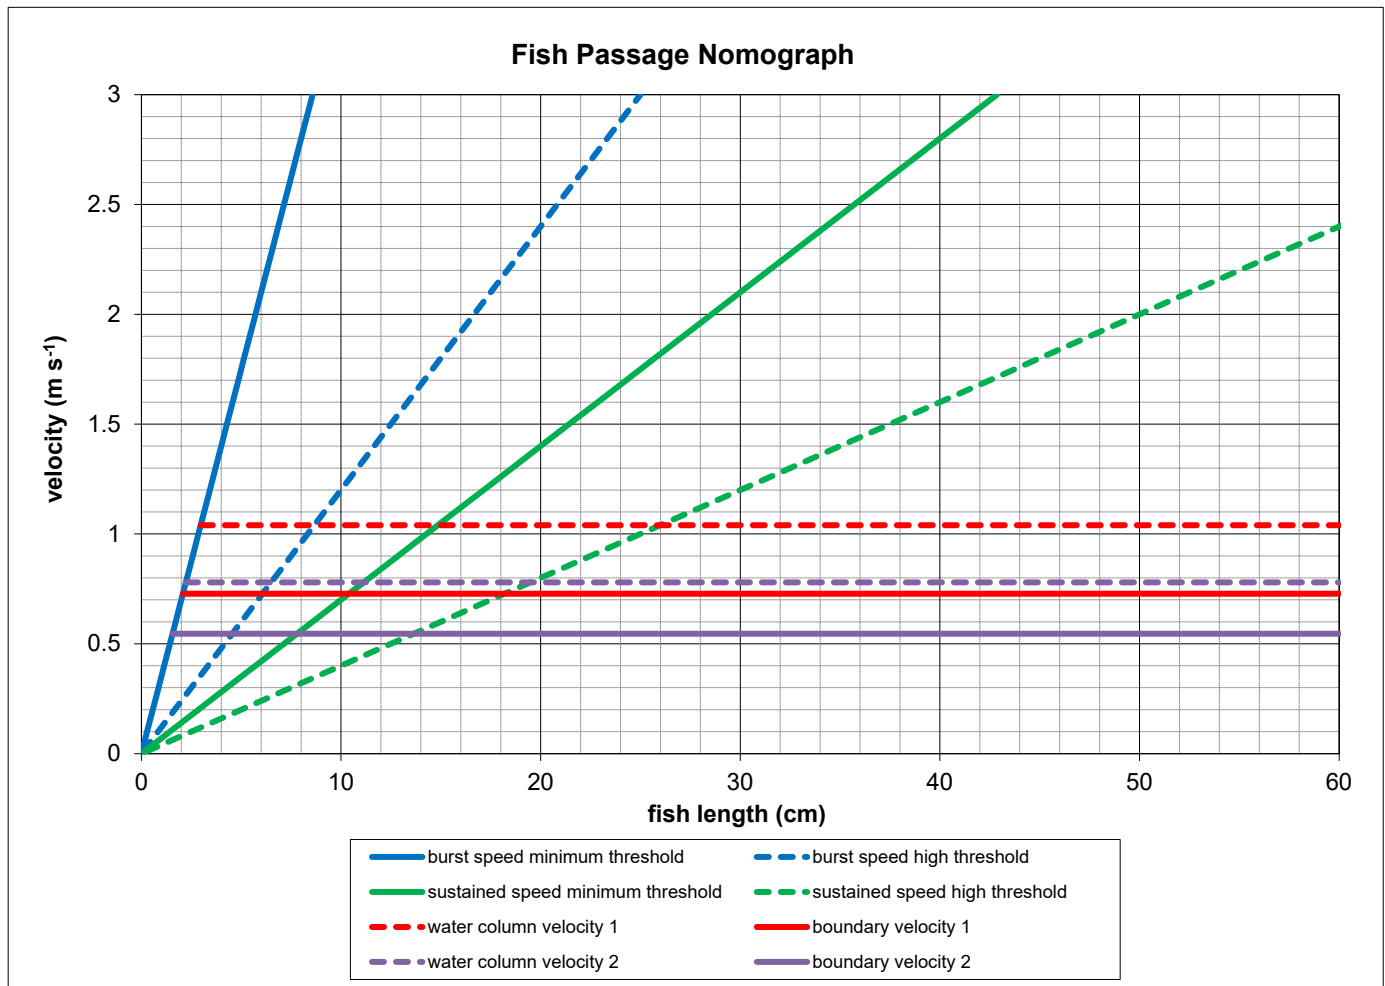
Fish Length Data					
		sustained speed high threshold	sustained speed minimum threshold	burst speed high threshold	burst speed minimum threshold
1	fish length L_f (cm) at V	26.0	14.9	8.7	3.0
	fish length L_f (cm) at V_b	18.2	10.4	6.1	2.1
2	fish length L_f (cm) at V	19.5	11.1	6.5	2.2
	fish length L_f (cm) at V_b	13.7	7.8	4.6	1.6
