Hydrogeological Investigation

CITY OF HAMILTON

HYDROGEOLOGICAL ASSESSMENT – Rev. 3

BLOCK 1, FRUITLAND-WINONA BLOCK SERVICING STRATEGY REPORT

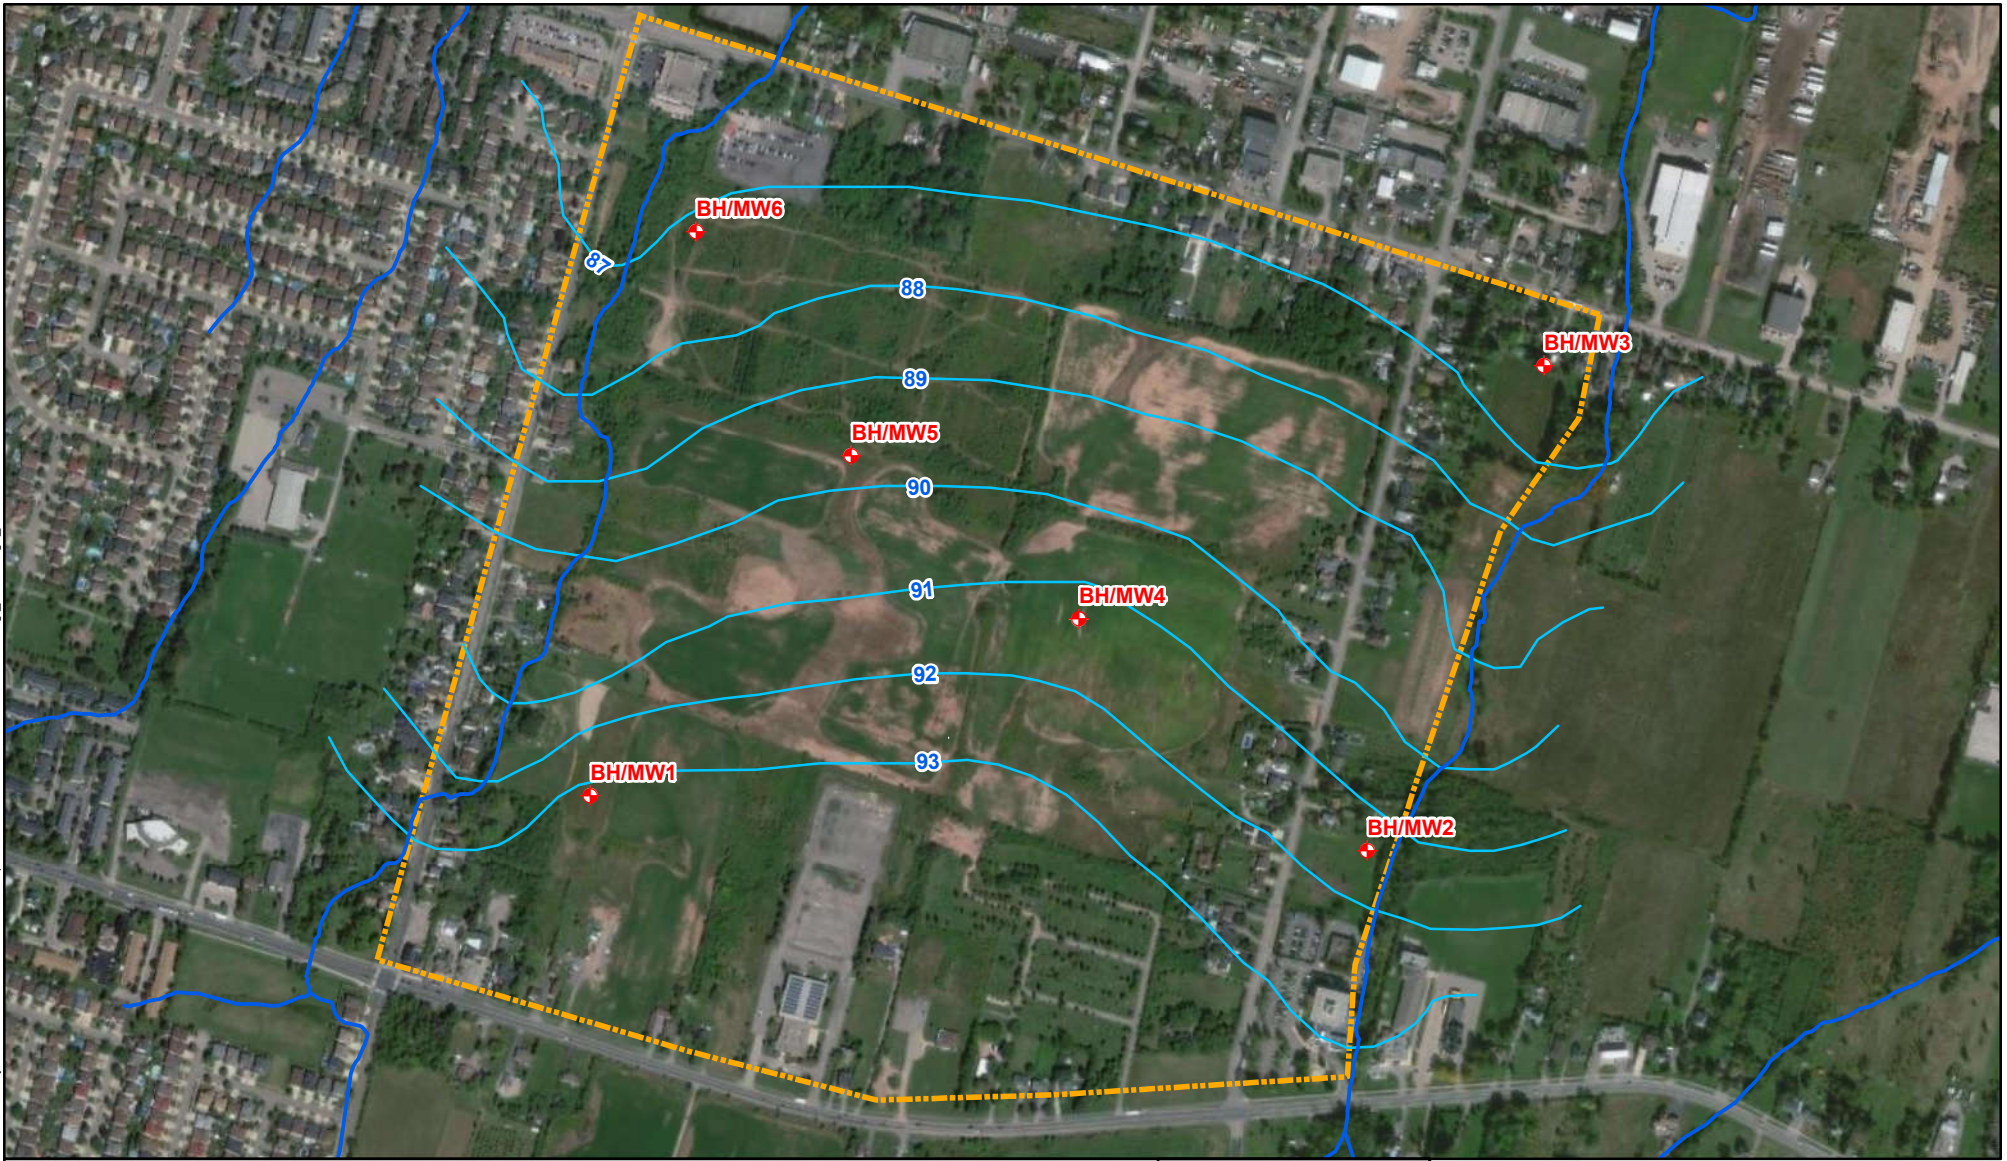
- Approximate Block 1 Property Boundary
- Groundwater Contours
- Borehole/Monitoring Well
- Watercourse

Hydraulic conductivities determined from slug tests carried out in the monitoring wells ranged from 8.7×10^{-5} m/s to 2.8×10^{-8} (geometric mean 8.5×10^{-7} m/s). The degree of variability in hydraulic conductivity is likely a reflection of the variability of the amount of weathering and fracturing occurring at different locations on the site. The groundwater flow direction is generally from the south-southwest towards the north-northeast with an average gradient of approximately 1.9%.

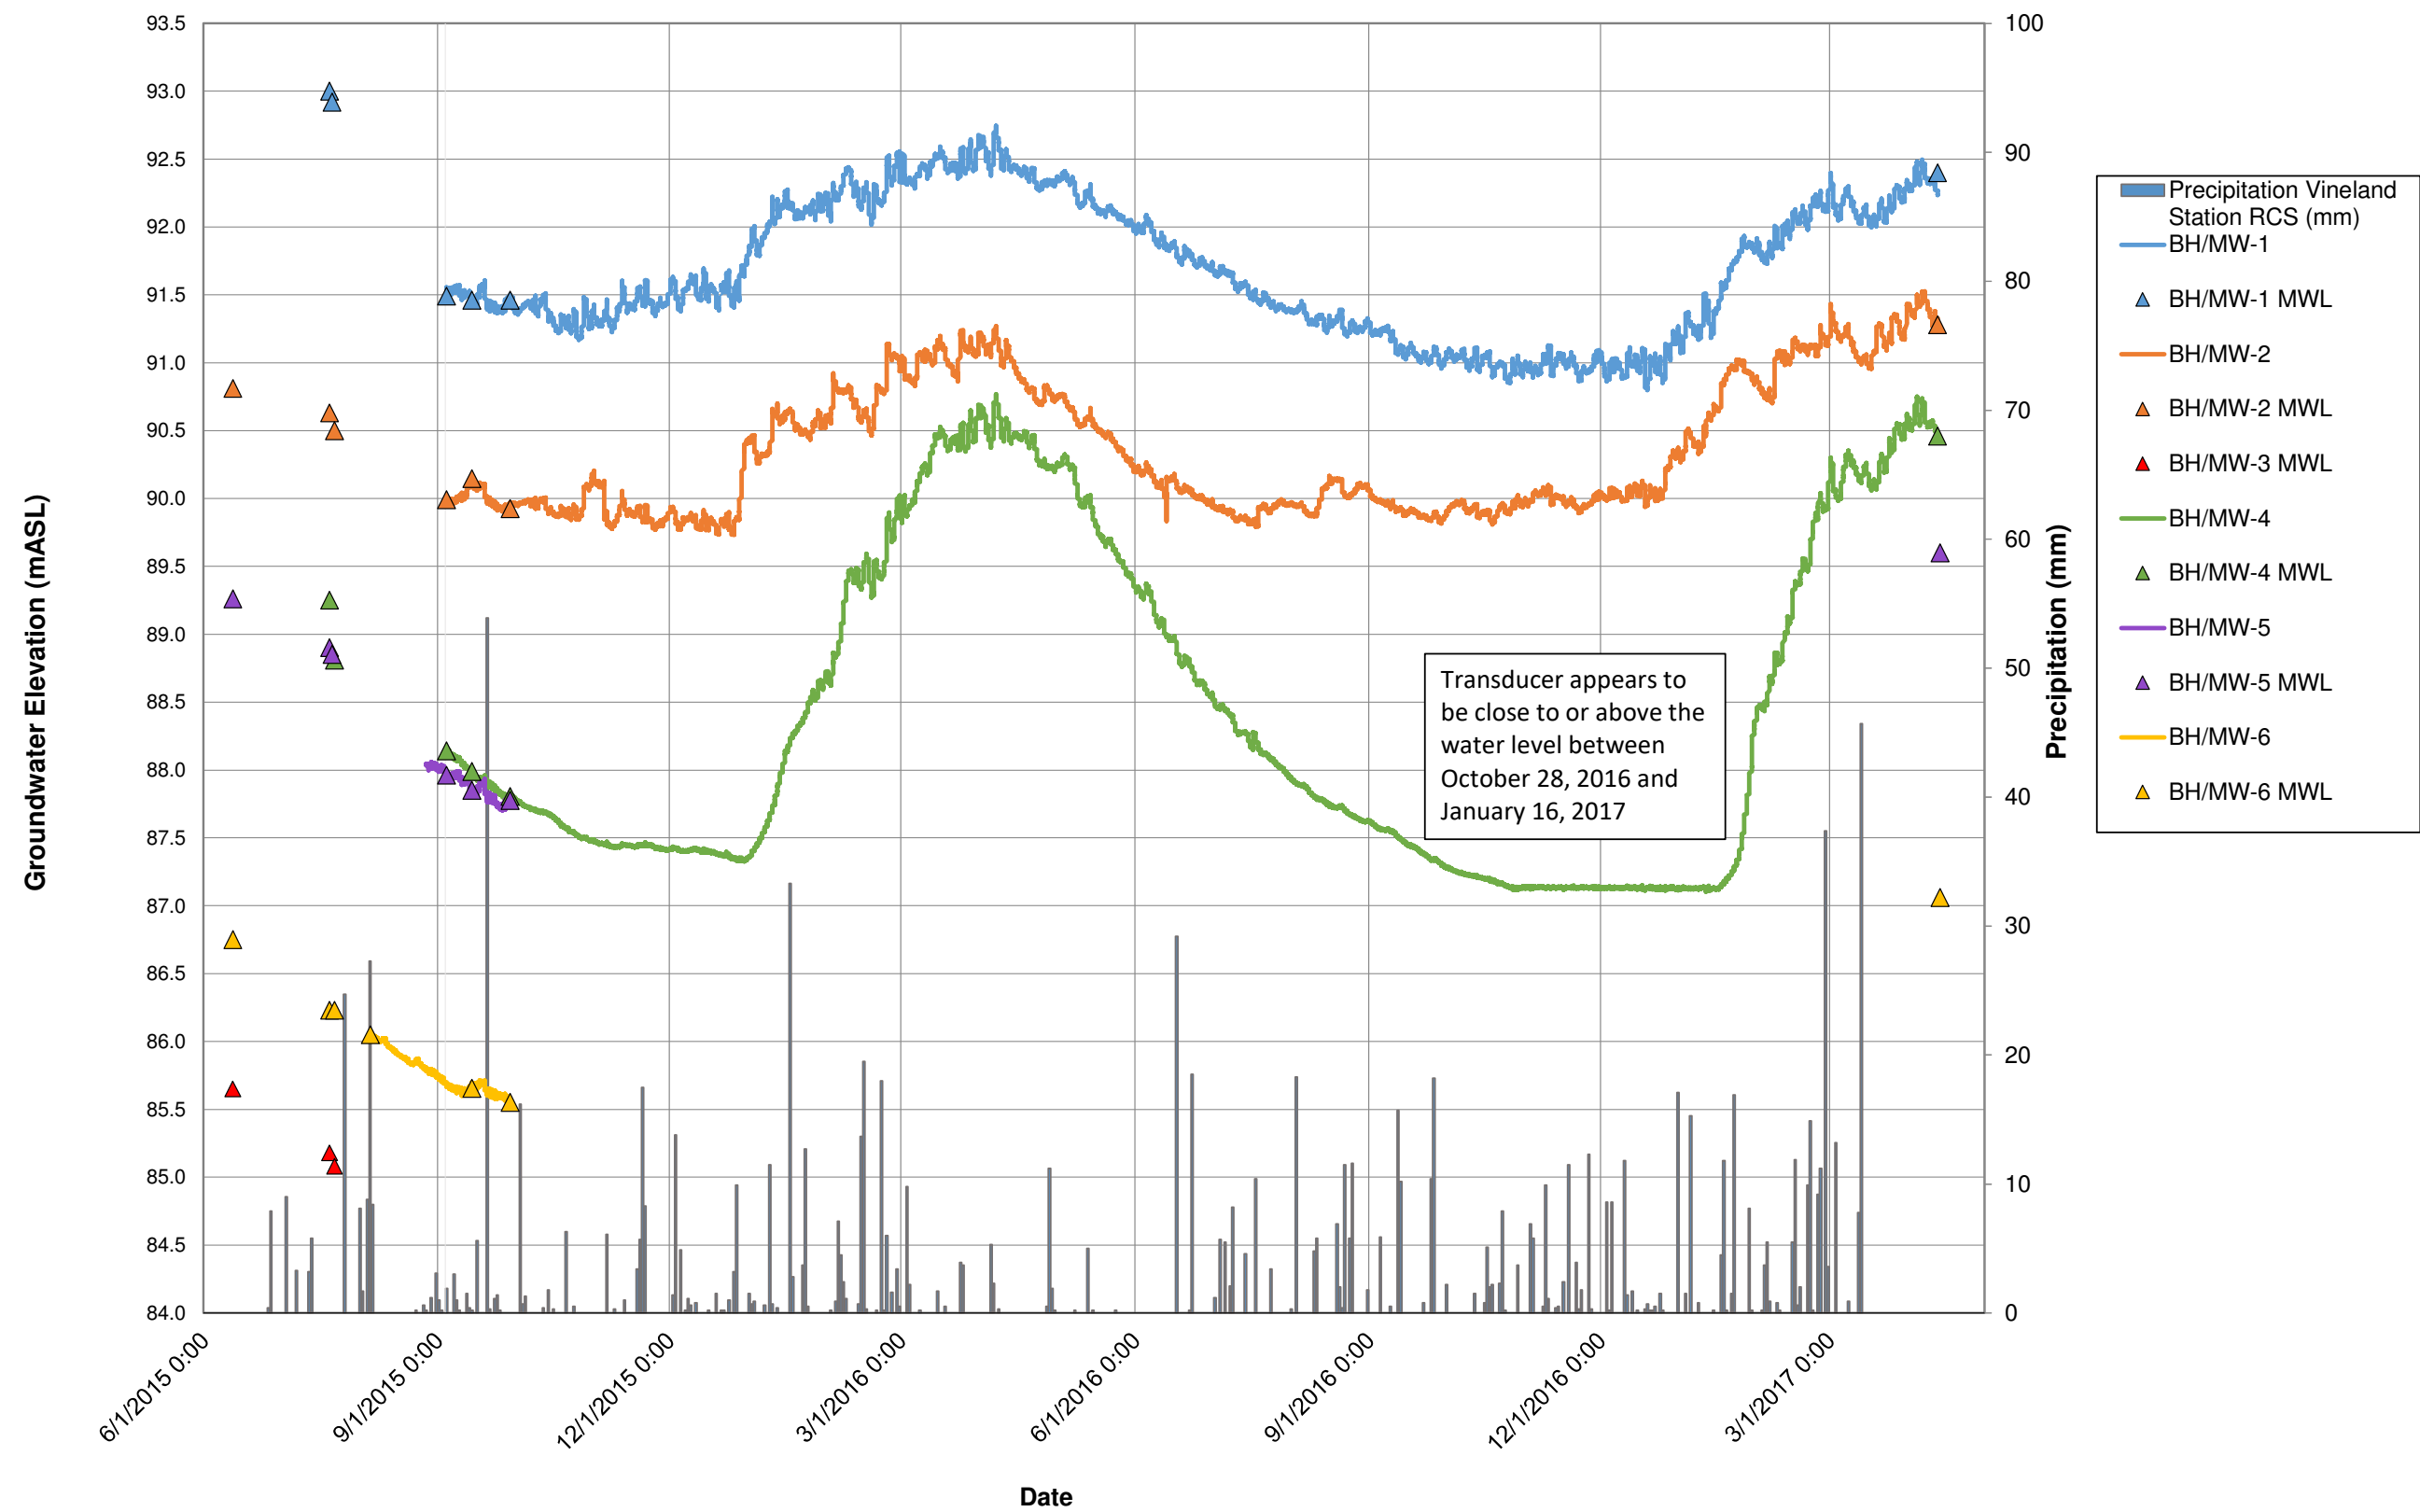
Figure 6: Hydrograph of Site Groundwater Monitoring Data

In general, although short term periods of artesian conditions were noted in July 2015 in BH/MW-1, water levels were seen to be declining over the initial period of measurement during August to September 2015. The overall decline in water levels varied between the monitoring locations from about 0.5 m at BH/MW-2 to about 1.5 m at BH/MW-1 during this period. Figure 5 shows that water levels continued to decline at BH/MW-1 to about October 19, 2015, at BH/MW-2 to about December 26, 2015, and at BH/MW-4 to about January 2, 2016. At BH/MW-1 there was a slow rise in water level between October and the end of 2015 followed by a more rapid rise at all three locations where transducers were present until a high point was reached during the first half of April 2016.

recorded values during April 2017 are comparable to those observed during 2016 at BH/MW-1 and BH/MW-4 and were about 0.23 m higher at BH/MW-2.

Groundwater level monitoring using automatic pressure transducers indicated a trend of seasonal water level fluctuations with groundwater levels generally rising annually from February to April then generally decreasing between April and December. The range of water level fluctuations observed during the period from June 2015 to April 2017 was approximately 1.5 m at BH-2, 1.9 m at BH-1 and 3.6 m at BH-4.

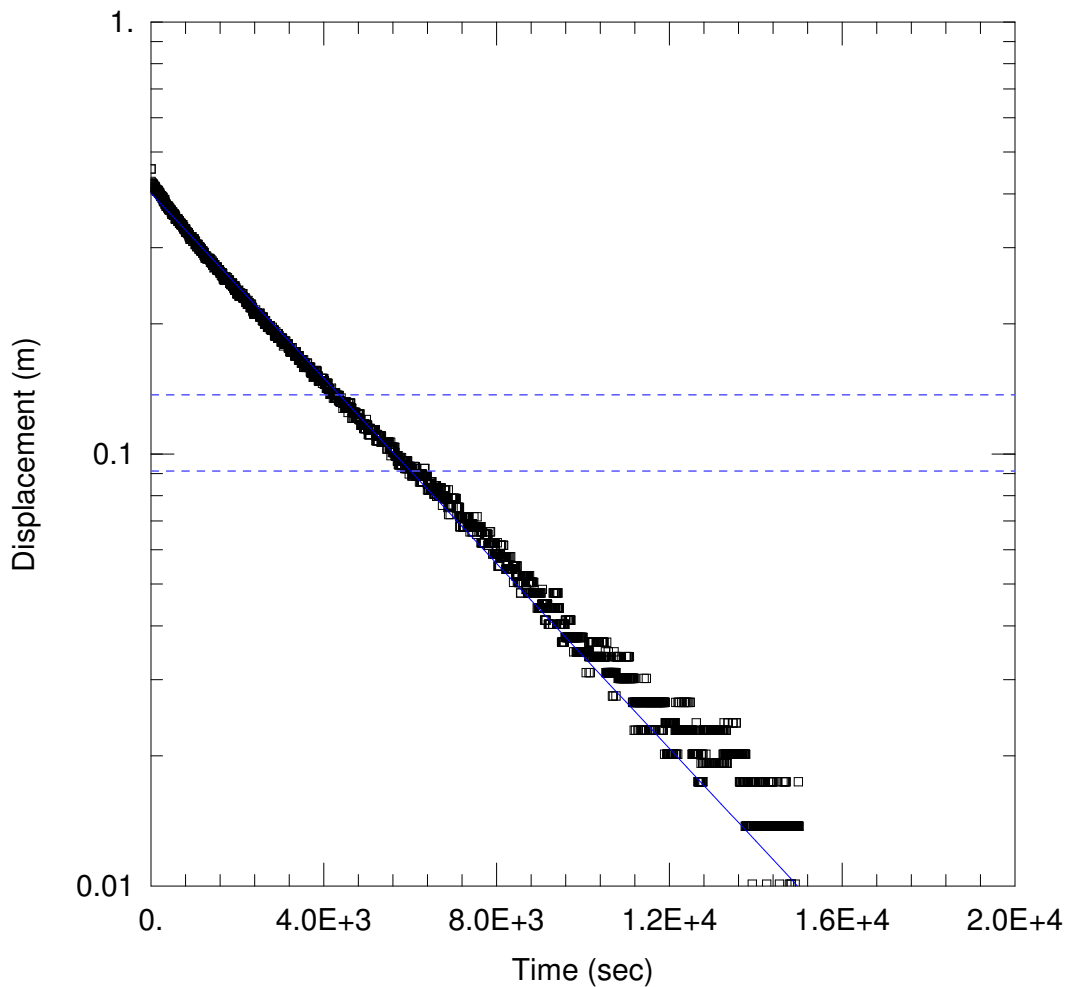
WELL TEST ANALYSIS

Aquifer Model: Confined
 $K = 1.47E-7$ m/sec

Solution Method: Bouwer-Rice
 $y_0 = 0.4014$ m

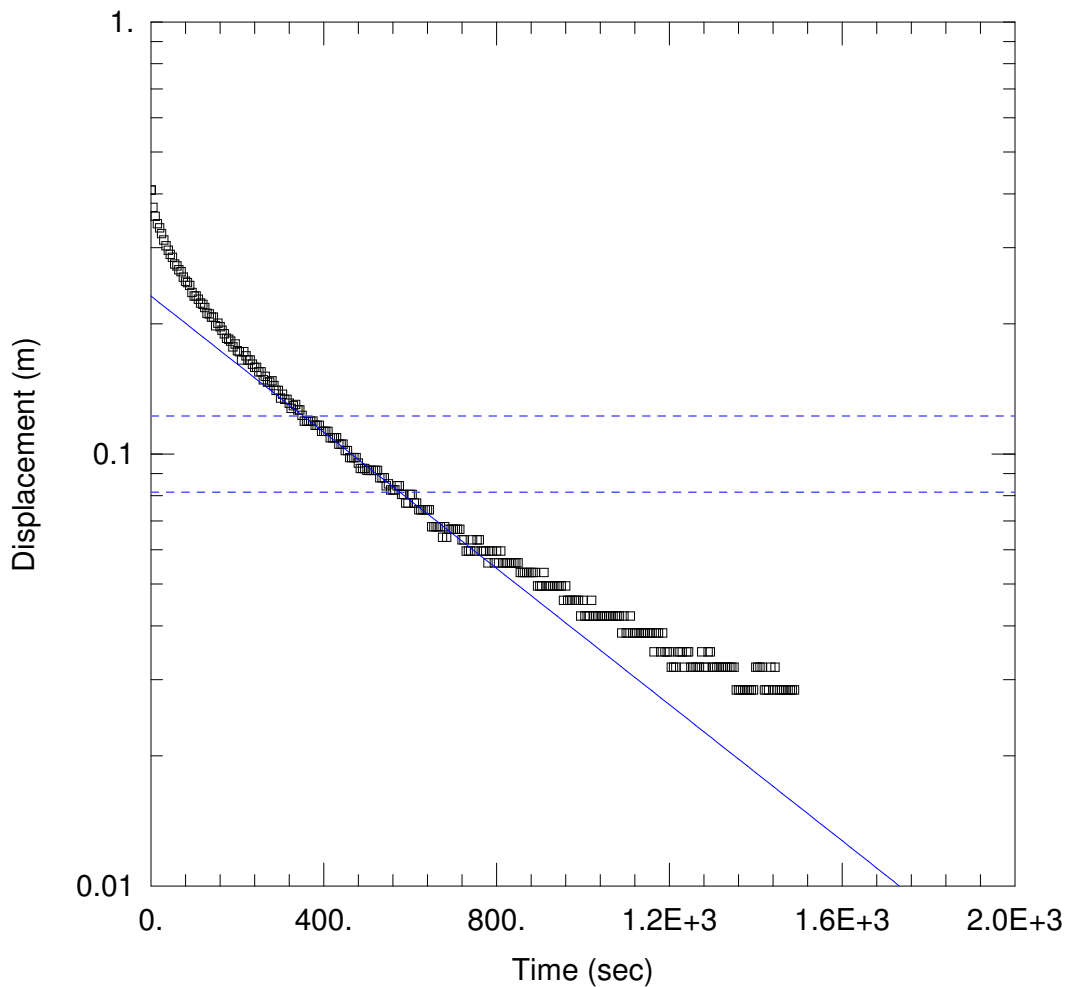
WELL TEST ANALYSIS

Aquifer Model: Unconfined
 $K = 1.442\text{E-}6$ m/sec

Solution Method: Bouwer-Rice
 $y_0 = 0.2319$ m

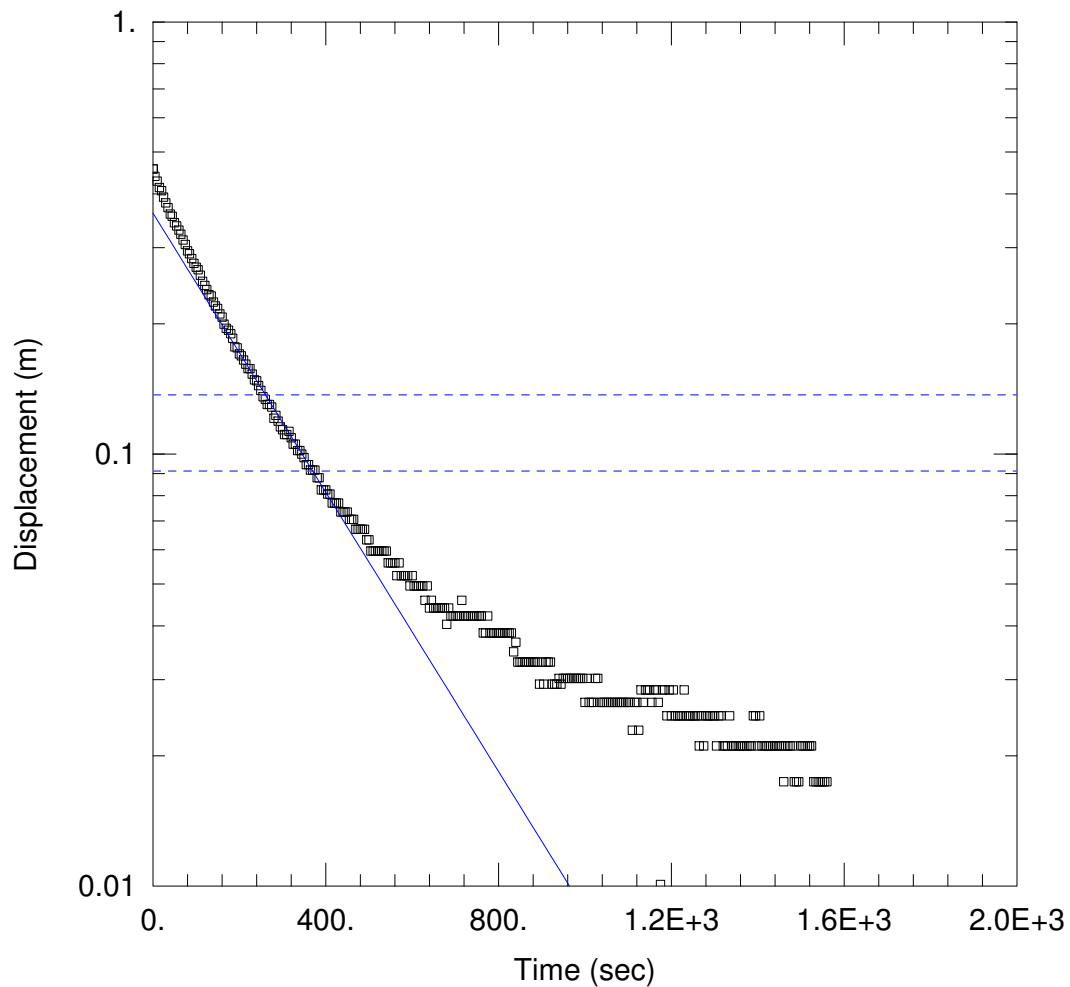
WELL TEST ANALYSIS

Aquifer Model: Unconfined
 $K = 2.712E-6$ m/sec

Solution Method: Bouwer-Rice
 $y_0 = 0.3608$ m

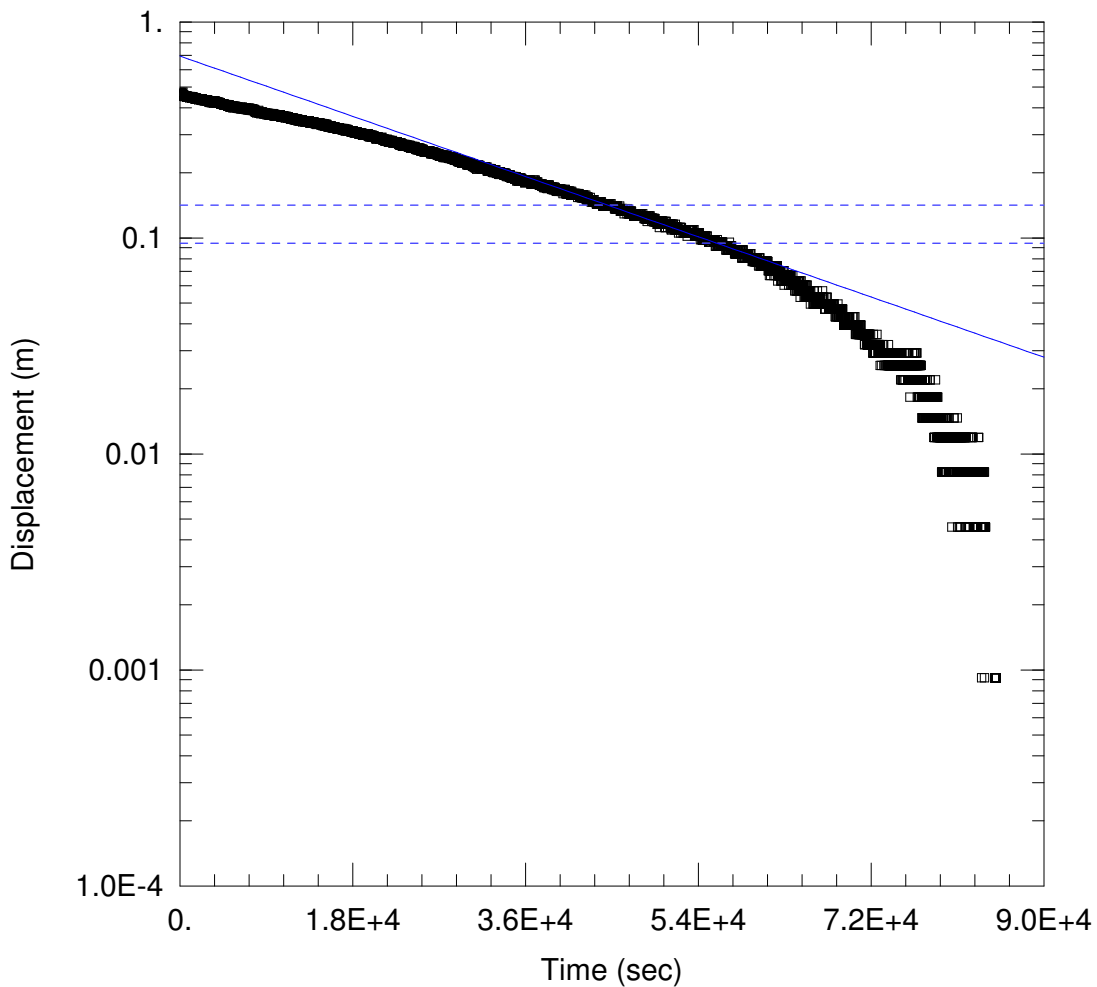
WELL TEST ANALYSIS

Aquifer Model: Confined
 $K = 2.792E-8$ m/sec

Solution Method: Bouwer-Rice
 $y_0 = 0.6947$ m

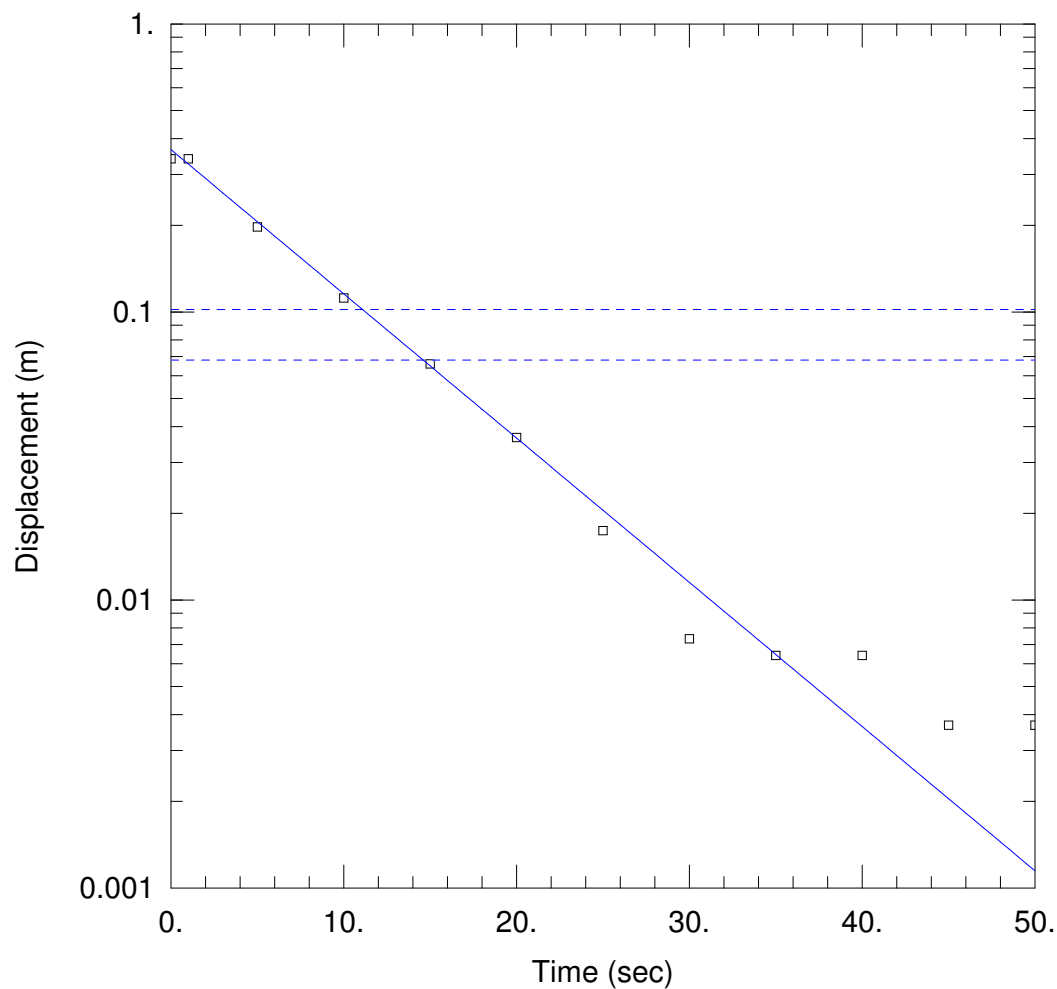
WELL TEST ANALYSIS

Aquifer Model: Confined
 $K = 8.715E-5$ m/sec

Solution Method: Bouwer-Rice
 $y_0 = 0.366$ m
