**NATURAL HERITAGE CHARACTERIZATION ASSESSMENT
BLOCK 1 LANDS - CITY OF HAMILTON**

Fruitland-Winona Block 1 Owners

Colville Consulting Inc.

File: C18028
Date: April 2024

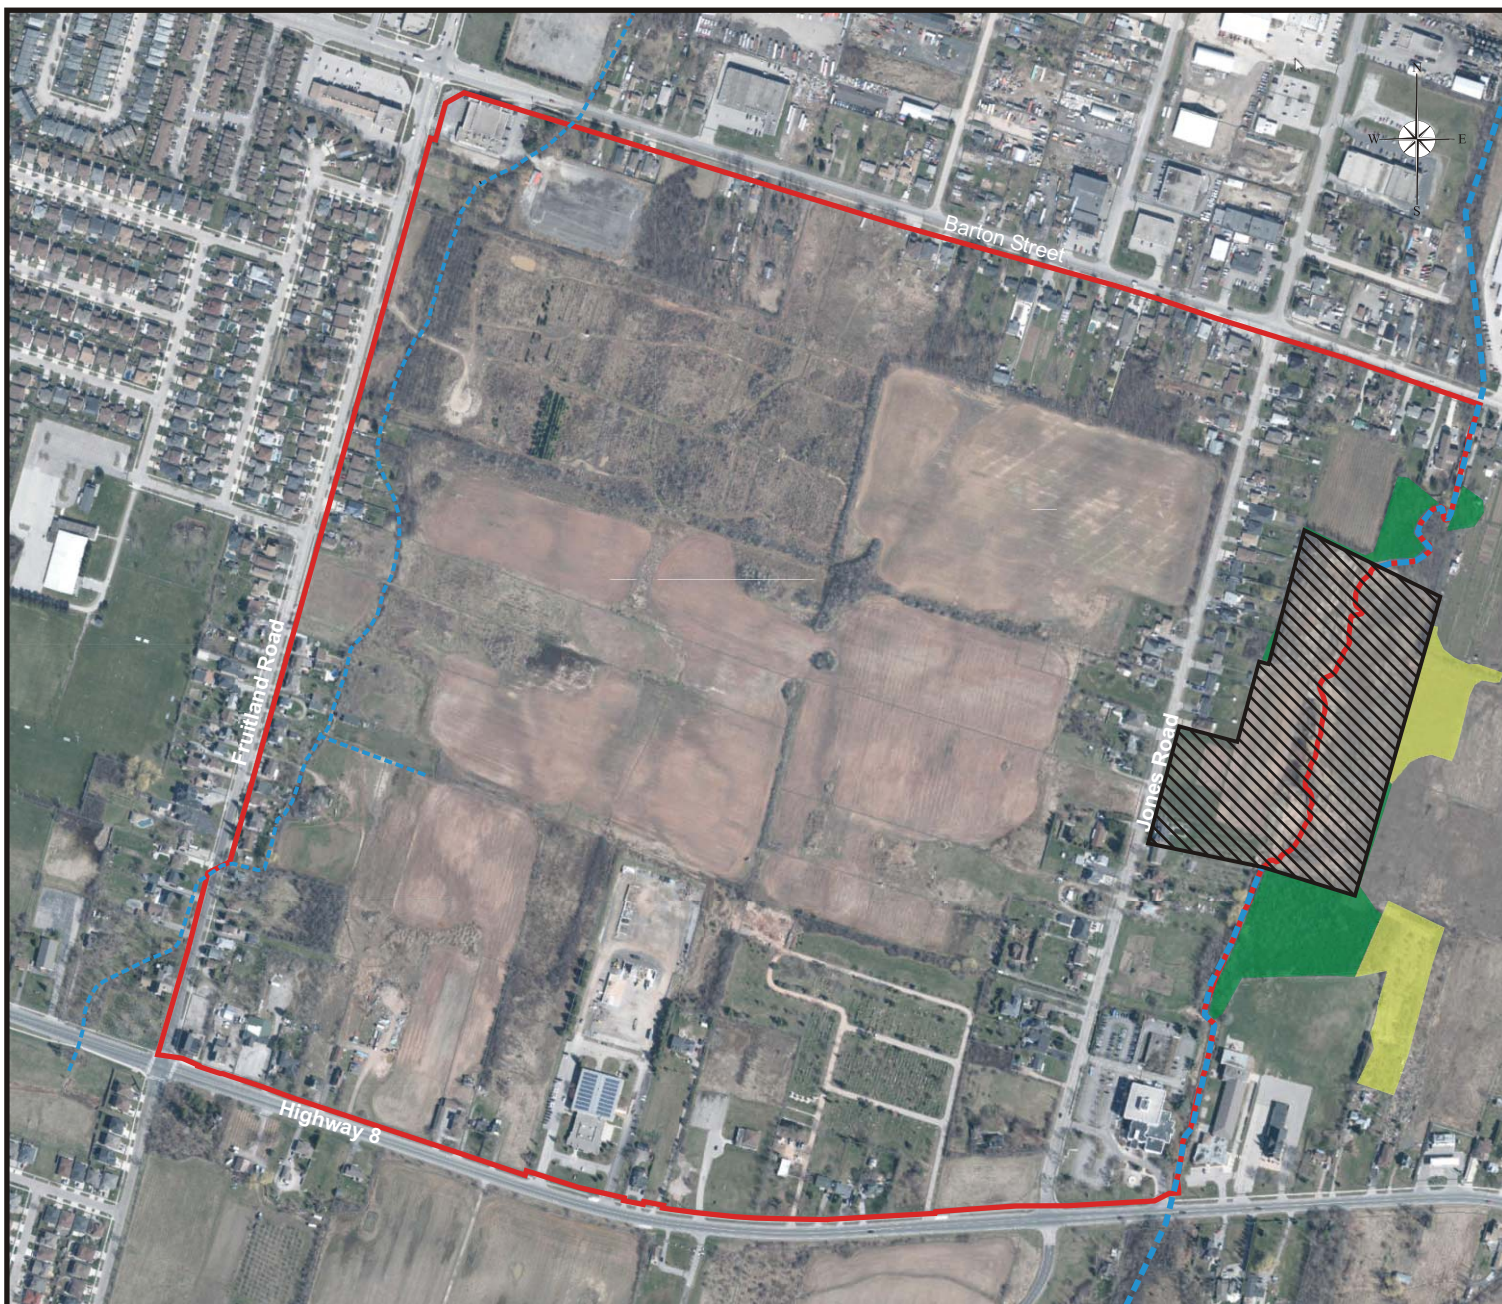
Figure 2
Mapped Natural Heritage Features
on the Subject Lands

- Subject Lands
- - - Watercourses
- Linkage
- Core Area (Significant Woodland)
- Lands Under Appeal

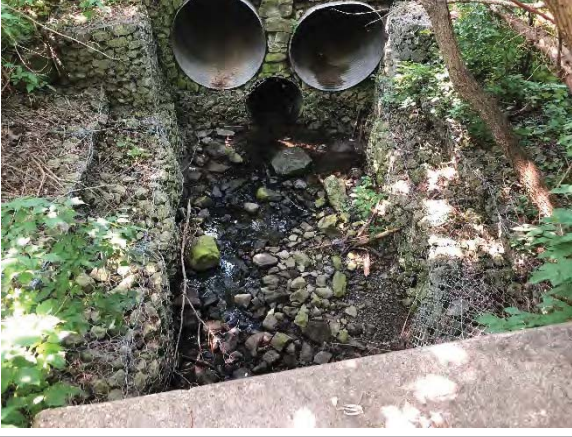
<p>Photo 1: 5 July 2021. Facing upstream of Highway 8 culvert inlet. Stormwater outlet culverts and outlet/inlet channel bordered by gabion baskets. Upstream extent of a discernable watercourse channel.</p>

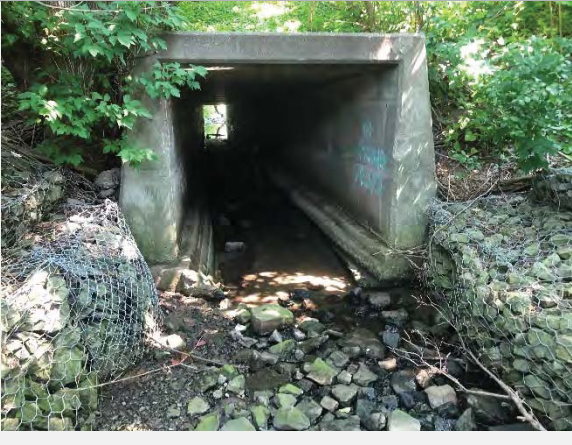
<p>Photo 2: 5 July 2021. Upstream of Highway 8 box culvert with view of structure inlet and gabion bank reinforcement (facing downstream).</p>

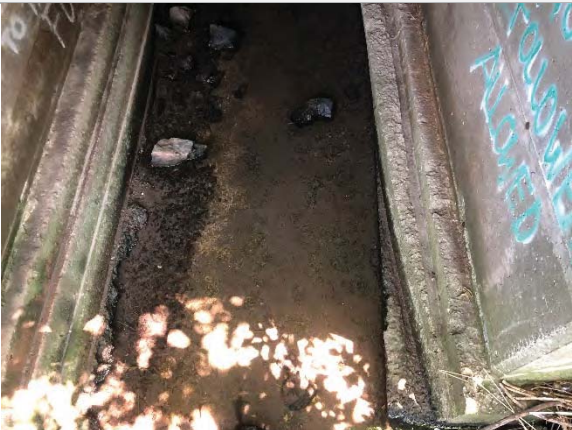
<p>Photo 3: 5 July 2021. Shallow water (3 mm deep) within Highway 8 culvert characteristic of limited aquatic habitat.</p>

The water within the approximately 1.8 m wide box culvert was observed from both ends of the culvert. The observed wetted width of 1.5 to 2.0 m and depth of 0.3 to 3.0 cm (Appendix D Photo 3) are dependent on the distribution of substrates on the culvert floor. Some cobble and gravel were present within the culvert, with a large area being characterized by exposed concrete culvert floor.

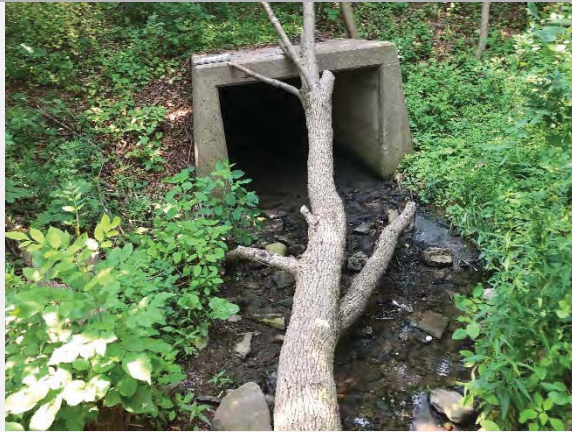
Photo 4: 5 July 2021. Highway 8 concrete box culvert outlet channel (facing upstream).

The culvert outlet channel was predominantly characterized by cobble substrates, with shallow water depths. The wetted width ranged from approximately 0.25 to 2 m and water depths ranged from 0.3 to 3.0 cm within the first 10 m downstream of the culvert (Appendix D Photos 4, 5). Cobble dominated the substrate, with gravel and silt also present. Dense riparian vegetation blocked visual

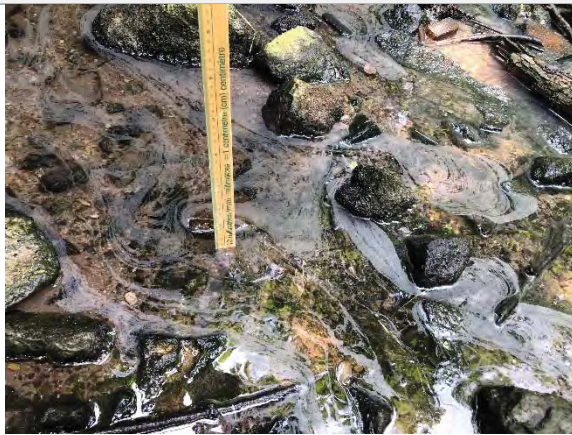
Photo 5: 5 July 2021. Shallow water (3 cm deep) in the Highway 8 box culvert outlet channel.

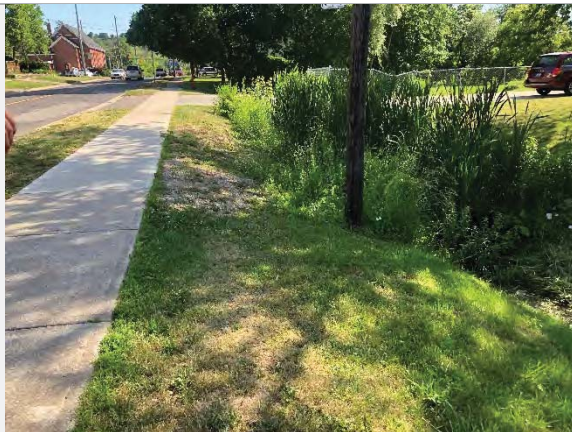
Photo 6: 17 June 2021. Watercourse 5.0 upstream view, west of Fruitland Road, in remnant section of roadside channel that appears naturalized with vegetation. Dense vegetation combined obscures the channel.

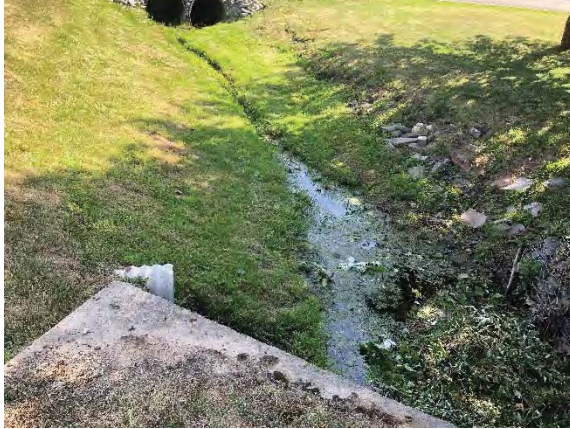
Photo 7: 17 June 2021. Fruitland Road box culvert inlet channel. Upstream view, west side of Fruitland Road, with twin CSP culverts of residential driveway crossing in background.

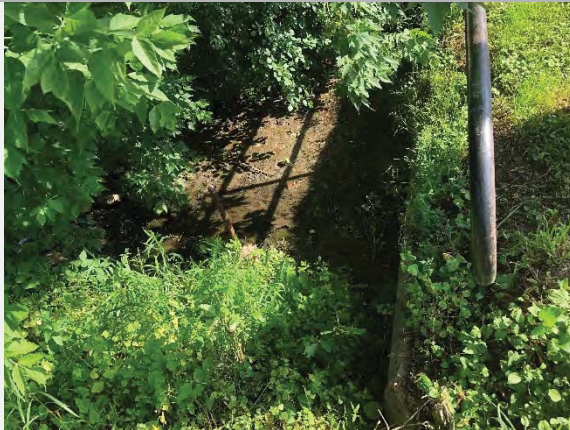
Photo 8: 17 June 2021. Fruitland Road culvert outlet. Standing water conditions (1 mm deep and with no observable flow).

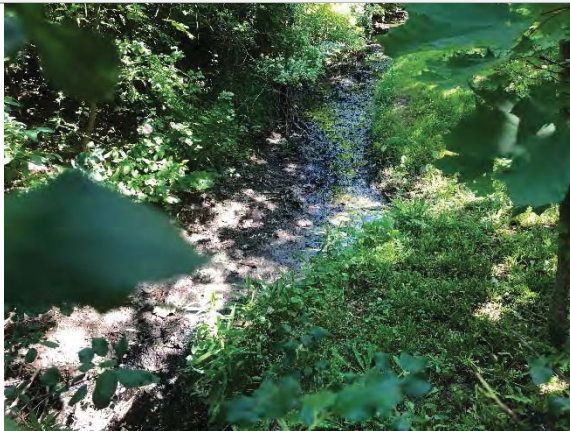
Photo 9: 17 June 2021. Upstream (south) of 212 Fruitland Road culvert inlet. Shallow water (approximately 1 to 2 mm) within the channel. Intermittently distributed dry sections of channel were present.

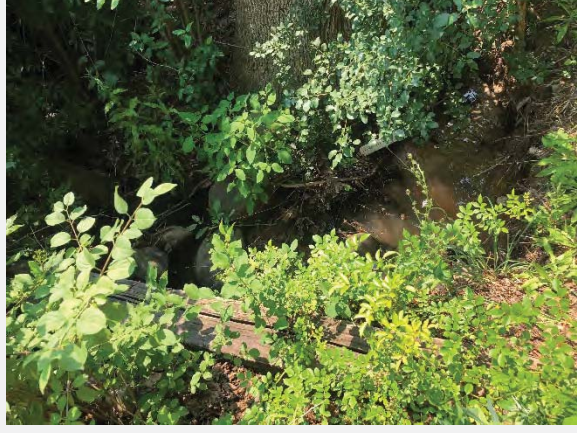
<p>Photo 10: 5 July 2021. Isolated pool immediately upstream (south) of 212 Fruitland Road culvert inlet. Standing water conditions with no observable flow.</p>

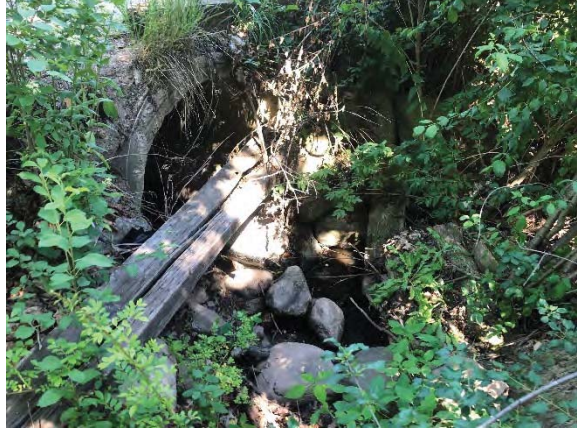
<p>Photo 11: 17 June 2021. Inlet of 212 Fruitland Road culvert. Cobble and wood may provide a barrier to fish movement in event of any higher flows.</p>

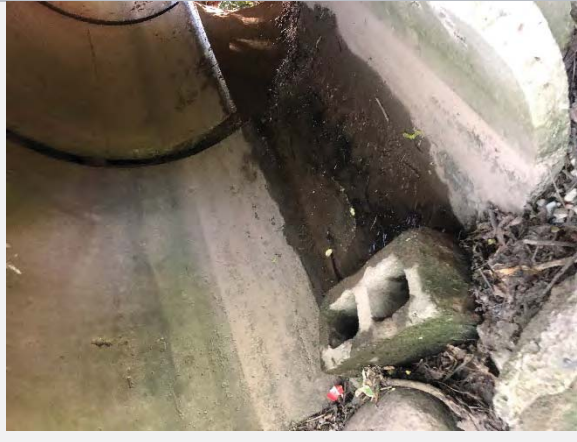
<p>Photo 12: 17 June 2021. Outlet of 212 Fruitland Road culvert. Shallow water (1 to 2 mm) within the culvert.</p>

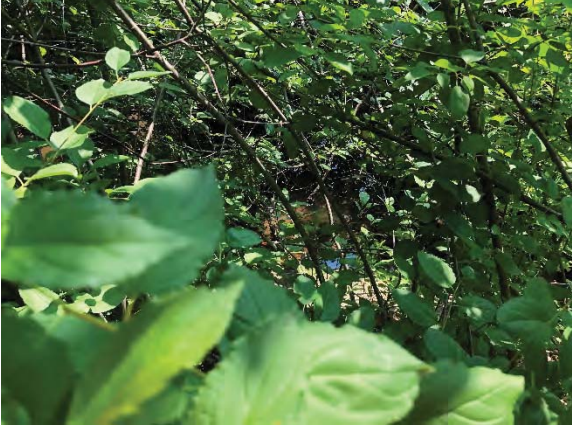
<p>Photo 13: 5 July 2021. Downstream of 212 Fruitland Road culvert outlet. Dense overhanging riparian vegetation. Shallow standing water observed within the channel.</p>

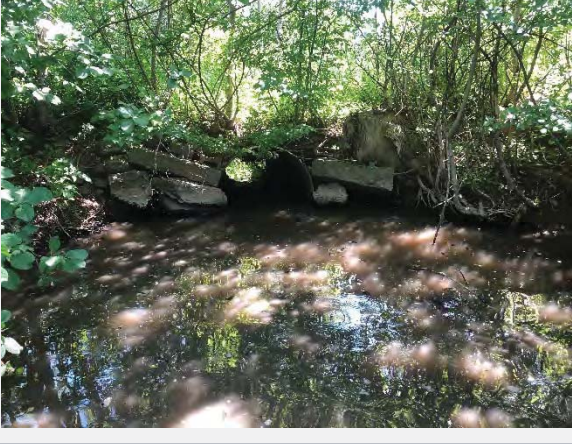
<p>Photo 14: 17 June 2021. Upstream (south) view of watercourse section WC5-A. Pool morphology with a maximum depth of 0.45 m. Outlet of metal culvert at inaccessible private property.</p>

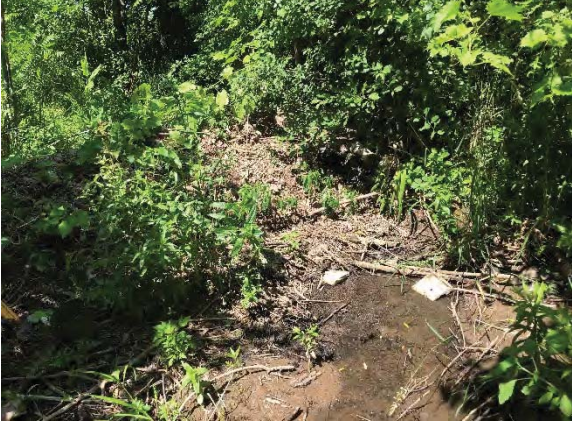
<p>Photo 15: 17 June 2021. Watercourse Section WC5-A. Shallow water (1 mm) and fallen pedestrian bridge with debris blocking channel and aquatic corridor function.</p>

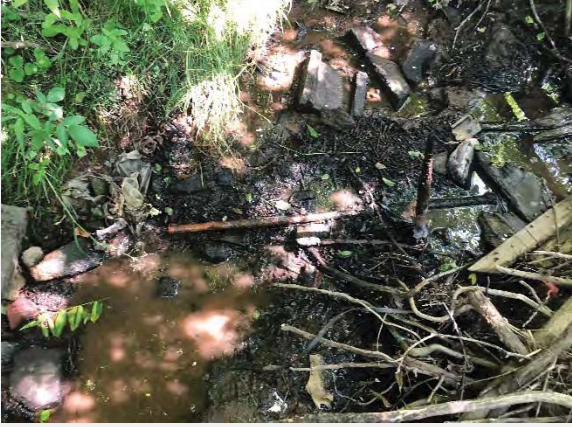
<p>Photo 16: 17 June 2021. Watercourse Section WC5-A. Dry area in channel surrounded by shallow (<2 cm) standing water. Substrates consisting of fines, cobble and assorted debris.</p>

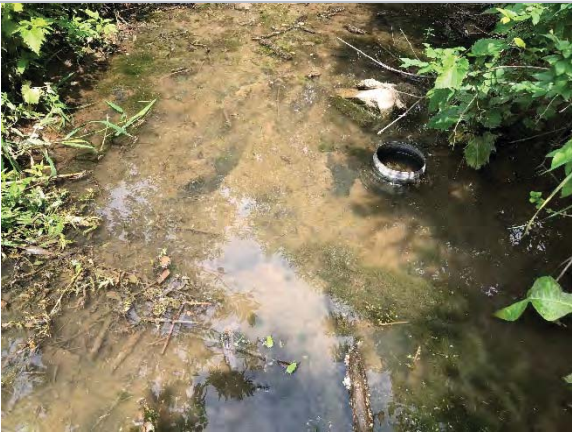
<p>Photo 17: 15 July 2021. Watercourse Section WC5-A. Standing water area of aquatic habitat with no observable flow within the channel. Fine substrates.</p>

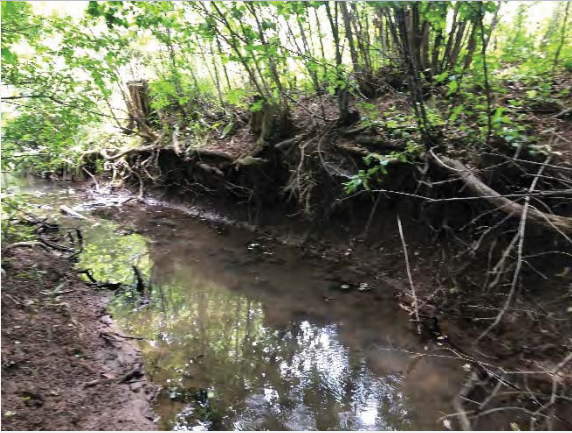
<p>Photo 18: 15 July 2021. Watercourse Section WC5-A, near downstream end of the reach. More defined channel with undercutting on right (west) bank and shallow pool habitat. Riparian vegetation is present along the channel providing overhead shading and cover.</p>

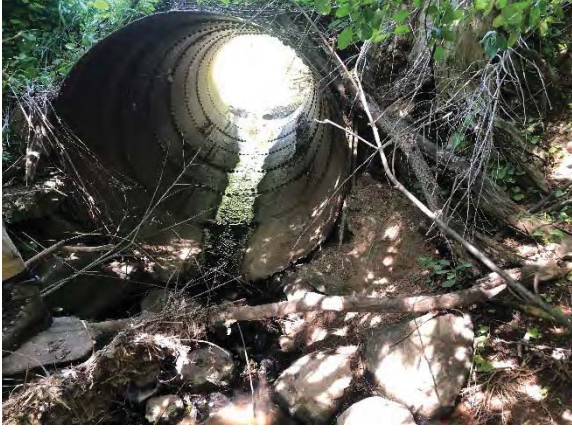
<p>Photo 19: 17 June 2021. Culvert inlet under grass access path between Watercourse sections WC5-A and WC5-B. Water 1 mm deep within the 4.5 m long culvert.</p>

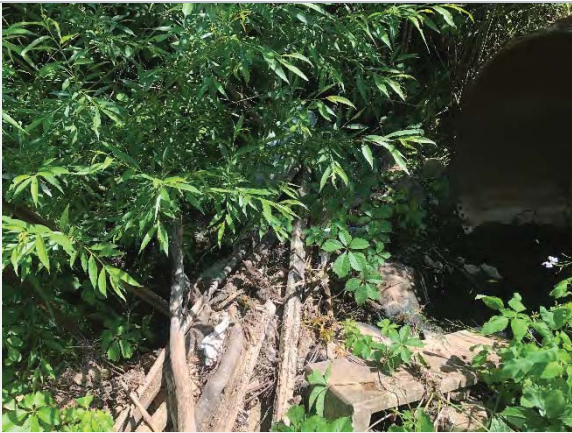
<p>Photo 20: 17 June 2021. Culvert outlet under grass access path between Watercourse sections WC5-A and WC5-B. Debris at culvert outlet extends 55 cm above channel invert partially blocking the flow path. No discernable flow was observed.</p>

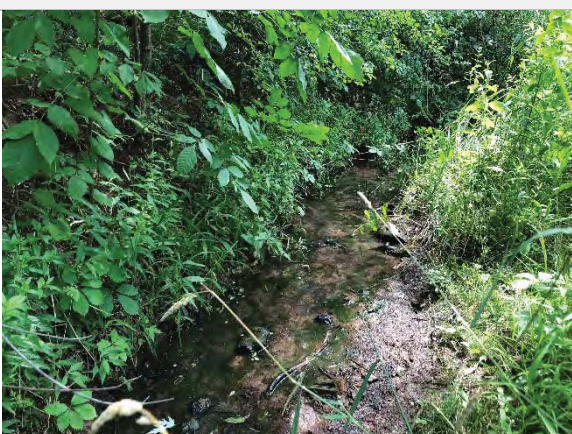
<p>Photo 21: 15 July 2021. Watercourse Section WC5-B exhibiting characteristic intermittent shallow water area with aquatic algae coating a substrate of fines and cobbles. No flow was observed.</p>

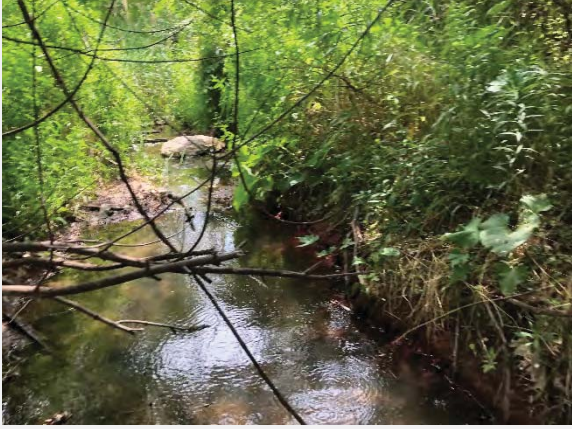
<p>Photo 22: 15 July 2021. Watercourse Section WC5-B exhibiting a shallow standing water pool habitat area.</p>

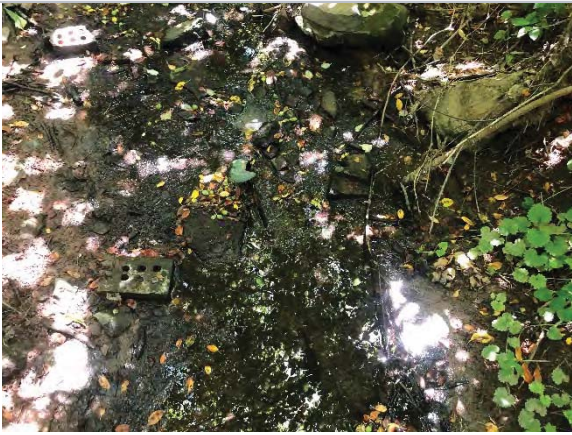
<p>Photo 23: 17 June 2021. Shallow water (≤ 1 mm) interspersed with dry segments within Watercourse Section WC5-B.</p>

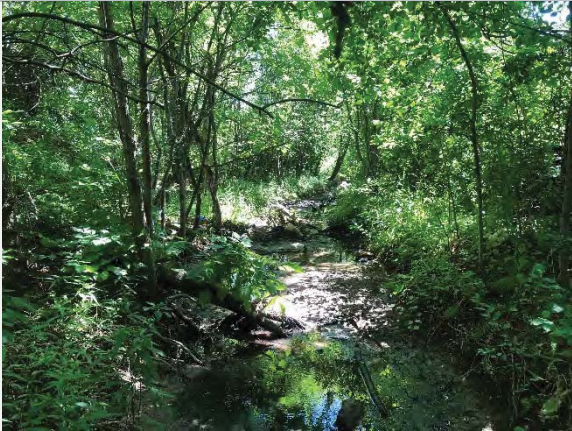
<p>Photo 24: 17 June 2021. Limited shallow standing water aquatic habitat within Watercourse Section WC5-B. No observable flow.</p>

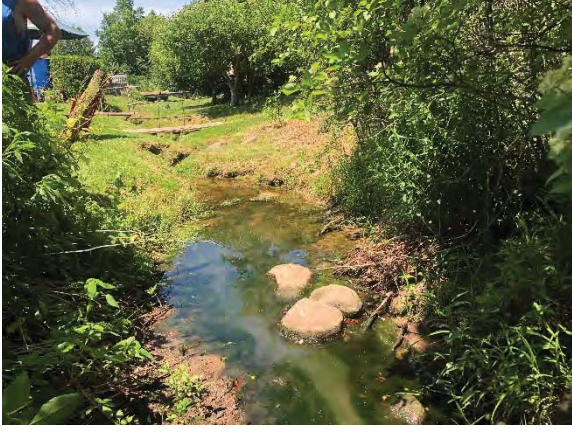
<p>Photo 25: 17 June 2021. Downstream end of Watercourse Station WC5-B, facing north toward inaccessible properties. Channel was narrow and most of the riparian vegetation maintained as lawn. Limited pool of standing water with notable growth of aquatic algae.</p>

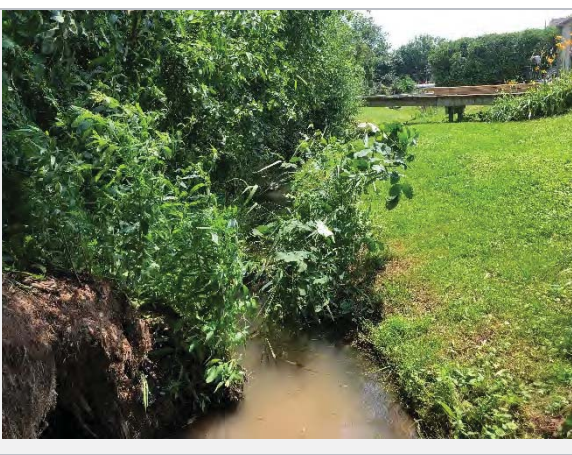
<p>Photo 26: 15 July 2021. Facing upstream from Watercourse Section WC5-C where the defined channel runs through residential properties. Areas beyond this view were not accessed due to private properties. Standing water in scour pool providing some aquatic habitat opportunities.</p>

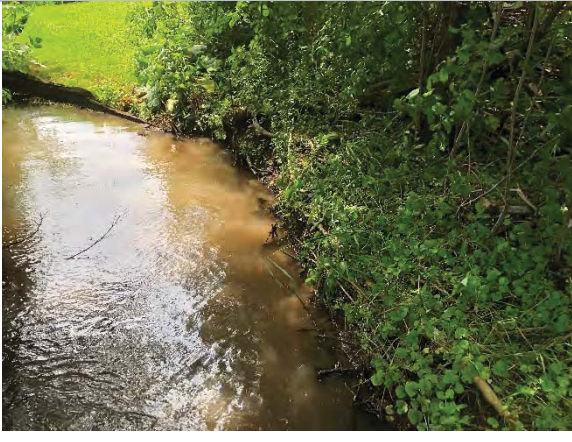
<p>Photo 27: 15 July 2021. Watercourse Section WC5-C upstream view showing mowed lawns, trimmed riparian vegetation leading to unmaintained riparian vegetation on banks of a scour pool providing aquatic habitat opportunities.</p>

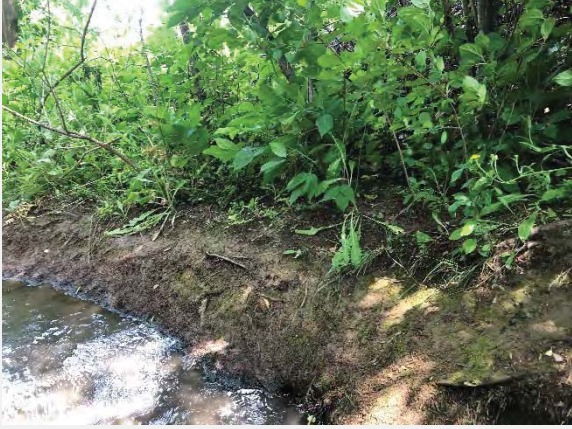
<p>Photo 28: 15 July 2021. Left (east) bank with exposed soil in Watercourse Section WC5-C showing exposed bank materials and partially vegetated riparian area adjacent to standing water pool.</p>

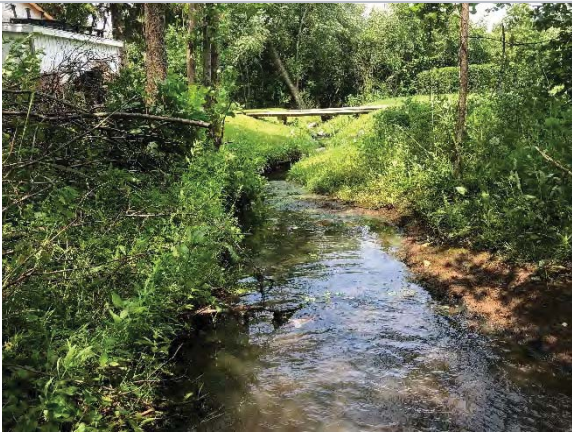
<p>Photo 29: 15 July 2021. Watercourse Section WC5-C, downstream view. Defined channel runs through residential properties immediately downstream (north) which were not accessible.</p>

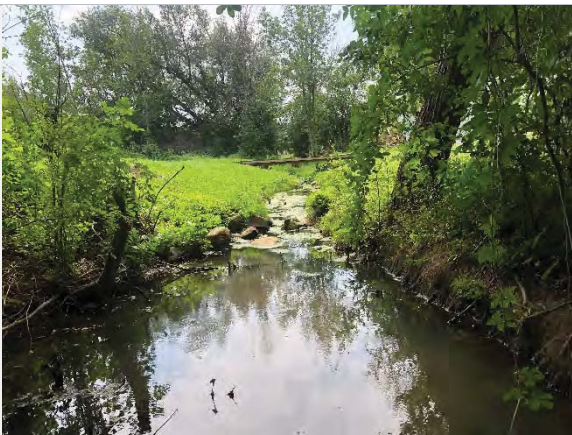
<p>Photo 30: 15 July 2021. Upstream view of Watercourse Section WC5-D. Channel runs through residential properties immediately upstream which were not accessible. Mowed grasses, walkway over the watercourse and placed boulder and stone all observed within this reach of standing water pool habitat.</p>

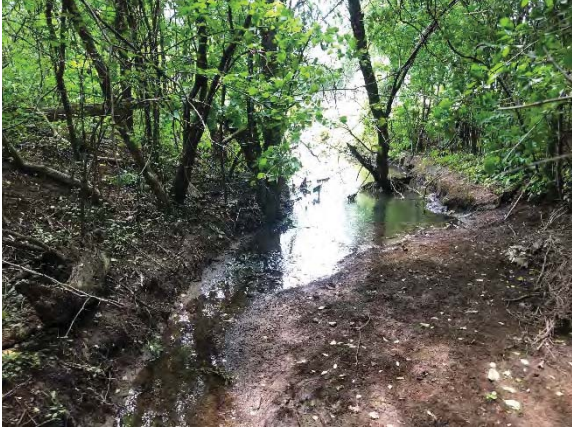
<p>Photo 31: 15 July 2021. Watercourse Section WC5-D. Shallow water pool area and exposed banks and dry channel bed at pool outlet.</p>

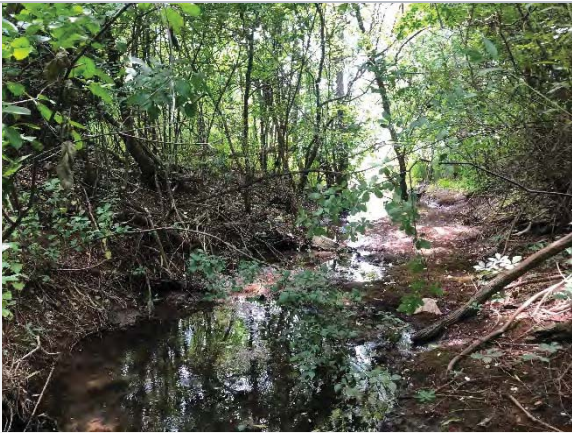
<p>Photo 32: 15 July 2021. Representative overview, facing upstream within Watercourse Section WC5-D. Signs of erosion and undercutting in a reach with dense riparian shrub growth.</p>

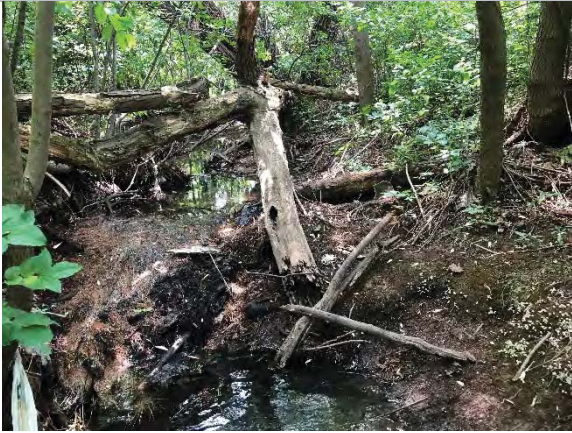
<p>Photo 33: 15 July 2021. Watercourse Section WC5-D. Potential impediment to fish movement – 0.45 m to 0.55 m vertical elevation change above 0.39 m deep pool, recorded in June and July. The channel is dry for approximately 0.7 m upstream of the elevation change. Stepped pool configuration of channel profile.</p>

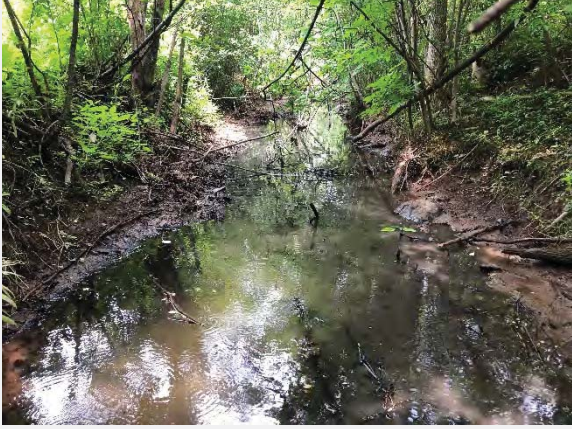
<p>Photo 34: 15 July 2021. Representative overview of Watercourse Section WC5-D. No flow was observed within the channel. Note densely vegetated riparian area and exposed banks.</p>

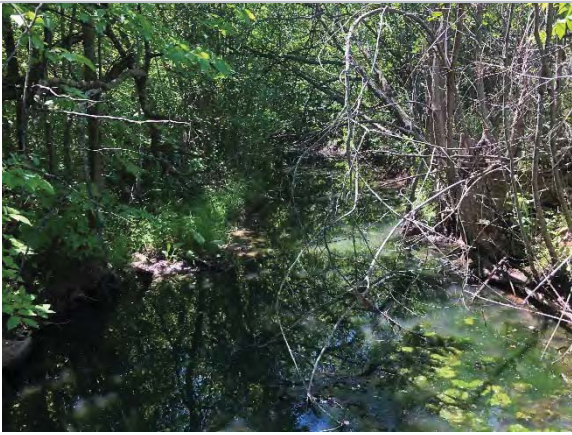
<p>Photo 35: 17 June 2021. Aquatic habitat within Watercourse Section WC5-D. Dense riparian shrub and tree vegetation, standing water pool characterized by a thick growth of aquatic algae across the channel width and length suggesting nutrient inputs.</p>

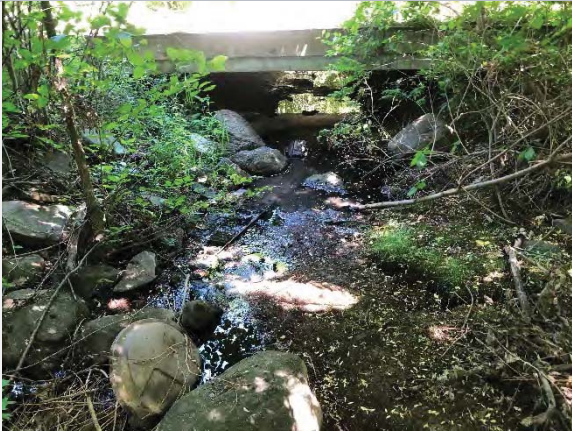
<p>Photo 36: 17 June 2021. Downstream view of Watercourse Section WC5-D toward gravel/dirt path bridge. Dry channel, 0.2 m elevation change over 2 m length. Water present under the bridge. Photos 37 and 38 also show this area.</p>

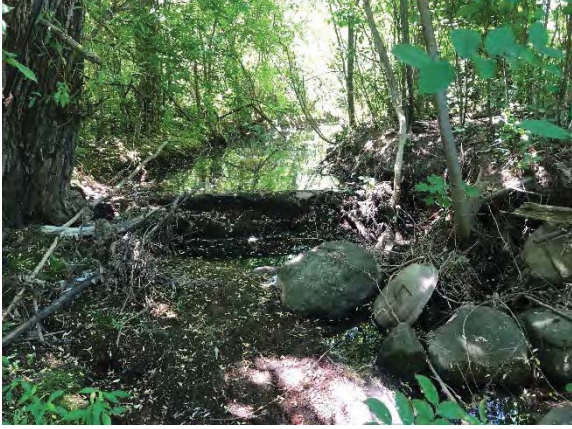
<p>Photo 37: 17 June 2021. Downstream end of Watercourse Section WC5-D. Facing upstream toward tree root growth across the channel and dry section of channel immediately downstream. Potential impediment to upstream fish movement due to approximately 0.4 m vertical elevation change recorded in June and July.</p>

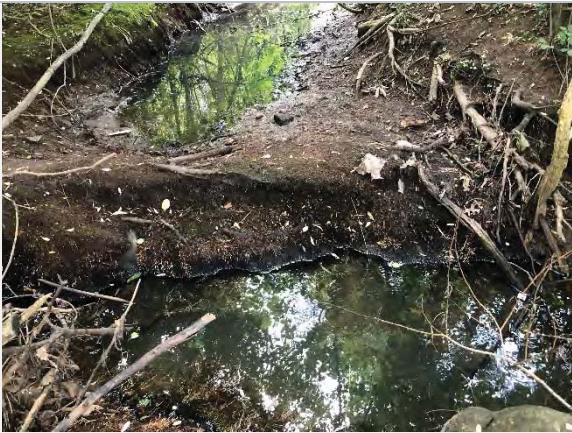
<p>Photo 38: 15 July 2021. Watercourse Section WC5-D. Facing upstream toward the tree root across the channel (shown in Photo 37) and short dry section of channel upstream of root.</p>

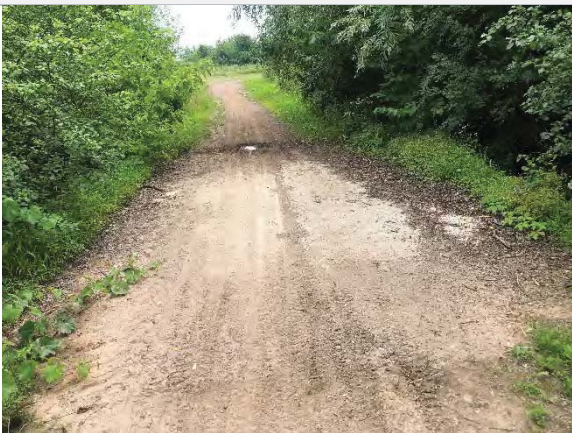
<p>Photo 39: 15 July 2021. Dirt/gravel path over Watercourse 5.0, separating Sections WC5-D and WC5-E.</p>

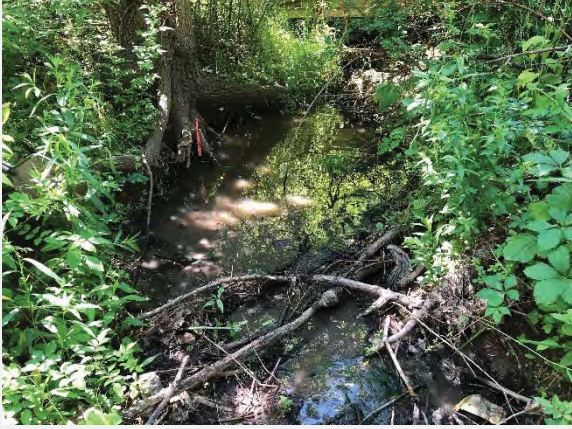
<p>Photo 40: 17 June 2021. Watercourse Section WC5-E. Approximately 10 m downstream of crossing structure (see photo 41 for July conditions). Dense riparian vegetation, standing water aquatic habitat and woody debris cover in the channel.</p>

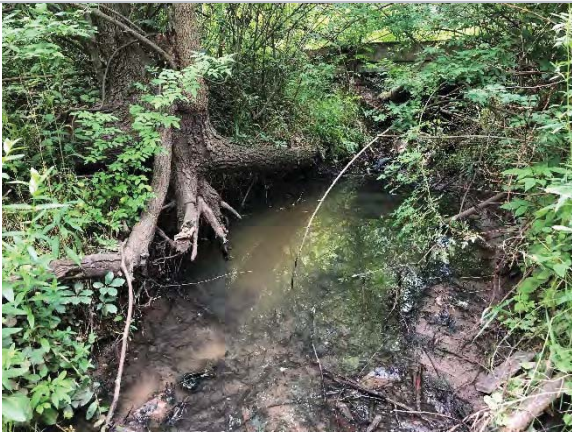
<p>Photo 41: 15 July 2021. Watercourse Section WC5-E. Approximately 10 m downstream of crossing structure.</p>

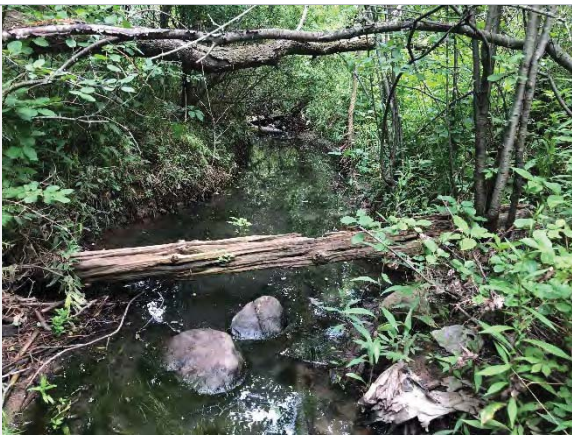
<p>Photo 42: 15 July 2021. Watercourse Section WC5-E. Standing water with dense aquatic algae present in long pool habitat area. Notable riparian vegetation cover.</p>

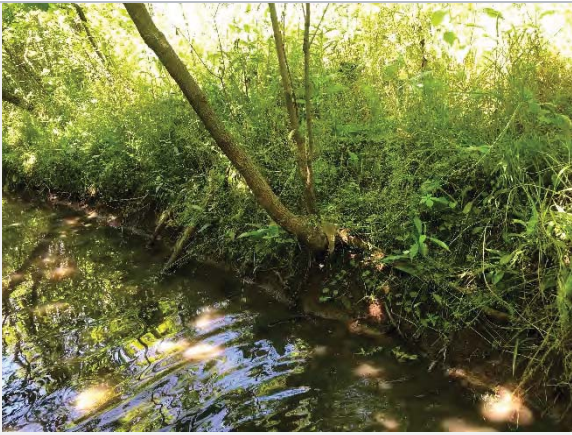
<p>Photo 44: 17 June 2021. Riparian vegetated bank with some exposed soil in Watercourse Section WC5-E. Deeper pool habitat throughout this apparent previously channelized reach.</p>

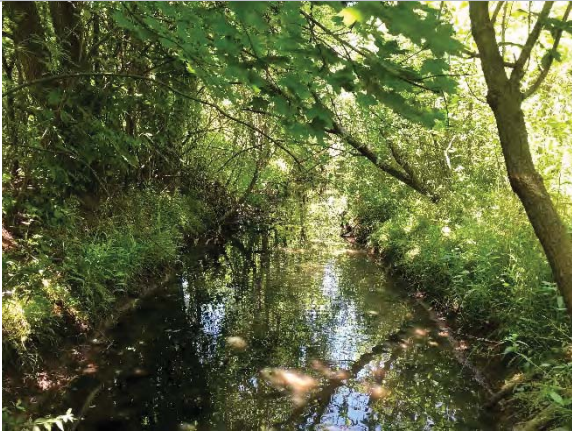
<p>Photo 45: 17 June 2021. Aquatic habitat near downstream end of Watercourse Section WC5-E. Straightened channel reach with standing water pool habitat with notable growths of algae, dense riparian vegetation and overhead shade.</p>

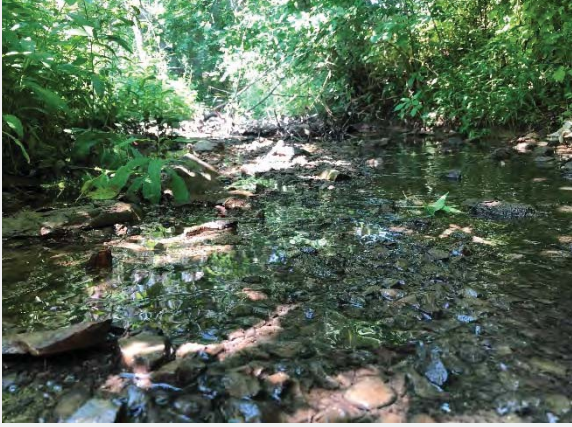
<p>Photo 46: 5 July 2021. Shallow-water reach upstream of Barton Street inlet channel with cobble substrates. Water level was very shallow with no discernable flow.</p>

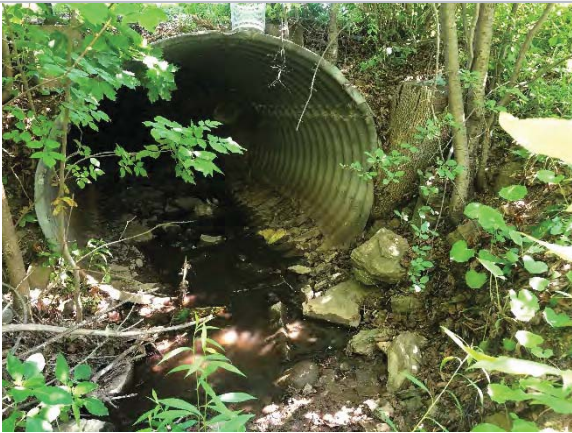
<p>Photo 47: 17 June 2021. Barton Street CSP culvert component inlet. Shallow ponded area of water immediately upstream of culvert inlet (facing downstream).</p>

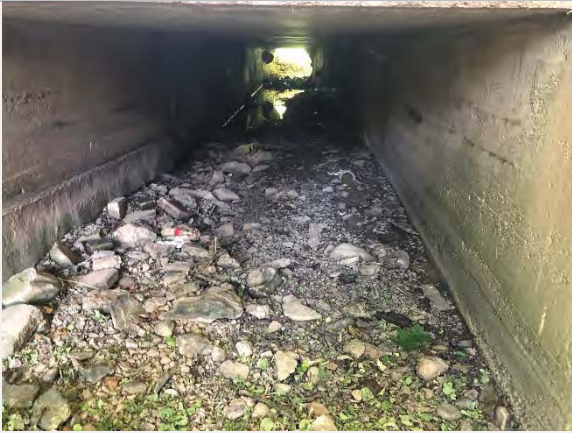
<p>Photo 48: 17 June 2021. View facing upstream through Barton Street concrete box culvert component. Area within the approximately 23 m long culvert was mostly lined with cobble substrates and exhibited dry conditions with no flow.</p>

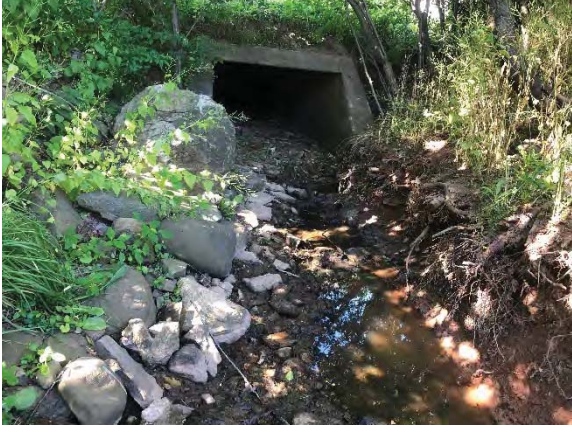
<p>Photo 49: 17 June 2021. Barton Street culvert outlet. Shallow standing water downstream of culvert representing limited habitat. See photo 50 for site conditions in July 2021.</p>

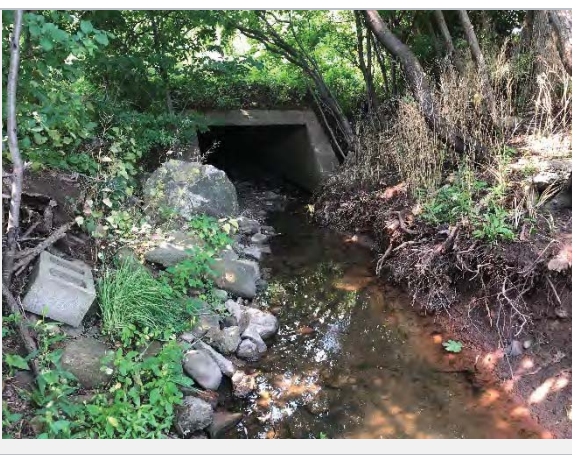
<p>Photo 50: 5 July 2021. Barton Street culvert outlet. Water level slightly higher compared to June due to recent precipitation. Conditions exhibited similar habitat limitations as in June (See photo 49 for site conditions in June 2021).</p>

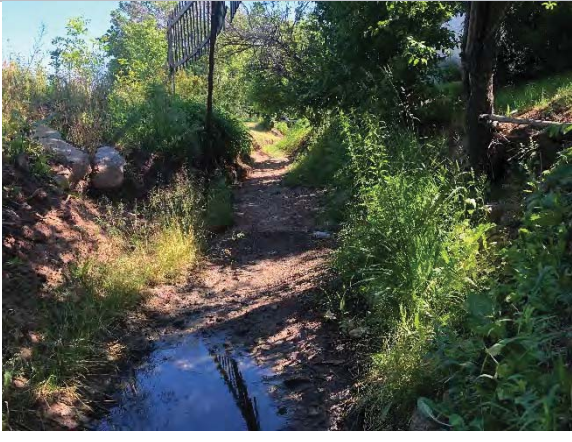
<p>Photo 51: 17 June 2021. Barton Street culvert outlet channel downstream view. Dry channel downstream of isolated shallow standing water area in foreground and vertical grade increase in channel floor. Intermittent nature of standing water areas limits function of aquatic corridor (see photo 52 for site conditions in July 2021).</p>

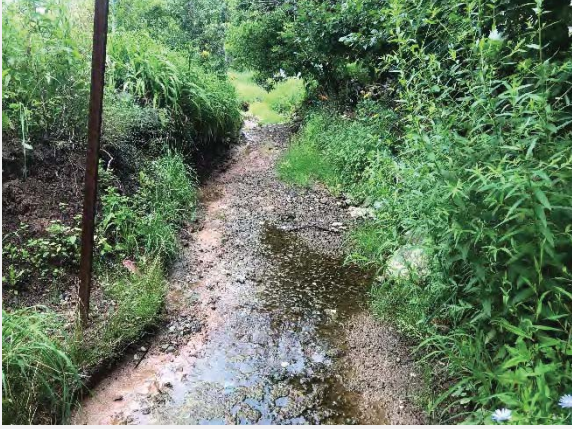
<p>Photo 52: 15 July 2021. Barton Street culvert outlet channel downstream view. Dry channel downstream of isolated shallow, stagnant water area. Aquatic habitat limitations similar to June observations (See photo 51 for site conditions in June 2021).</p>

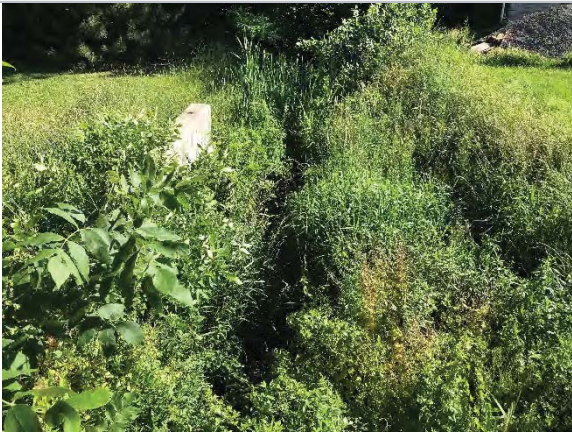
<p>Photo 53: 17 June 2021. Arvin Avenue culvert inlet channel upstream view. Dense vegetation in predominantly dry channel. Very limited aquatic habitat.</p>

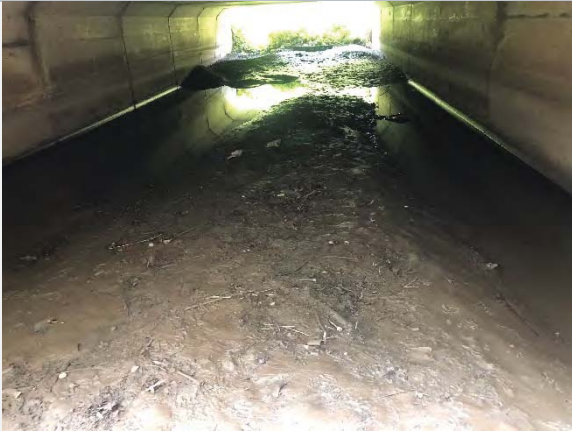
<p>Photo 54: 5 July 2021. Arvin Avenue concrete box culvert inlet area, with view facing downstream within culvert. Predominantly dry channel, limited aquatic habitat represented by standing water area. Impediment to potential fish movement during low flows as observed.</p>

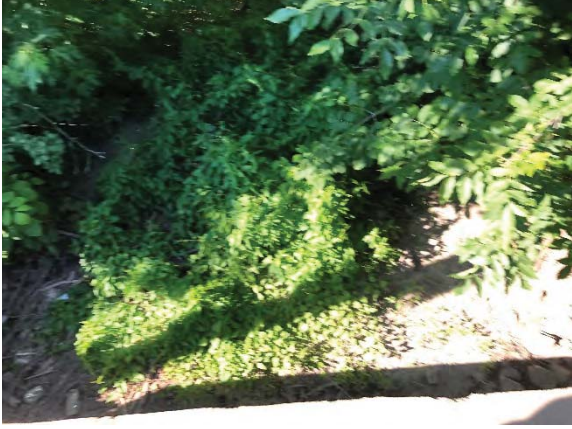
<p>Photo 55: 17 June 2021. Arvin Avenue culvert outlet. Channel was dry at the time of assessment and choked with terrestrial vegetation, suggesting characteristic seasonally dry conditions as observed.</p>

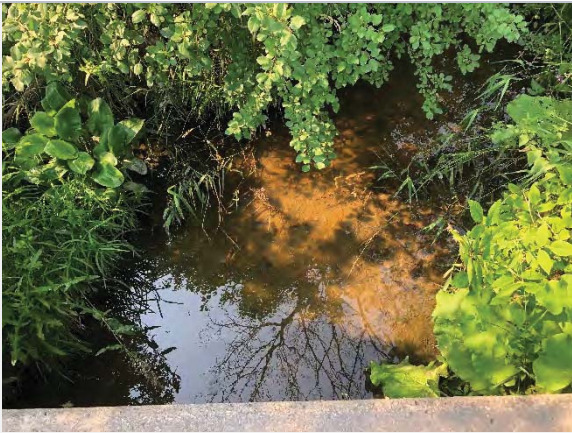
<p>Photo 56: 5 July 2021. South Service Road culvert inlet channel. No observable flows. Very limited aquatic habitat in the form of standing water pool area.</p>

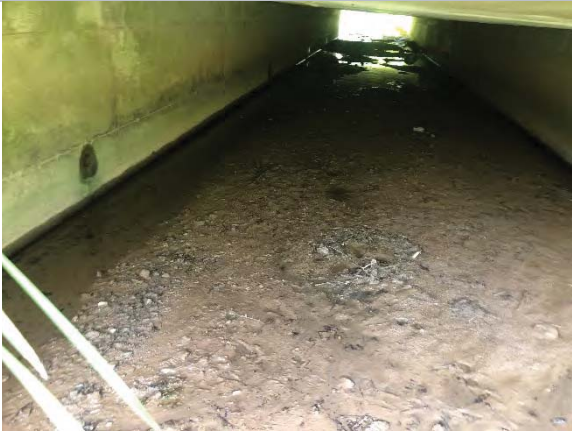
<p>Photo 57: 5 July 2021. South Service Road culvert outlet. Predominantly dry channel with limited aquatic habitat and impediment to potential fish movement under low flow conditions.</p>

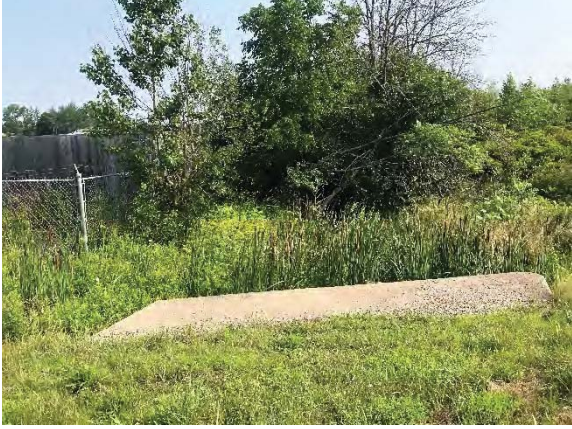
<p>Photo 61: 5 July 2021. Representative overview of South Service Road culvert outlet channel area.</p>

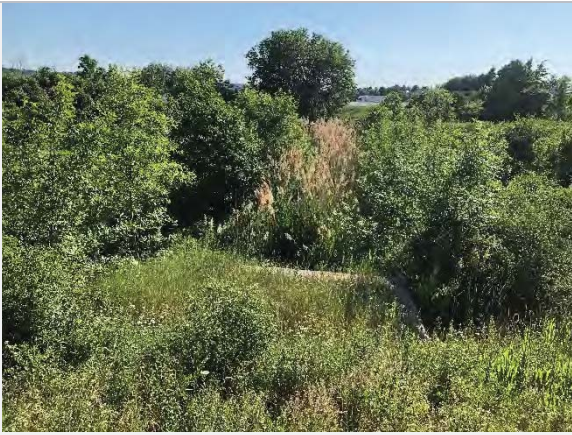
<p>Photo 62: 17 June 2021. Representative overview of North Service Road inlet channel. Dense phragmites in the upstream channel.</p>

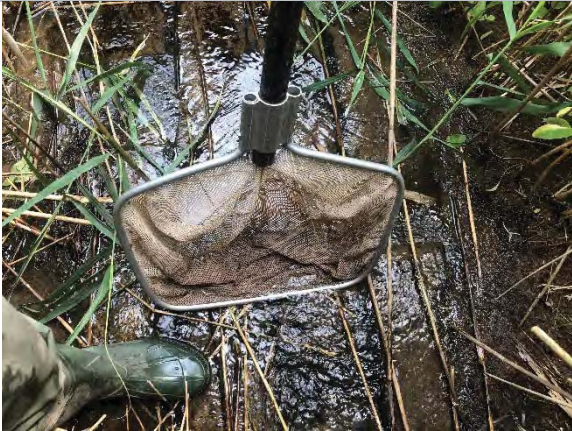
<p>Photo 63: 15 July 2021. Shallow water immediately upstream of North Service Road culvert. Limited aquatic habitat and shallow water levels. Minimal flows were observed in this lower reach of the watercourse.</p>

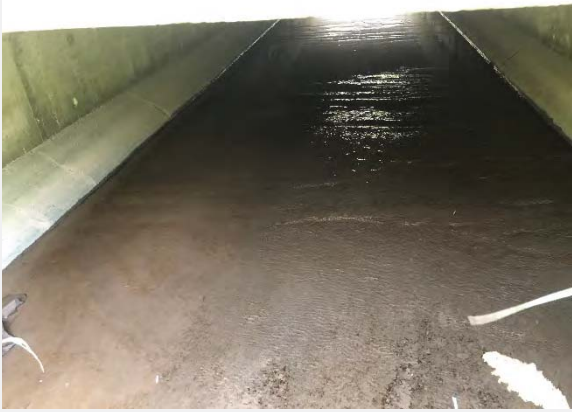
<p>Photo 64: 5 July 2021. Shallow (0.1 to 0.5 cm) water within the approximately 37.4 m long North Service Road concrete box culvert. Shallow water and concrete channel represent limited aquatic habitat and would impede potential fish movement during characteristics low flows as observed.</p>

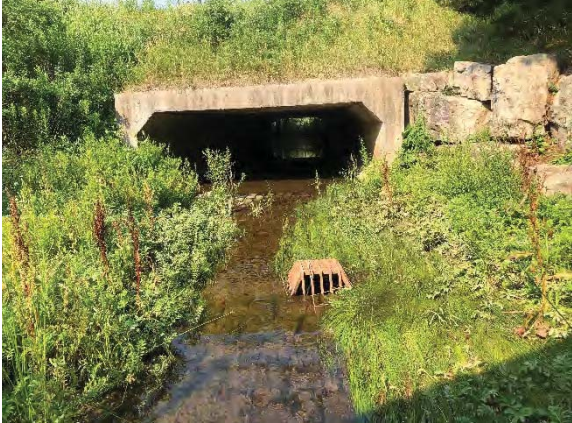
<p>Photo 65: 5 July 2021. North Service Road box culvert outlet channel. Water depth 2 cm downstream of the culvert outlet, with run habitat embedded cobble substrate.</p>

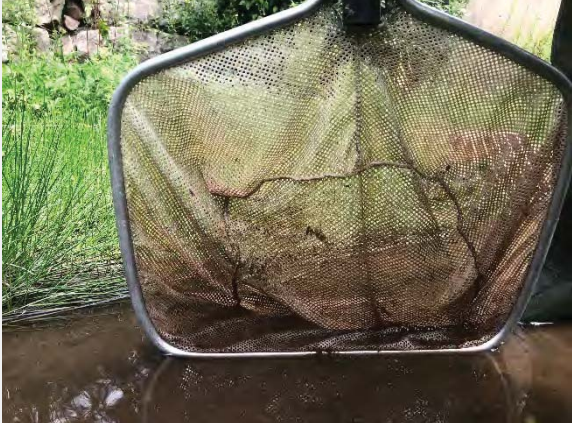
<p>Photo 66: 15 July 2021. North Service Road culvert outlet with 2 mm water depths. Limited to no refuge as aquatic habitat.</p>

Large cement blocks form the right bank. A 1 to 2 m wide open area with brick/stone flat floor is present in the middle, with dense herbaceous vegetation along each side. Water width and depth ranged from 0 to 1.5 m and 0 to 2 cm, respectively (Appendix D Photos 65 to 67) with slow moving water present during the July field surveys.

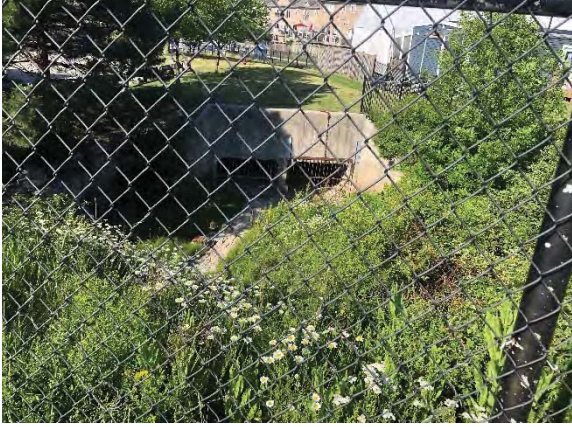
<p>Photo 67: 17 June 2021. Facing downstream from North Service Road. Dry channel upstream of culvert which outlets to Lake Ontario creating a notable impediment to upstream fish movement.</p>

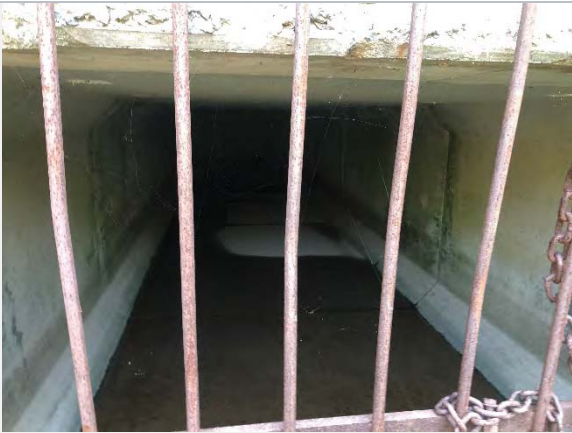
<p>Photo 68: 5 July 2021. Inlet of concrete box culvert structure outletting to Newport Yacht Club and corridor to Lake Ontario. Water level (0 to 1 mm) represents a barrier to fish movement during low flows observed.</p>

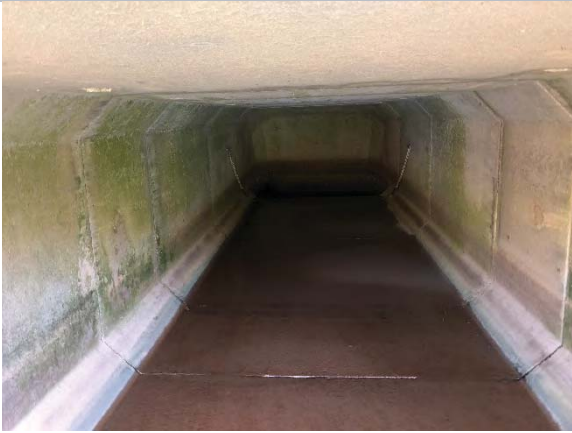
<p>Photo 69: 5 July 2021. Facing downstream into culvert that outlets to Lake Ontario. Opening and associated drop in the culvert floor represents the outlet of Watercourse 5.0 flows to the lake. Outlet drop structure appears to notably impede any upstream fish movement and access from permanent fish habitat in Lake Ontario into the culvert and subsequently Watercourse 5.0.</p>
