**NATURAL HERITAGE CHARACTERIZATION ASSESSMENT
BLOCK 1 LANDS - CITY OF HAMILTON**

Fruitland-Winona Block 1 Owners

Colville Consulting Inc.

File: C18028
Date: April 2024

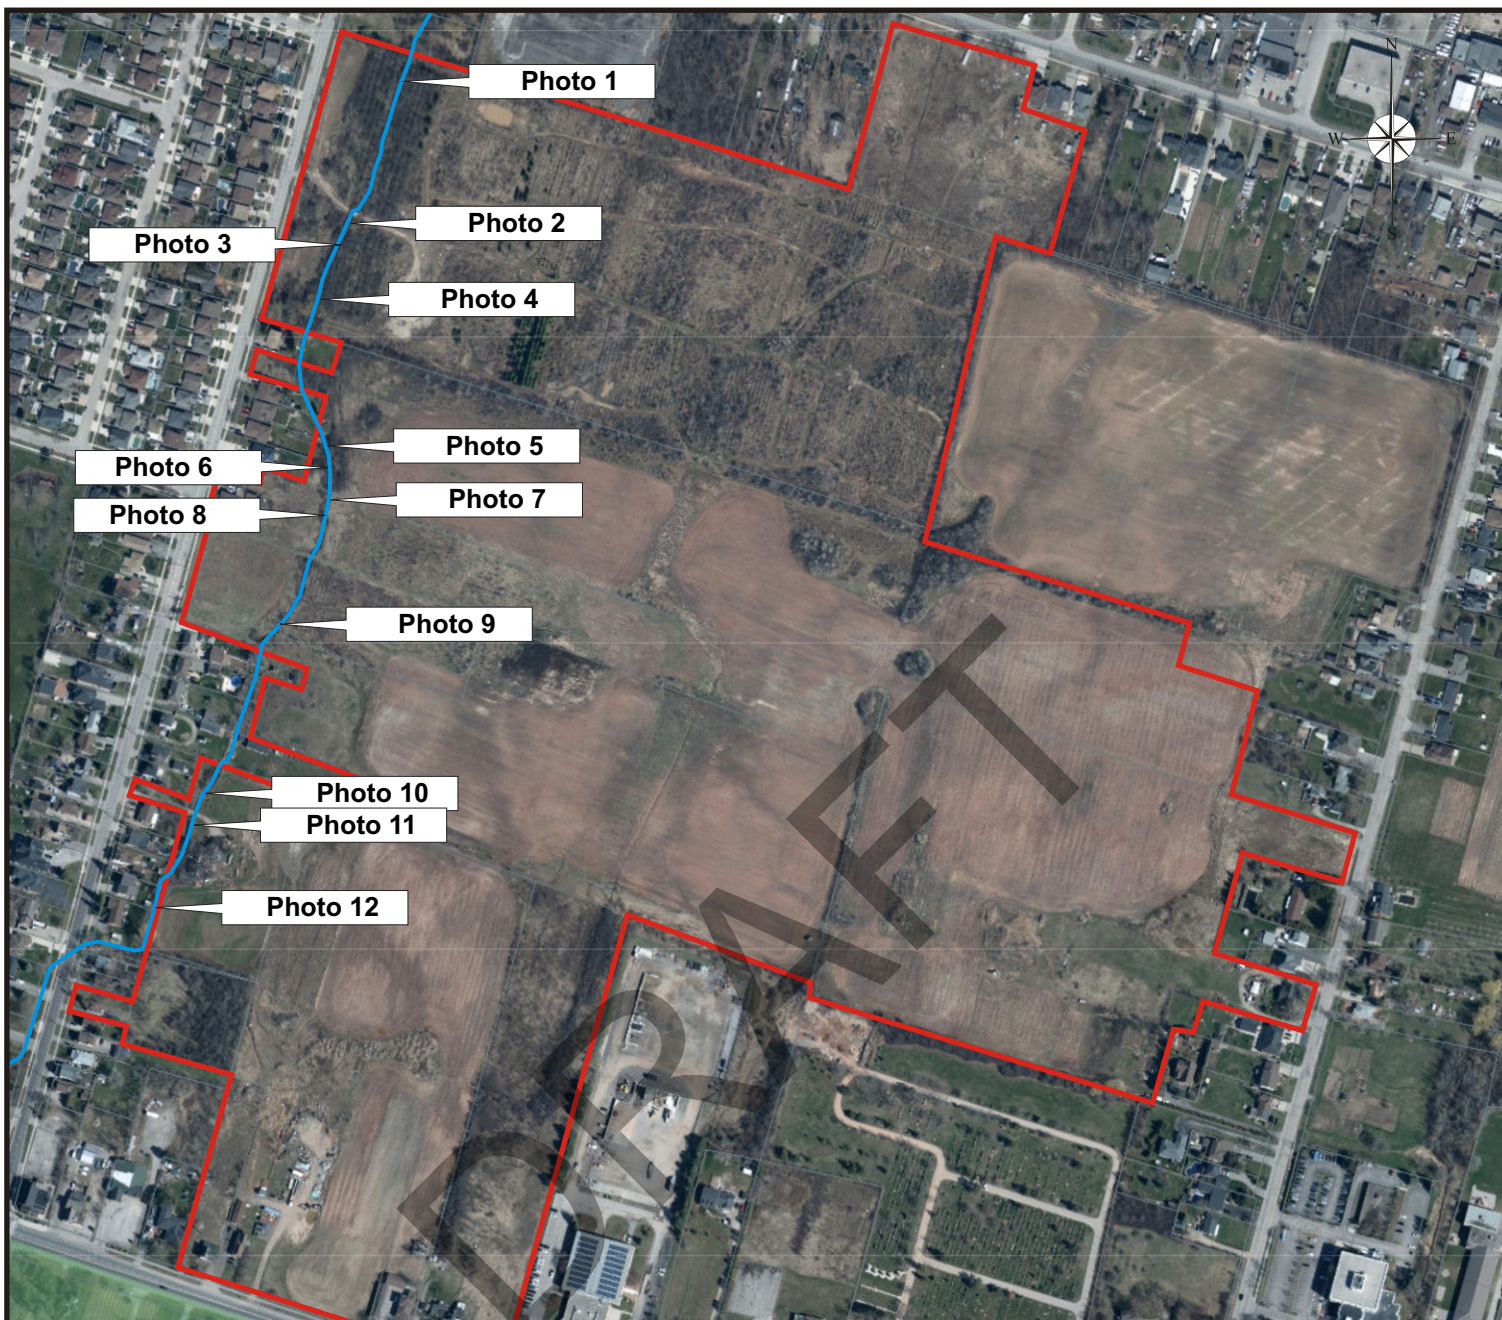
Figure 1
Watercourse 5 Photo Locations
on the Subject Lands

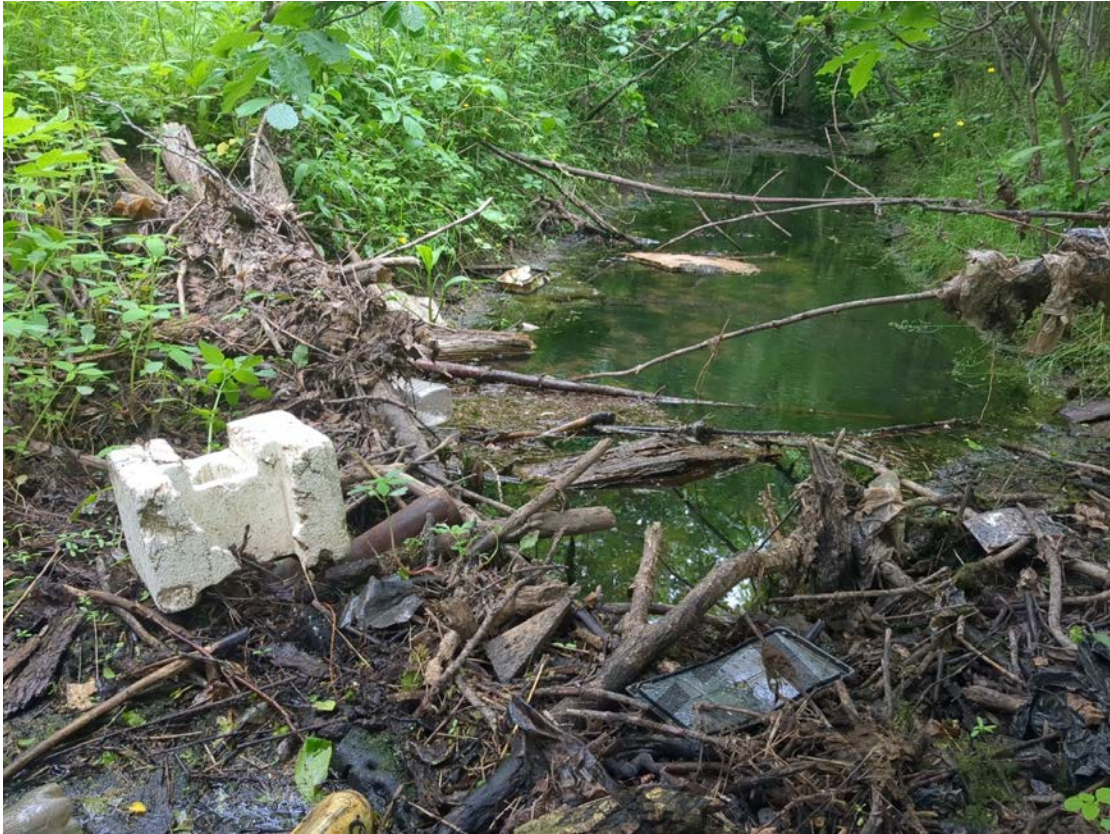
Photo 1: Example of channel conditions in Watercourse 5 near the north end of the Study Area. Photo facing north.

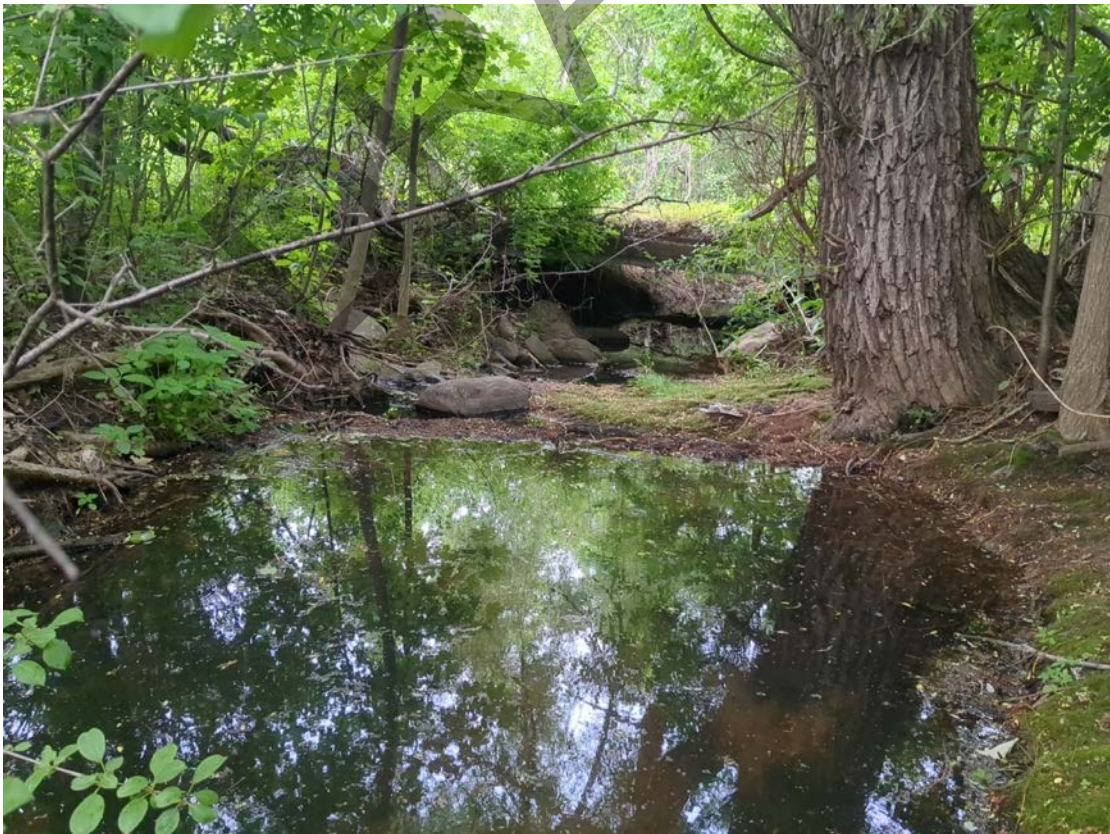
Photo 2: Channel conditions in Watercourse 5 immediately south of culvert and access laneway at 248 Fruitland Road. Photo facing north.

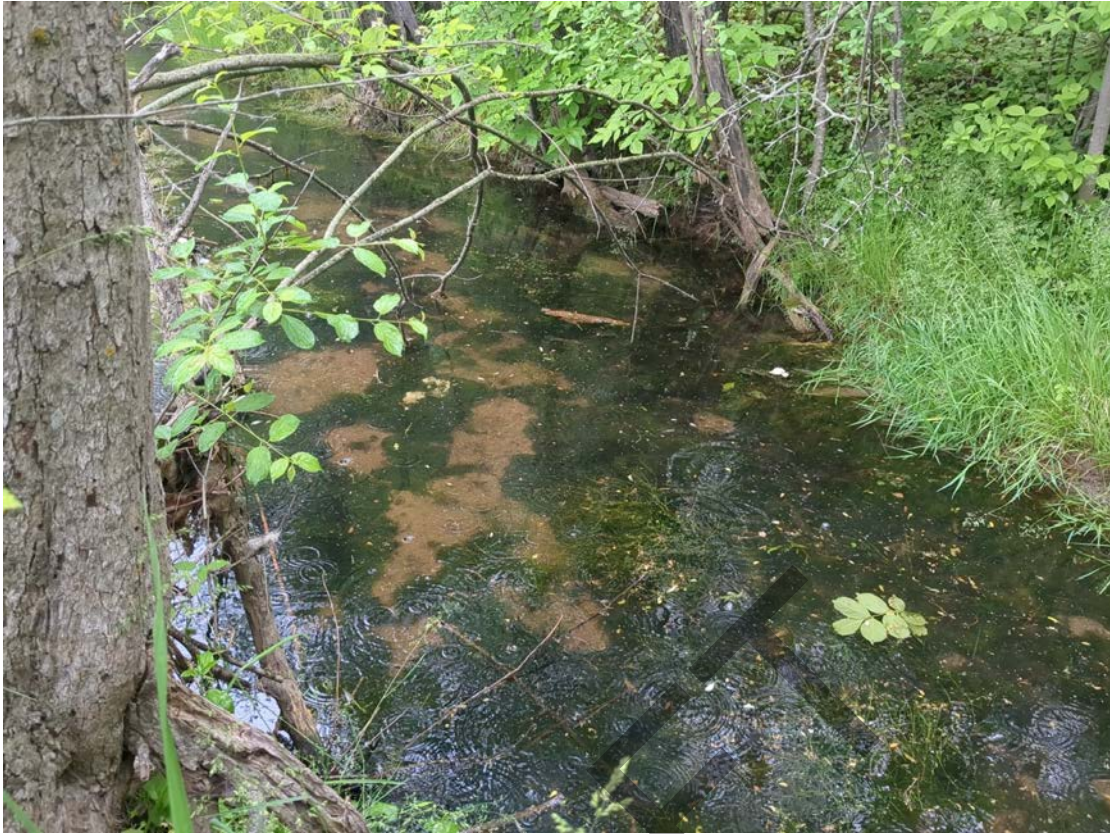
Photo 3: Example of channel conditions in Watercourse 5 further south of culvert and access laneway at 248 Fruitland Road. Photo facing northeast.

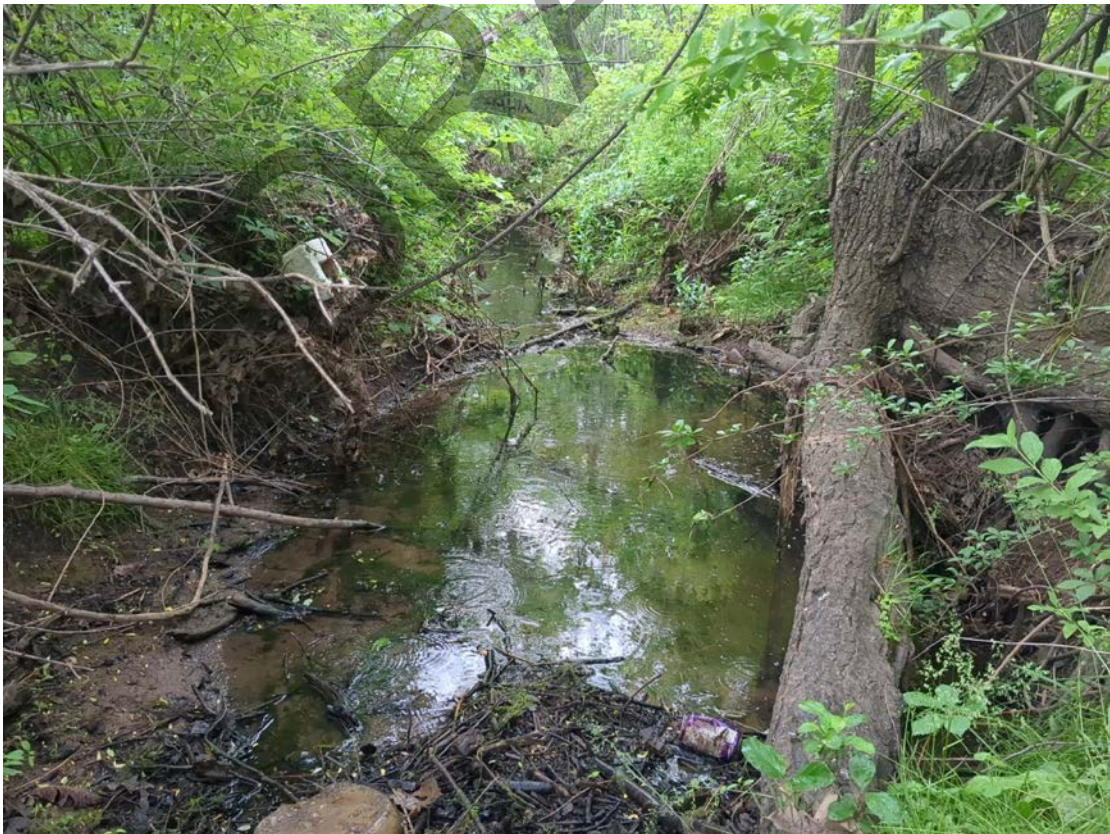
Photo 4: Example of channel and bank conditions in Watercourse 5. Photo facing north.

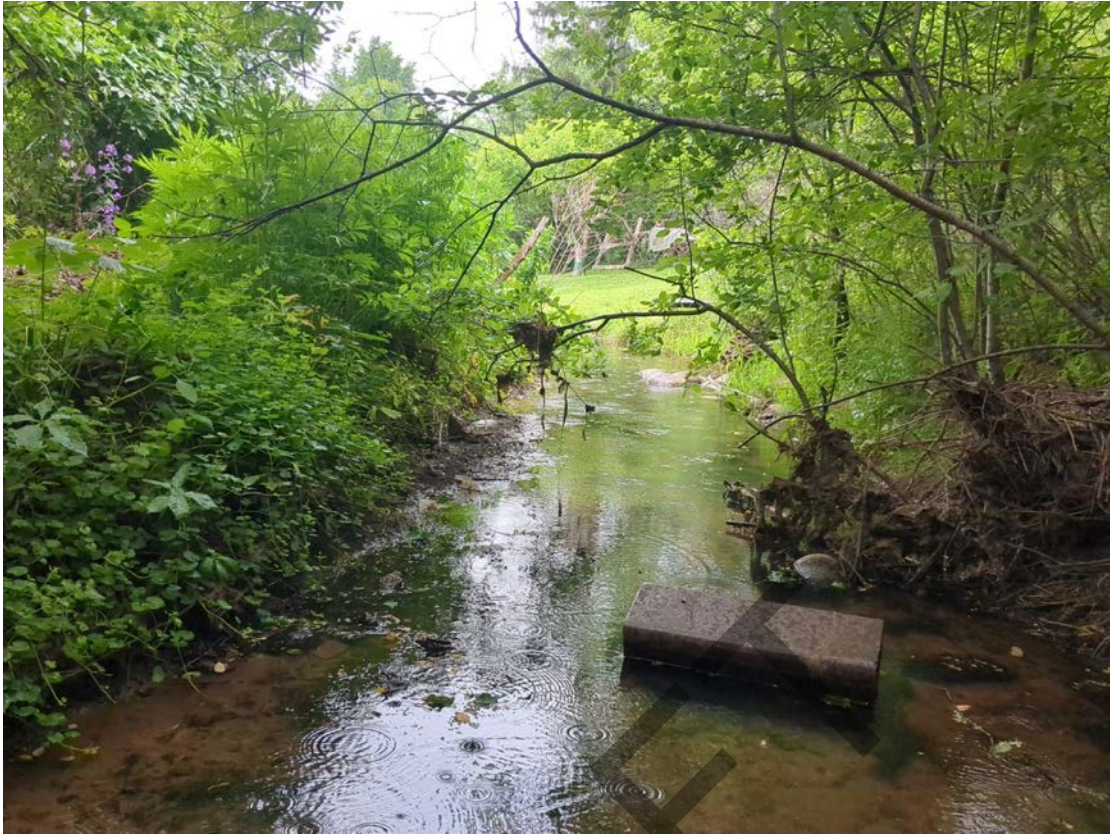
Photo 5: Example of channel conditions in Watercourse 5 before crossing 252 Fruitland Road property (visible in background). Photo facing northwest.

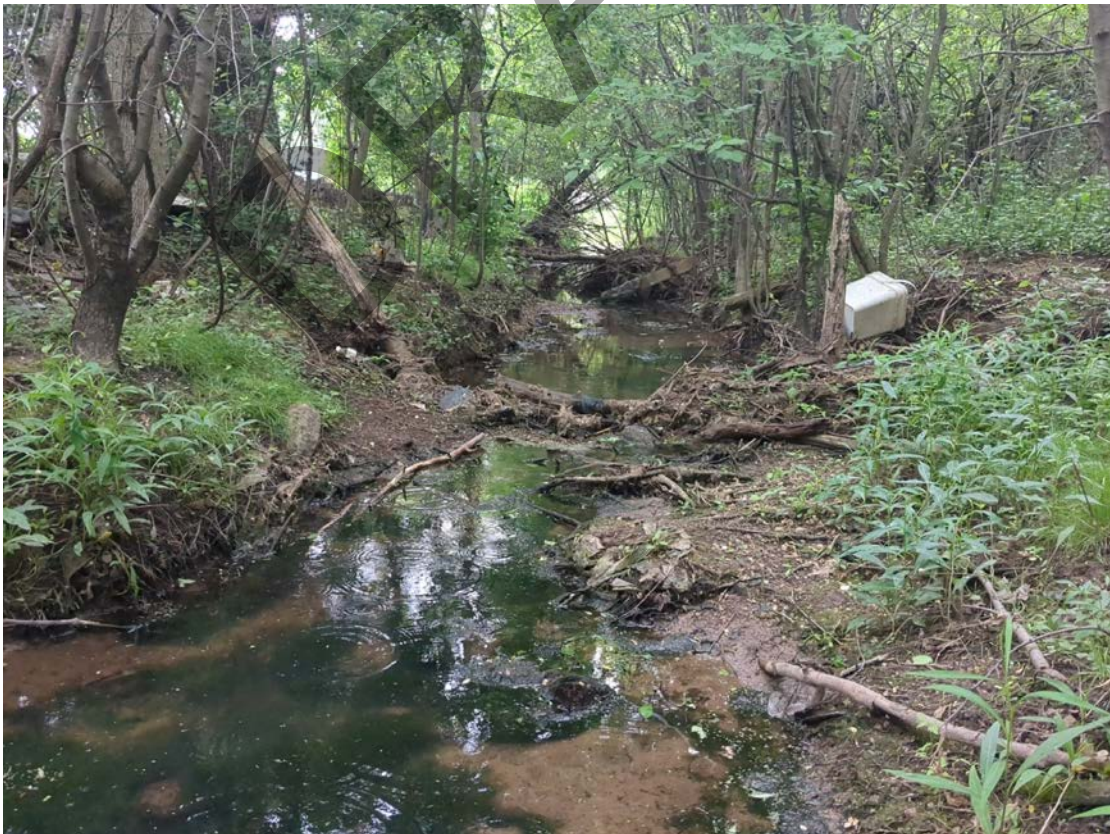
Photo 6: Example of channel conditions in Watercourse 5 within thicket east of 250 Fruitland Road. Photo facing northwest.

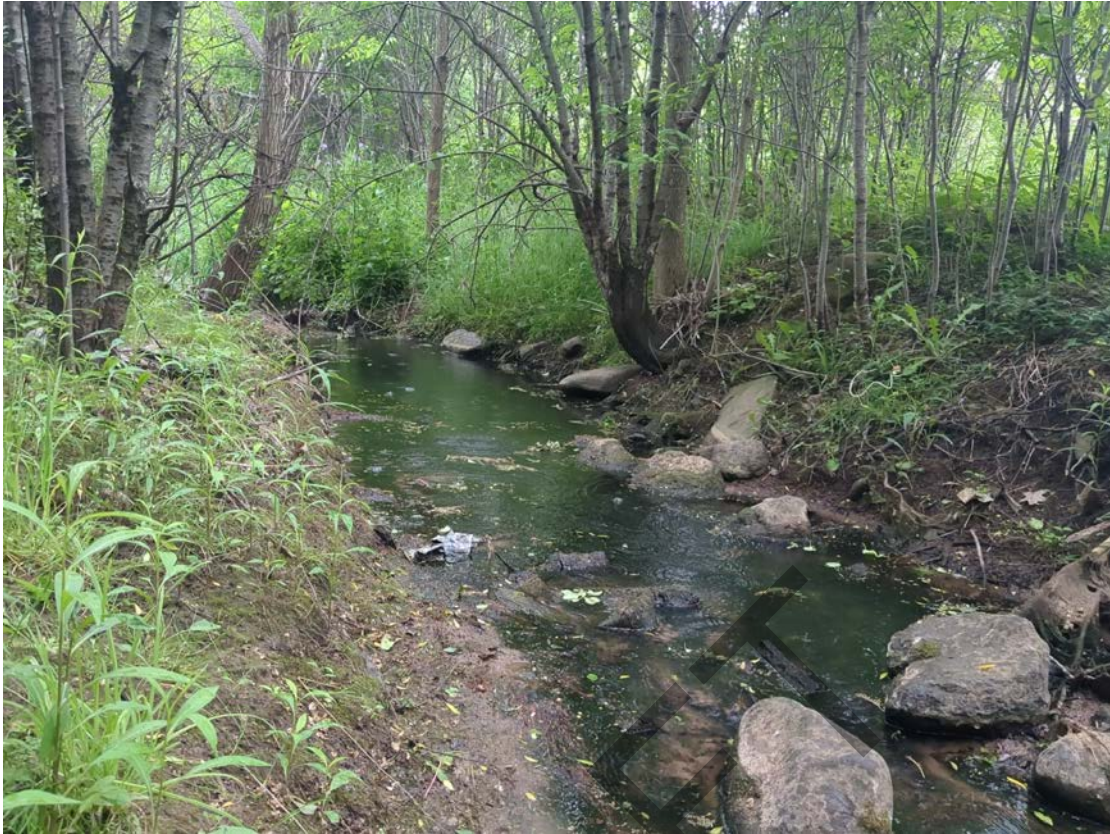
Photo 7: Example of channel conditions in Watercourse 5 within thicket east of 248 Fruitland Road. Photo facing south.

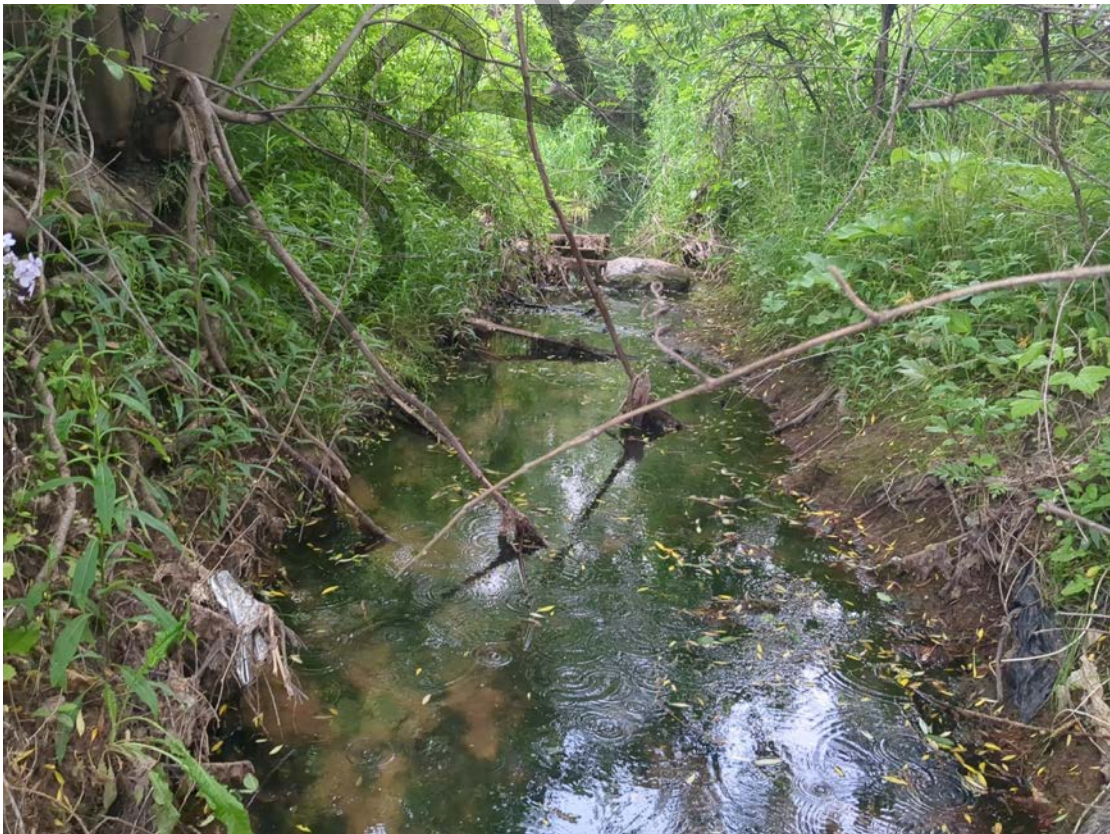
Photo 8: Example of channel conditions in Watercourse 5 east of 242 Fruitland Road. Photo facing south.

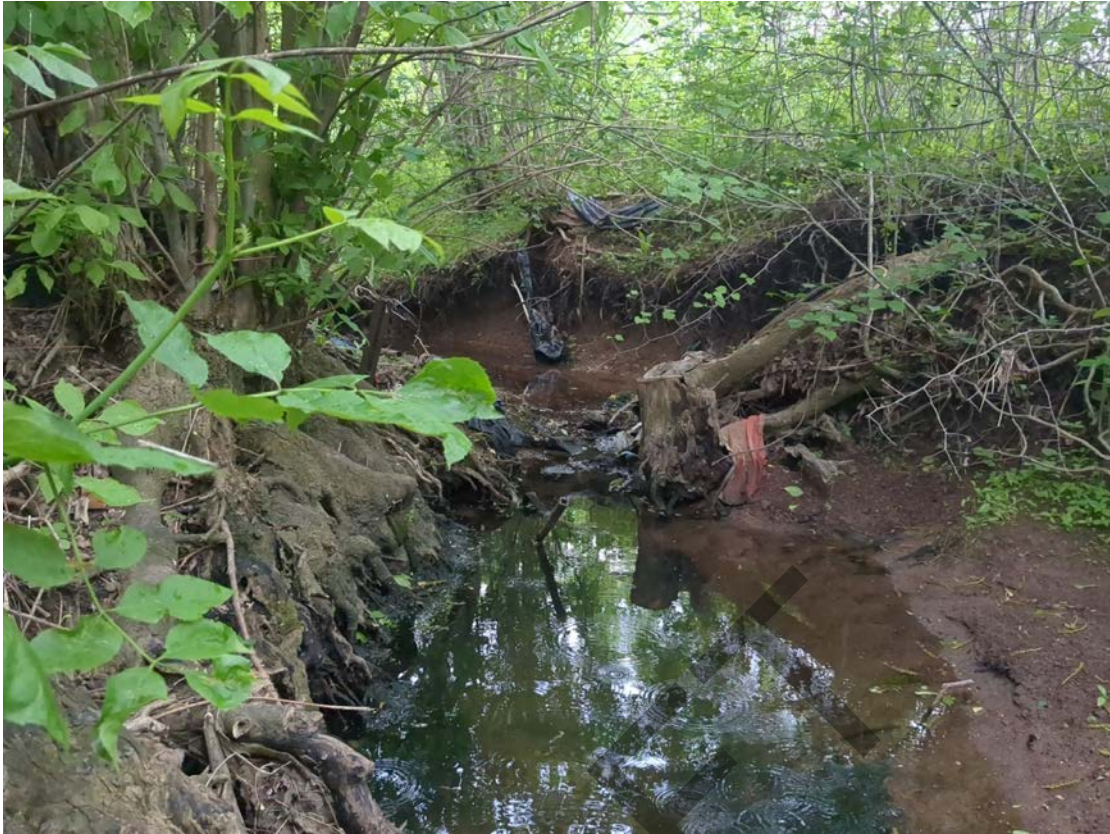
Photo 9: Example of channel conditions and debris in Watercourse 5 east of 230 Fruitland Road. Photo facing southwest.

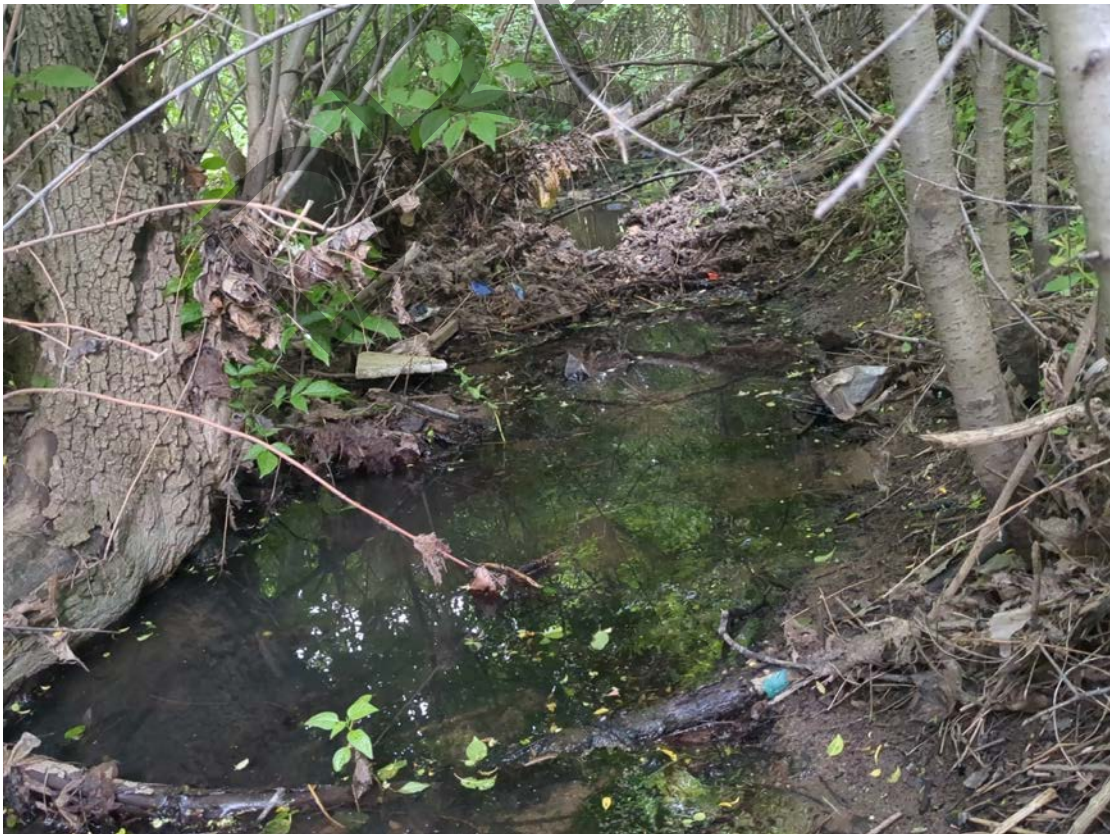
Photo 10: Example of channel conditions in Watercourse 5 east of 214 Fruitland Road. Photo facing north.

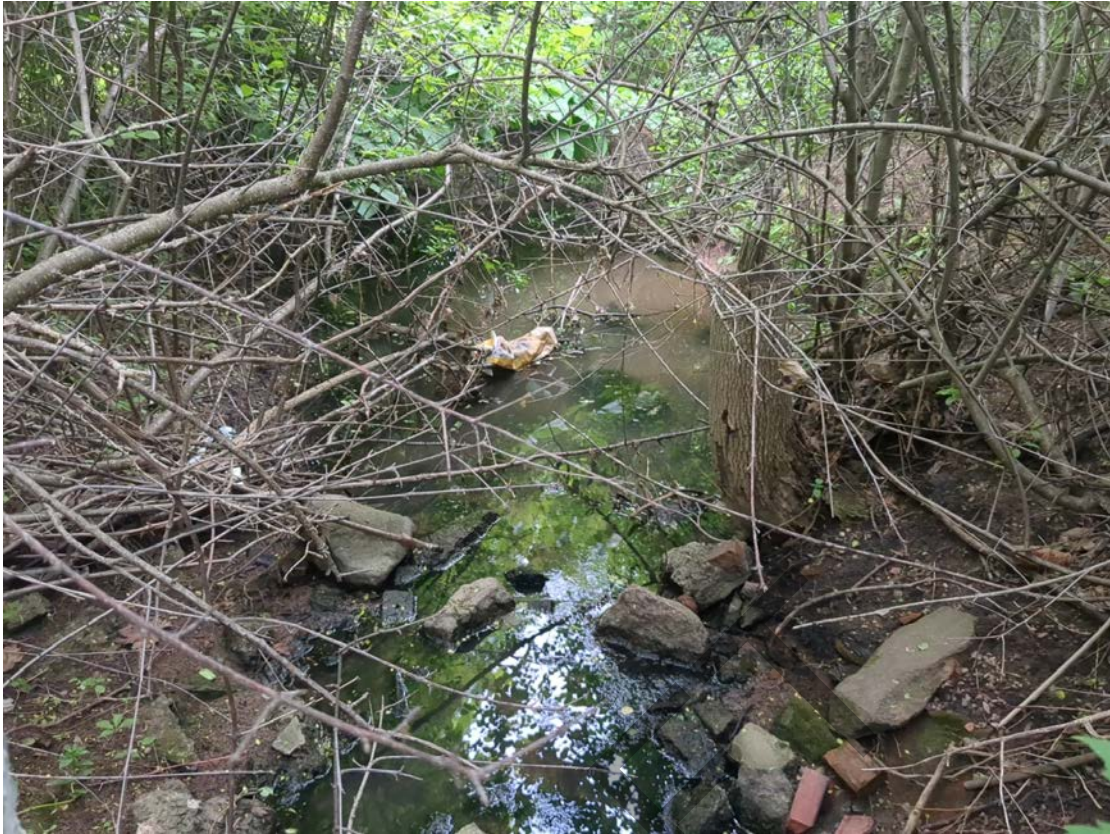
Photo 11: Channel conditions in Watercourse 5 immediately north of culvert and access laneway at 212 Fruitland Road. Photo facing north.

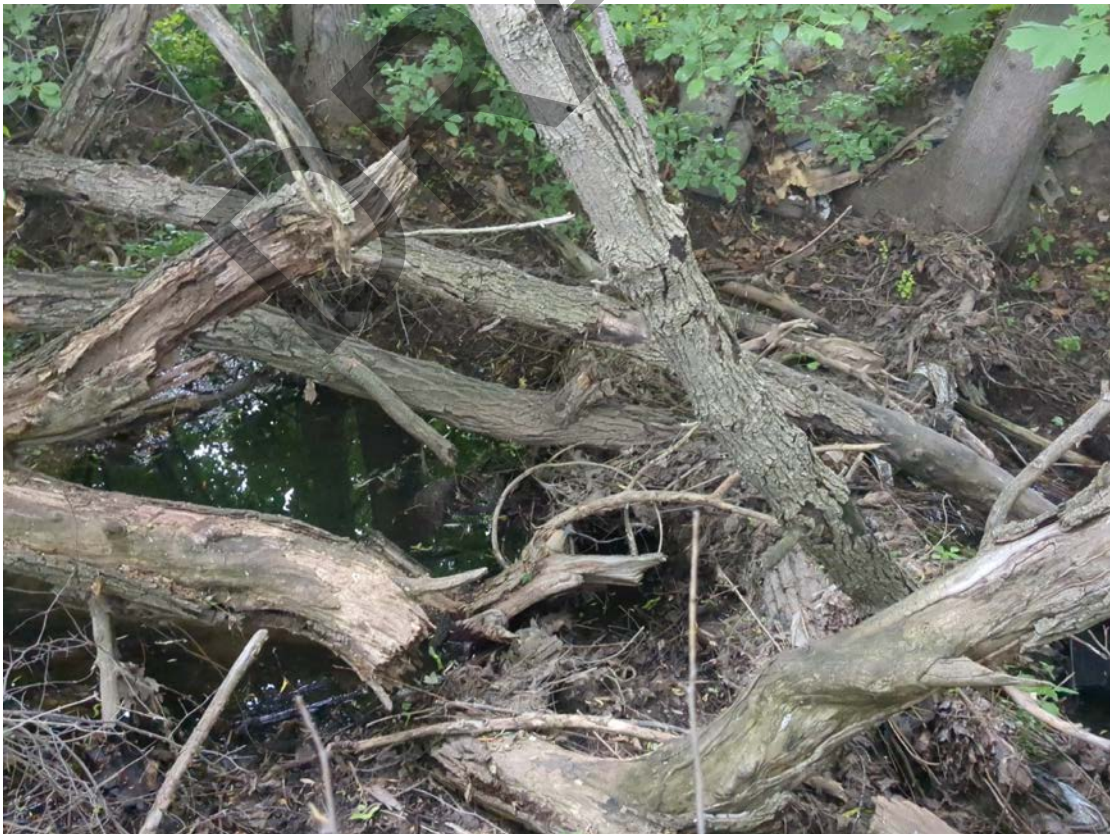
Photo 12: Example of channel conditions and woody debris in Watercourse 5 near the south end of the Study Area and east of 204 Fruitland Road. Photo facing west.
