PURPOSE OF THIS PUBLIC INFORMATION CENTRE

PURPOSE & SCOPE OF THE SAFARI ROAD CLASS EA STUDY

This Study will address flooding issues within the public right-of-way (ROW) along Safari Road and improve road conditions to ensure safety and accessibility.

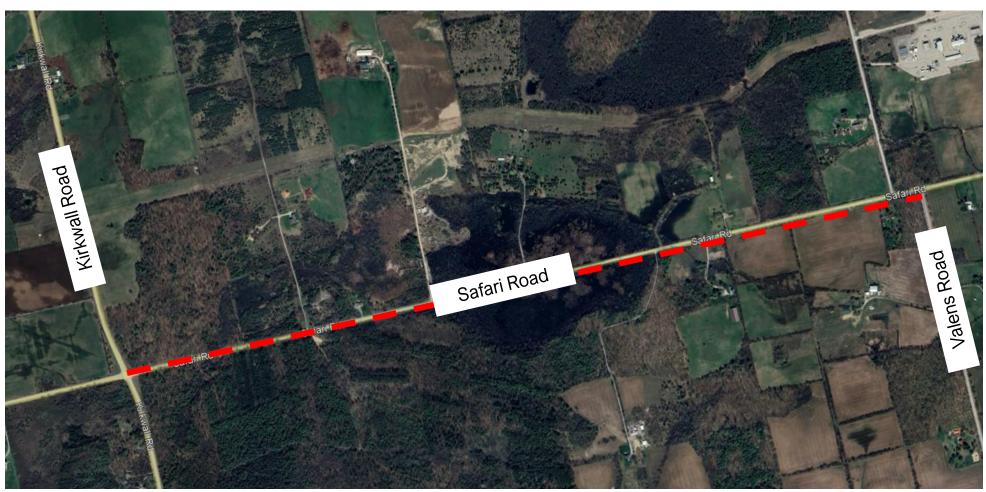
STUDY AREA

The Study includes the Safari Road right-of-way (ROW) from Kirkwall Road to Valens Road.

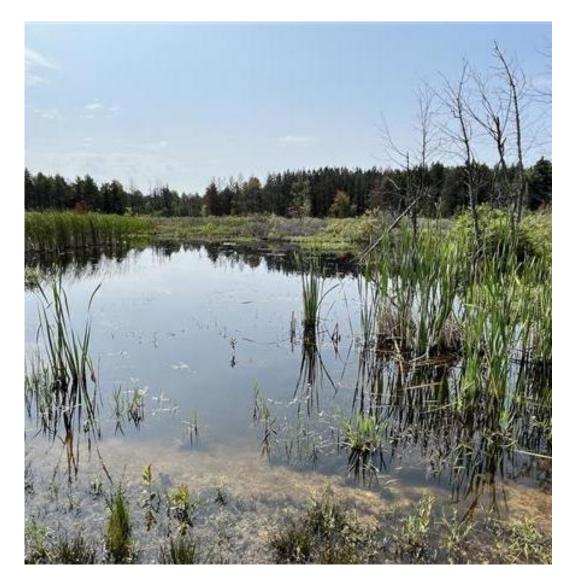
- Drainage and flooding along Safari Road
- > Residential access / driveway grades
- Heavy presence of aquatic wildlife and ecological features, including birds and Species at Risk
- Maintaining connectivity between the upper and lower ends of the watershed
- Other issues to be determined as we move forward in the Study

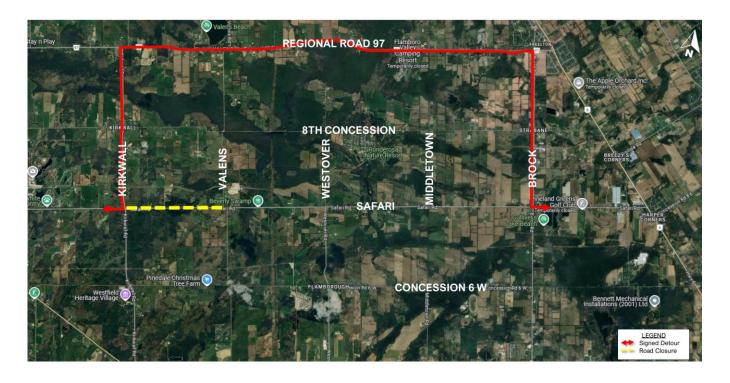
Truck Route & Detour

Other roadways within the vicinity of Safari Road are not suitable for truck traffic, thus the current signed detour truck route uses Brock Road, Regional Road 97, and Kirkwall Road.

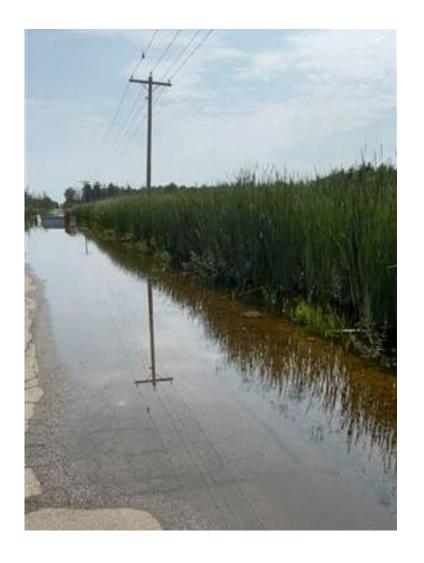
Drainage & Hydraulic Analysis

- The catchment is characterized as 222 Ha of rural area with a large wetland complex, 2 Safari Road crossing culverts at the west and east end of the project limits and an equalization culvert in the area of persistent flooding.
- Crossing culverts were analyzed according to the Provincial Drainage Design Standards (Rural Arterial).
 - Road to remain stable and safe under a 25-year storm event.
 - Modelling works assume the recommendations from the Municipal Drain Study are implemented.
- All culverts require upsizing and raising of the road profile up to 1m (approximately) to increase resiliency to flooding.

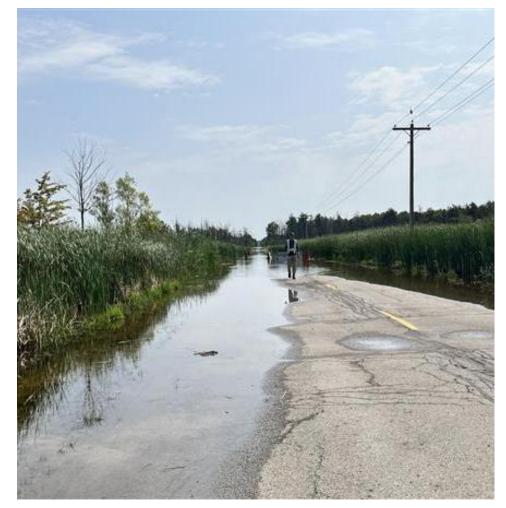
ALTERNATIVE 1: DO NOTHING

No improvements are made to Safari Road. This alternative is required to be evaluated as per the MCEA process as a baseline comparison.

- Road remains subject to frequent flooding and therefore, the risk to public safety is not addressed. Road structure deterioration continues. Truck route and active transportation requirements are not addressed.
- Safari Road will continue to be closed frequently due to flooding and subsequent repairs, impacting access for residents, emergency services, and postal services.
- Increased risk of terrestrial and aquatic wildlife being injured on flooded roads. No negative impacts to wetland or climate change.
- Lowest initial capital cost but increased operations and maintenance cost due to deteriorating road structure.

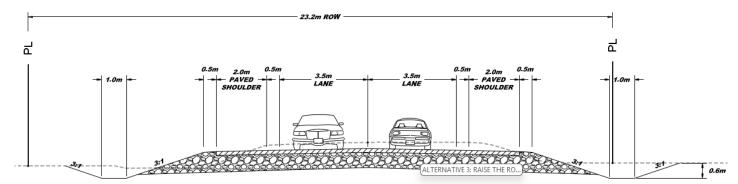
The road profile is raised to meet current applicable flood resiliency criteria (i.e. 25-year storm). Where required, a retaining wall is implemented at the right-of-way limits in the wetland area and flat bottom ditches outside of the wetland.

Within Wetland Area

Outside of Wetland Area

(HEIGHT VARIES)

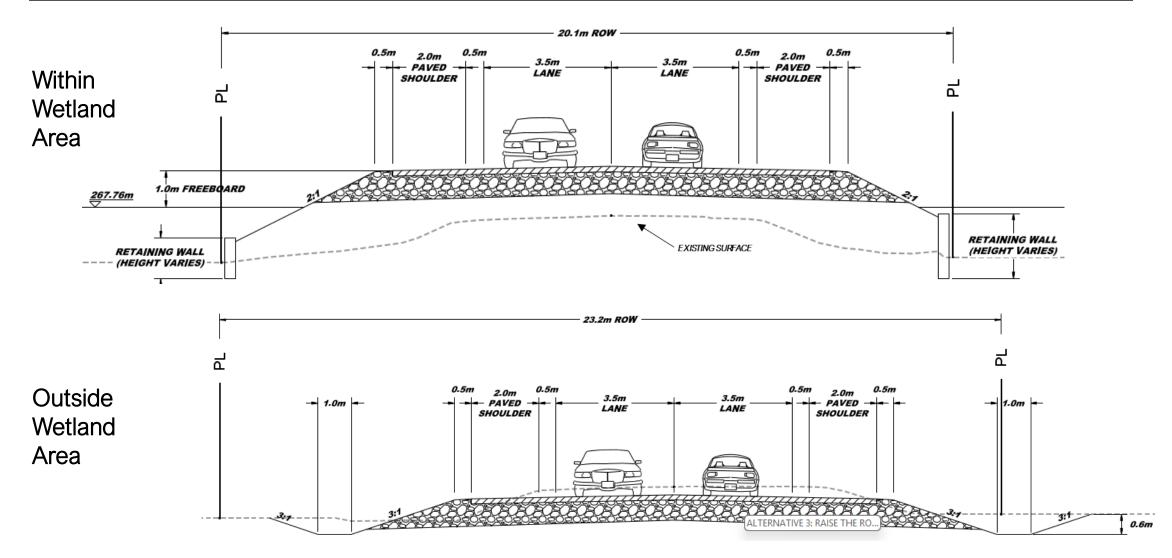
RECOMMENDED SOLUTION

The recommended solution is **Alternative 3 – Raise the Road.**
