Phase One Environmental Site Assessment

Garner Road (Wilson Street to Highway
403 Off-Ramp), Hamilton, Ontario

Contract C11-13-20, Municipal Class
Environmental Assessment Phase 3
and 4

Final Report
January 23, 2023

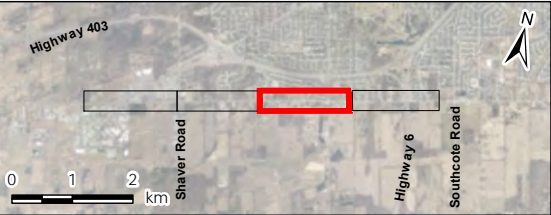
APEC	Location of APEC	PCA	Location of PCA	Contaminants of Potential Concern	Media Potentially Impacted
1	Entire Site	Imported Fill of Unknown Quality (PCA #30)	On-site	PHCs, VOCs including BTEX, PAHs, and metals	Soil
4	Southwest and within the intersection of Garner Road West and Fiddlers Green Road	Gasoline and Associated Products Storage in Fixed Tanks (PCA #28) – Historical Gasoline Service Station	Off-site 12 Garner Road West / 538 Fiddlers Green Road	PHCs, VOCs including BTEX, PAHs, and metals	Soil and groundwater
		Petroleum hydrocarbon spills	On-site Within intersection of Garner Road West and Fiddlers Green Road	PHCs, VOCs including BTEX	Soil and groundwater

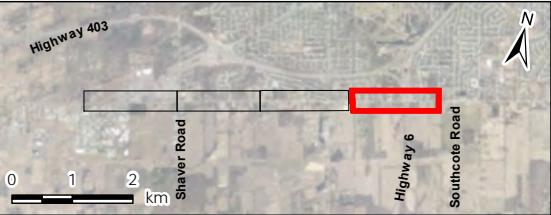
APEC	Location of APEC	PCA	Location of PCA	Contaminants of Potential Concern	Media Potentially Impacted
1	Entire Site	Imported Fill of Unknown Quality (PCA #30)	On-site	PHCs, VOCs including BTEX, PAHs, and metals	Soil
5	North side of Phase One Property south of Gabel Court	Pesticides (PCA #40) – Former Orchard	Off-site, Gabel Court and including land approximately 50 m west of Gabel Court	OC Pesticides	Soil and groundwater
6	Eastern portion of the Phase One Property	Pesticides (PCA #40) – Former Orchard	Off-site, Highway 6 north of Phase One Property (including the area between the offramps and the land approximately 40 m east of the onramp)	OC Pesticides	Soil and groundwater

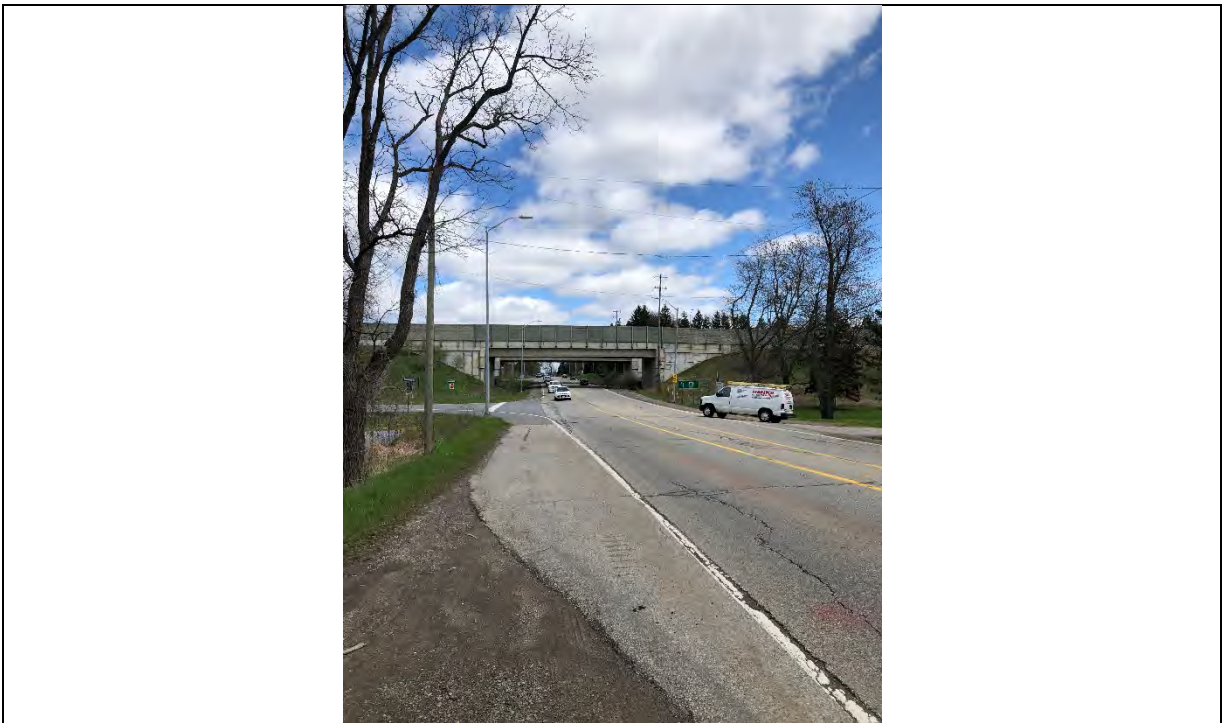
Photo 1: View of eastern portion of the Phase One Property, adjacent to Highway 403 off-ramp, facing southeast. The Phase One Property primarily consisted of asphalt or concrete paved areas.

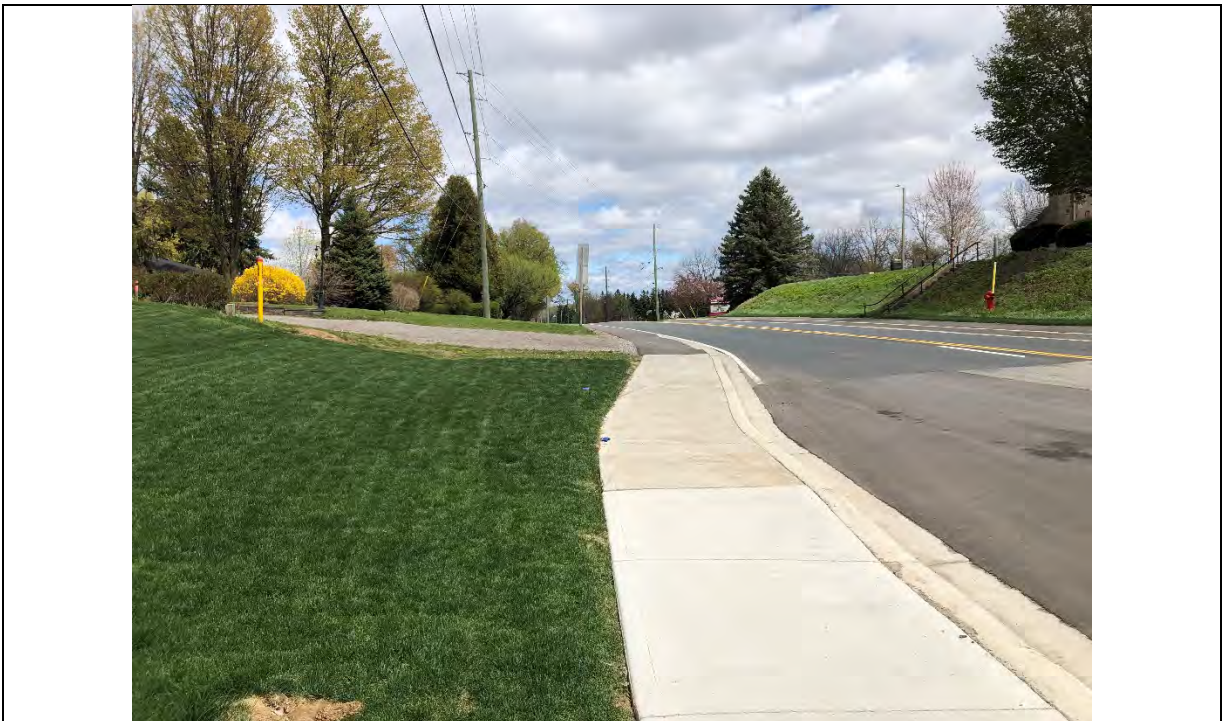
Photo 2: Portions of the Phase One Property consisted of paved sidewalks, view facing east

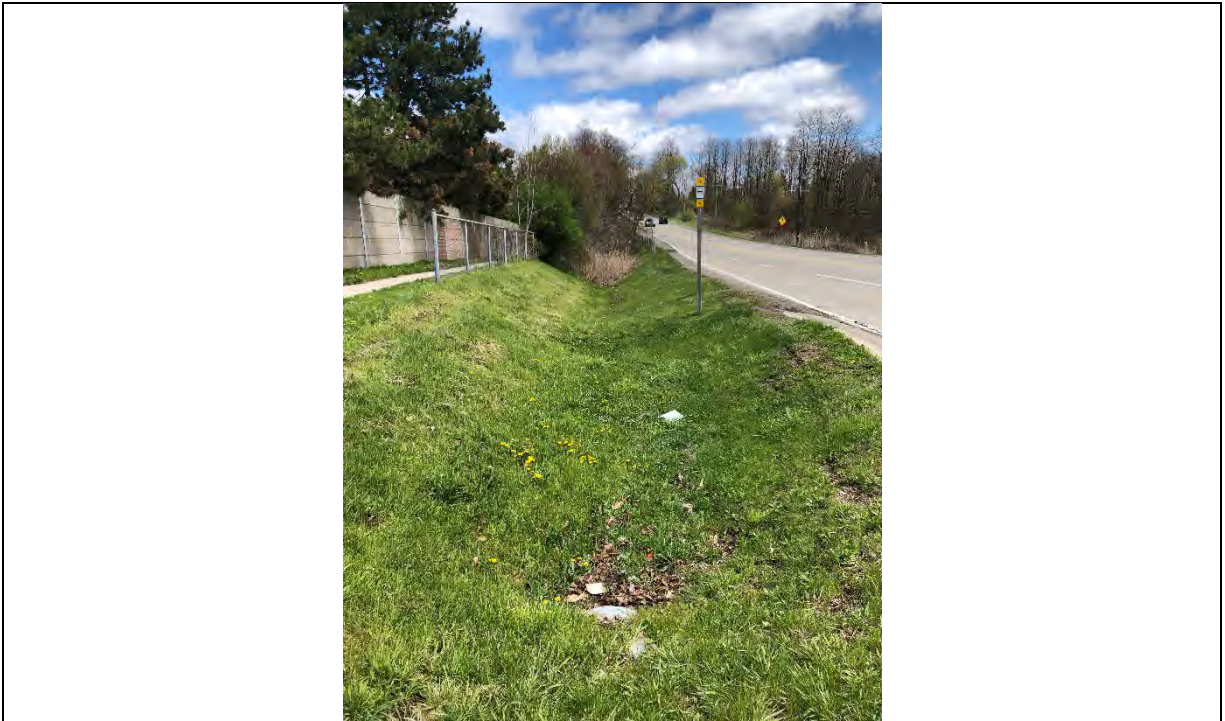
Photo 3: View of ditch observed on the north side of Garner Road, near residential developments. Phase One Property was generally flat but there were areas with observed elevation changes.

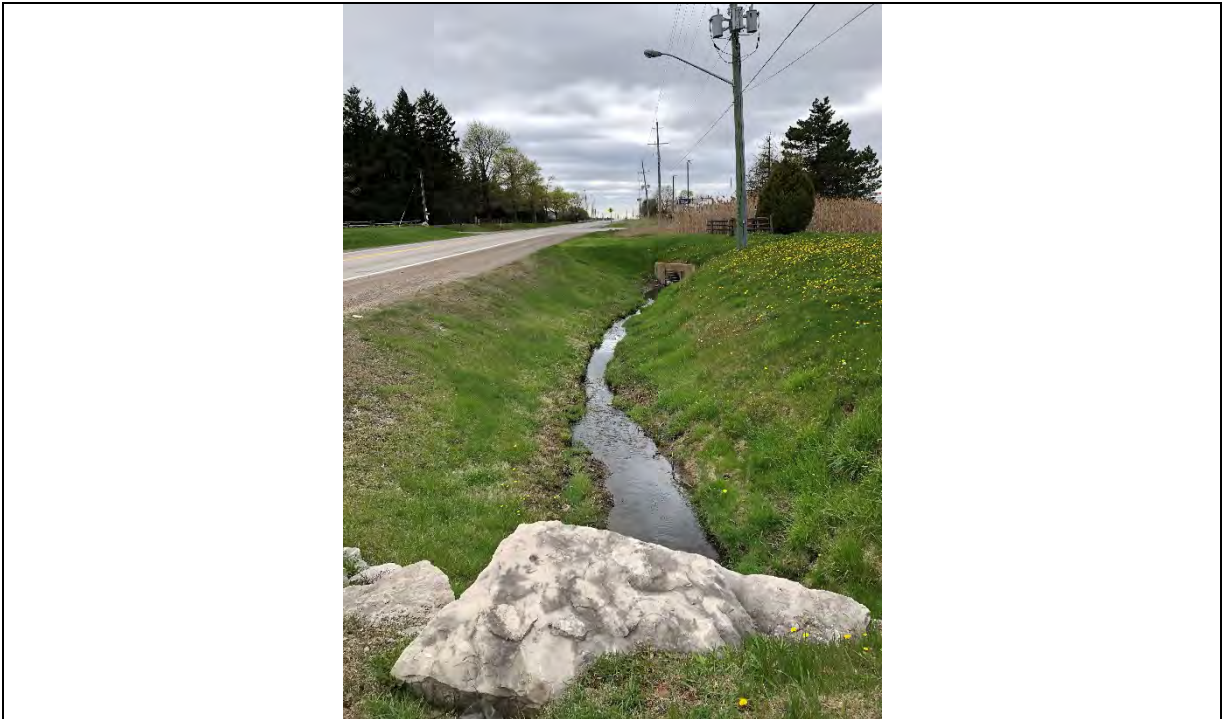
Photo 4: View of one of many culverts observed on the north and south sides of the Phase One Property.

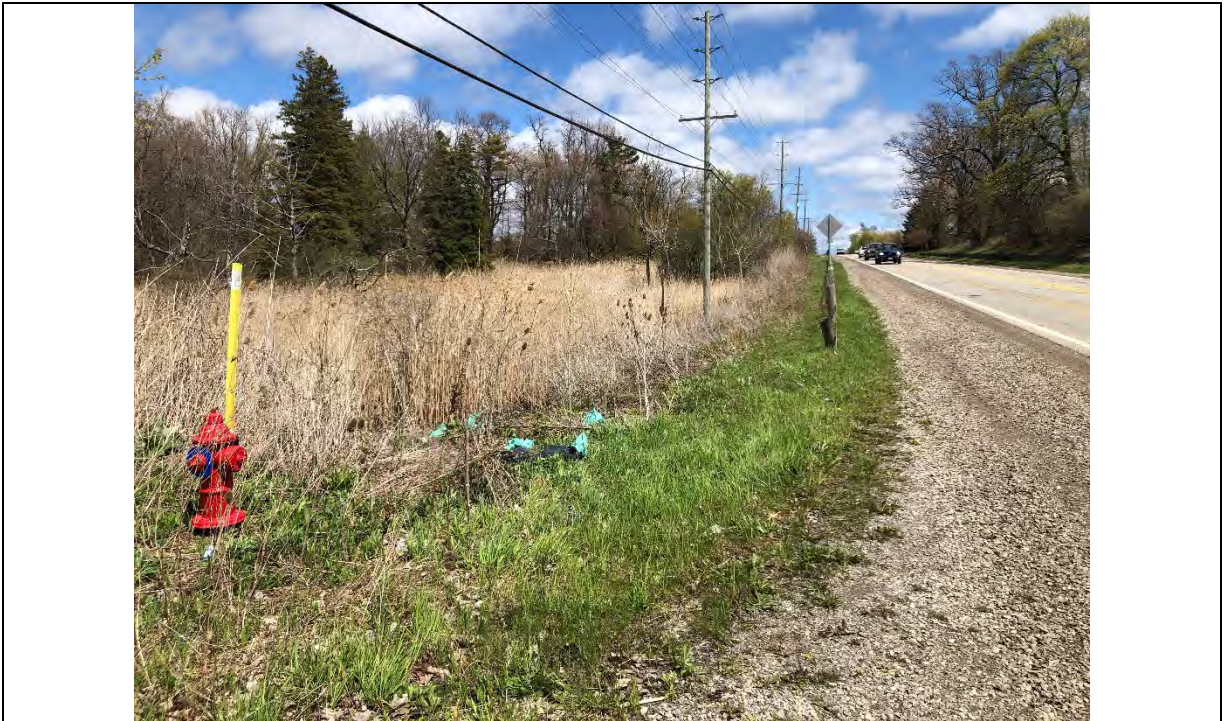
Photo 5: Portions of the Phase One Property covered in gravel and adjacent to unnamed wetlands. View taken from the south side of Phase One Property, facing west.

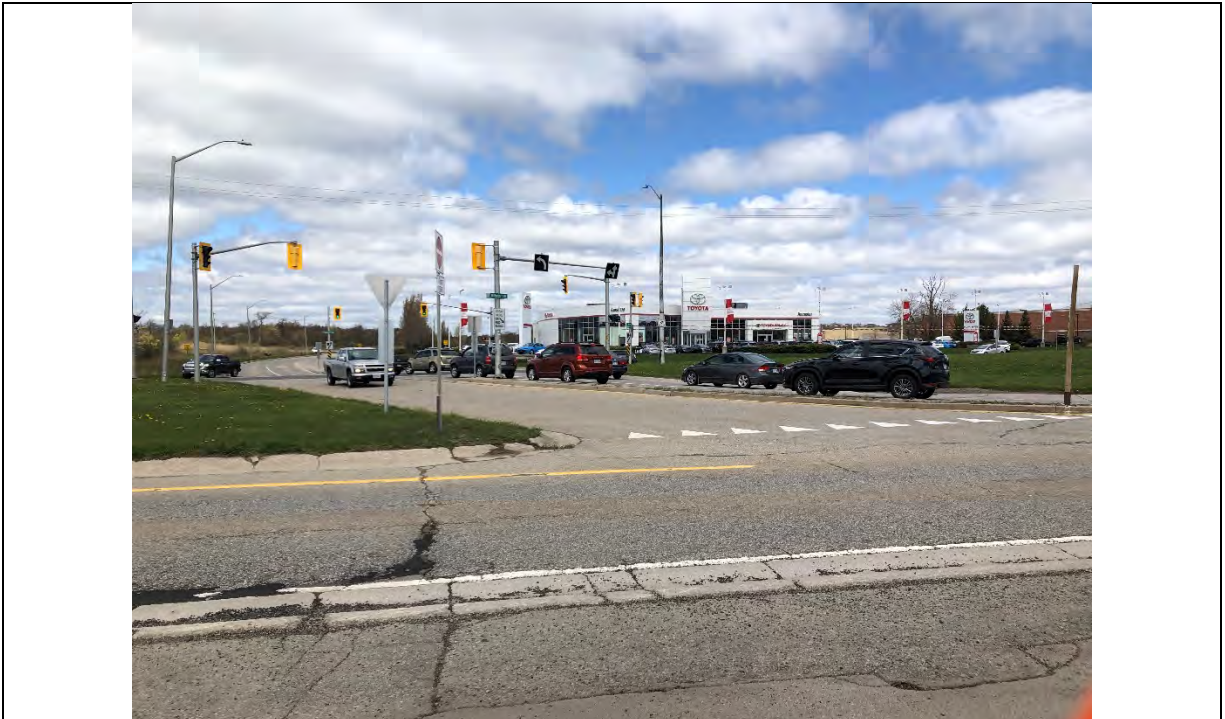
Photo 6: View of the western portion of the Phase One Property, from the south side of the intersection at Wilson Street and Garner Road East, facing north

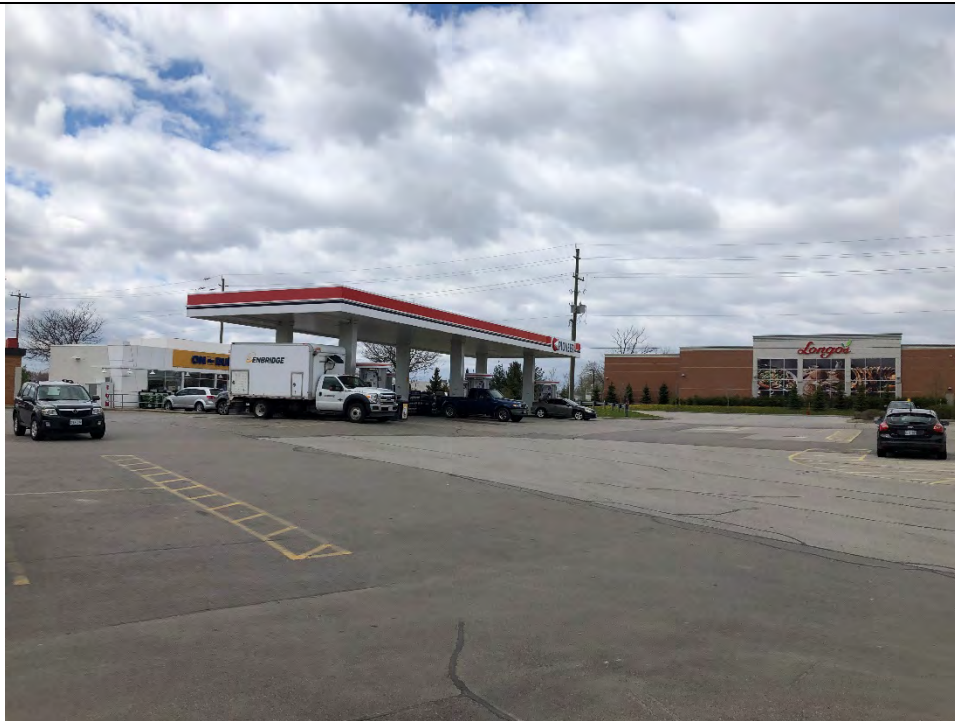
Photo 7: Gasoline service station at 1180 Wilson Street, east of the intersection at Wilson Street and Garner Road

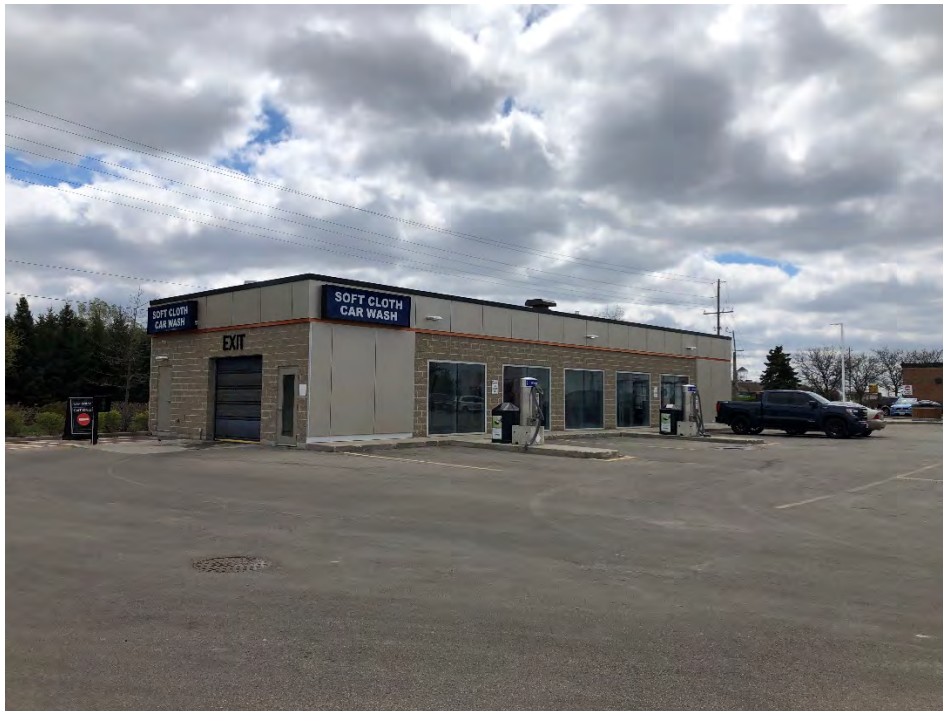
Photo 8: Car wash facility associated with the gasoline service station at 1180 Wilson Street West

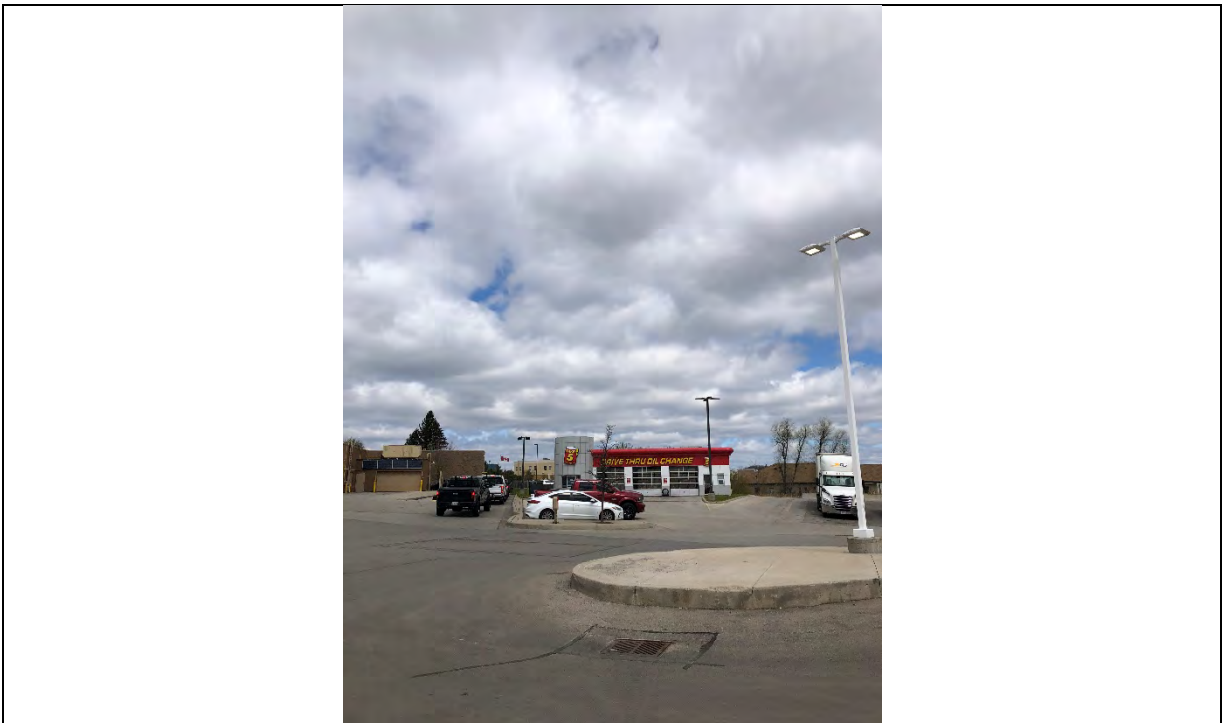
Photo 9: Take Five Oil Changers located at 1184 Wilson Street West, east of the intersection of Wilson Street and Garner Road

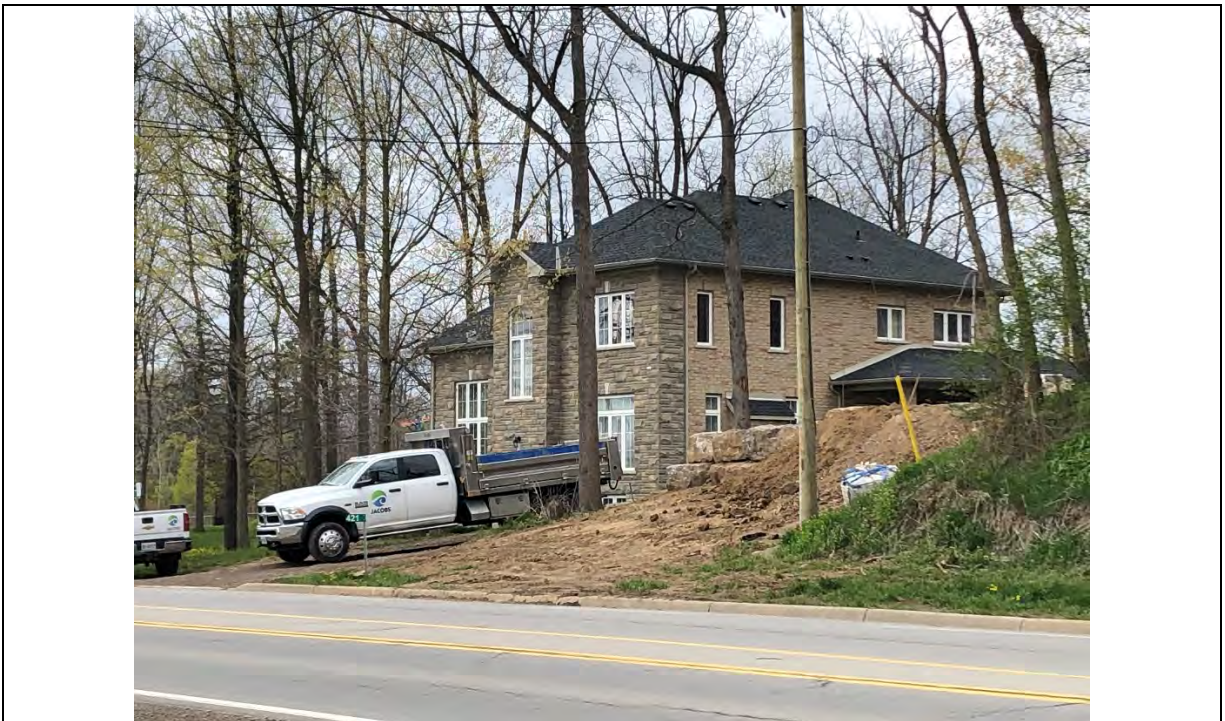
Photo 10: Importation of unknown fill associated with various residential developments observed on the north side of Phase One Study Area

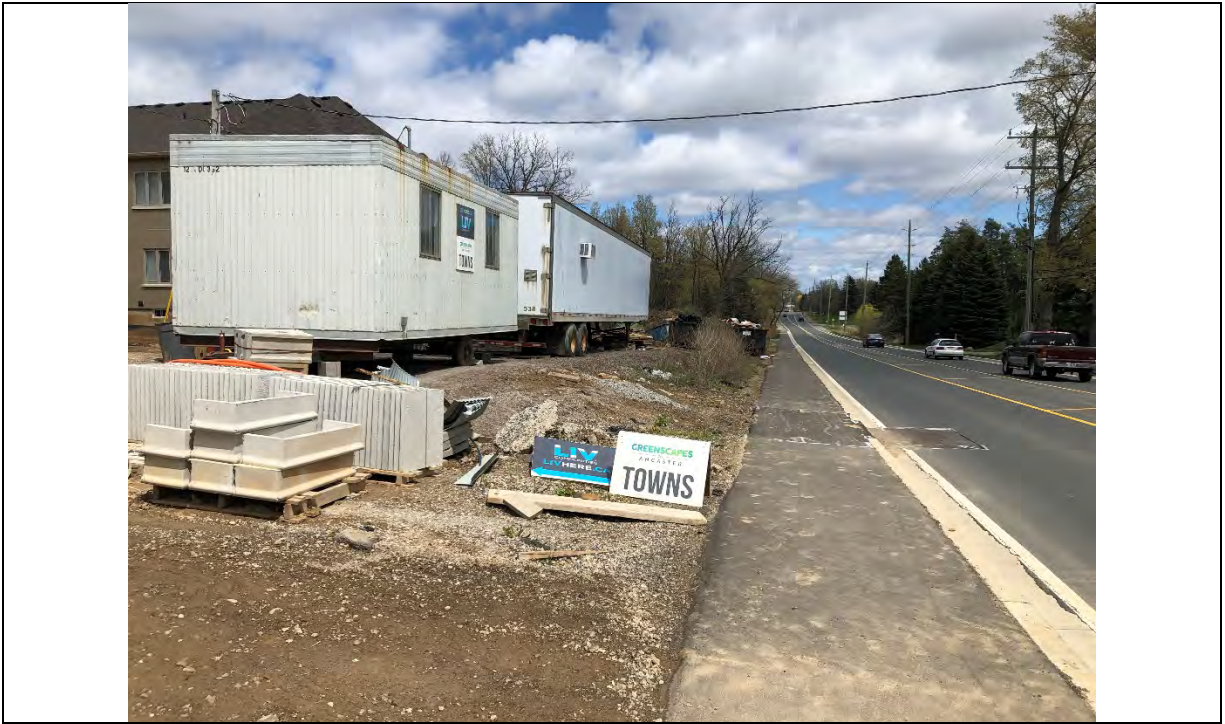
Photo 11: Importation of unknown fill associated with various residential developments observed on the north side of Phase One Study Area

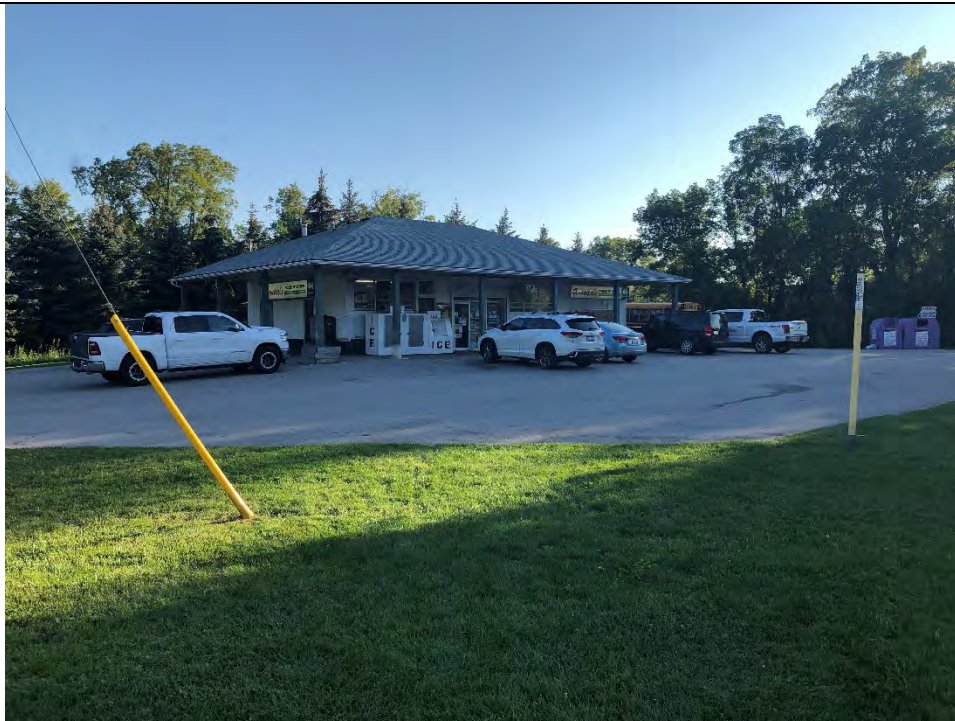
Photo 13: Former gasoline service station at 538 Fiddlers Green Road, which is inferred to be located at 12 Garner Road West

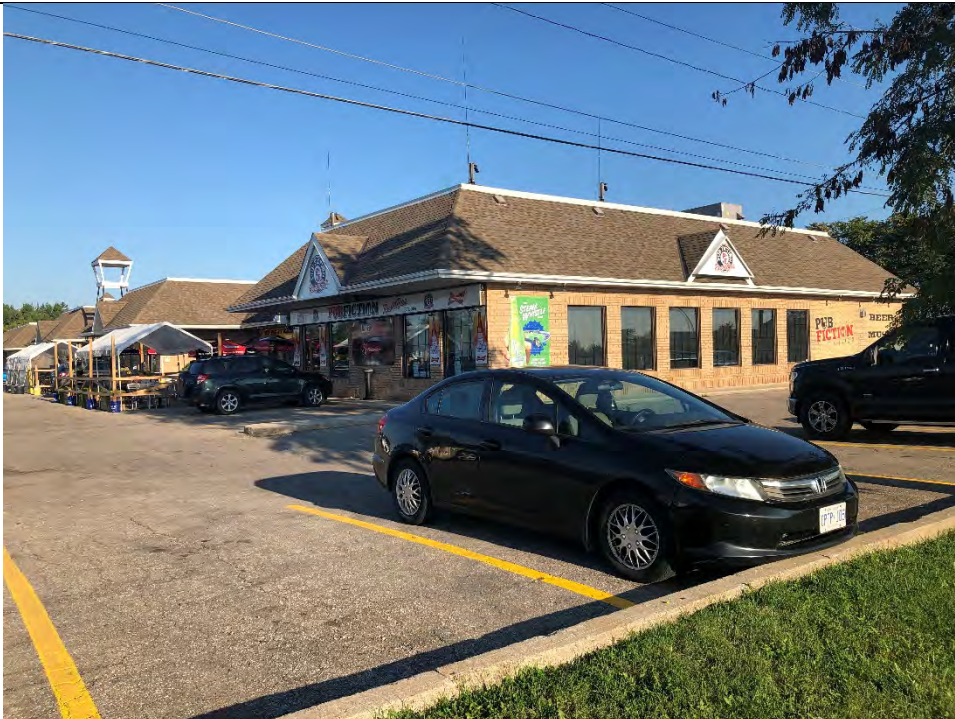
Photo 4: Former gasoline service station listed at 1254 Highway 53 that may have been decommissioned for the construction of the commercial plaza in 2005
