Elfrida Community Builders Group Inc.

Elfrida Subwatershed Plan

April 2026 / Project Number 160623199

Prepared by:
 Stantec Consulting Ltd.
 GeoProcess Research Associates
 Landtek Limited
 SLR Consulting

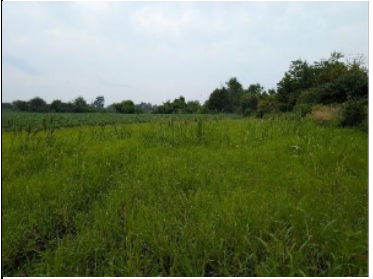
| Wetland, Size, and Watershed | Description | Recommendation | Photo |
|--|---|---|---|
| MAM2 0.42 ha Parcel 3 Twenty Mile Creek | A portion of this wetland was previously farmed and tilled (rutting present). It contains several wetland species including barnyard grass (<i>Echinochloa sp.</i>), pale smartweed (<i>Persicaria lapathifolia</i>), yellow nutsedge (<i>Cyperus esculentus</i>), and fringed willowherb (<i>Epilobium ciliatum</i>). One small upland pocket is included in it that contains Queen Anne's lace (<i>Daucus carota</i>), wild grape (<i>Vitis riparia</i>), cow vetch (<i>Vicia cracca</i>), ragweed (<i>Ambrosia sp.</i>), and common milkweed (<i>Asclepias syriaca</i>). There is also a transition area where wetland and upland vegetation is mixed. | Candidate for future OWES evaluation. | |

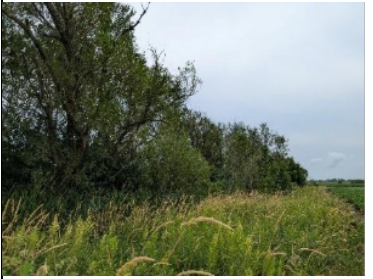
| Wetland, Size, and Watershed | Description | Recommendation | Photo |
|--|---|---|---|
| SWD4-1 0.60 ha Parcel 45 Stoney Creek | Wetland vegetation, including cattails (<i>Typha sp.</i>), reed canary grass (<i>Phalaris arundinacea</i>), and purple loosestrife (<i>Lythrum salicaria</i>), follows the watercourse and is riparian. The vegetated area is wider and includes upland species at edges, like common milkweed (<i>Asclepias syriaca</i>), bur oak (<i>Quercus macrocarpa</i>), and Queen Anne's lace (<i>Daucus carota</i>). Scattered willow trees (<i>Salix spp.</i>) are present along the riparian edge. | Candidate for future OWES evaluation. | |

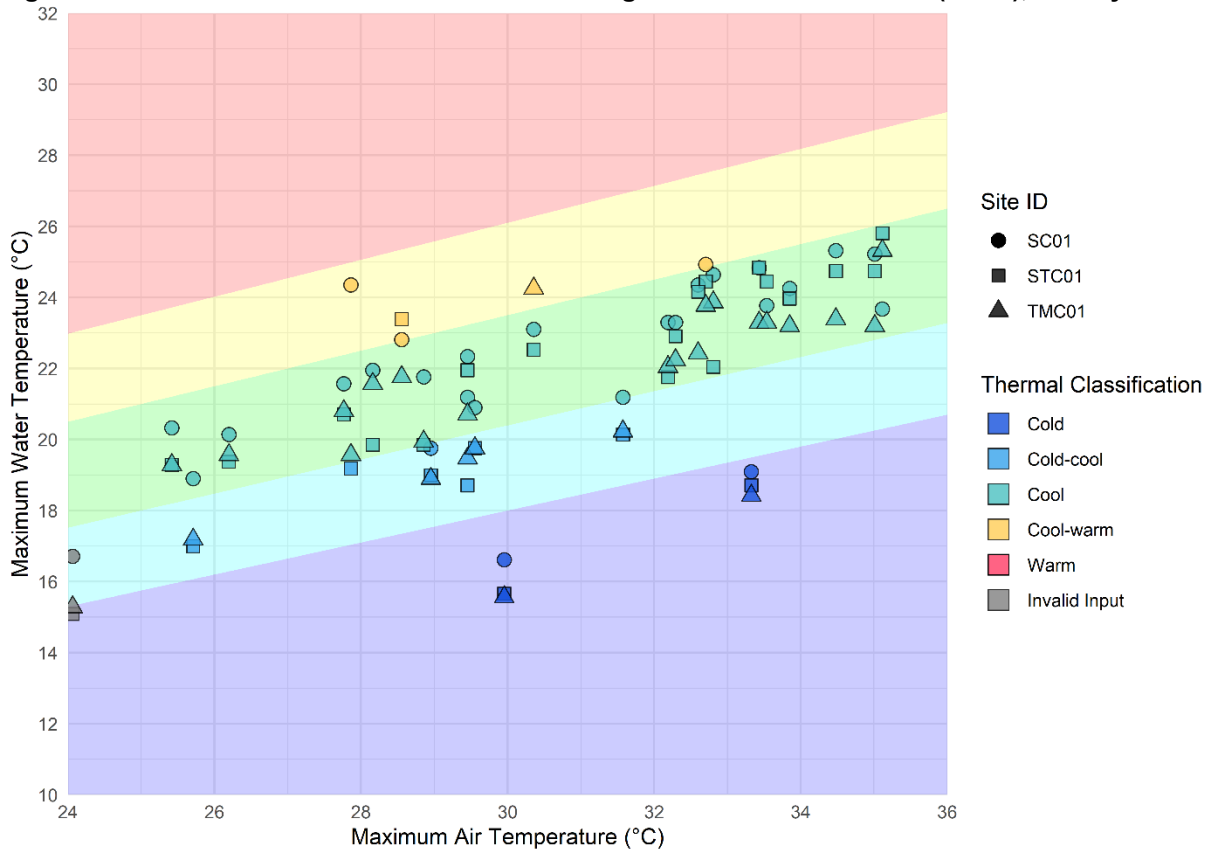
Figure 3.3.1 Stream Thermal Classification Nomogram for Sinkhole Creek (SC01), Stoney Creek

preliminary results of monitoring as presented within the nomogram in Figure 3.3.1 and secondary source information.

(ST01) and Twenty Mile Creek (TMC01) based on the methodology of Chu et al. (2009)
