**Fluvial
Geomorphology**

APPENDIX D1

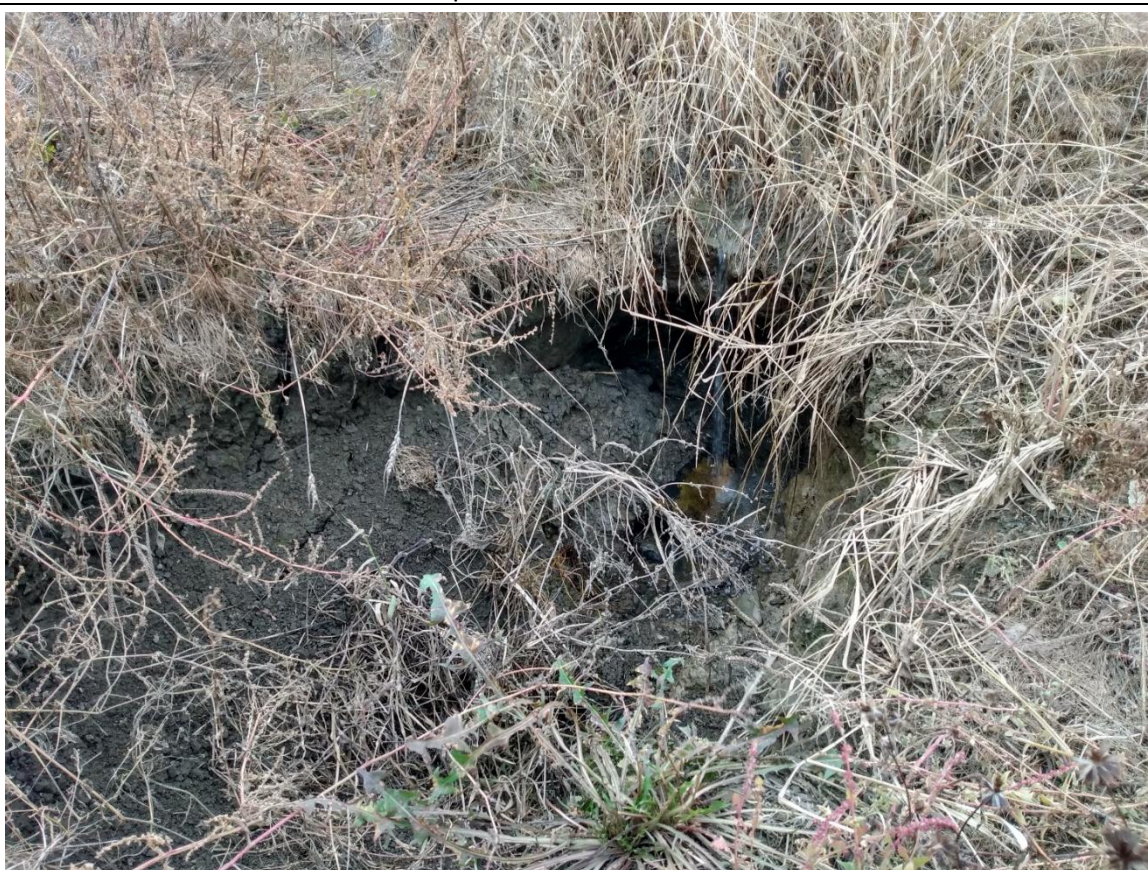
Headcut formed where surfaced water flows down into broken tile drain. Downstream of this headcut, baseflow is conveyed subsurface through the tile drain.

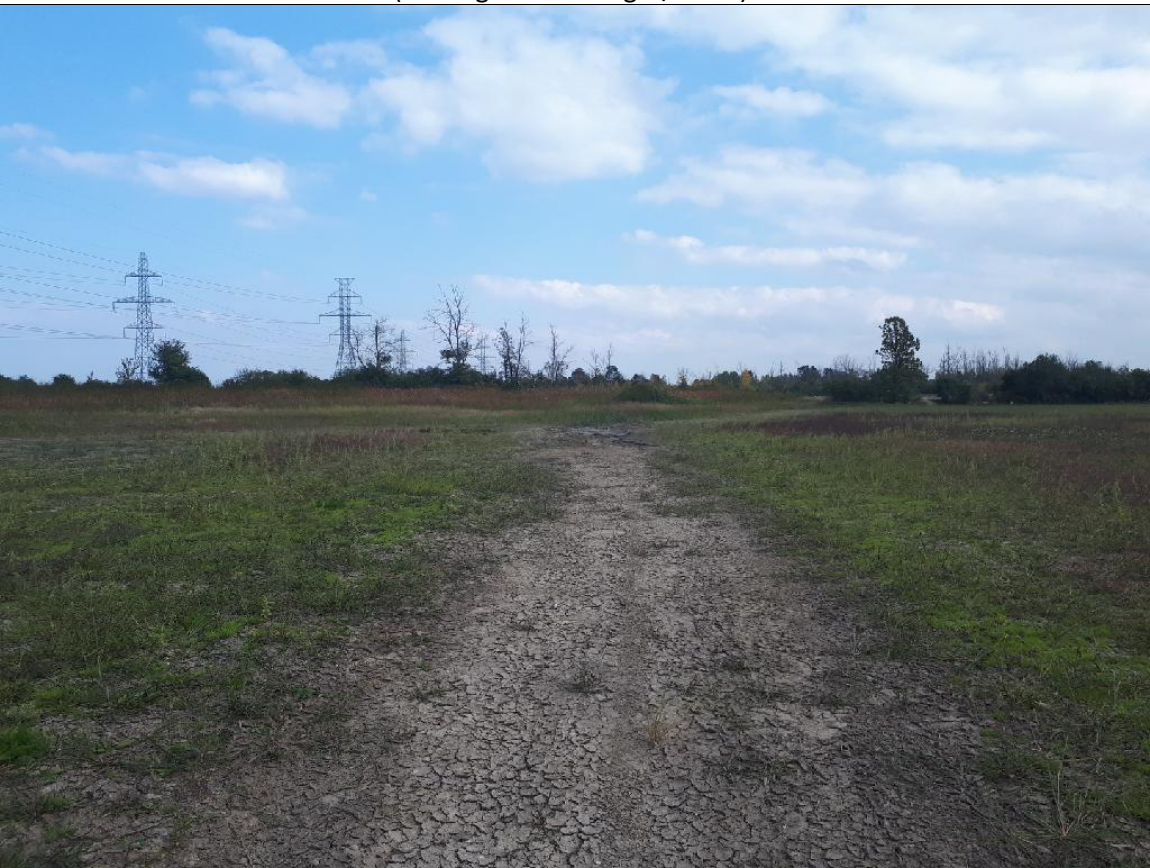
<p>Facing downstream along Reach 1-SIC4 during dry conditions, towards the confluence with HDF 1-SIC3-1a.</p>
<p>Photo 40</p> <p>Reach 1-SIC4</p> <p>May 9, 2025</p>

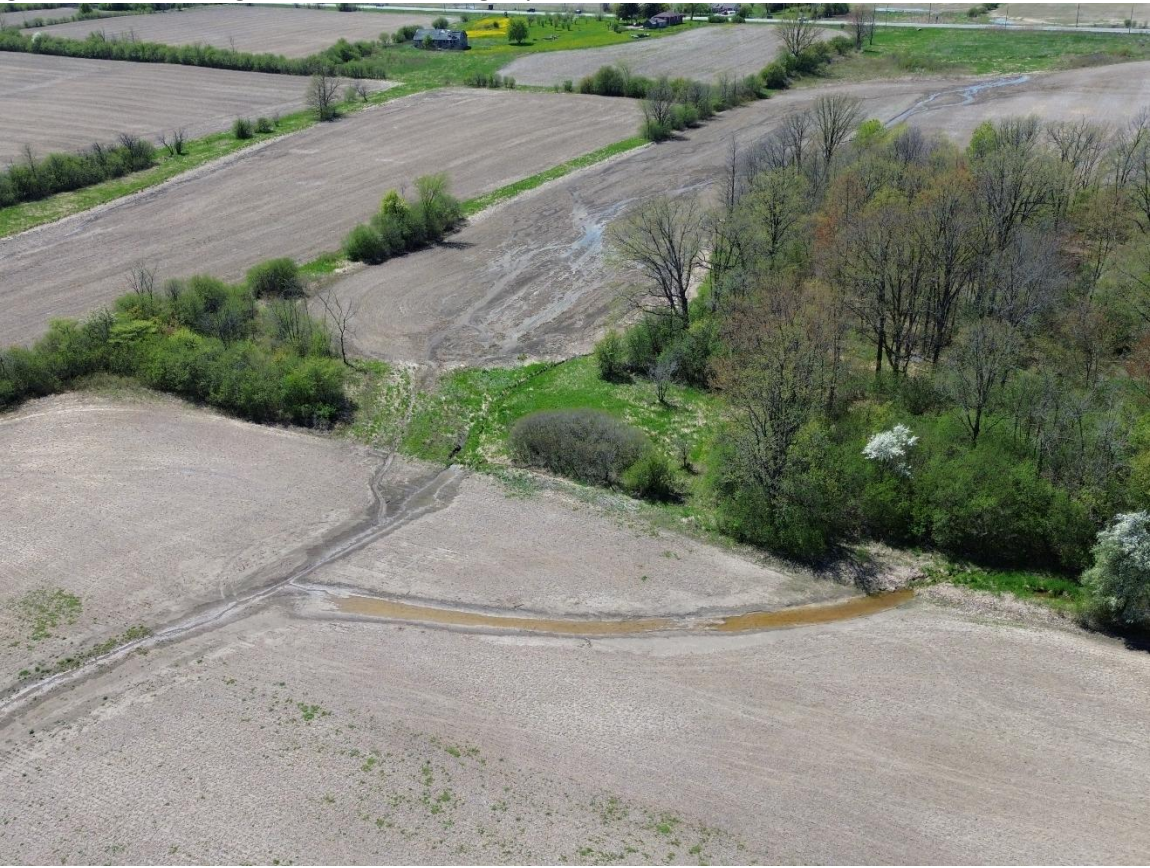
<p>Facing southwest at the upstream end of Reach 1-SIC4 (left) and the confluence between HDFs 1-SIC5 (flowing from the woodlot) and 1-SIC4-1a (upper centre).</p>

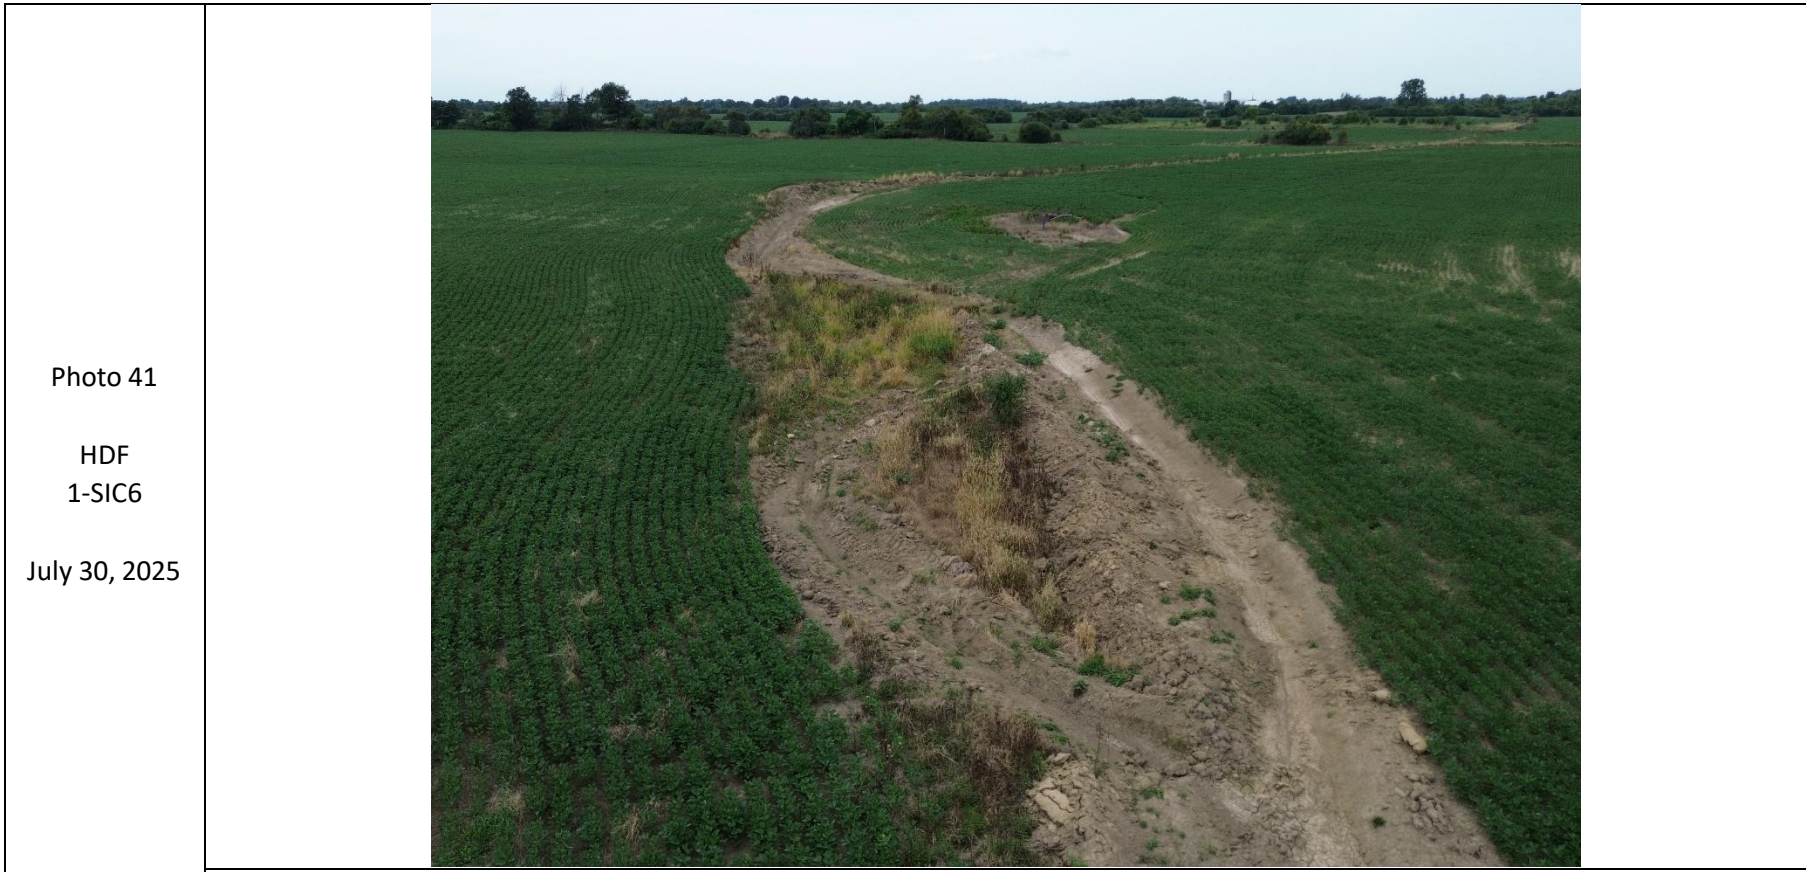
Facing upstream along HDF 1-SIC6 during dry conditions. Unconsolidated sediments with uprooted grassy vegetation piled along the feature edge provide evidence of recent modifications.

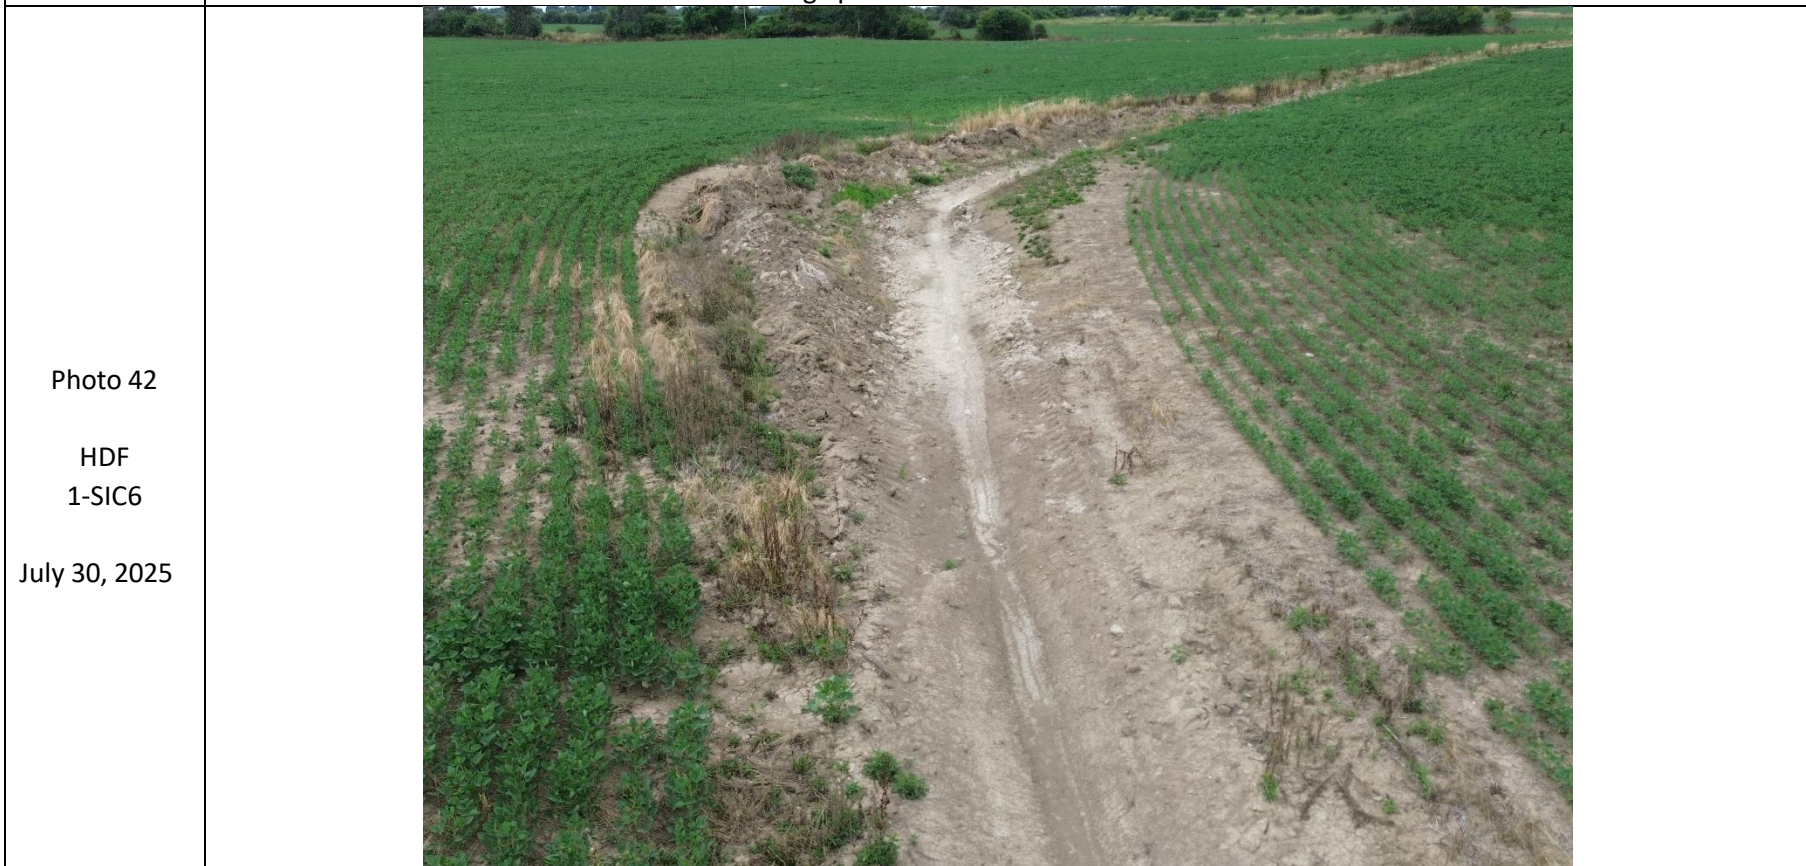
Facing upstream along HDF 1-SIC6 during dry conditions. Additional piled unconsolidated sediments and tracks along the HDF provide evidence of recent modifications.
