# **Safari Road (Kirkwall Road to Valens Road) Municipal Class Environmental Assessment**

Natural Heritage Assessment Report  
Final

## **Natural Heritage Assessment Report**

**City of Hamilton**

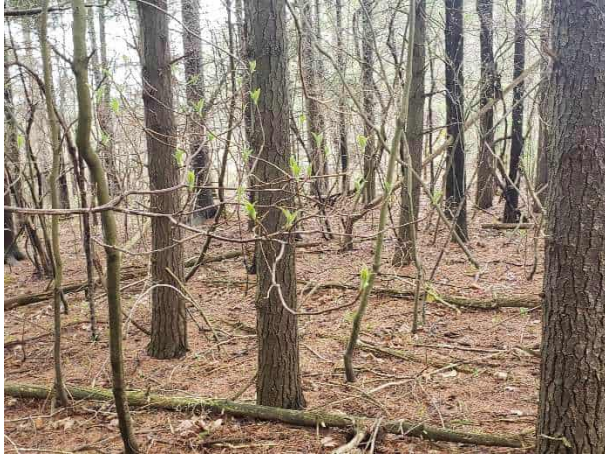
1 – 20250602 – South-facing view of Mineral Cultural Plantation within Polygon 6.

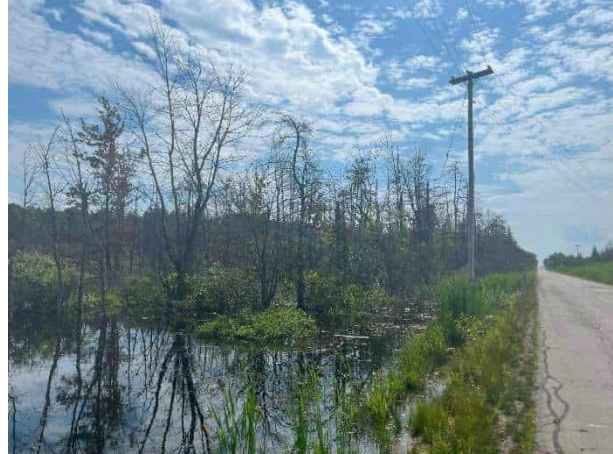
2 – 20250711 – Dead conifers within Polygon 10, an emerging Mineral Thicket Swamp within a declining Coniferous Cultural Plantation.

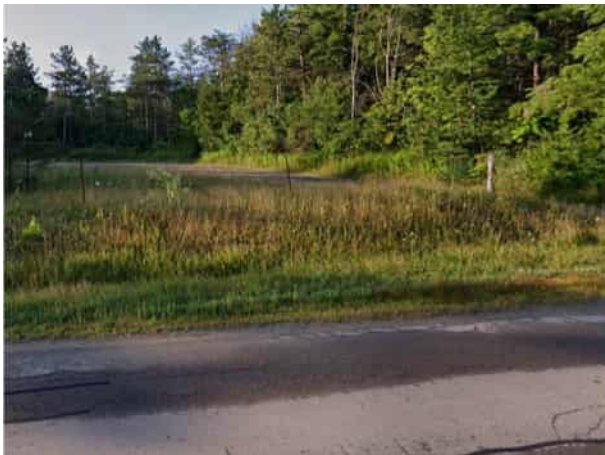
3 – 20250711 – South-facing view Typical Mineral Cultural Meadow within Polygon 25c.

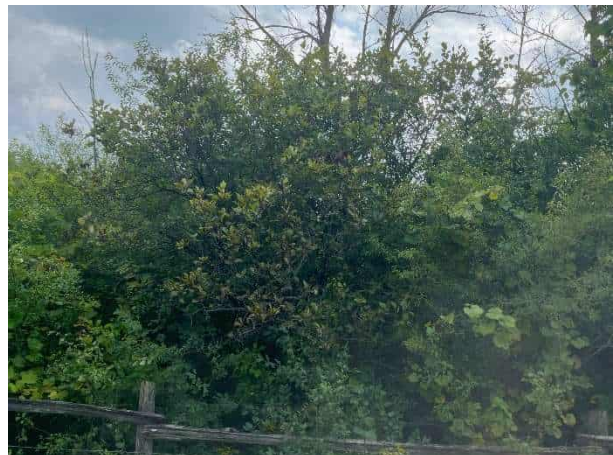
4 – 20250905 – South-facing view of Mineral Cultural Thicket, Polygon 15.

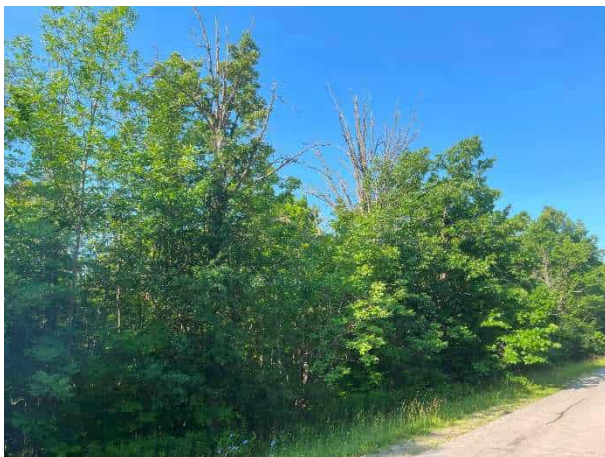
5 – 20250704 – North-facing view of edge of Polygon 8, a Mineral Cultural Woodland.

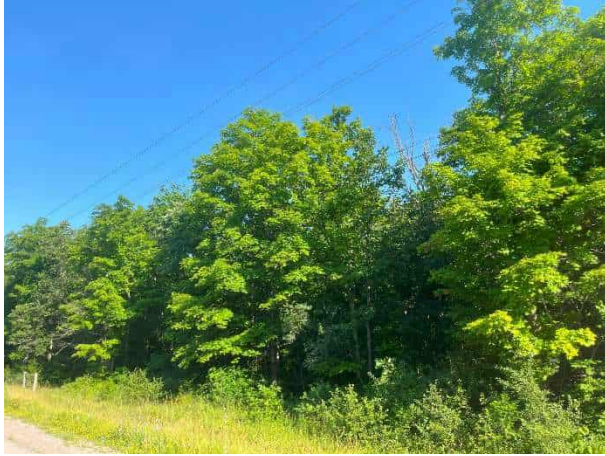
7 – 20250711 – North-facing view of Polygon 1 showing mature Dry-Fresh Sugar Maple –Hardwood Deciduous Forest.

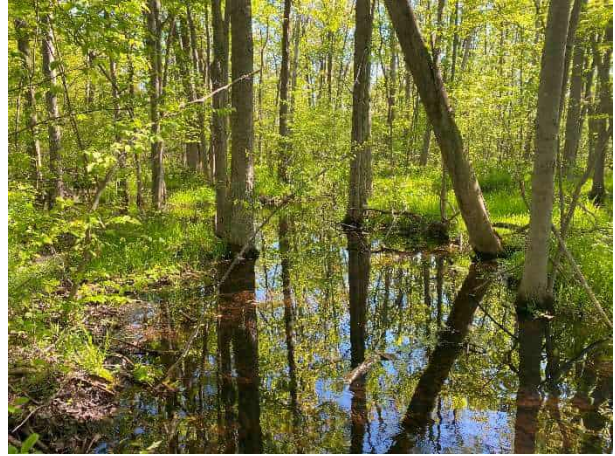
8 – 20250604 – North-facing view of flooded area along Fairchild Creek within Polygon 3, a Swamp Maple Mineral Deciduous Swamp.

**Mineral Deciduous Swamp (SWD3)**, specifically Swamp Maple Mineral Deciduous Swamp (SWD3-3), was found throughout the Sheffield-Rockton PSW Complex bordering Fairchild Creek and the Mineral Shallow Marsh. Polygons **3** and **4** were surveyed directly, but PTE was not granted for **Polygons 13a - 13e**. **Polygons 3** and **4** are associated with the Fairchild Creek headwaters and were dominated by Freeman Maple (*Acer x freemanii*) with occasional Trembling Aspen (*Populus tremuloides*), American Basswood, American Elm, and Bur Oak. **Polygon 3** was more mature with a closed canopy (**Photo 8**), whereas **Polygon 4** was relatively open with pockets of Narrow-leaved Sedge Mineral Shallow Marsh (MAS2-3), dominated by Tussock Sedge (*Carex stricta*), and shrub-dominant areas with Red-Osier Dogwood (*Cornus sericea*) and Nannyberry (*Viburnum lentago*) (**Photo 9**). The groundcover within **Polygon 3** included a diversity of wetland sedges (*Carex projecta*, *C. tenera*, *C. cristatella*), and forbs including Spotted Jewelweed (*Impatiens capensis*), Marsh

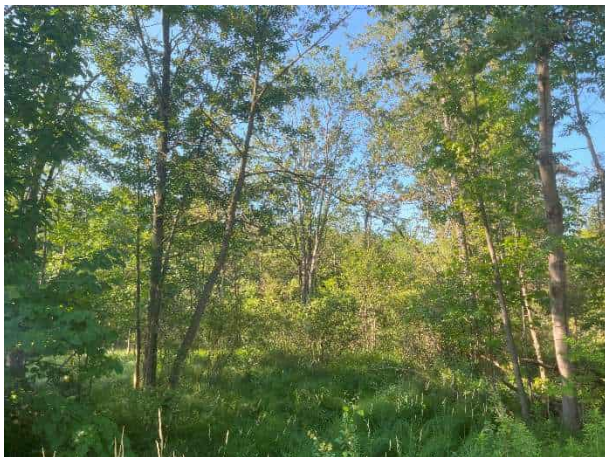
9 – 20250711 – South-facing view of Polygon 4 showing Swamp Maple Mineral Deciduous Swamp with pockets of Narrow-leaved Mineral Sedge Marsh.

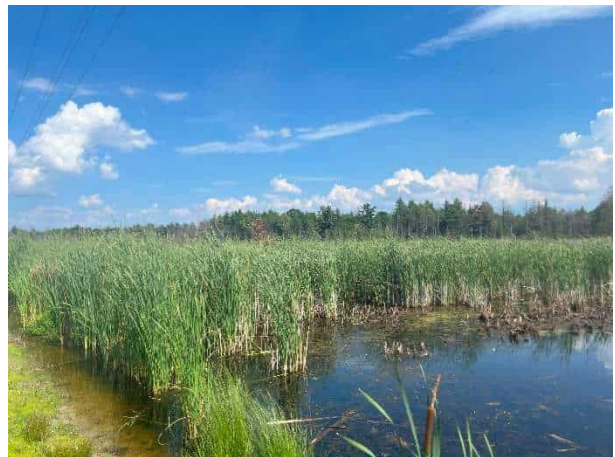
10 – 20250711 – Southeast-facing view of Polygon 12d showing dense Cattail Mineral Shallow Marsh.

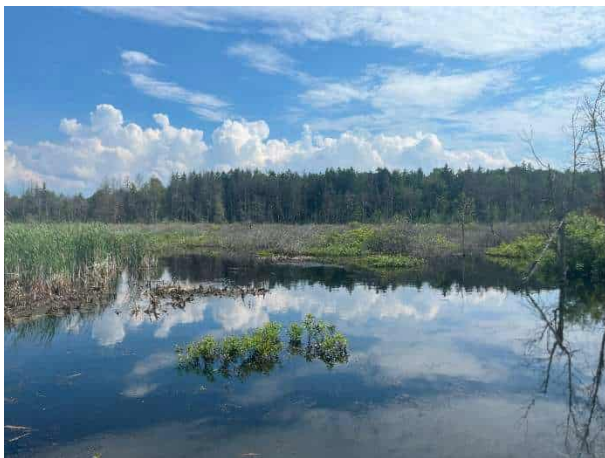
11 – 20250711 – South-facing view of Polygon 11 (background showing Buttonbush-dominant Mineral Thicket Swamp).

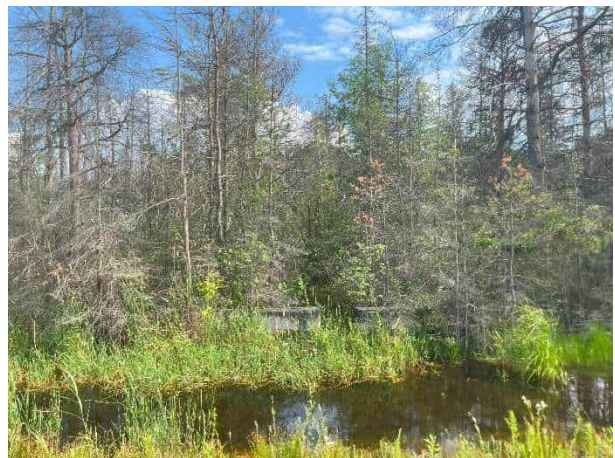
12 – 20250711 – South-facing view of Polygon 10 showing dead conifers in canopy and dense Mineral Thicket Swamp undergrowth.

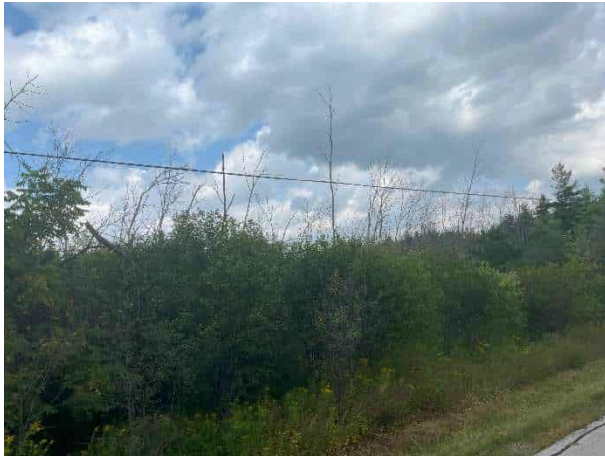
13 – 20250905 – Mineral Thicket Swamp (Polygon 17) with dead standing Ash trees.

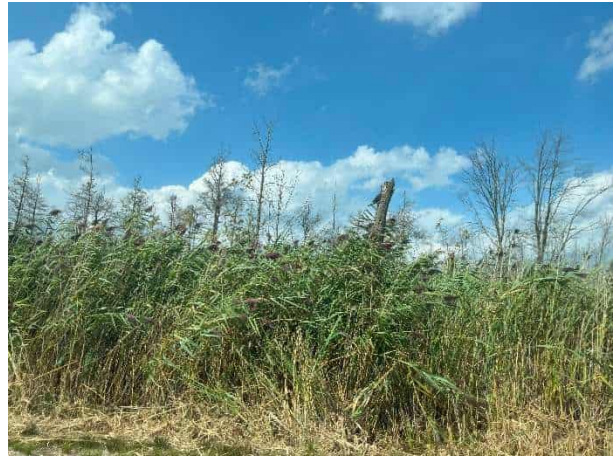
14 – 20250711 – Dense stand of European Reed in Polygon 12b.

A total of 33 species considered invasive in Ontario were observed during the field investigations (**Appendix D**). Notable invasive species that were common included Autumn Olive (*Elaeagnus umbellata*), Glossy Buckthorn (*Frangula alnus*), Scots Pine (*Pinus sylvestris*), European Common Reed (*Phragmites australis ssp. australis*), and Common Buckthorn (*Rhamnus cathartica*). Invasive species were observed in all of the vegetation communities surveyed with PTE. The exotic trees and shrubs were most abundant the Mineral Cultural Thicket (**Polygon 15**) Mineral Cultural Plantations (**Polygons 6 and 7**), Mineral Cultural Woodlands (**Polygons 8a-c, 9**), and Mineral Thicket Swamp (**Polygons 11 and 10**), but were also encountered along the roadside edges of the Deciduous and Mixed Forest (**Polygons 1, 2, 20, 21**). European Common Reed appeared to be most abundant near Safari Road within Polygons 12a and 12b, as well as pockets within Polygons 13c and 13d (**Map 3, Photograph 14**).

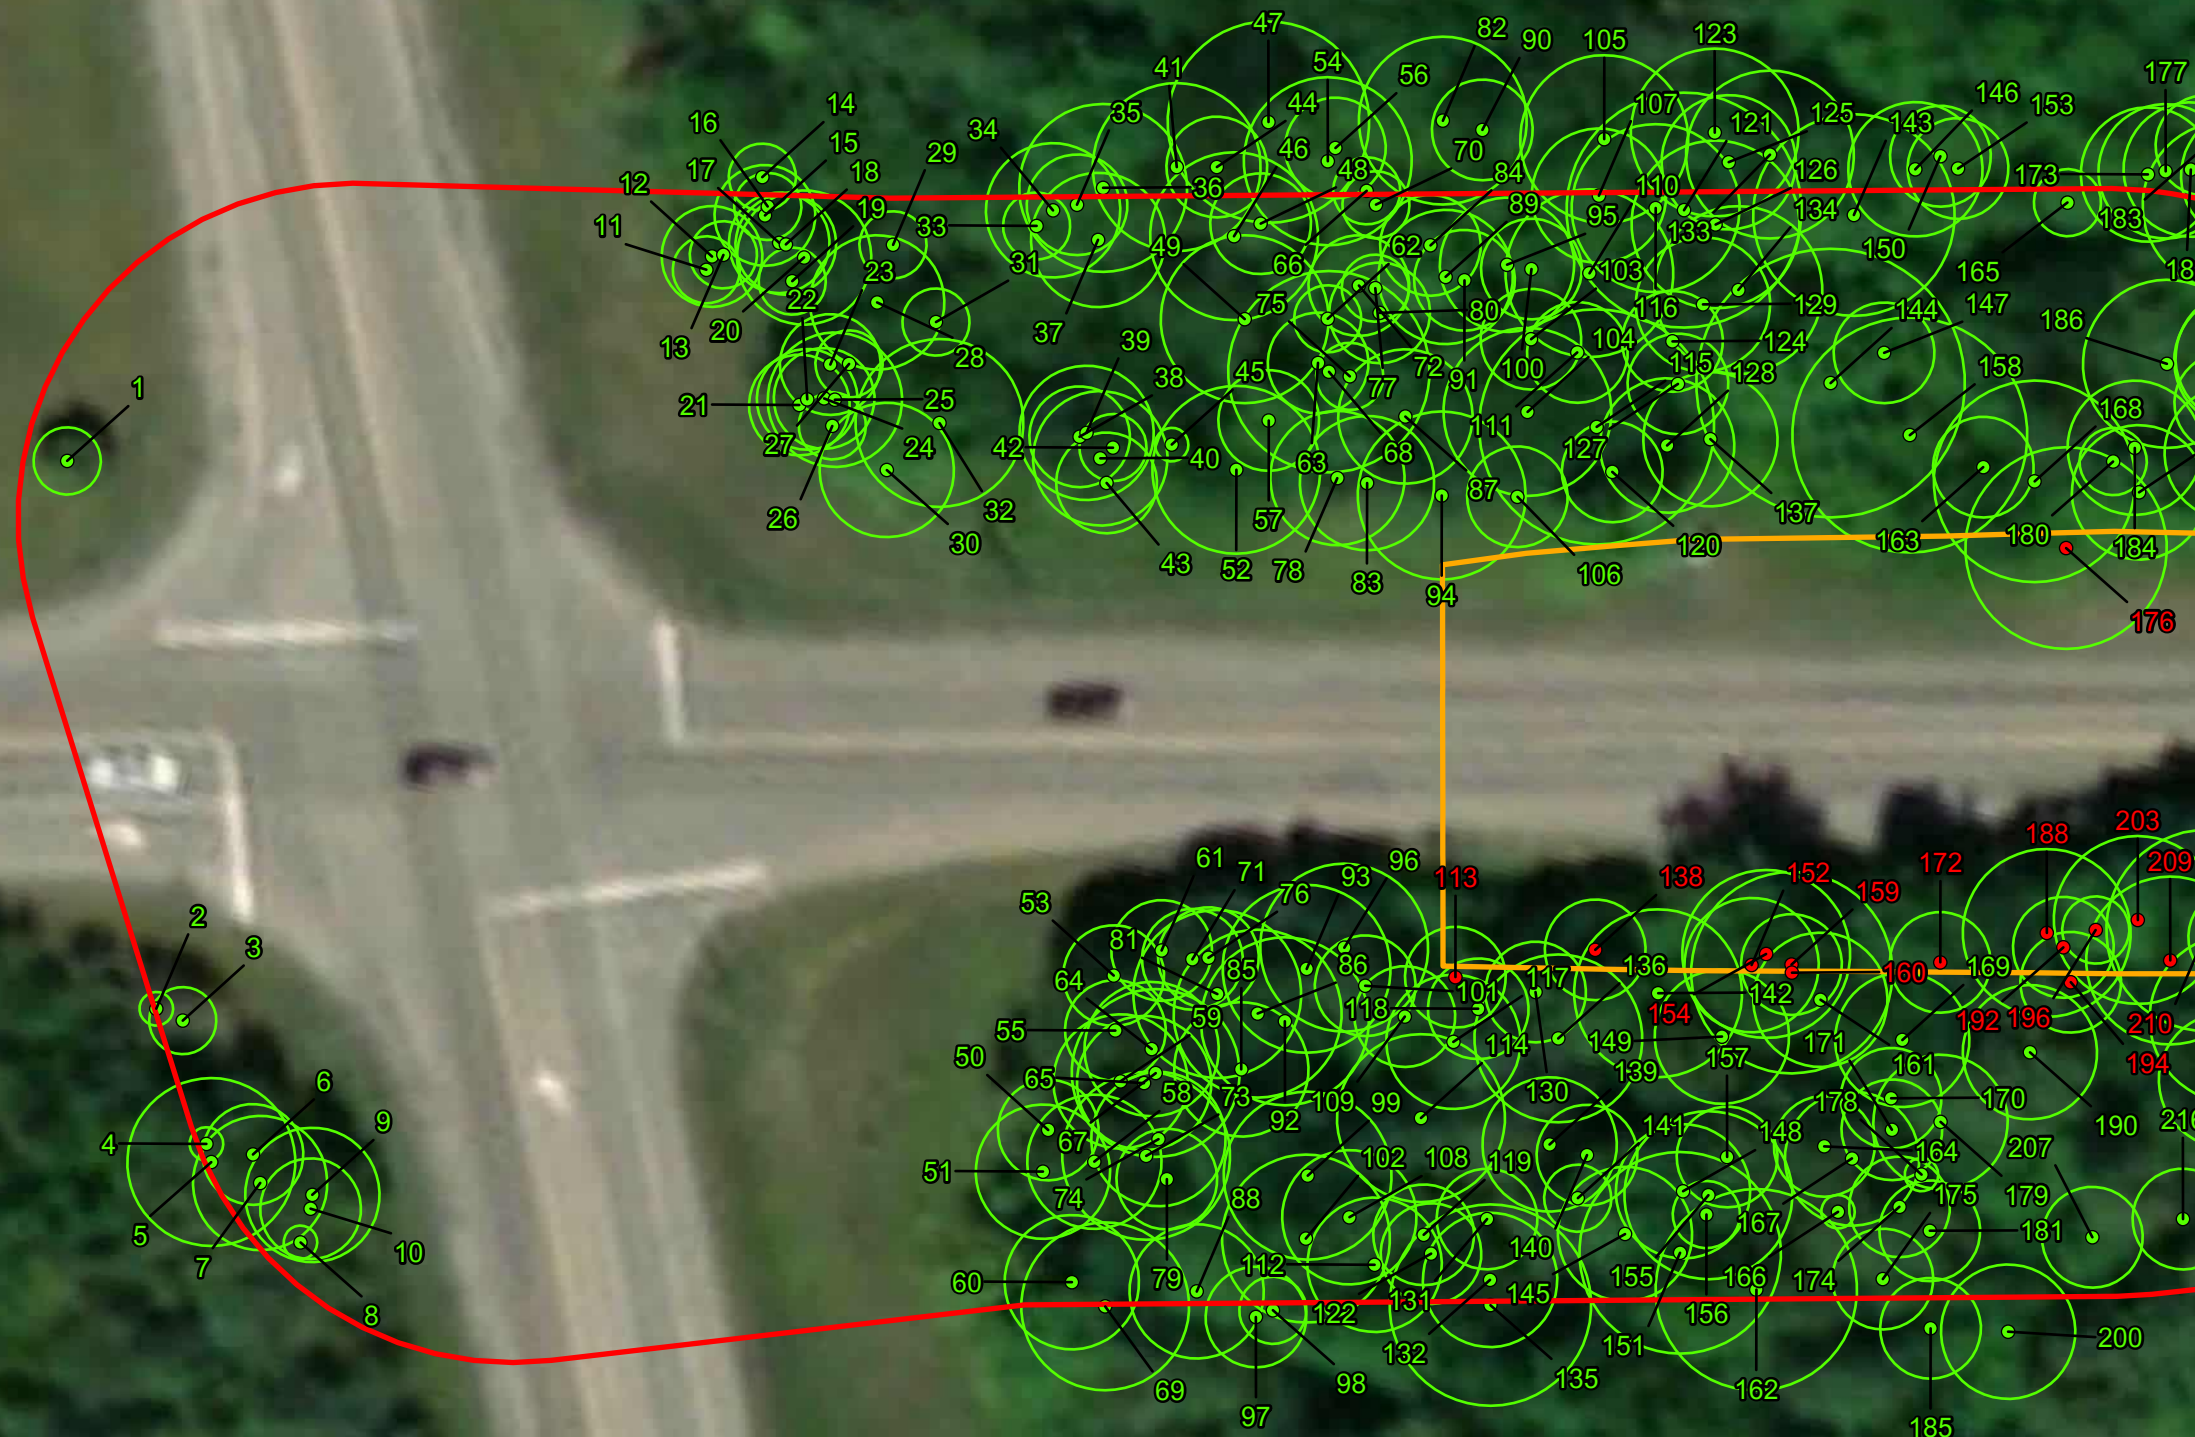
Map  
**4**

**Tree Inventory and  
Proposed Grading Limit**

- Study Area
- Proposed Grading Limit
- Dripline

A total of 1392 trees were inventoried within and up to 20 m outside the Safari Road ROW within the Study Area (**Appendix E**) where PTE was granted. Some trees were rooted outside this envelope, but their canopies overlapped so were included. The locations of each inventoried tree are shown in **Map 4** which can be found in **Appendix E**. Some areas were dominated by trees and shrubs smaller than 10 cm DBH, so contained few surveyed trees.
