**CULTURAL HERITAGE MEMORANDUM**

## Memorandum

**Subject:** Cultural Heritage Comments Regarding Safari Road Municipal Class Environmental Assessment (between Kirkwall and Valens Road)

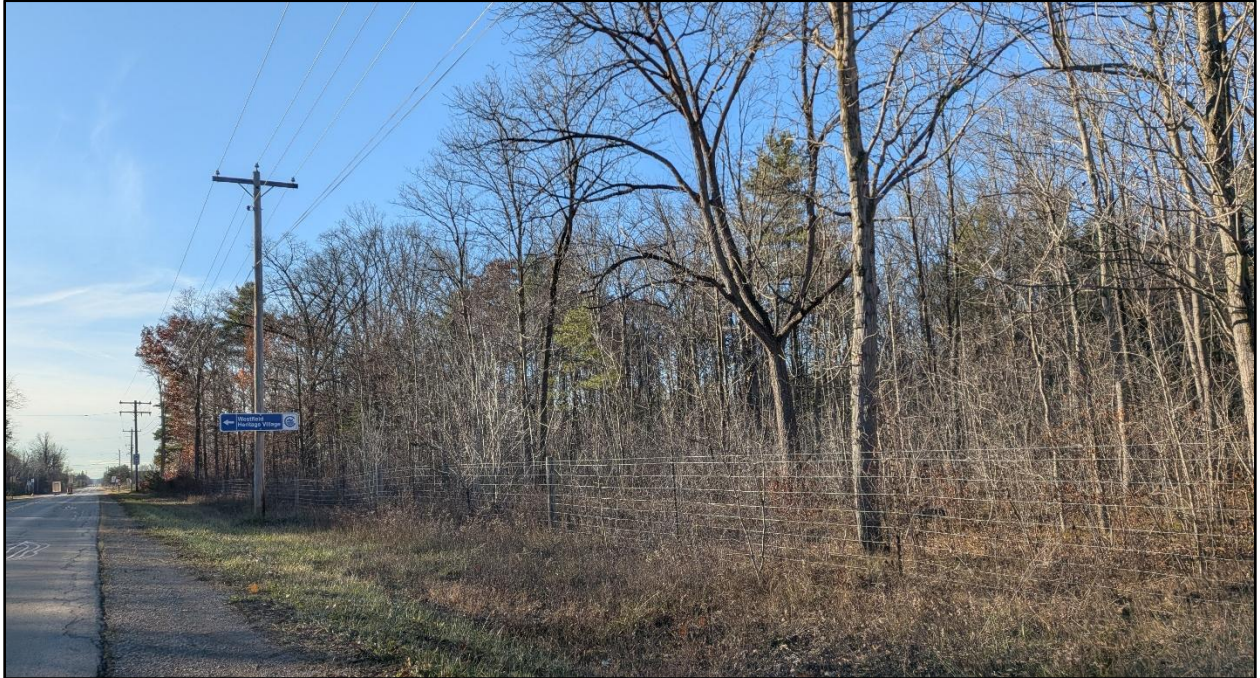
**Image Two:** Municipally addressed parcel 1492-1500 Kirkwall Road where the property borders Safari Road, depicting the existing fence.

The property located at 1492-1500 Kirkwall Road is a representative example of a circa 1860 stone farmhouse designed in the Ontario Cottage style with Georgian and Classical Revival influences. Staff can confirm that the structure fronts on to Kirkwall Road, and all major features associated with the historic farmhouse are concentrated around the farmhouse itself. While the property abuts Safari Road at the west end of the study area no historic landscape features are present. A standard wire mesh farm fence with wood and rebar posts was present along the right of way of Safari and is associated with 1492-1500 Kirkwall Road. However, this fence does not appear to be of historic value and is not considered a cultural heritage landscape feature, a photograph of the fence is provided as Image Two under the Supplementary Content heading. Staff are of the opinion that the proposed work will not have impacts on the cultural heritage value or interest of this property and the cultural heritage resource will be conserved.

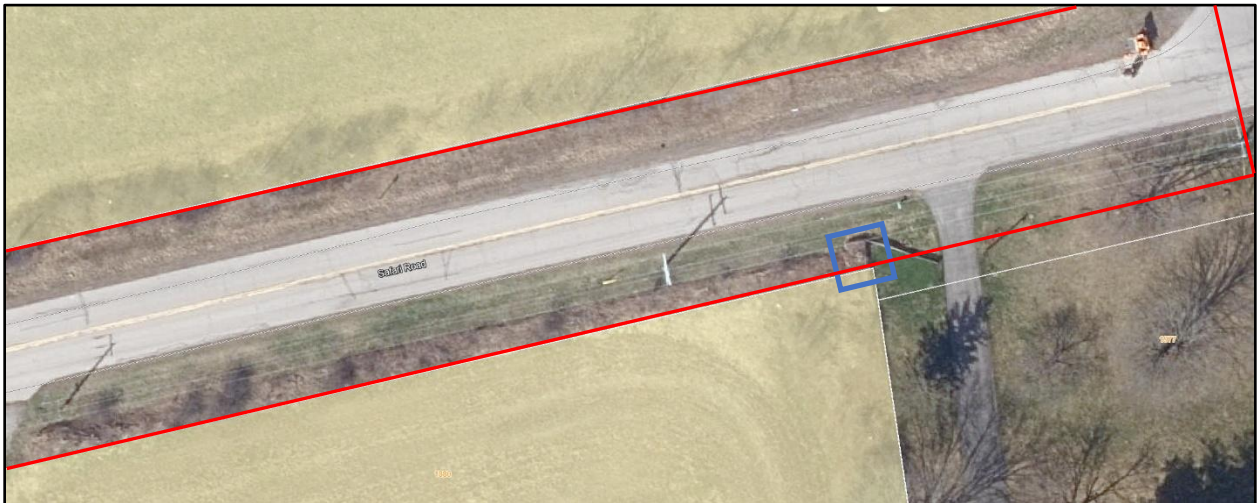
**Image Three:** Municipally addressed parcel 1267 Valens Road where the property borders Safari Road. Location of study area marked in red, location of stone landscape feature shown in blue.

The structure located at 1267 Valens Road a two-storey farmhouse with an MPCA construction date of 1880. Staff can confirm that the structure fronts on to Valens Road, and all major features associated with the historic farmhouse are concentrated around the farmhouse itself. The property municipality addressed as 1267 Valens Road abuts Safari Road at the southeast end of the study area. One cultural heritage landscape feature of note was present adjacent to the property line. Located on the northeast edge of the farm property (Image Three) stands a stone cairn, demarcating the edge of the farmer's field. The feature is a square shaped cairn of dry-stone construction, the date of construction is unknown (Image Four and Five). It is common during farm settlement for stones found in farmers' fields to be dragged out and piled to create boundary markers. Therefore, it is possible that this is a remnant feature from the early settlement. While this landscape feature is present and may be considered historical, it is at the very end of the study area and staff feel that retention in situ may be appropriate and feasible. Should the feature need to be removed to support the work in the study area, staff have sufficiently documented the feature.

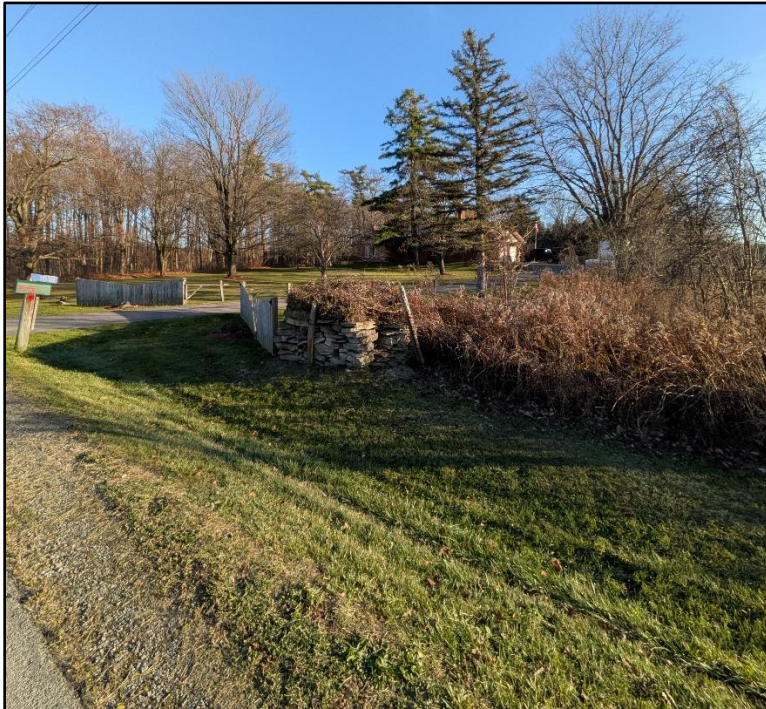
**Image Four:** Stone landscape feature located adjacent to Safari Road on the property municipally addressed as 1267 Valens Road.

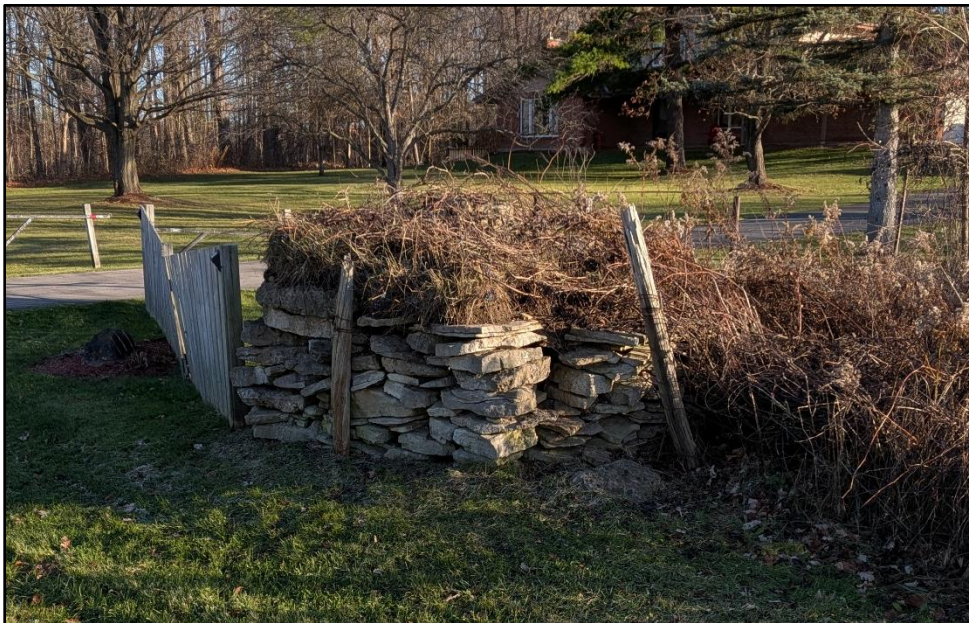
**Image Five:** Close up of stone landscape feature located adjacent to Safari Road on the property municipally addressed as 1267 Valens Road.
