**FLUVIAL GEOMORPHOLOGY ASSESSMENT
REPORT**

To: Mila Khatri, Junior Environmental Planner
From: Michelle Robinson, Tatiana Hrytsak, & Robin McKillop
Company: R.V. Anderson Associates Limited **SLR Consulting (Canada) Ltd.**
cc:
Date: July 28, 2025
Project No. 243.V24532.00000
Revision 00

RE: Fluvial Geomorphology Crossing Assessment for Safari Road (Kirkwall Road to Valens Road)
Schedule B Municipal Class Environmental Assessment for Road and Drainage Improvements and Preliminary Design for the City of Hamilton

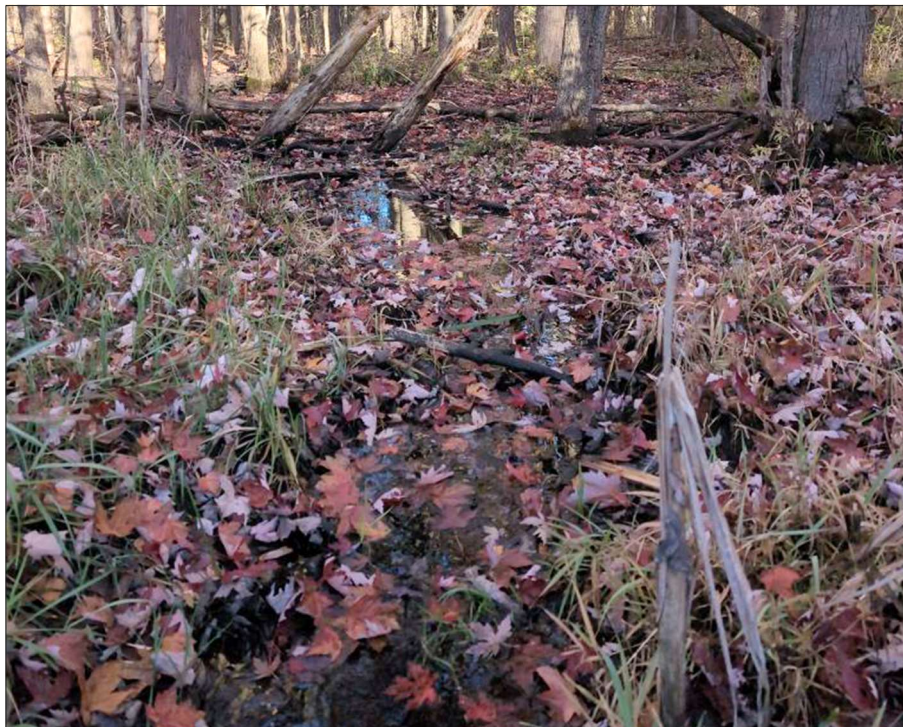
The channel immediately upstream of the Safari Road culverts has a poorly defined irregular meandering planform, situated in a low-lying forested area (**Photo 1**). The primary flow path is aligned with the culvert; however, supplemental drainage channels associated with the wetland were observed in the forested area. The banks comprise loose alluvium that has been deposited around hard natural features, such as boulders or trees. The erodible banks and saturated ground readily allow planform changes during high flows, especially seasonally when the channel overtops the banks and Safari Road.

The channel has a low gradient with a mixture of silt, organic matter, and matted vegetation along its bed. Such characteristics are typical of a wetland channel. The bankfull depth is approximately 0.4 m. The average bankfull width is approximately 2 m north of the culverts and 4 m south of the culverts (**Table 1**). The wetted width is 1 m north of the culverts and 2 m south of the culverts. Herbaceous vegetation lines the channel banks and roadside ditch (perpendicular to the channel). Scour and erosion were neither observed upstream nor downstream of the culverts. It is anticipated that the upstream wetland has the capacity to attenuate high flows and reduce the erosive energy during flood events. The culverts are in stable condition, not blocked by sediment or vegetation, and currently pose no impediment to fish passage.

Photo 1. Upstream view of the primary channel, north of Safari Road.

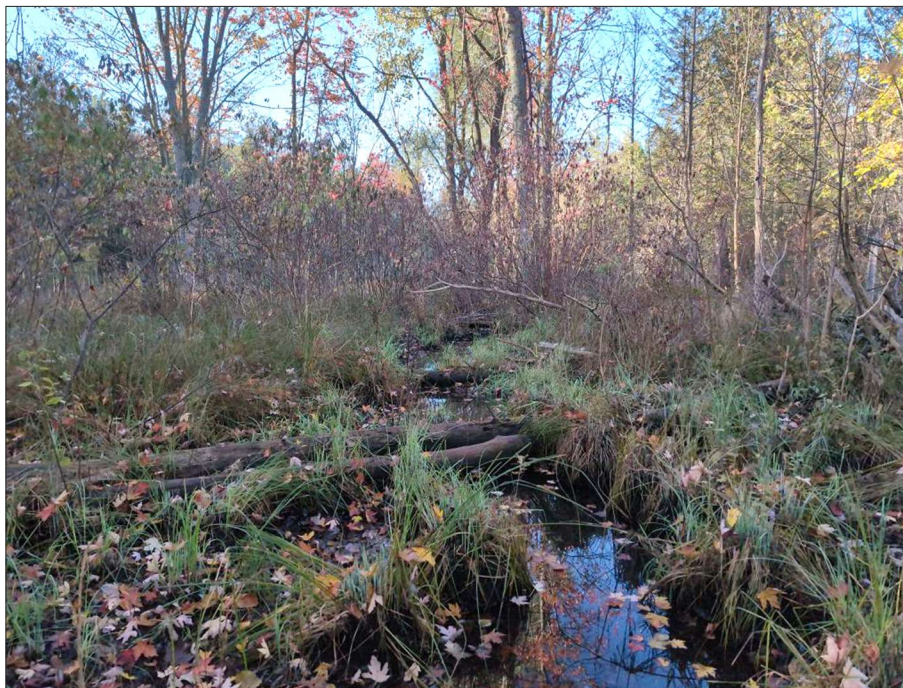
The channel becomes more well-defined downstream of the culverts (**Photo 2**). It has a similar irregularly meandering planform, and aerial imagery reveals multiple drainage paths in the vicinity of the channel associated with the wetland. Water in the channel and culverts had limited velocity at the time of the site visit.

Photo 2. Downstream view of the channel, south of Safari Road.

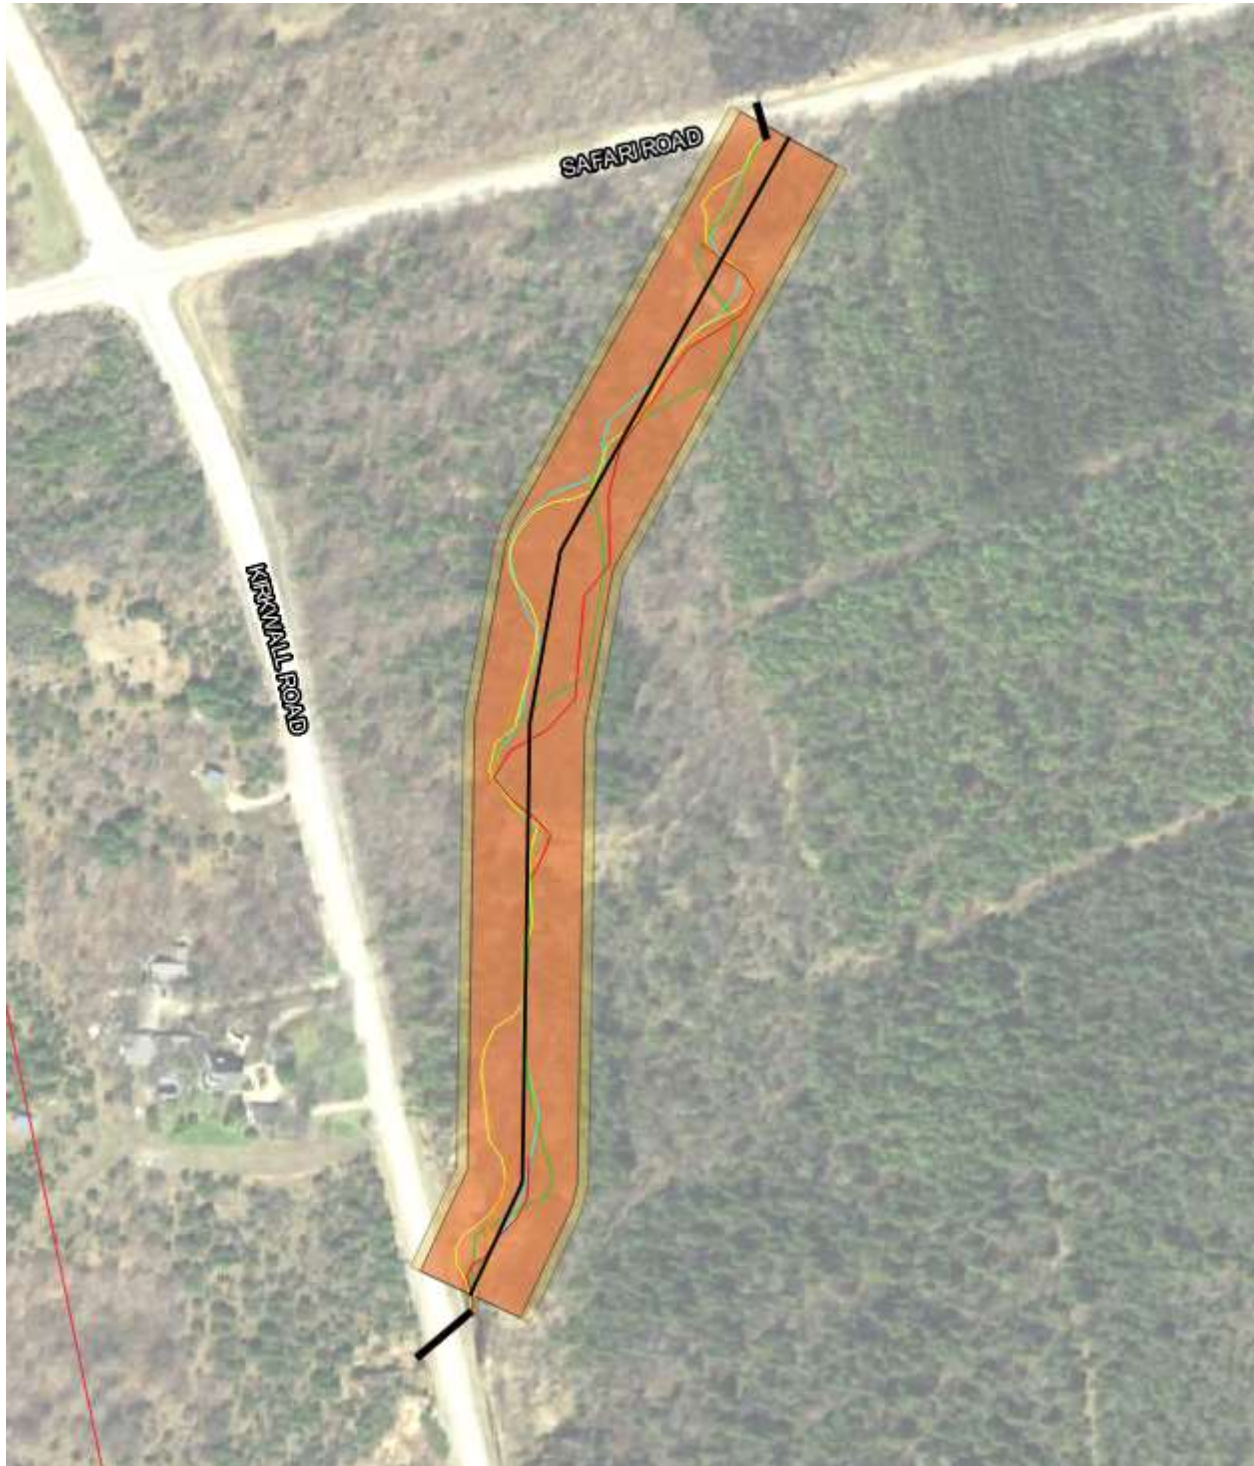
The existing crossing on Safari Road is located 280 m east of Kirkwall Road and comprises three parallel CSP culverts perpendicular to Safari Road (**Figure 1**). The watercourse north of Safari Road is oriented northeast-southwest and drains an area of wetland associated with the Beverly Swamp. The downstream section of the channel is approximately 590 m long and flows southwestward, ultimately crossing beneath Kirkwall Road through a concrete box culvert.

Comparative overlay analysis using recent imagery reveals a generally stable planform downstream of the Safari Road crossing (**Figure 1**). Given the limitations associated with delineating the meander belt along a treed channel in a wetland setting, an empirical approach was used as a check of the findings of the overlay assessment. The Williams – Hydraulic Depth (1986) empirical meander belt formula was used to determine an existing belt width (**Formula 1**). The resulting value was found to correlate reasonably well with the meander belt width estimated through the overlay assessment, although it was slightly less conservative. The existing and final meander belt width results at Safari Road are identified in **Table 2**, according to both the empirical and imagery overlay assessment methods. The final belt widths include a 20% factor of safety to account for potential future changes in the hydrological regime associated with potential upstream development and ongoing climate change.

Figure 1. Safari Road crossing and downstream historical planform assessment

Comparative overlay analyses reveal minimal changes to the channel planform alignment over the past 20 years of record (2002 to 2020) (**Figure 1**) and the final meander belt is 57.6 m wide. The stability of the planform precludes establishment of site-specific 100-year erosion rates and justifies crossing spans being based on measures other than meander amplitudes or belt widths.
