**Safari Road  
Schedule 'B' Municipal  
Class Environmental Assessment**

Project File Report

Final

April 15, 2026

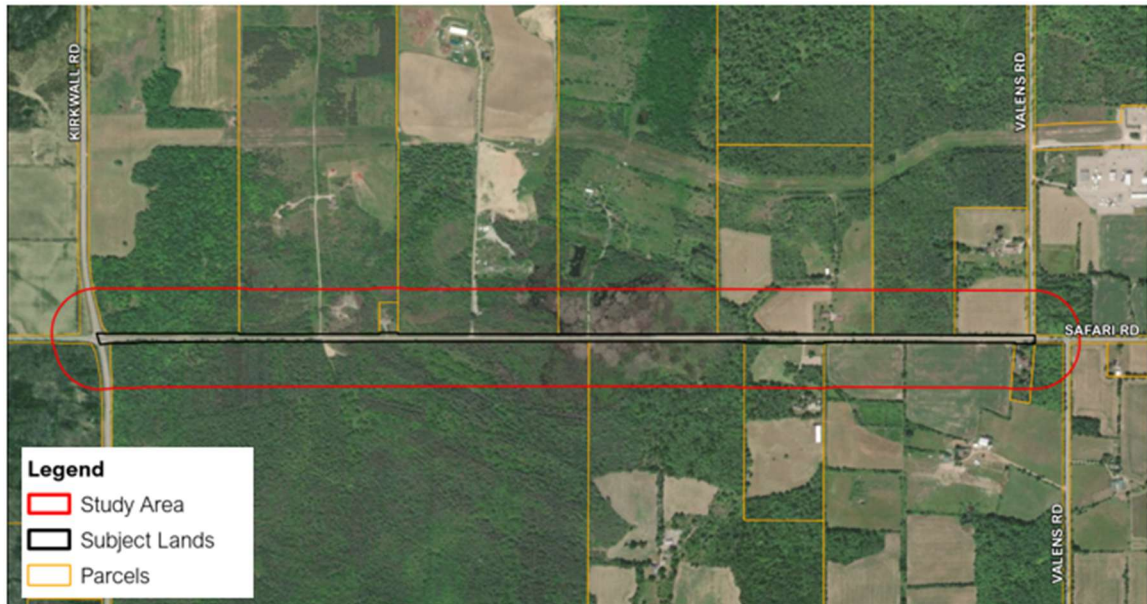
Figure 1.1 Study Area

The Study Area includes Safari Road from Kirkwall Road to Valens Road, within the City of Hamilton. Safari Road is a 2-lane rural road with no active transportation (AT) facilities and no on-street parking and is designated as a full-time commercial truck route. The road is surrounded by agricultural land and low-density residential areas. Between Kirkwall Road and Valens Road, Safari Road is situated in a low-lying area with wetlands on either side of the road, with significant natural features (watercourses) and terrestrial Species at Risk (SAR). The Study Area is shown in Figure 1.1.

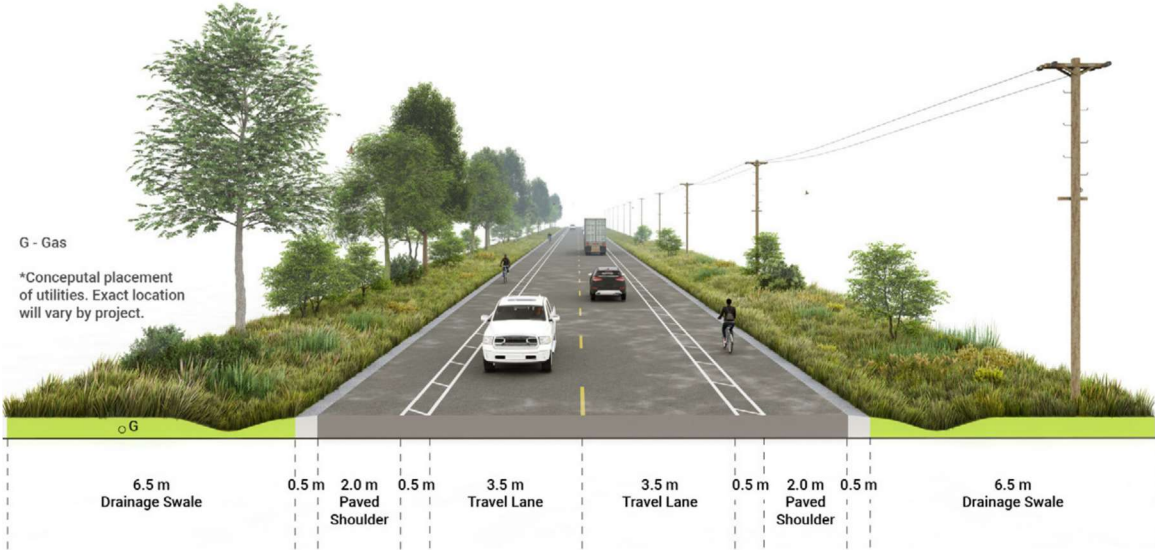
Figure 1.3 Complete Streets Design Guidelines for Rural Roads

Rural Roads are located outside Hamilton's urban area, primarily in agricultural and natural areas. Their primary function is motor vehicle and goods movement. They may also serve slow-moving agricultural vehicles, people cycling for recreation or to travel to other communities, and in some cases may feature transit service.

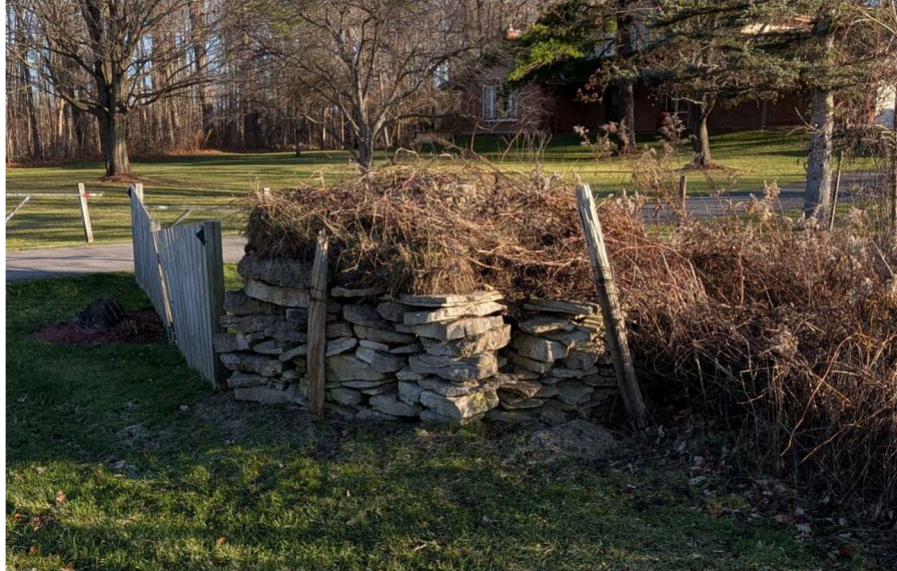
Figure 3.5 Close up of Stone Landscape Feature at 1267 Valens Road

1267 Valens Road – This is a two-storey farmhouse that fronts on to Valens Road, with all major features associated with the historic farmhouse concentrated around the farmhouse itself. The structure abuts Safari Road at the southeast end of the Study Area. One (1) cultural heritage landscape feature of note was present adjacent to the property line. Located on the northeast edge of the farm property stands a stone cairn Figure 3.5, demarcating the edge of the farmer's field, and could possibly be a remnant feature from the early settlement.

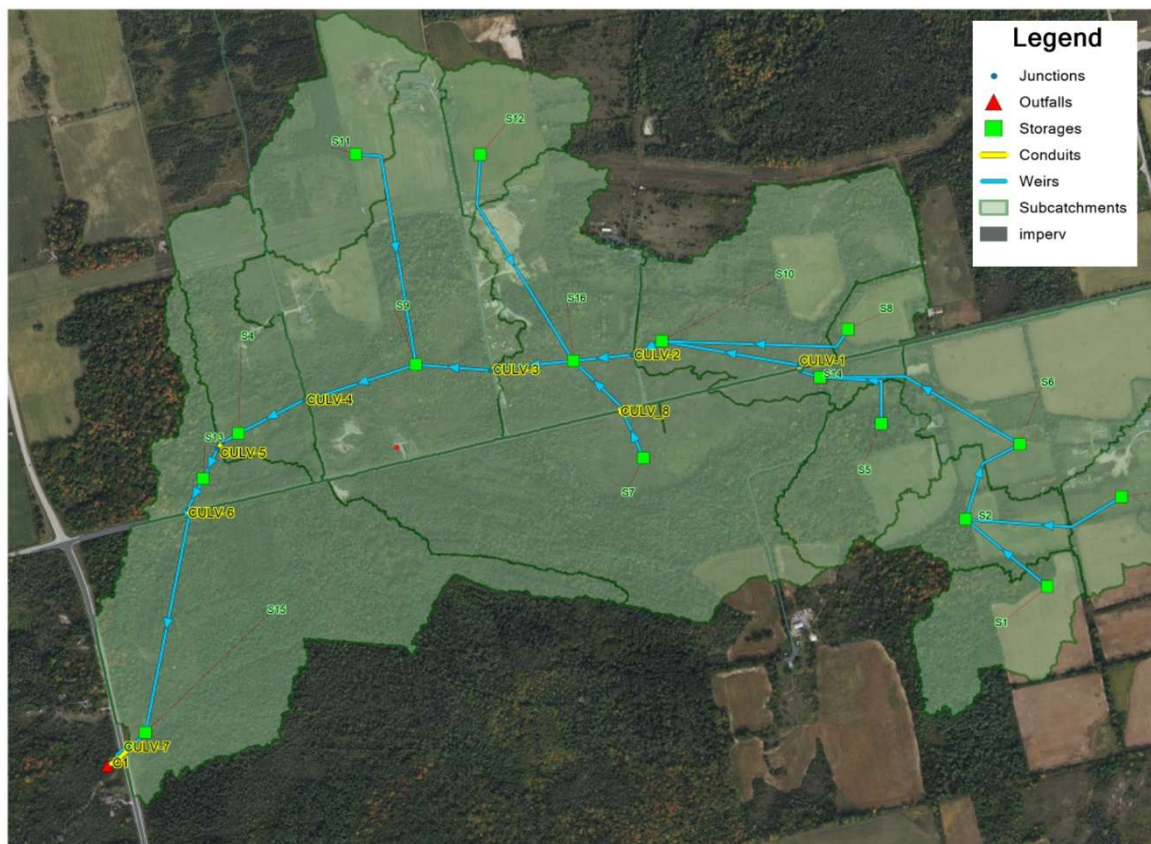
Figure 3.6 Drainage Area Plans

CULV ID	Location	Size	Material	Cumulative Drainage Area
		(mm)		(ha)
CULV-1	Safari Road – culvert crossing at eastern project limit	600	CSP	56.21
CULV-2	North of Safari Road – crosses private driveway	500	CSP	77.47
CULV-3	North of Safari Road – crosses private driveway	600 (collapsed)	CSP	133.18
CULV-4	North of Safari Road – crosses private driveway	Existing blast rock – no culvert		173.28
CULV-5	North of Safari Road – crosses private driveway	Bridge (limited opening)		183.98
CULV-6	Safari Road – culvert crossing at western project limit	3 x 600	HDPE	189.64
CULV-7	Kirkwall Road – culvert crossing	3000 x 1200	Concrete	223.19
CULV-8	Safari Road – wetland equalization culvert	600	CSP	31.85

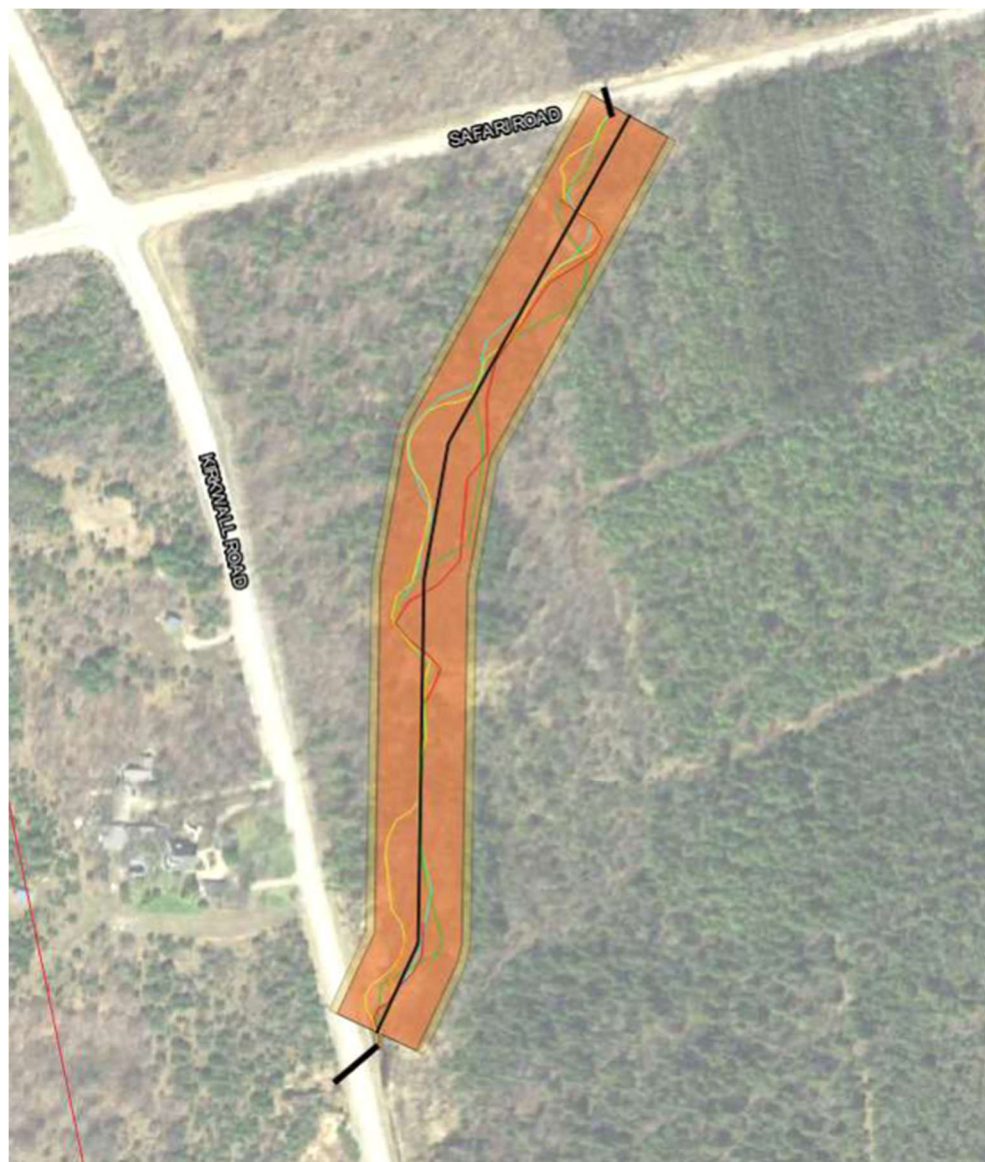
Figure 3.7 Safari Road Crossing and Downstream Channel

The channel has a low gradient with a mixture of silt, organic matter, and matted vegetation along its bed. Such characteristics are typical of a wetland channel. Herbaceous vegetation lines the channel banks and roadside ditch (perpendicular to the channel). It is anticipated that the upstream wetland has the capacity to attenuate high flows and reduce the erosive energy during flood events. The culverts are in stable condition, not blocked by sediment or vegetation, and currently pose no impediment to fish passage.

The channel becomes more well-defined downstream of the culverts. It has a similar irregularly meandering planform, and aerial imagery reveals multiple drainage paths in the vicinity of the channel associated with the wetland.
