# Welcome to the Public Open House for The City Of Hamilton Utility Relocation Schedule "B" Class Environmental Assessment

## Public Information Centre #1

November 5, 2015  
6:00 pm to 8:00 pm  
Knox Presbyterian Church  
80 Mill Street North  
Waterdown, Ontario

The objective of this Class Environmental Assessment (EA) is to identify and evaluate the alternative solutions to permit the replacement and potential relocation of existing utilities (water, wastewater, hydro, telecommunications utilities, etc.) as part of the future bridge rehabilitation activities.

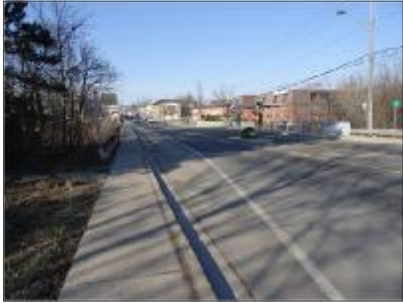
The focus of the study is the Highway 5 Dundas Street (Vinegar Hill) bridge spanning Grindstone Creek and the utilities that run beside, beneath, and within the bridge.

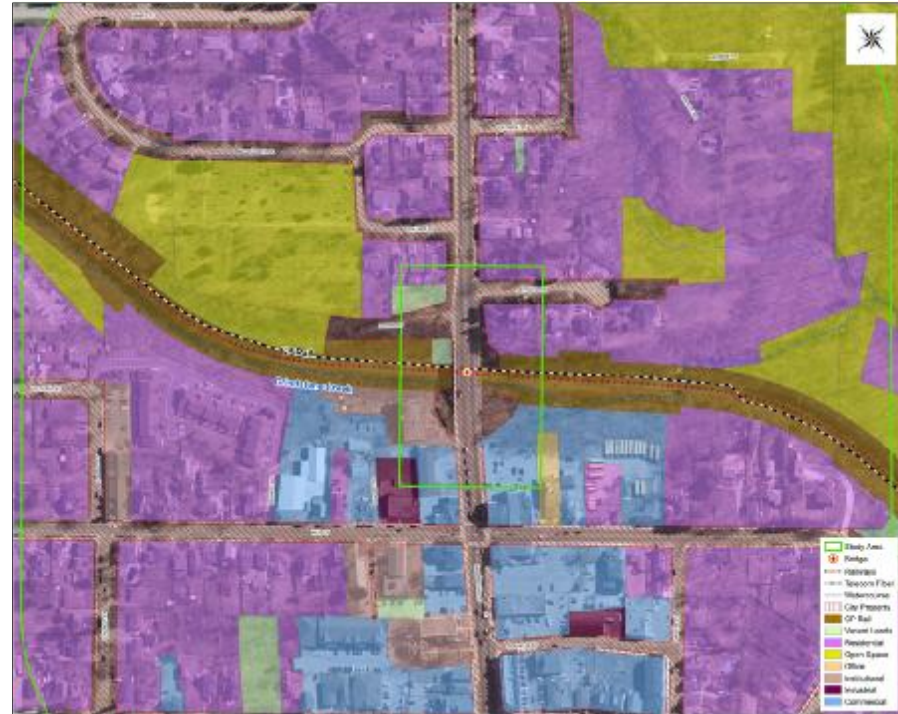
Completing these options will require making potential arrangements including consultation with approval agencies, new bridge construction, and land purchasing. Current City land ownership can be seen in the figure on the right.

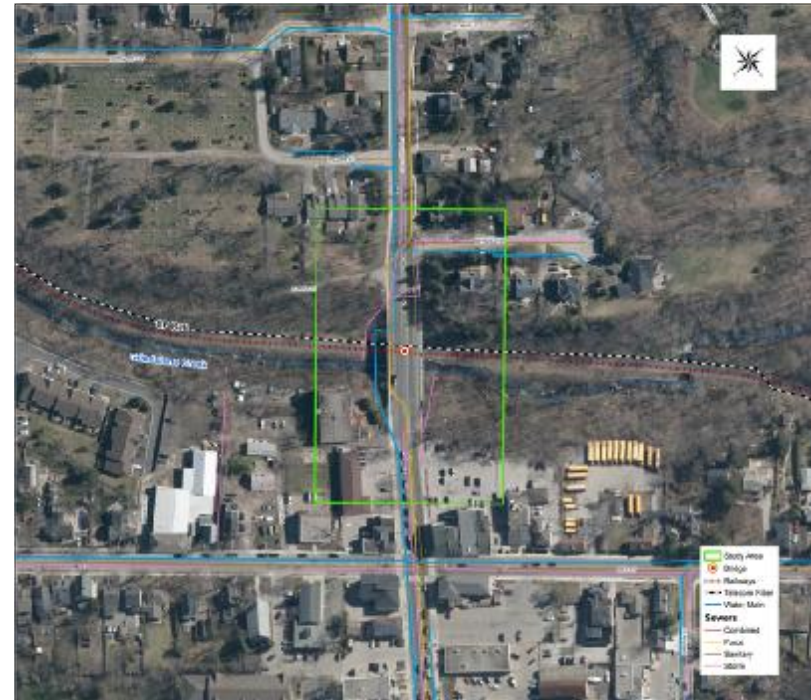
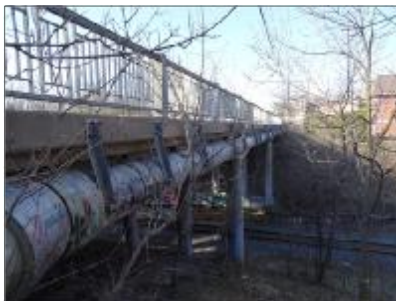
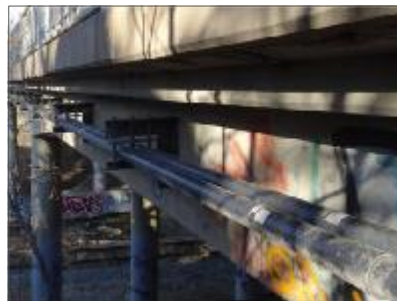
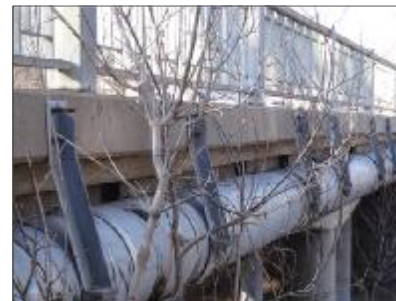
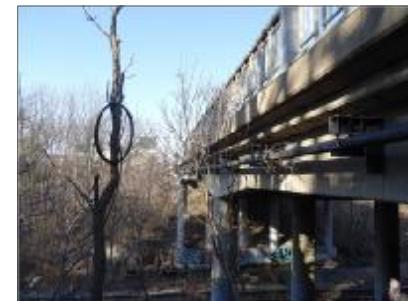
- 500mm Ø sanitary forcemain
- 200mm Ø insulated asbestos cement pipe watermain supported below the deck
- 250mm Ø sanitary sewer
- Bell telecommunications
  - 8 embedded 108mm diameter Bell ducts in the north sidewalk
  - 89mm diameter Bell duct supported on the southern exterior girder that was installed in 2009
- One (1) 76mm diameter electrical duct (transite) in each sidewalk

- Existing pumping station approximately 300m upstream
- Sanitary system is relatively new
- Watermain - 1 of 4 feeds to the east side of Waterdown
- CP Rail infrastructure, includes CP communications lines and Fiber-optic located approximately 5 feet from the edge of the railway tie/rail

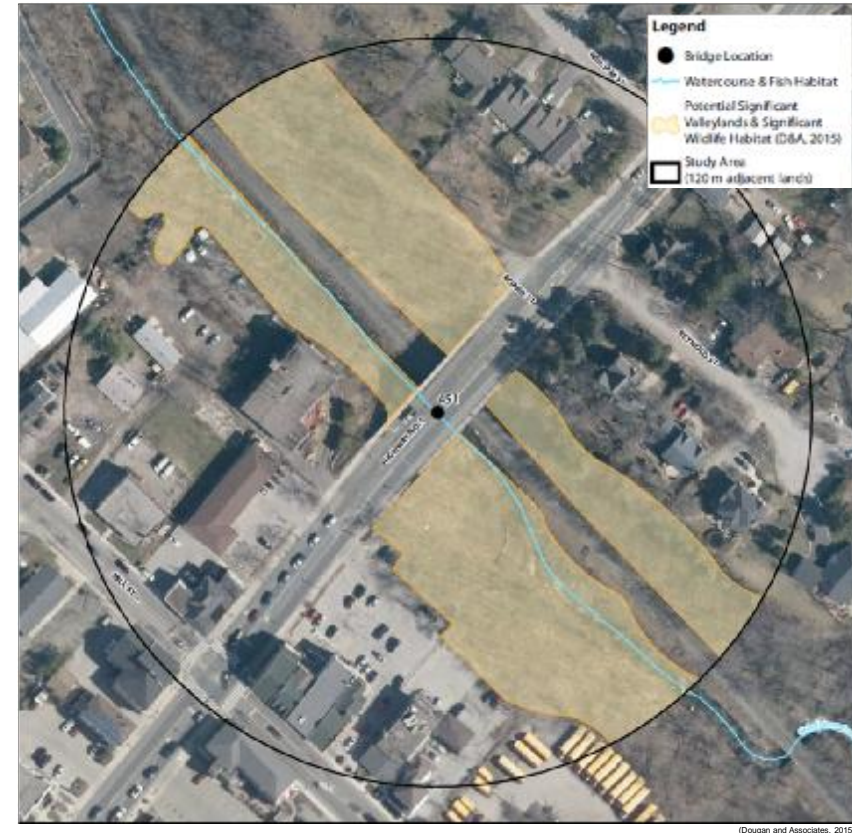
(Dougan and Associates, 2015)

- Natural heritage features/functions associated with the study area include: Significant Wildlife Habitat, Fish Habitat, and potentially Significant Valleylands (pictured, right)
- A portion of the study area is designated as Escarpment Natural Area and is subject to the Niagara Escarpment Plan.
