Former Fire Hall / Municipal Building

4 BARTON ST

Heritage Status: Inventoried

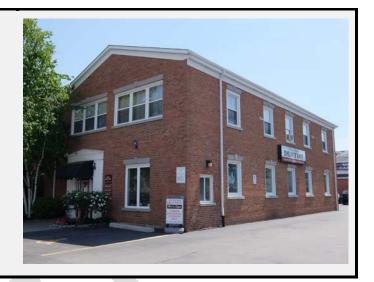
The property is a representative example of a vernacular municipal building constructed in the mid-20th century. The building was constructed circa 1956 as a two-storey brick building laid in Common bond with a side gable roof, the central main entrance to the municipal offices fronting onto Barton Street with two flanking bays of windows and two large garage doors opening up on to Main Street South for the Fire Hall. In the late-20th century the building was converted from municipal offices to commercial space and a sympathetic two-storey front addition was constructed on the south side of the building towards Barton Street. Features remaining from the original construction include the gable roofline, the brick laid in Common bond, the five window bays on the north facade and the second-storey window openings in the east (Barton Street) facade.

The property helps support the character of the area. The property is functionally, visually and historically linked to its surroundings, located on the west side of Main Street South at the corner of Main and Barton Street with entrances fronting onto both streets. The former municipal building helps support the historic character Main Street South and its significance as an historic transportation corridor in the Village.

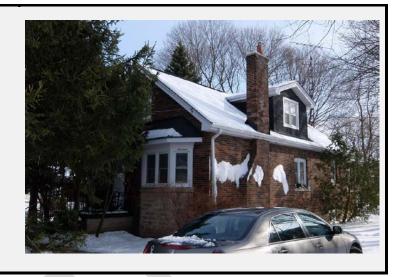
19 BARTON ST

The property is representative of a vernacular early-20th centruy cottage, including the one-and-one-half storey massing, front gable roof with window below and front bay window with hip roof.

The property is important in supporting the character of the area. The vernacular cottage helps support the historic character of village, primarily consisting of late-19th and early-20th century dwellings. The property is visually and historically linked to its surroundings, located on the south side of Barton Street, an historic transportation corridor in the village.

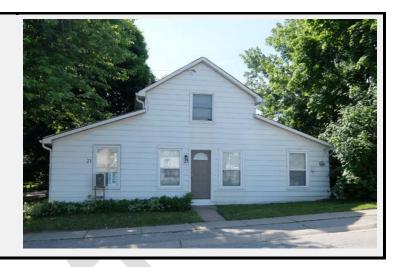
21 - 23 BARTON ST

The property is a unique example of a vernacular house constructed circa 1890, including the one-and-one-half storey central massing with a front gable roof and window below the gable, flanking one-storey side wings with shed roofs, horizontal siding and central entrance with two bays of flanking flat-headed windows on the ground floor. The design of this building closely resembles the vernacular dwelling located at 24 Union Street.

The property helps define the character of the area. The property is functionally, visually and historically linked to its surroundings, located on the prominent southeast corner of Flamboro and Barton Streets, two of the earliest roads in the village, with a shallow setbacks from both right-of-ways. The unique circa 1890 dwelling helps define the historic character of the streets and the Village of Waterdown, which primarily consists of late-19th and early-20th century buildings.

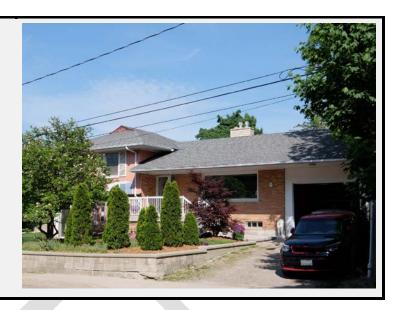
50 BARTON ST

The property is reflective of the Suburban Split-level style.

The 1957 Surburban Split-level dwelling with attached garage does not support the historic character of the area, which primarily consists of late-19th and early-20th century dwellings.

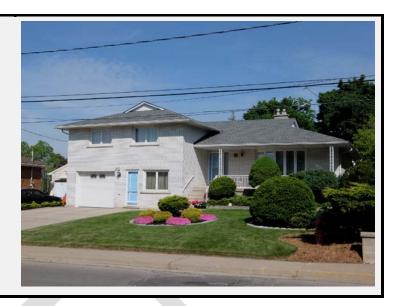
54 BARTON ST

The property is reflective of the Suburban Split-level style.

The 1975 Surburban Split-level dwelling with attached front garage does not support the historic character of the area, which primarily consists of late-19th and early-20th century dwellings.

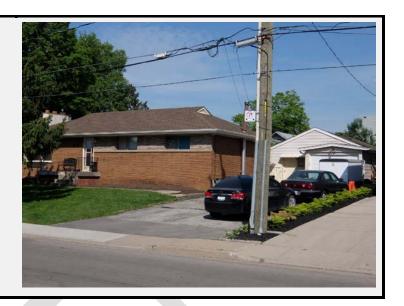
56 BARTON ST

The property is reflective of the vernacular Ranch architectural style, including the long low profile, low hip roof with projecting eaves with windows below and raised front entrance with an open porch.

The 1950 Ranch-style dwelling neither supports nor detracts from the historic character of the area, which consists of late-19th and early-20th century dwellings.
