TO:	Mayor and Members City Council
DATE:	December 6, 2022
SUBJECT:	City Hall Pedestrian Access Walkway (Wishbone Structure) Repairs Communication Update (Ward 2) (EFFM22-02)
WARD(S) AFFECTED:	Ward 2
SUBMITTED BY:	Craig Murdoch Acting Director, Energy Fleet & Facilities Maintenance Public Works Department
SIGNATURE:

November 23rd 2022

**RE: Structural review of Existing Concrete Entrance Structure at the rear of the Building Located at 71 Main St. W, Hamilton, ON
Our Project No. 2022-JPS-101**

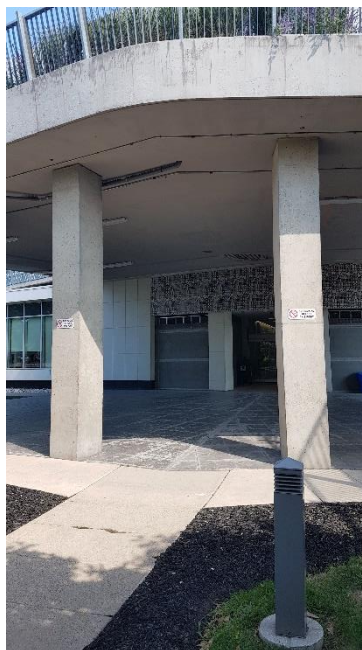
Appendix A: Additional site photos

We performed a visual review of the slab soffits, columns and other areas of concern that were visible at the time of our site walkthrough. The structure was also surveyed for any obvious signs of damage in the form of abnormal cracks, displacements, and signs of deterioration where readily visible during our walk-through. A few pictures are included below identifying the structural damage to the elements of the entrance structure.

- The portion of the structural elements and areas identified in the attached drawings need to be repaired immediately as they may lead to a catastrophic structural damage and also are safety hazards.
- Barricades and adequate caution signage should be provided and not removed until concrete repairs identified in the drawings are undertaken.
- The deteriorated slab soffits are an immediate safety hazard and tenant/pedestrian access should be prohibited until repairs are completed.
- To prevent any catastrophic structural failures and to prevent injuries, it is our recommendation that concrete repairs should begin immediately in conjunction with the application of permit to perform the concrete repairs.
