COMMUNICATION UPDATE

TO:	Mayor and Members City Council
DATE:	February 1, 2024
SUBJECT:	Longwood Road Bridge (Bridge 282) Upcoming Reconstruction (ENG24001) (City Wide)
WARD(S) AFFECTED:	City Wide
SUBMITTED BY:	Jackie Kennedy Director, Engineering Services Public Works Department
SIGNATURE:

Appendix "A" to Communication Update ENG24001: BRIDGE 282_2020_OSIM

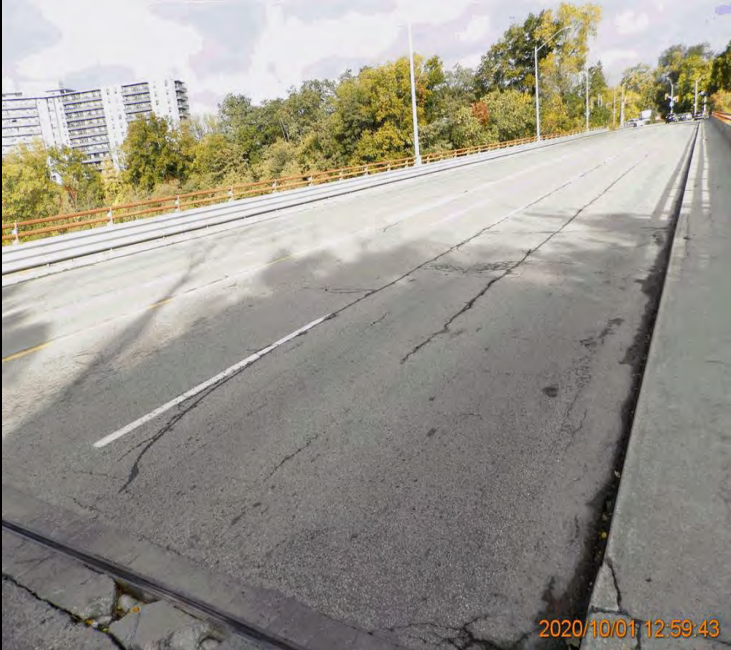
<p>Description Bridge Deck From Southeast Corner. Note: M-S unsealed longitudinal cracks and M-S pattern cracks.</p>

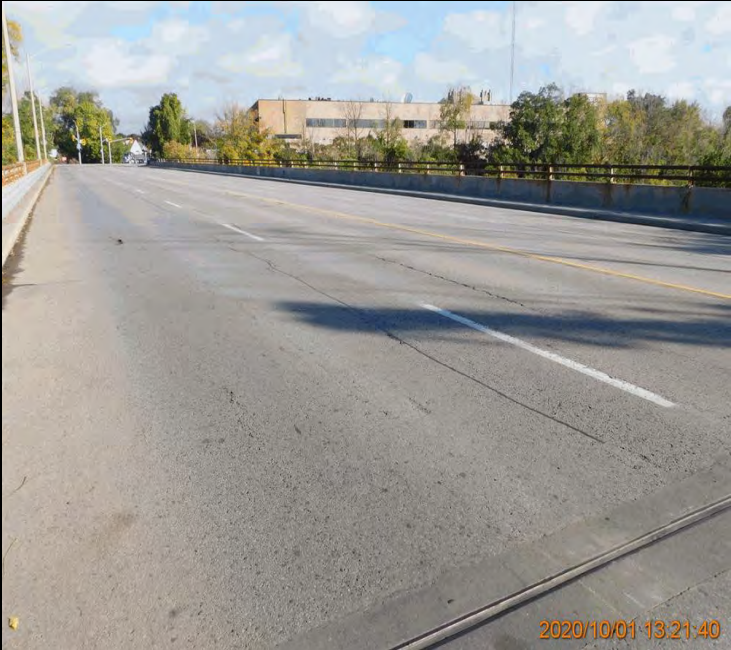
<p>Description Bridge Deck From Southwest Corner. Note: Sealed longitudinal cracks and M-S unsealed longitudinal cracks.</p>

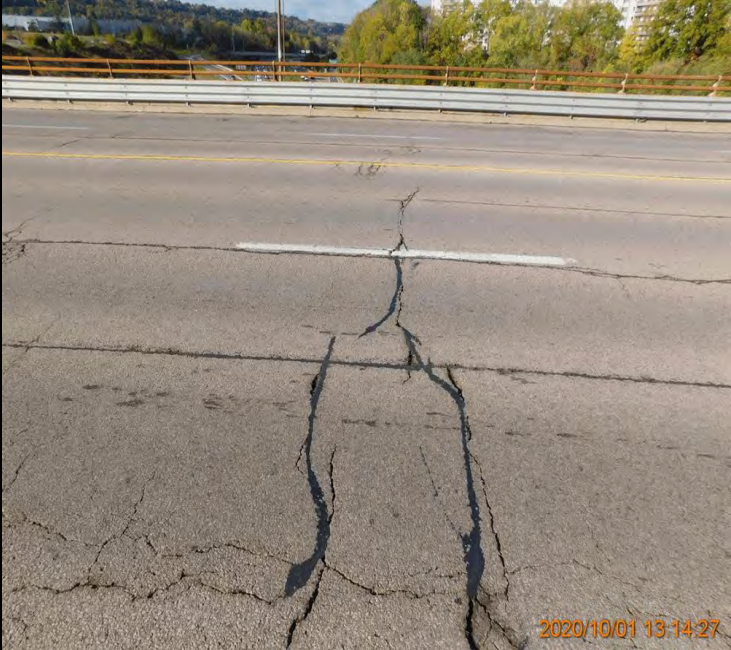
Description Sealed & Unsealed Trans&Longit Cracks @ Pier 3, Looking West		
	Elem Grp/Class Elem Type Sub Element Material Type Locator Defect Descript1 Defect Descript2 Defect Other	Decks/Wearing surface Asphalt Poor condition Cracks	
File Name	09 Sealed & Unsealed Trans&Longit Cracks @ Pier 3, Looking West.JPG

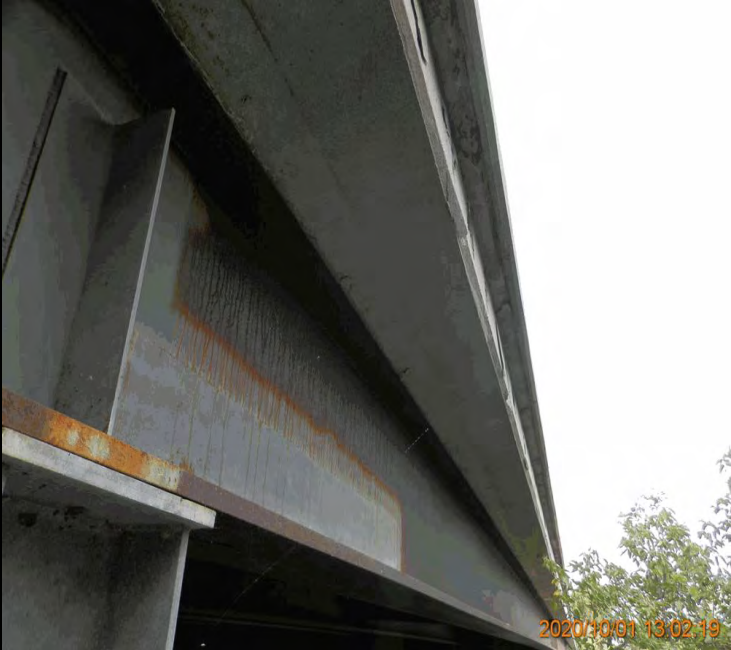
Description East Exterior Soffit at South Abutment, Looking North. Note: Local areas of light delamination on soffit.		
	Elem Grp/Class Elem Type Sub Element Material Type Locator Defect Descript1 Defect Descript2 Defect Other	Decks/Soffit - Thin Slab Exterior Cast-in-place concrete General Poor condition Delamination	
File Name		11 East Exterior Soffit at South Abutment, Looking North.JPG

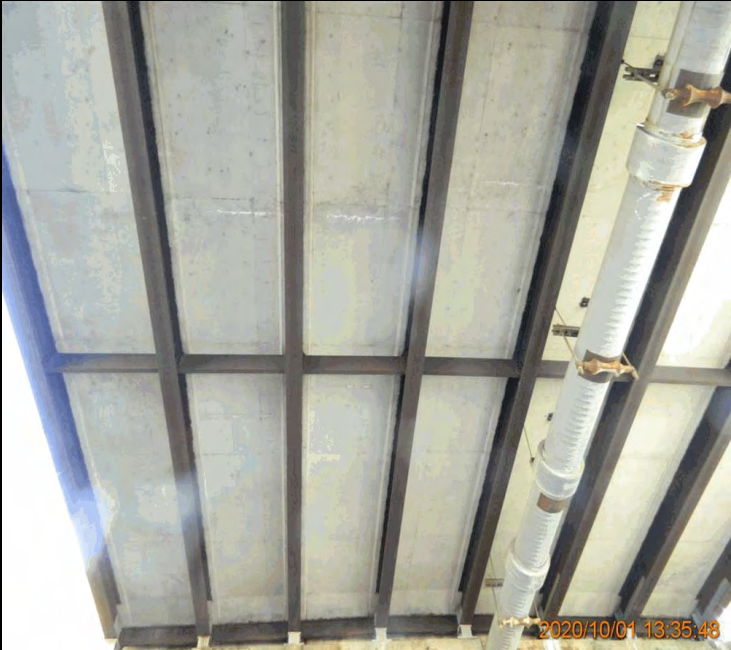
Description Interior Soffit and Girders @ Pier 1, Looking South. Note: N-M efflorescence stained transverse cracks.		
	Elem Grp/Class Elem Type Sub Element Material Type Locator Defect Descript1 Defect Descript2 Defect Other	Decks/Soffit - Thin Slab Interior Cast-in-place concrete General Poor condition Cracks	
File Name		12 Interior Soffit and Girders @ Pier 1, Looking South.JPG

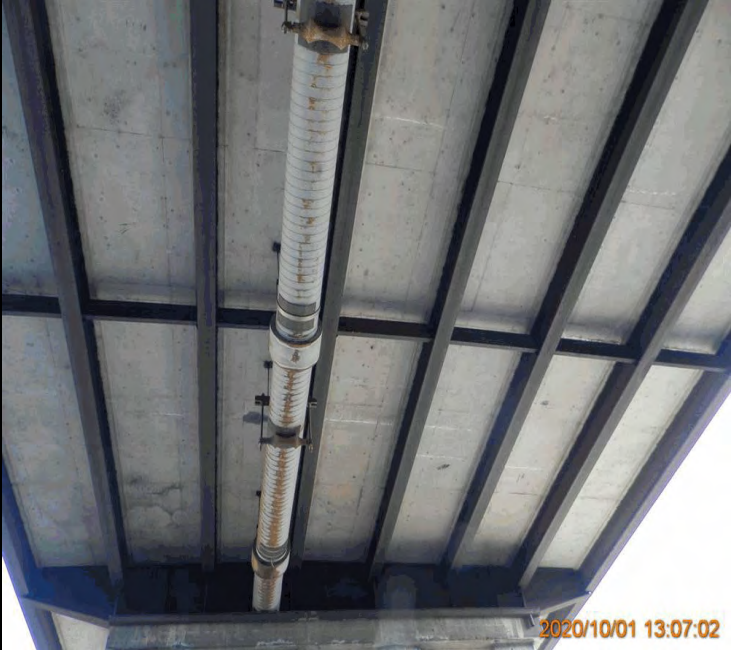
Description Interior Soffit and Girders @ Pier 1, Looking North. Note: N-M efflorescence stained transverse cracks.		
	Elem Grp/Class Elem Type Sub Element Material Type Locator Defect Descript1 Defect Descript2 Defect Other	Decks/Soffit - Thin Slab Interior Cast-in-place concrete General Poor condition Transverse Cracks	
File Name	13 Interior Soffit and Girders @ Pier 1, Looking North.JPG

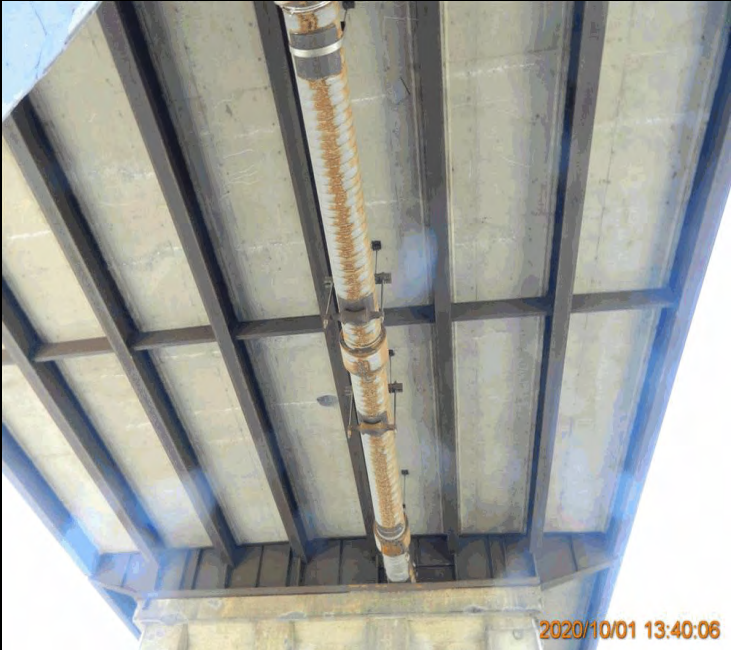
Description Interior Soffit and Girders @ Pier 3, Looking South. Note: N-M efflorescence stained transverse cracks.		
	Elem Grp/Class Elem Type Sub Element Material Type Locator Defect Descript1 Defect Descript2 Defect Other	Decks/Soffit - Thin Slab Interior Cast-in-place concrete General Poor condition Transverse Cracks	
File Name	14 Interior Soffit and Girders @ Pier 3, Looking South.JPG

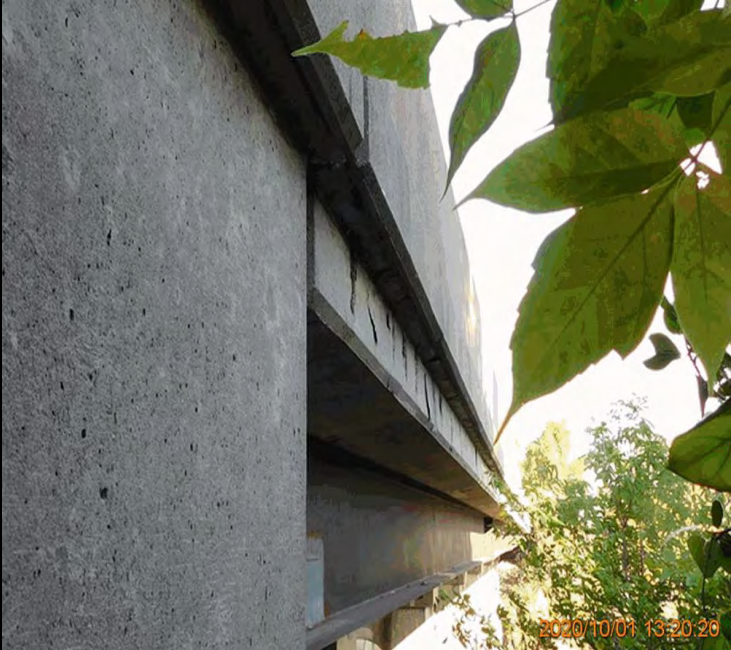
Description Delams & Spalls on West Fascia @ South Abut, looking North		
	Elem Grp/Class Elem Type Sub Element Material Type Locator Defect Descript1 Defect Descript2 Defect Other	Decks/Soffit - Thin Slab End Cast-in-place concrete Poor condition Delamination	
File Name	19 Delams & Spalls on West Fascia @ South Abut, looking North.JPG

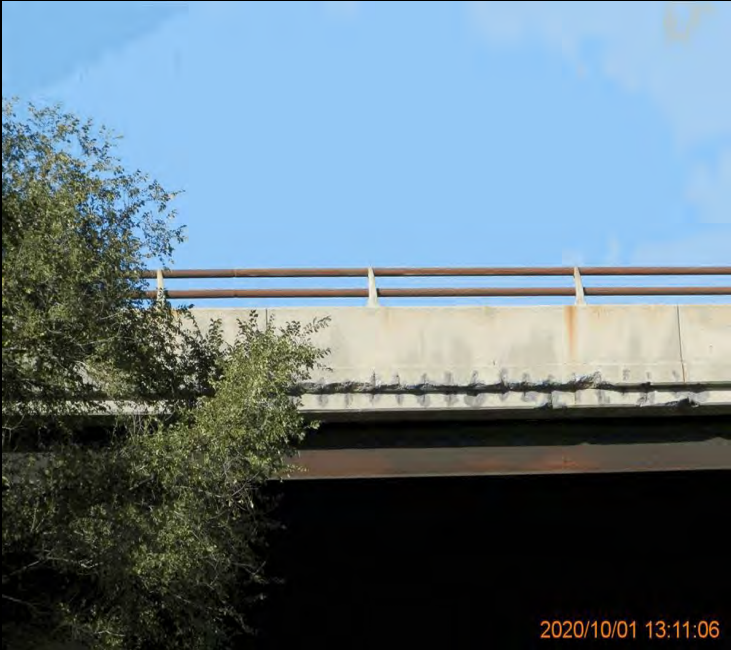
Description Severe Spalls on East Fascia Over Hwy 403 EB		
	Elem Grp/Class Elem Type Sub Element Material Type Locator Defect Descript1 Defect Descript2 Defect Other	Decks/Soffit - Thin Slab Exterior Cast-in-place concrete Poor condition Spalling	
File Name	20 Severe Spalls on East Fascia Over Hwy 403 EB.JPG

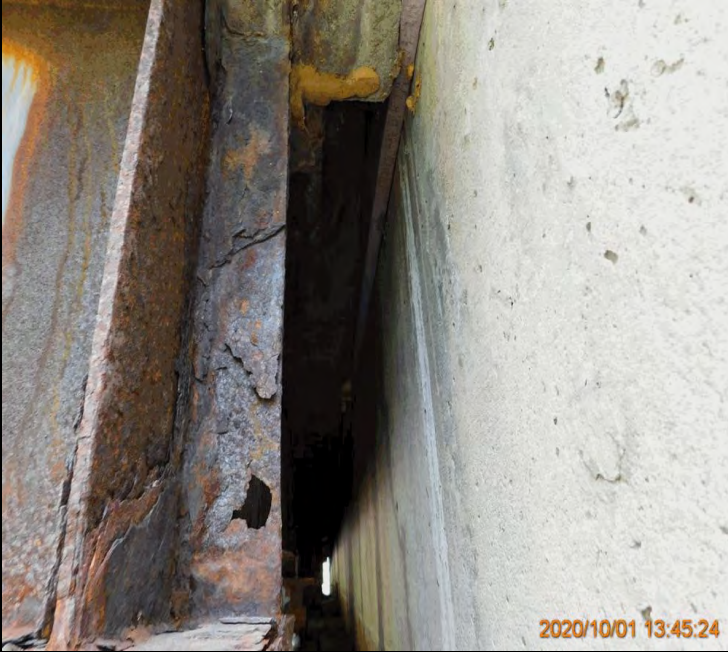
Description		
	M-S Corrosion (TYP) & Local Perforation @ S End of West Girder		
	Elem Grp/Class	Beams/MLE's/Girders	
	Elem Type	I type	
	Sub Element	End	
	Material Type	Steel	
	Locator		
	Defect Descript1	Poor condition	
	Defect Descript2		
	Defect	Corrosion	
	Other		
File Name	25 M-S Corrosion (TYP) & Local Perforation @ S End of West Girder.JPG

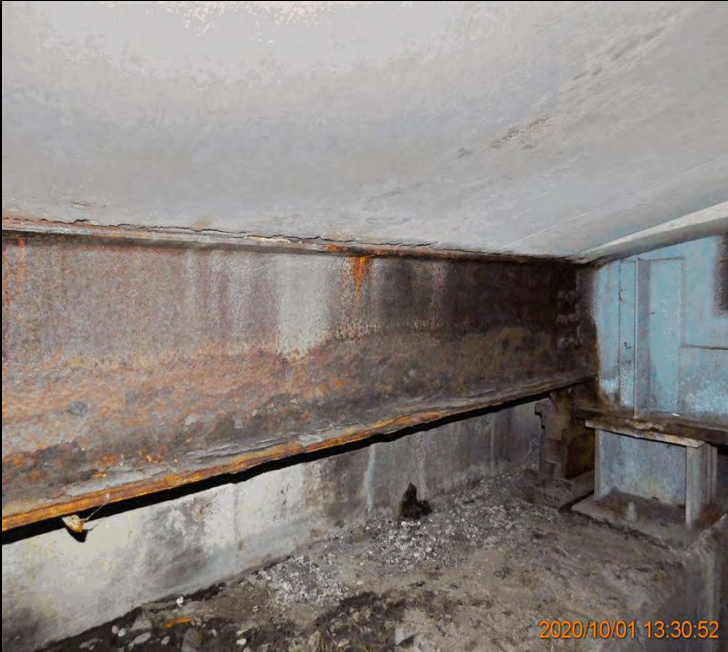
Description		
	Severe Corrosion @ S Abut Diaphragm Btwn Girders 2&3 from East		
	Elem Grp/Class	Beams/MLE's/Diaphragms	
	Elem Type	I type	
	Sub Element	End	
	Material Type	Steel	
	Locator		
	Defect Descript1	Poor condition	
	Defect Descript2		
	Defect	Corrosion	
	Other		
File Name	26 Severe Corrosion @ S Abut Diaphragm Btwn Girders 2&3 from East.JPG

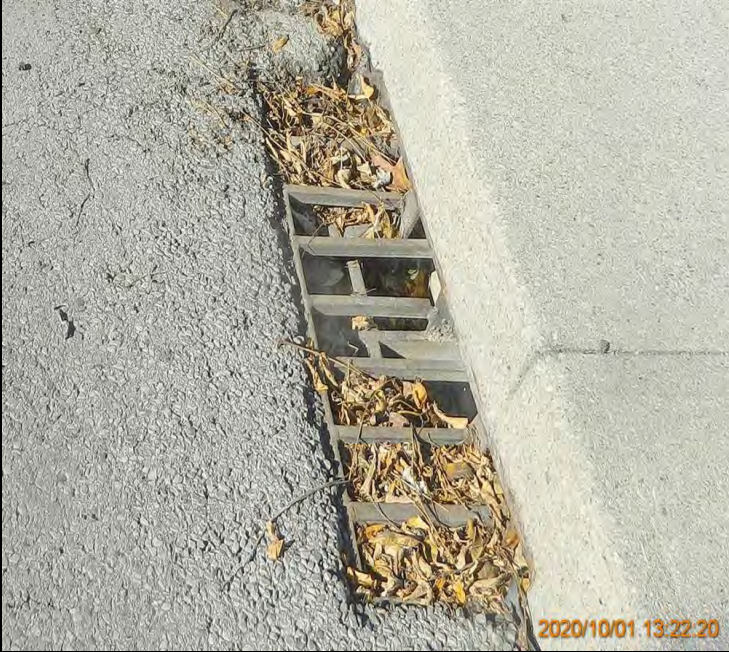
<p style="text-align: right; color: orange; font-size: small;">2020/10/01 13:22:20</p>	<p>Description Deck Drain with Basin at Deck Surface at Span 5, East Drain Shown. Note: Debris filled in deck drain.</p>
<p>Elem Grp/Class Elem Type Sub Element Material Type Locator Defect Descript1 Defect Descript2 Defect Other</p>	<p>Decks/Drainage</p> <p>Good condition</p>
<p>File Name 27 Deck Drain with Basin at Deck Surface at Span 5, East Drain Shown.JPG</p>

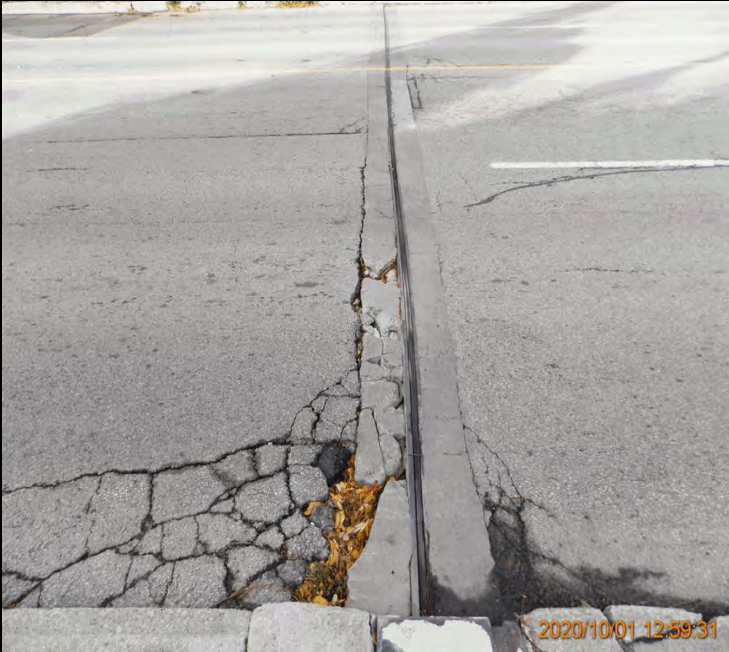
<p style="text-align: right; color: orange; font-size: small;">2020/10/01 12:59:31</p>	<p>Description South Expansion Joint, Looking West. Note: Severe spalling on end dam.</p>
<p>Elem Grp/Class Elem Type Sub Element Material Type Locator Defect Descript1 Defect Descript2 Defect Other</p>	<p>Joints/Concrete end dams</p> <p>Other General Poor condition Spalling</p>
<p>File Name 28 South Expansion Joint, Looking West.JPG</p>

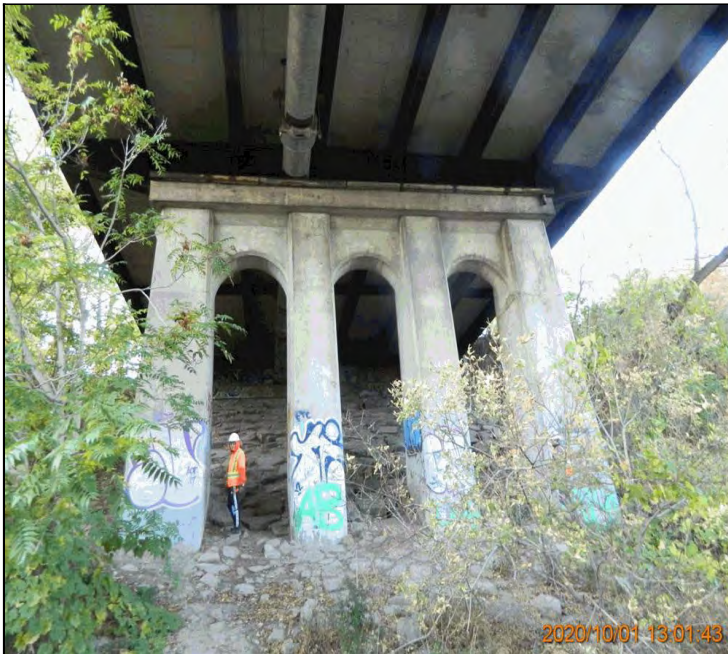
Description South Elevation of Pier 6. Note: Graffiti on pier columns.	
Elem Grp/Class	Piers/Shfts/columns/Pile Bent
Elem Type	Conc rectangular columns with
Sub Element	
Material Type	Cast-in-place concrete
Locator	General
Defect Descript1	
Defect Descript2	
Defect	
Other

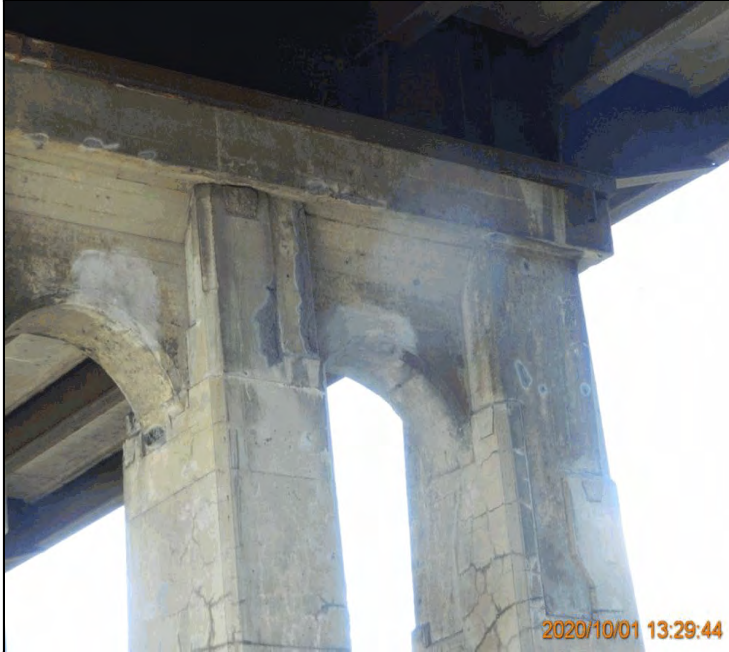
Description M-S Spalls on South Face of Pier 2 Columns and Cap	
Elem Grp/Class	Piers/Caps
Elem Type	
Sub Element	
Material Type	Cast-in-place concrete
Locator	
Defect Descript1	Poor condition
Defect Descript2	
Defect	Spalling
Other

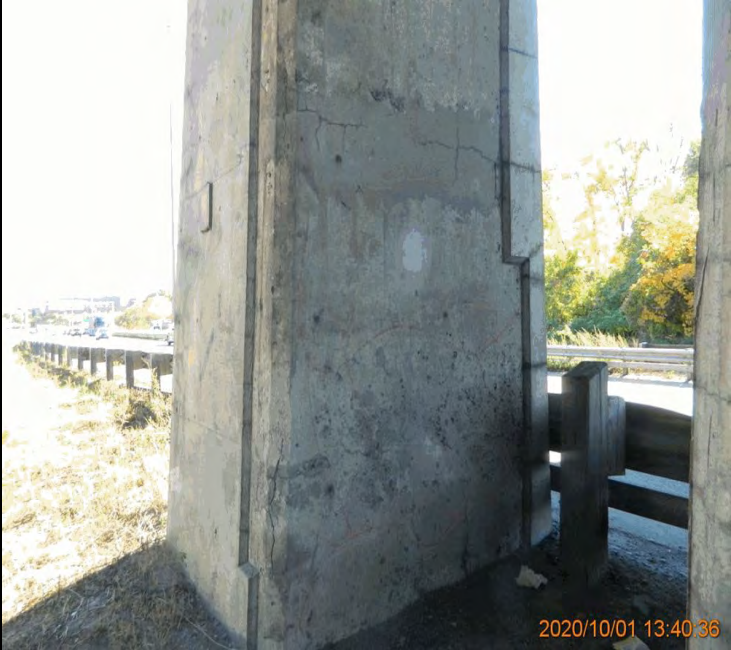
<p style="text-align: right; color: orange; font-size: small;">2020/10/01 13:40:36</p>	<p>Description</p> <p>Very Severe Delam on Column 4 From West @ Pier P3 (TYP)</p>

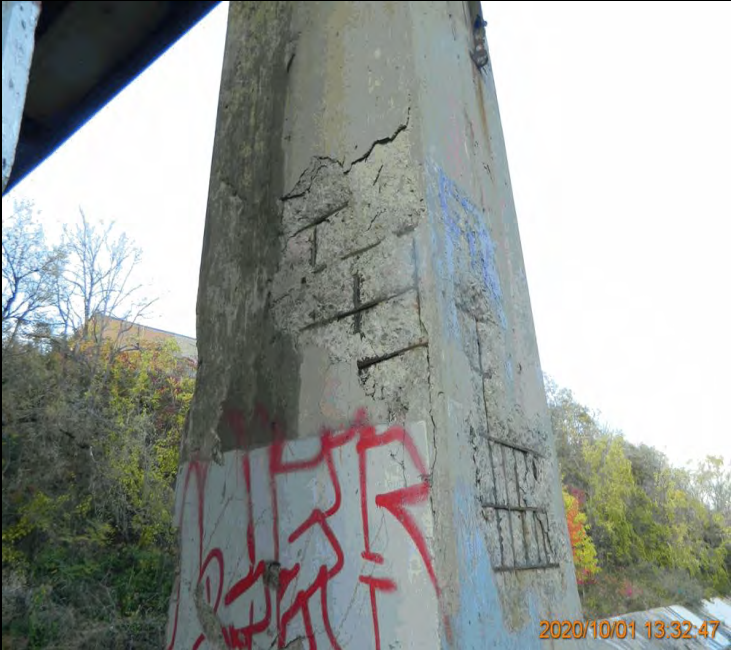
<p style="text-align: right; color: orange; font-size: small;">2020/10/01 13:32:47</p>	<p>Description</p> <p>Very Severe Spalls on South & West Face of Column @ Pier 4 (TYP).</p>

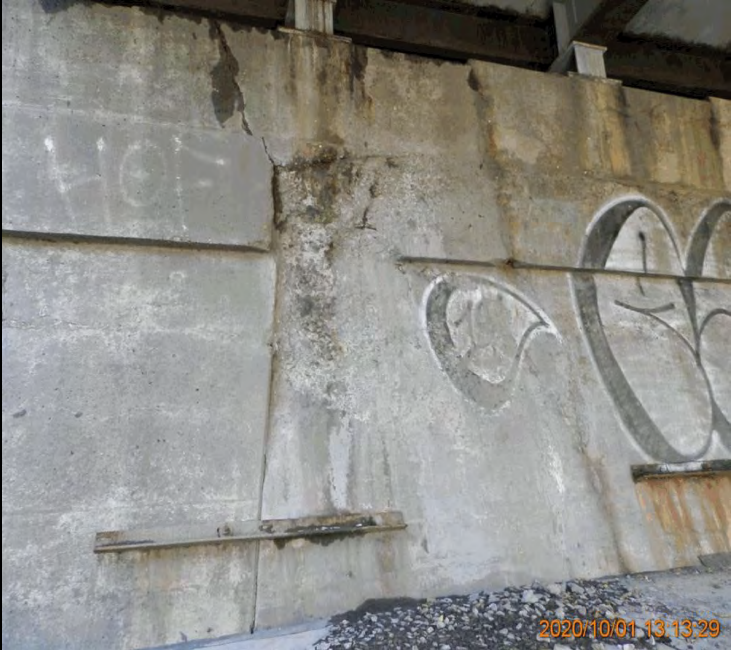
S delam @ W end of N abut. Multiple S spalls @ upper W section of south abutment. S delam @ central section of S abut. VS spalls @ E section of S abut. Few M-W stained vertical cracks & local wet stains on both abutments. (Ref Photos: #57-61).

Description	Very Severe Spall @ East Section of South Abutment	
	Elem Grp/Class	Abutments/Abutment walls	
Elem Type	Conventional closed		
Sub Element			
Material Type	Cast-in-place concrete		
Locator			
Defect Descript1	Poor condition		
Defect Descript2			
Defect	Spalling		
Other			
File Name	59 Very Severe Spall @ East Section of South Abutment.JPG

Recommended Work	Category	Timing	Quantity	Unit Cost	Total Cost (\$)
CO301 Rehab Concrete (sqm)	Major Rehab	1 - 5 year	12.000	650	7800

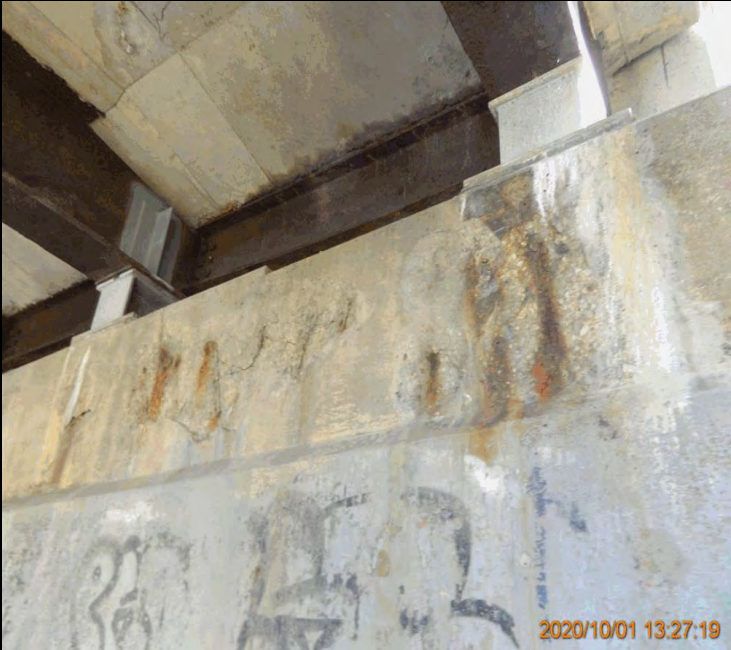
Description	Severe Shallow Spalls @ West Section of South Abutment	
	Elem Grp/Class	Abutments/Abutment walls	
Elem Type	Conventional closed		
Sub Element			
Material Type	Cast-in-place concrete		
Locator			
Defect Descript1	Poor condition		
Defect Descript2			
Defect	Spalling		
Other			
File Name	60 Severe Shallow Spalls @ West Section of South Abutment.JPG

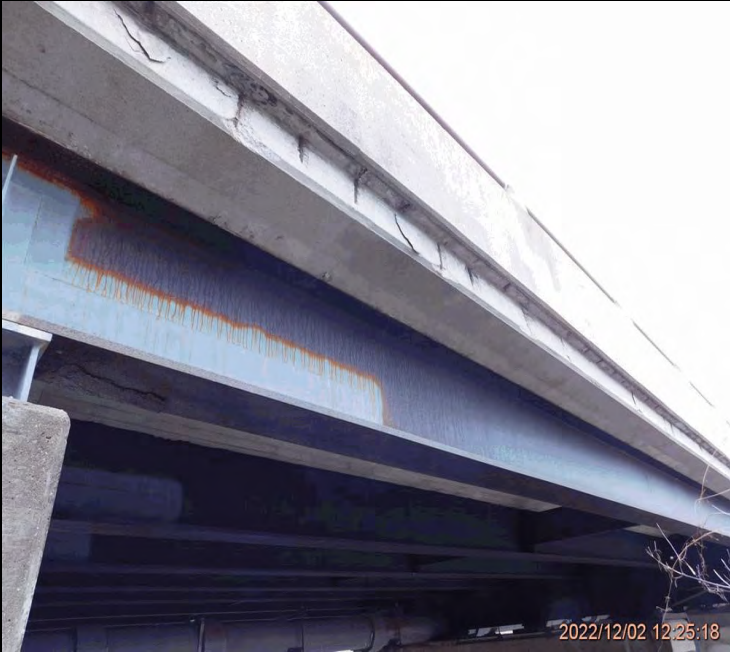
Description Local Delamination & Spalls on South Section of East Fascia

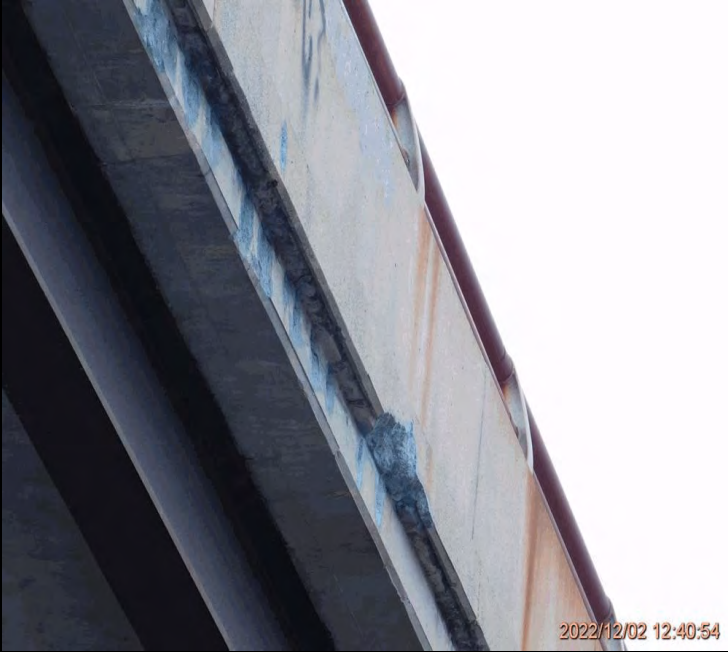
Description		
	Removed Loose Concrete Areas over Hwy 403, East Edge at Span 2 Shown		
Elem Grp/Class		Decks/Soffit - Thin Slab	
Elem Type		Exterior	
Sub Element		Cast-in-place concrete	
Material Type		Cast-in-place concrete	
Locator		East	
Defect Descript1		Poor condition	
Defect Descript2			
Defect		Spalling	
Other			
File Name	09 Removed Loose Concrete Areas over Hwy 403, East Edge at Span 2 Shown.JPG

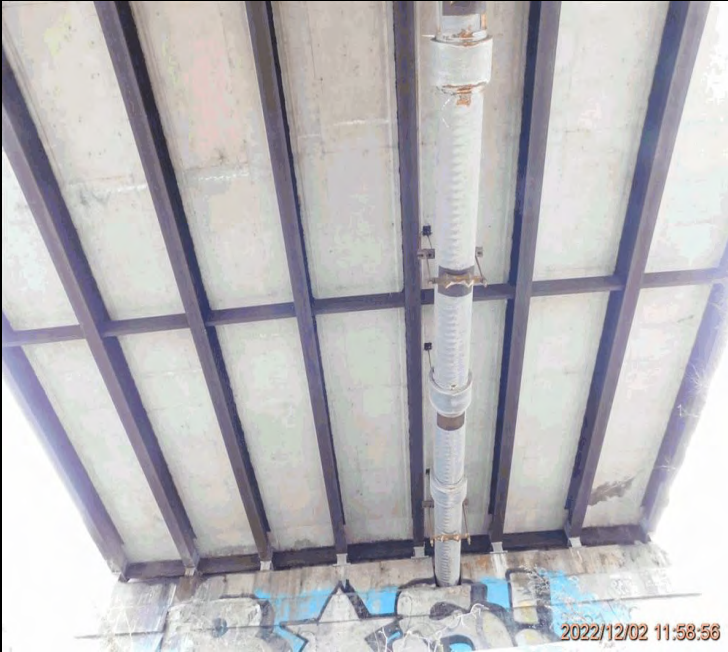
Description		
	South Span (Span 1), Interior Soffit, looking South		
Elem Grp/Class		Decks/Soffit - Thin Slab	
Elem Type		Interior	
Sub Element		Cast-in-place concrete	
Material Type		Cast-in-place concrete	
Locator		Interior	
Defect Descript1		Good condition	
Defect Descript2			
Defect			
Other			
File Name	10 South Span (Span 1), Interior Soffit, looking South.JPG

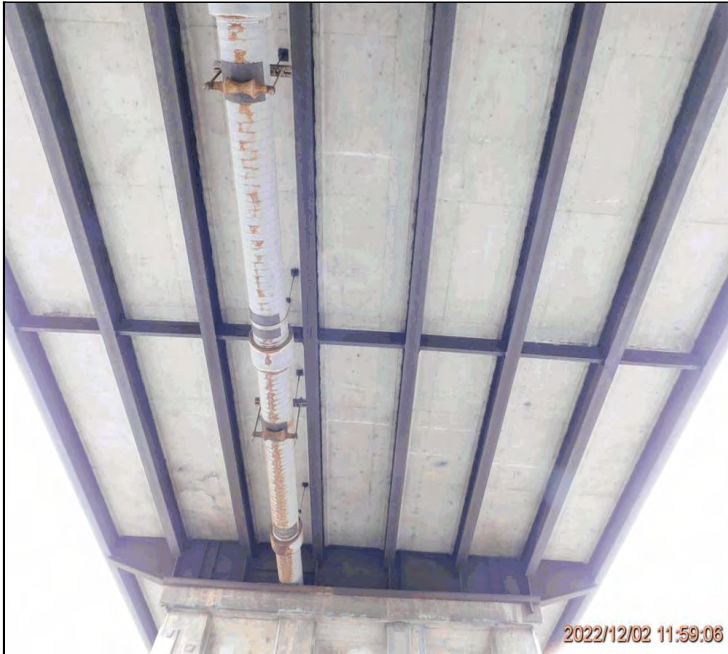
File Name 11 South Intermediate Span (Span 2), Interior Soffit over 403EB, looking North.JPG

Description South Intermediate Span (Span 2), Interior Soffit over 403EB, looking North	
Elem Grp/Class	Decks/Soffit - Thin Slab
Elem Type	
Sub Element	Interior
Material Type	Cast-in-place concrete
Locator	Interior
Defect Descript1	Good condition
Defect Descript2	
Defect	
Other

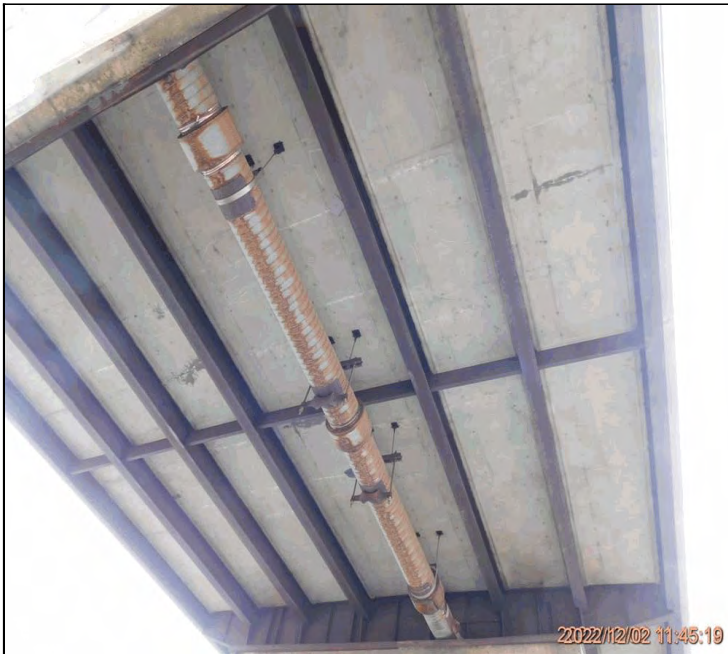
File Name 12 Span 3, Interior Soffit over 403WB, looking South.JPG

Description Span 3, Interior Soffit over 403WB, looking South	
Elem Grp/Class	Decks/Soffit - Thin Slab
Elem Type	
Sub Element	Interior
Material Type	Cast-in-place concrete
Locator	Interior
Defect Descript1	Good condition
Defect Descript2	
Defect	
Other

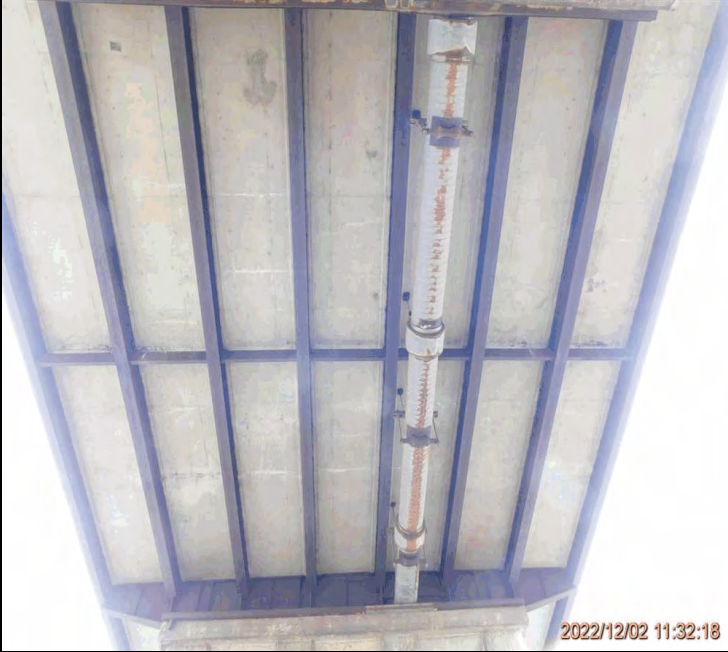
<p style="text-align: right; font-size: small; color: red;">2022/12/02 11:32:18</p>	<p>Description Span 4, Interior Soffit, looking South</p>

Elem Grp/Class	Decks/Soffit - Thin Slab	Elem Type		Sub Element	Interior	Material Type	Cast-in-place concrete	Locator	Interior	Defect Descript1	Good condition	Defect Descript2		Defect		Other
Elem Grp/Class	Decks/Soffit - Thin Slab																	
Elem Type																		
Sub Element	Interior																	
Material Type	Cast-in-place concrete																	
Locator	Interior																	
Defect Descript1	Good condition																	
Defect Descript2																		
Defect																		
Other																		
File Name	13 Span 4, Interior Soffit, looking South.JPG

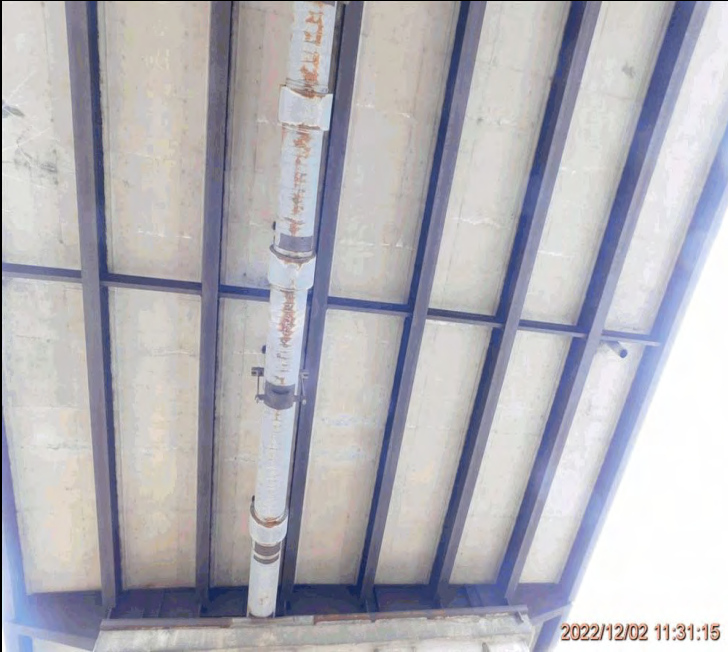
<p style="text-align: right; font-size: small; color: red;">2022/12/02 11:31:15</p>	<p>Description Span 5, Interior Soffit, looking North</p>

Elem Grp/Class	Decks/Soffit - Thin Slab	Elem Type		Sub Element	Interior	Material Type	Cast-in-place concrete	Locator	Interior	Defect Descript1	Good condition	Defect Descript2		Defect		Other
Elem Grp/Class	Decks/Soffit - Thin Slab																	
Elem Type																		
Sub Element	Interior																	
Material Type	Cast-in-place concrete																	
Locator	Interior																	
Defect Descript1	Good condition																	
Defect Descript2																		
Defect																		
Other																		
File Name	14 Span 5, Interior Soffit, looking North.JPG

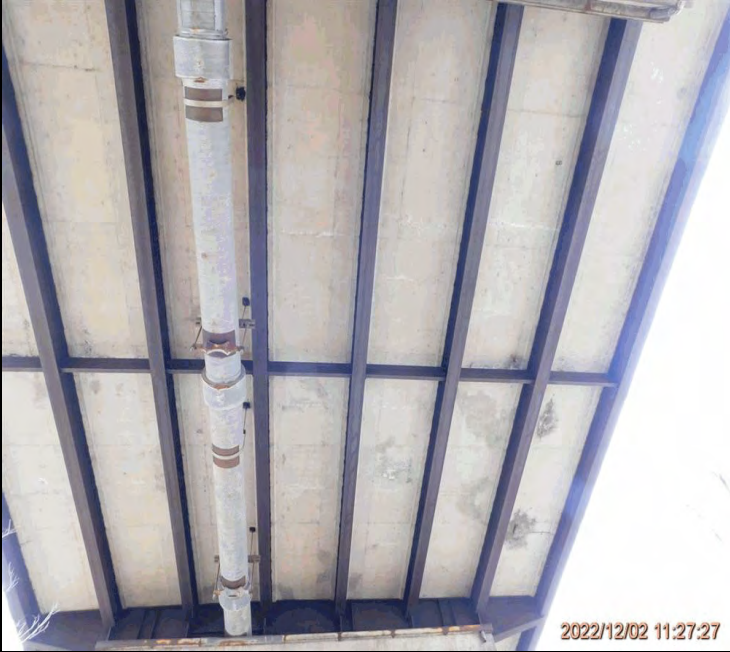
Description North Intermediate Span (Span 6), Interior Soffit, looking North		
	Elem Grp/Class Elem Type Sub Element Material Type Locator Defect Descript1 Defect Descript2 Defect Other	Decks/Soffit - Thin Slab Interior Cast-in-place concrete Interior Good condition Stained	
File Name	15 North Intermediate Span (Span 6), Interior Soffit, looking North.JPG

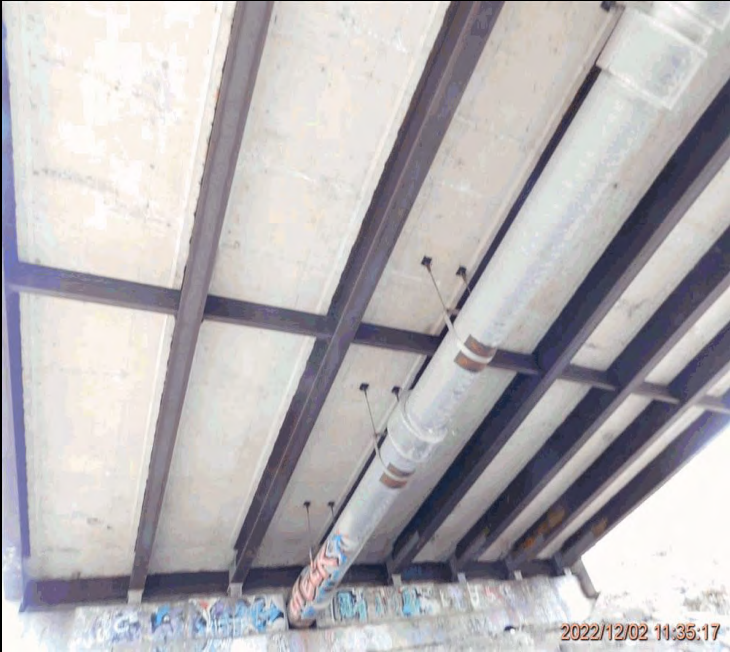
Description North Span (Span 7), Interior Soffit, looking North		
	Elem Grp/Class Elem Type Sub Element Material Type Locator Defect Descript1 Defect Descript2 Defect Other	Decks/Soffit - Thin Slab Interior Cast-in-place concrete Interior Good condition	
File Name	16 North Span (Span 7), Interior Soffit, looking North.JPG

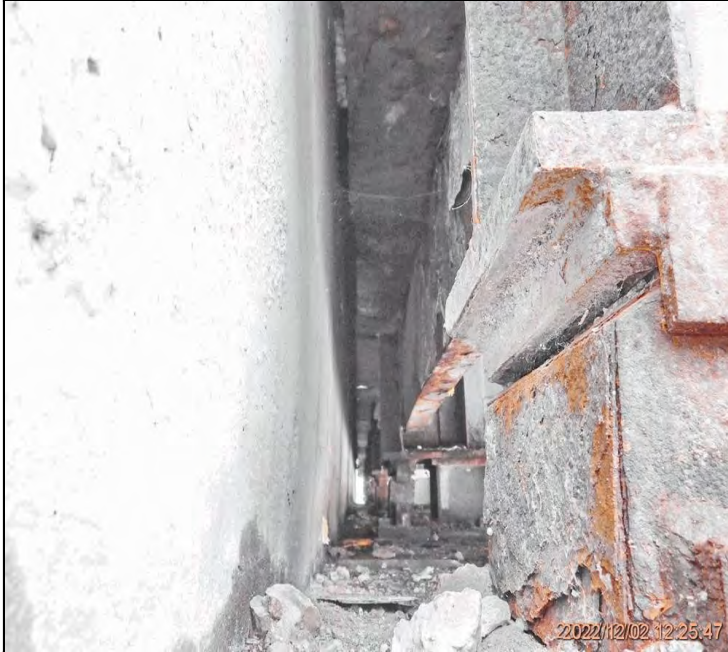
File Name 17 Local Small Delam and Heavy Corrosion below South Expansion Joint, looking West.JPG

Description Local Small Delam and Heavy Corrosion below South Expansion Joint, looking West	
Elem Grp/Class	Decks/Soffit - Thin Slab
Elem Type	End
Sub Element	Cast-in-place concrete
Material Type	South
Locator	Fair condition
Defect Descript1	
Defect Descript2	
Defect	Stained
Other

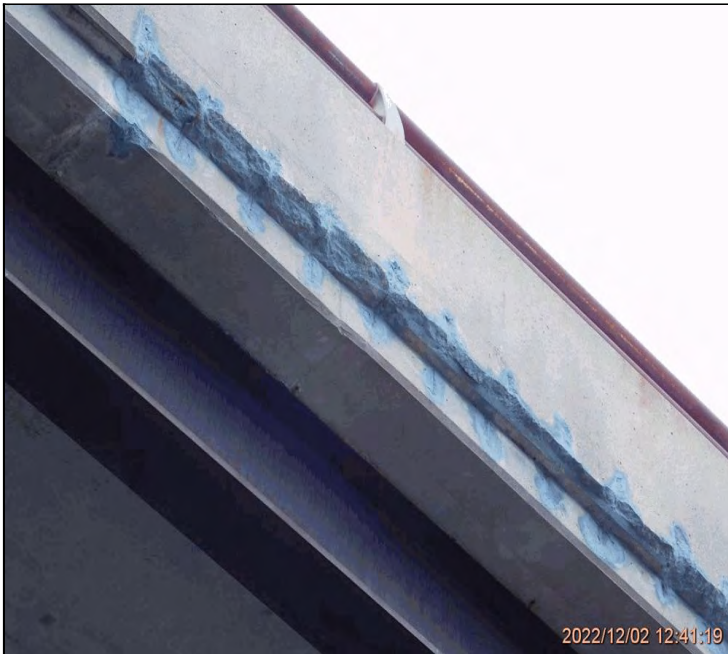
File Name 18 Severe Spall on East Exterior Soffit between Pier 1 and 2.JPG

Description Severe Spall on East Exterior Soffit between Pier 1 and 2	
Elem Grp/Class	Decks/Soffit - Thin Slab
Elem Type	Exterior
Sub Element	Cast-in-place concrete
Material Type	Exterior
Locator	Poor condition
Defect Descript1	
Defect Descript2	
Defect	Spalling
Other

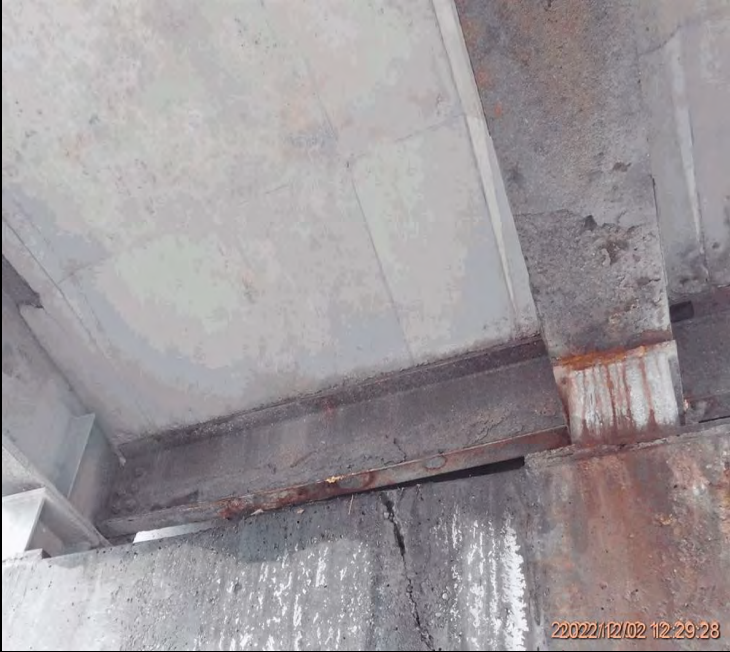
Description Heavy Corrosion on End-Diaphragm & Bottom of Girders at SE Corner of South Span Soffit	
	Elem Grp/Class Elem Type Sub Element Material Type Locator Defect Descript1 Defect Descript2 Defect Other	Beams/MLE's/Girders I type End Weathering steel South Poor condition Corrosion
File Name 19 Heavy Corrosion on End-Diaphragm & Bottom of Giders at SE Corner of South Span Soffit.JPG

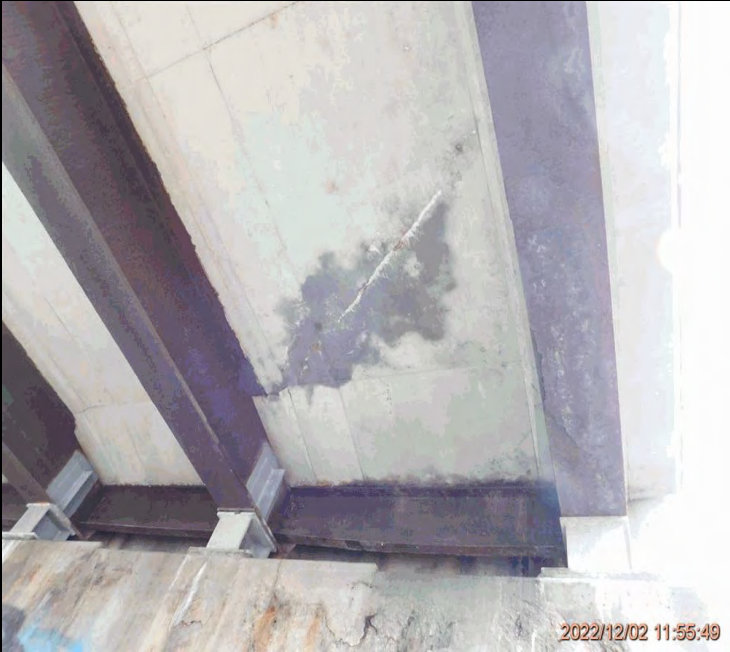
Description Stained Crack with Wet Area at SW Corner of South Span Soffit	
	Elem Grp/Class Elem Type Sub Element Material Type Locator Defect Descript1 Defect Descript2 Defect Other	Decks/Soffit - Thin Slab End Cast-in-place concrete South Fair condition Crack
File Name 20 Stained Crack with Wet Area at SW Corner of South Span Soffit.JPG

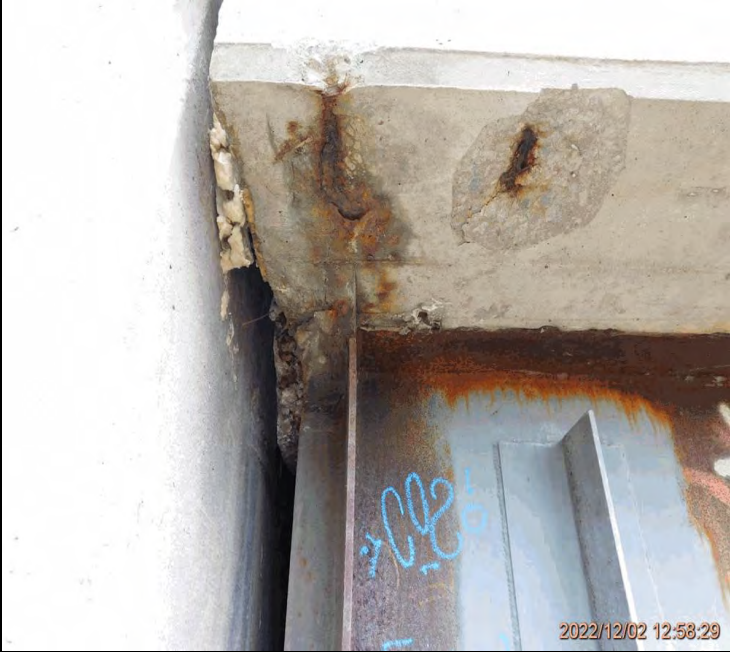
Description		
	Local Spalls at NW Corner of North Span Soffit		
		Elem Grp/Class	Decks/Soffit - Thin Slab
		Elem Type	End
		Sub Element	Cast-in-place concrete
		Material Type	North
		Locator	Poor condition
		Defect Descript1	Spalling
		Defect Descript2	
		Defect	
		Other	
File Name	21 Local Spalls at NW Corner of North Span Soffit.JPG

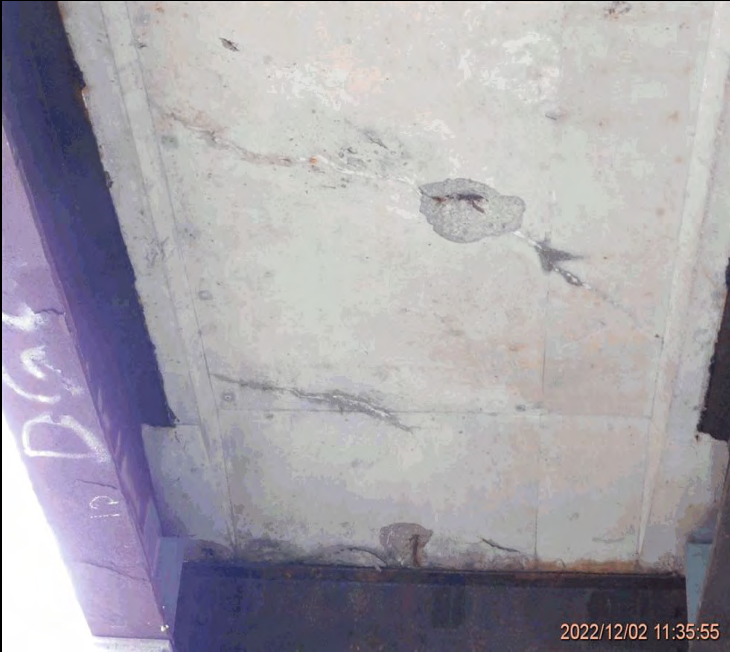
Description		
	Local Delam, Spalls, and Narrow-Medium Stained Cracks on NW Section of North Span Soffit		
		Elem Grp/Class	Decks/Soffit - Thin Slab
		Elem Type	End
		Sub Element	Cast-in-place concrete
		Material Type	North
		Locator	Fair condition
		Defect Descript1	Crack
		Defect Descript2	
		Defect	
		Other	
File Name	22 Local Delam, Spalls, and Narrow-Medium Stained Cracks on NW Section of North Span Soffit.JPG

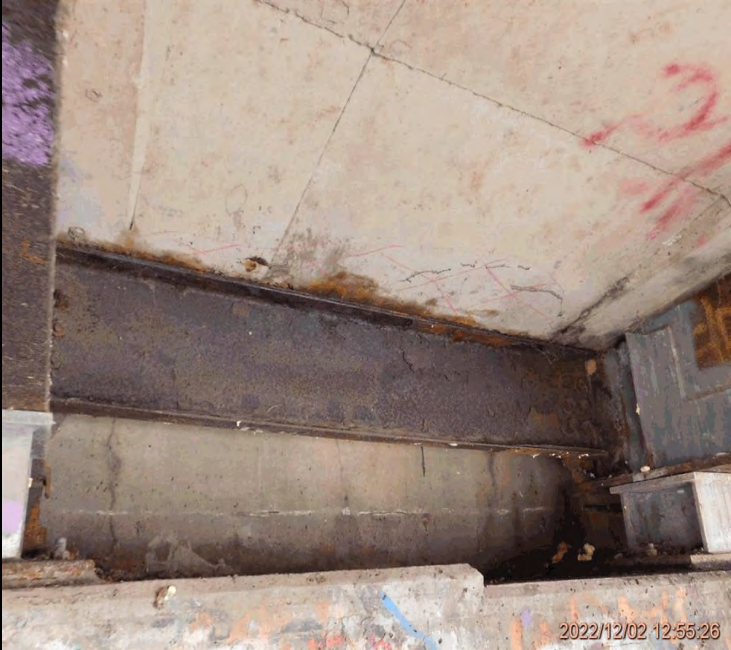
Description Severe Delam on Soffit & Heavy Corrosion on End-Diaphragm at NE Corner of North Span Soffit		
	Elem Grp/Class Elem Type Sub Element Material Type Locator Defect Descript1 Defect Descript2 Defect Other	Decks/Soffit - Thin Slab End Cast-in-place concrete North Poor condition Delamination	
File Name	23 Severe Dalam on Soffit & Heavy Corrosion on End-Diaphragm at NE Corner of North Span Soffit

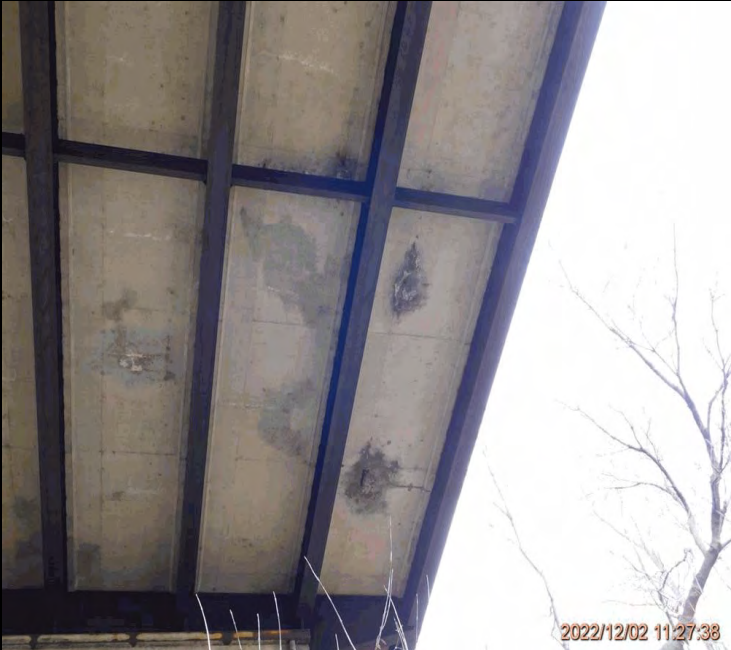
Description Wet Areas with Local Spalls on NE Seciton of Soffit at Span 6		
	Elem Grp/Class Elem Type Sub Element Material Type Locator Defect Descript1 Defect Descript2 Defect Other	Decks/Soffit - Thin Slab Interior Cast-in-place concrete Interior Fair condition Staining	
File Name	24 Wet Areas with Local Spalls on NE Seciton of Soffit at Span 6.JPG

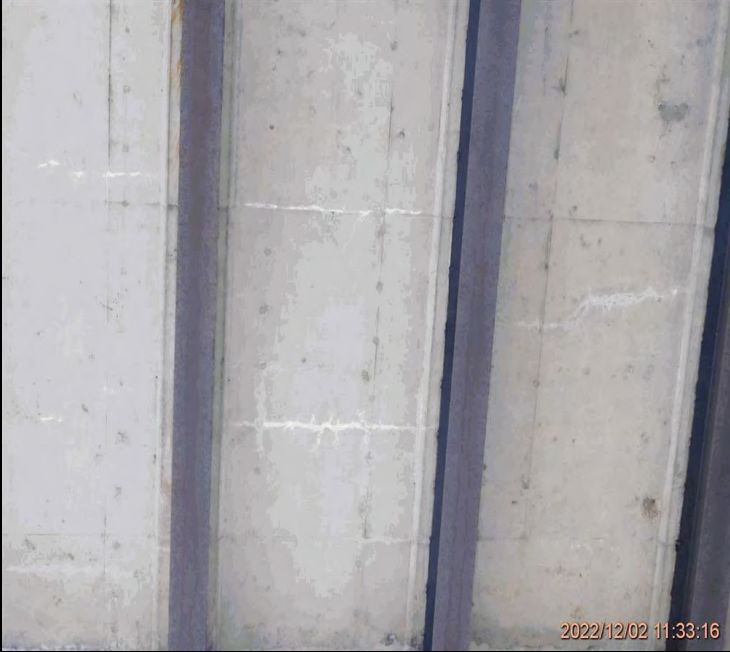
Description Typical Narrow Stained Cracks on Interior Soffit, Span 4 Shown

Elem Grp/Class	Decks/Soffit - Thin Slab	Elem Type		Sub Element	Interior	Material Type	Cast-in-place concrete	Locator	Interior	Defect Descript1	Good condition	Defect Descript2		Defect	Crack	Other
Elem Grp/Class	Decks/Soffit - Thin Slab																	
Elem Type																		
Sub Element	Interior																	
Material Type	Cast-in-place concrete																	
Locator	Interior																	
Defect Descript1	Good condition																	
Defect Descript2																		
Defect	Crack																	
Other																		
File Name	25 Typical Narrow Stained Cracks on Interior Soffit, Span 4 Shown.JPG

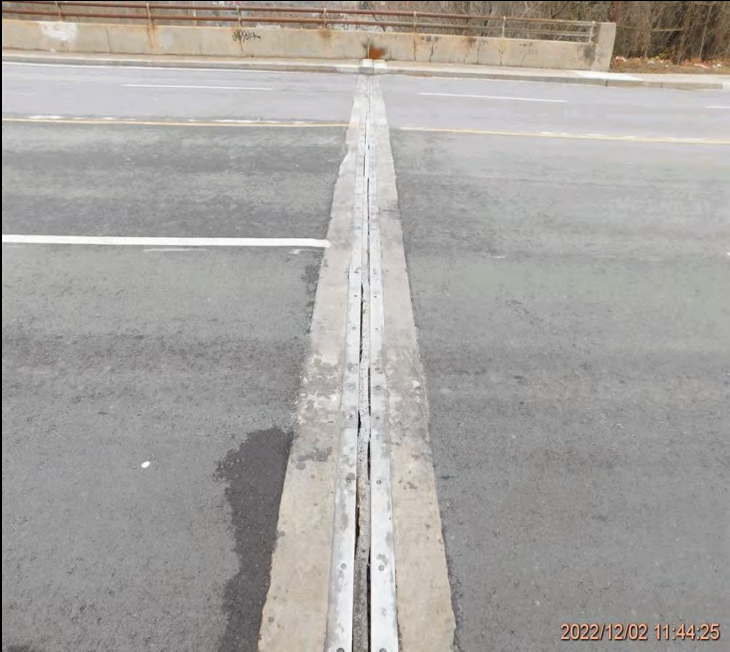
Description South Expansion Joint, looking East

Elem Grp/Class	Joints/Concrete end dams	Elem Type		Sub Element		Material Type	Cast-in-place concrete	Locator	South	Defect Descript1	Excellent condition	Defect Descript2		Defect		Other
Elem Grp/Class	Joints/Concrete end dams																	
Elem Type																		
Sub Element																		
Material Type	Cast-in-place concrete																	
Locator	South																	
Defect Descript1	Excellent condition																	
Defect Descript2																		
Defect																		
Other																		
File Name	26 South Expansion Joint, looking East.JPG

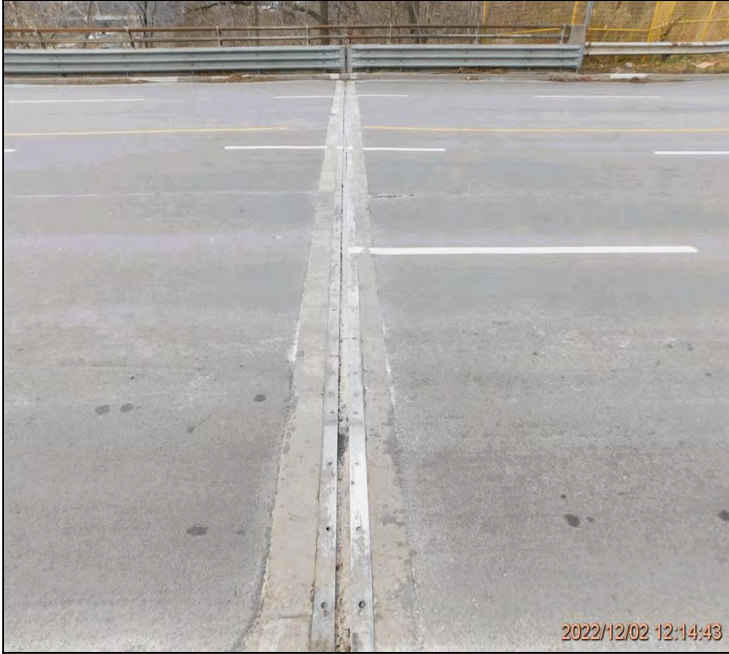
File Name 27 North Expansion Joint, looking West.JPG

Description
North Expansion Joint, looking West

Elem Grp/Class	Joints/Armoring/retaining device
Elem Type	
Sub Element	
Material Type	Steel
Locator	North
Defect Descript1	Excellent condition
Defect Descript2	
Defect	
Other
