COMMUNICATION UPDATE

TO:	Mayor and Members City Council
DATE:	February 1, 2024
SUBJECT:	Longwood Road Bridge (Bridge 282) Upcoming Reconstruction (ENG24001) (City Wide)
WARD(S) AFFECTED:	City Wide
SUBMITTED BY:	Jackie Kennedy Director, Engineering Services Public Works Department
SIGNATURE:

Appendix "A" to Communication Update ENG24001: BRIDGE 282_2020_OSIM

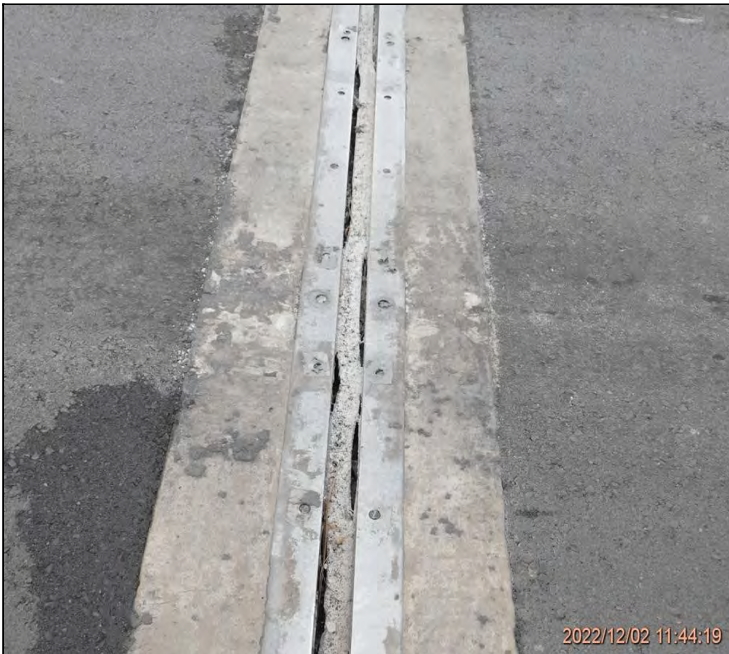
Description
South Expansion Joint, Gaps from Debonded Caulking atop Joint Seal (TYP)

Elem Grp/Class	Joints/Seals/sealants
Elem Type	Other
Sub Element	
Material Type	
Locator	South
Defect Descript1	Good condition
Defect Descript2	
Defect	
Other

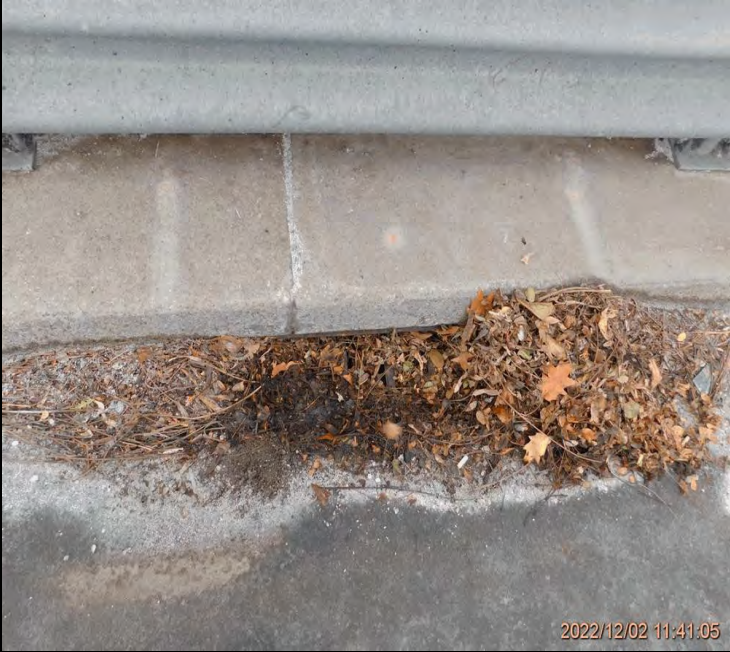
Description	Typical Debris CLogging Deck Drain, West Drain Shown	
	Elem Grp/Class	Decks/Drainage	
Elem Type	Drain pipes with basins		
Sub Element			
Material Type	Steel		
Locator	West		
Defect Descript1	Good condition		
Defect Descript2			
Defect			
Other			
File Name	29 Typical Debris CLogging Deck Drain, West Drain Shown.JPG

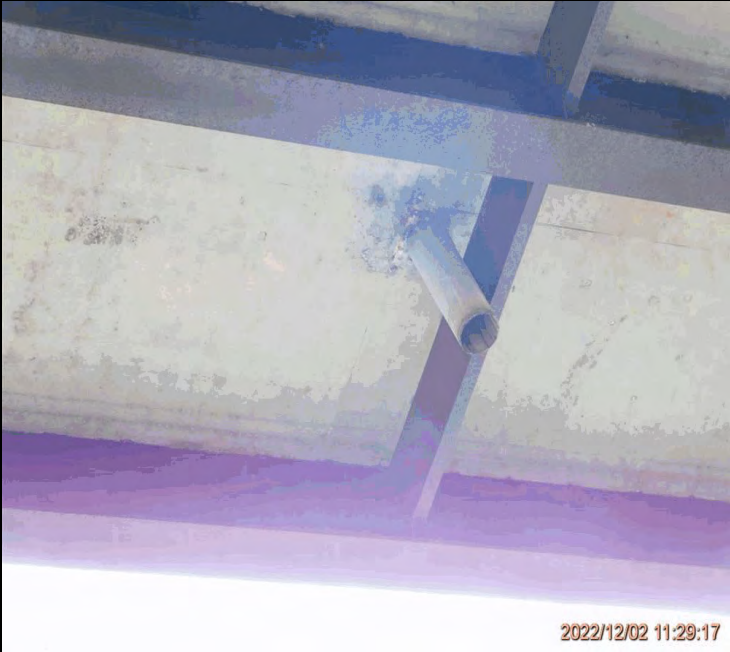
Description	Typical Drain Downspout, East Drain in Span 5 Shown	
	Elem Grp/Class	Decks/Drainage	
Elem Type	Drain pipes with basins		
Sub Element			
Material Type	Steel		
Locator	East		
Defect Descript1	Good condition		
Defect Descript2			
Defect			
Other			
File Name	30 Typical Drain Downspout, East Drain in Span 5 Shown.JPG

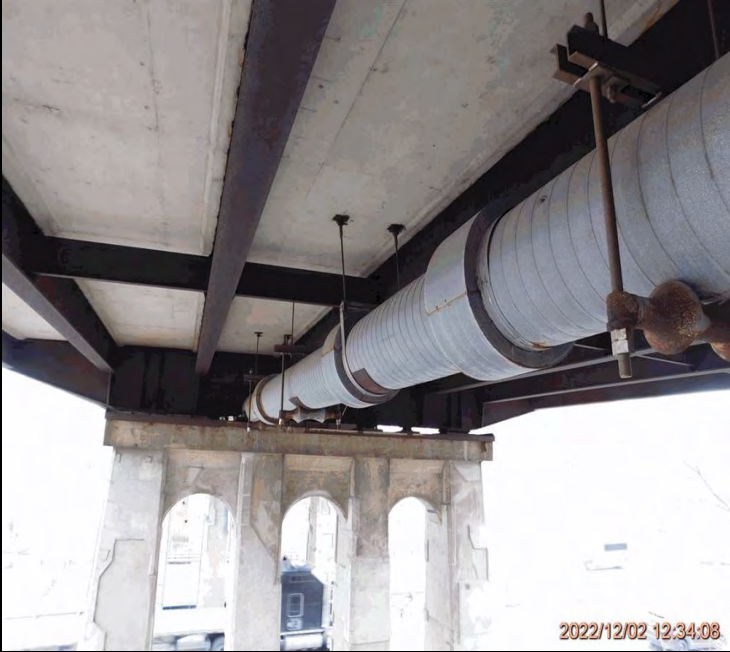
<p style="text-align: right; font-size: small; color: red;">2022/12/02 12:34:08</p>	Description	Insulated Watermain below Bridge deck, looking North

Elem Grp/Class	Attachments, Signs, and Utilities	Elem Type		Sub Element		Material Type		Locator	South	Defect Descript1	Good condition	Defect Descript2		Defect		Other		
Elem Grp/Class	Attachments, Signs, and Utilities																			
Elem Type																				
Sub Element																				
Material Type																				
Locator	South																			
Defect Descript1	Good condition																			
Defect Descript2																				
Defect																				
Other																				
File Name	31 Insulated Watermain below Bridge deck, looking North.JPG

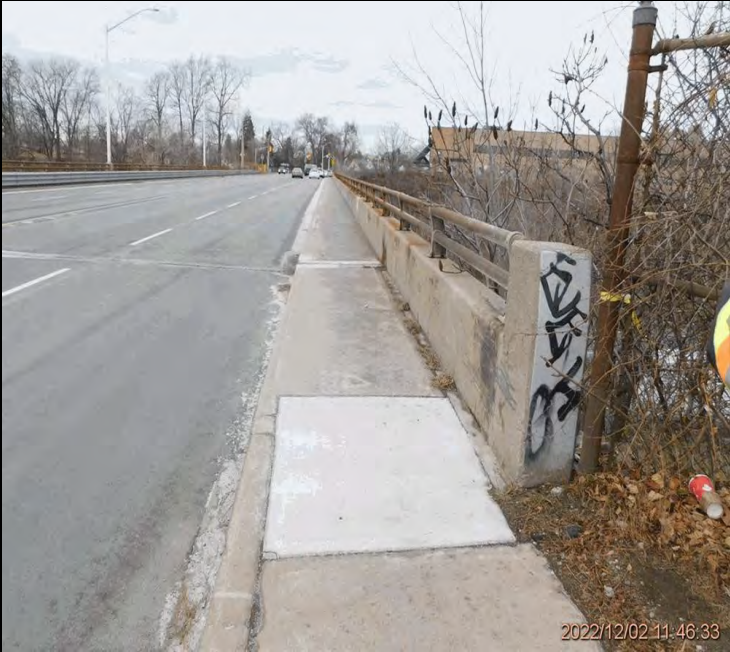
<p style="text-align: right; font-size: small; color: red;">2022/12/02 11:46:33</p>	Description	East Sidewalk & Parapet Wall from South

Elem Grp/Class	Sidewalks/curbs/Curbs	Elem Type		Sub Element		Material Type	Cast-in-place concrete	Locator	East	Defect Descript1	Good condition	Defect Descript2		Defect		Other		
Elem Grp/Class	Sidewalks/curbs/Curbs																			
Elem Type																				
Sub Element																				
Material Type	Cast-in-place concrete																			
Locator	East																			
Defect Descript1	Good condition																			
Defect Descript2																				
Defect																				
Other																				
File Name	32 East Sidewalk & Parapet Wall from South.JPG

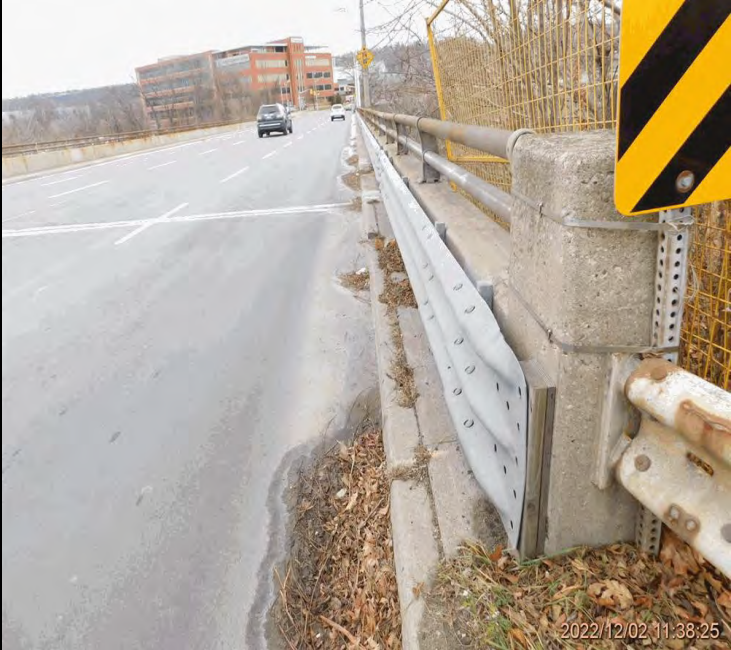
Description West Curb & Parapet Wall from North		
	Elem Grp/Class	Sidewalks/curbs/Curbs	
Elem Type			
Sub Element			
Material Type	Cast-in-place concrete		
Locator	West		
Defect Descript1	Good condition		
Defect Descript2			
Defect			
Other			
File Name	33 West Curb & Parapet Wall from North.JPG

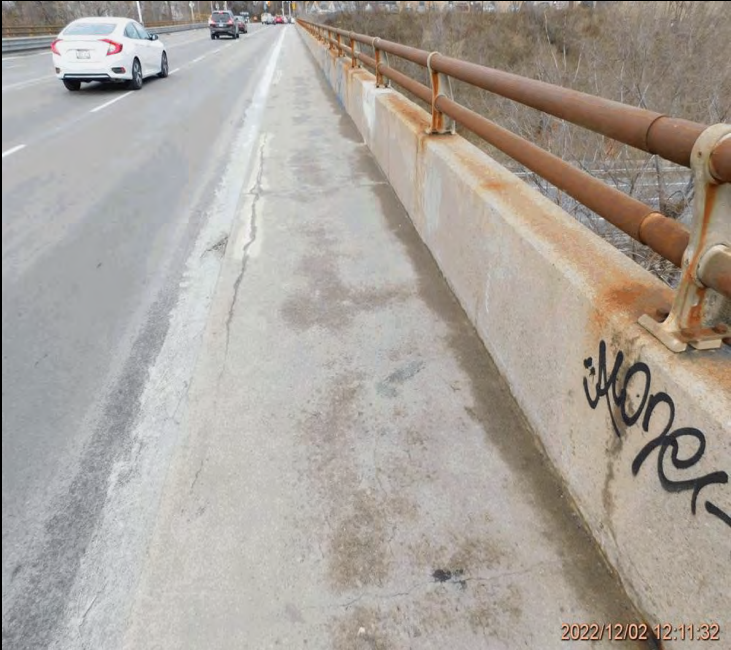
Description Wide Longitudinal Crack on South Section of East Sidewalk, looking North		
	Elem Grp/Class	Sidewalks/curbs/Curbs	
Elem Type			
Sub Element			
Material Type	Cast-in-place concrete		
Locator	East		
Defect Descript1	Fair condition		
Defect Descript2			
Defect	Crack		
Other			
File Name	34 Wide Longitudinal Crack on South Section of East Sidewalk, looking North.JPG

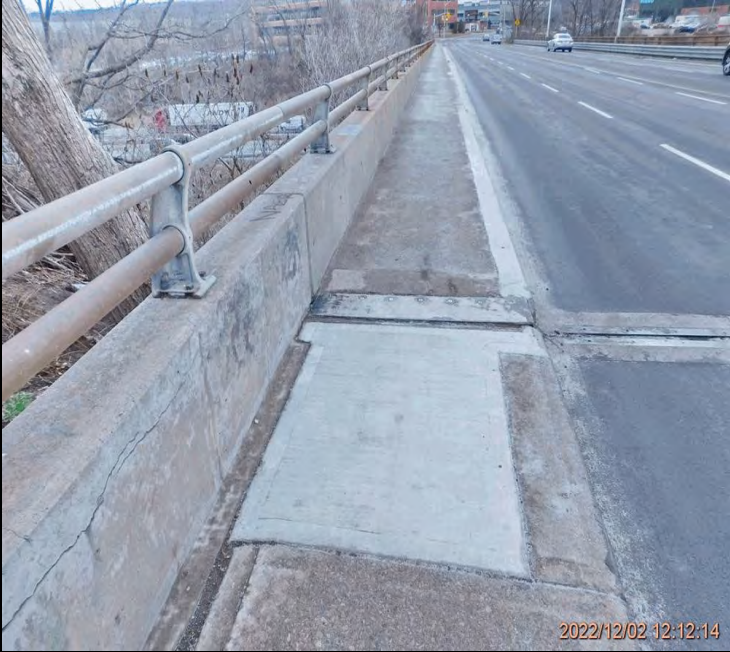
Description Large Patched Area on East Sidewalk at North Expansion Joint (TYP)	
	Elem Grp/Class Elem Type Sub Element Material Type Locator Defect Descript1 Defect Descript2 Defect Other	Sidewalks/curbs/Curbs Cast-in-place concrete North Good condition
File Name 35 Large Patched Area on East Sidewalk at North Expansion Joint (TYP).JPG

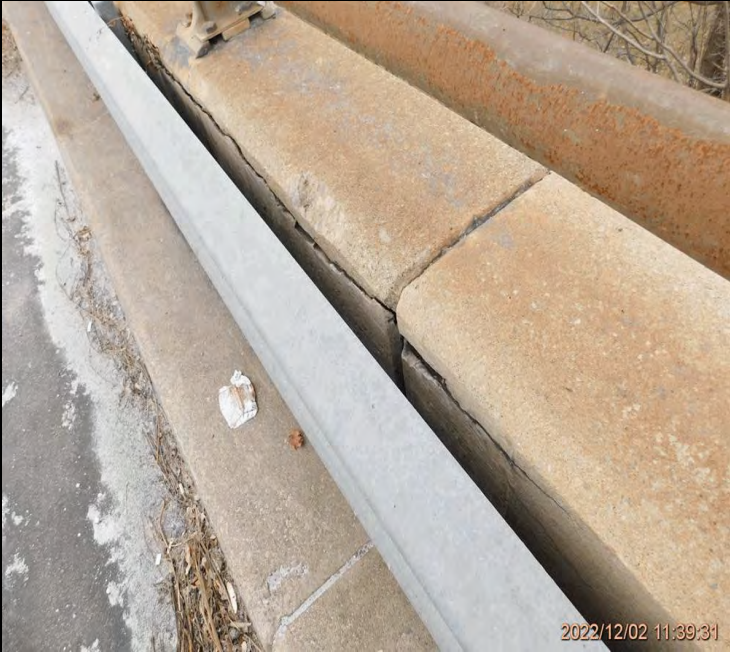
Description West Parapet Wall, Severe Delamination on Wall behind Thrie-Beam Guardrail	
	Elem Grp/Class Elem Type Sub Element Material Type Locator Defect Descript1 Defect Descript2 Defect Other	Barriers/Barrier/Parapet Walls Parapet Wall with two rails Interior Cast-in-place concrete West Poor condition Delamination
File Name 36 West Parapet Wall, Severe Delamination on Wall behind Thrie-Beam Guardrail.JPG

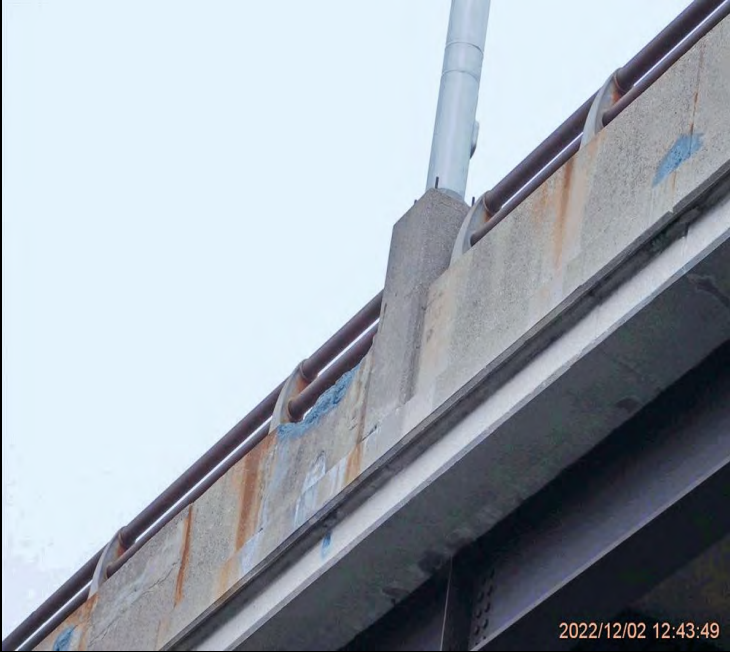
<p style="text-align: right; font-size: small; color: red;">2022/12/02 12:43:49</p>	<p>Description Scaled Exterior Face of West Parapet Wall over 403WB</p>

Elem Grp/Class	Attachments, Signs, and Utilities	Elem Type		Sub Element		Material Type		Locator	West	Defect Descript1	Fair condition	Defect Descript2		Defect		Other
Elem Grp/Class	Attachments, Signs, and Utilities																	
Elem Type																		
Sub Element																		
Material Type																		
Locator	West																	
Defect Descript1	Fair condition																	
Defect Descript2																		
Defect																		
Other																		
File Name	37 Scaled Exterior Face of West Parapet Wall over 403WB.JPG

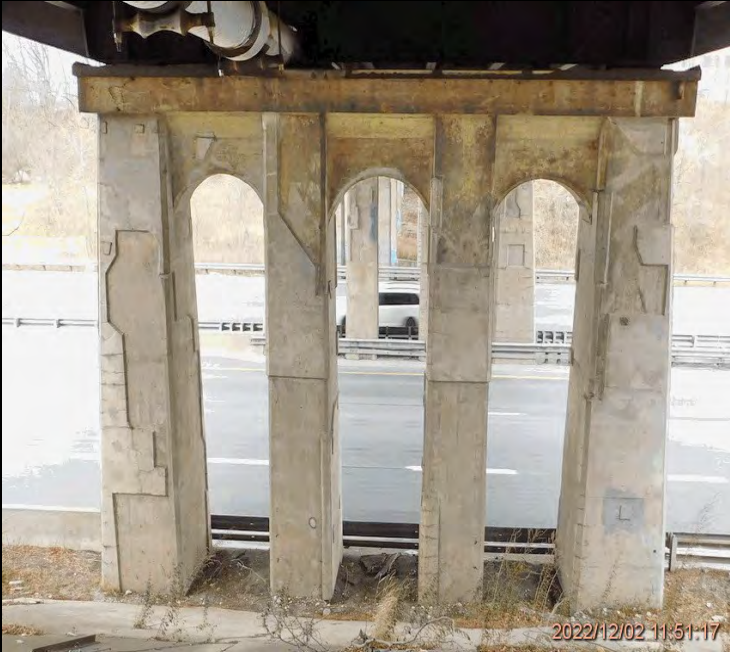
<p style="text-align: right; font-size: small; color: red;">2022/12/02 11:51:17</p>	<p>Description South Pier (Pier 1), South Elevation</p>

Elem Grp/Class	Piers/Shfts/columns/Pile Bent	Elem Type	Conc rectangular columns with	Sub Element		Material Type	Cast-in-place concrete	Locator	South	Defect Descript1	Good condition	Defect Descript2		Defect		Other
Elem Grp/Class	Piers/Shfts/columns/Pile Bent																	
Elem Type	Conc rectangular columns with																	
Sub Element																		
Material Type	Cast-in-place concrete																	
Locator	South																	
Defect Descript1	Good condition																	
Defect Descript2																		
Defect																		
Other																		
File Name	38 South Pier (Pier 1), South Elevation.JPG

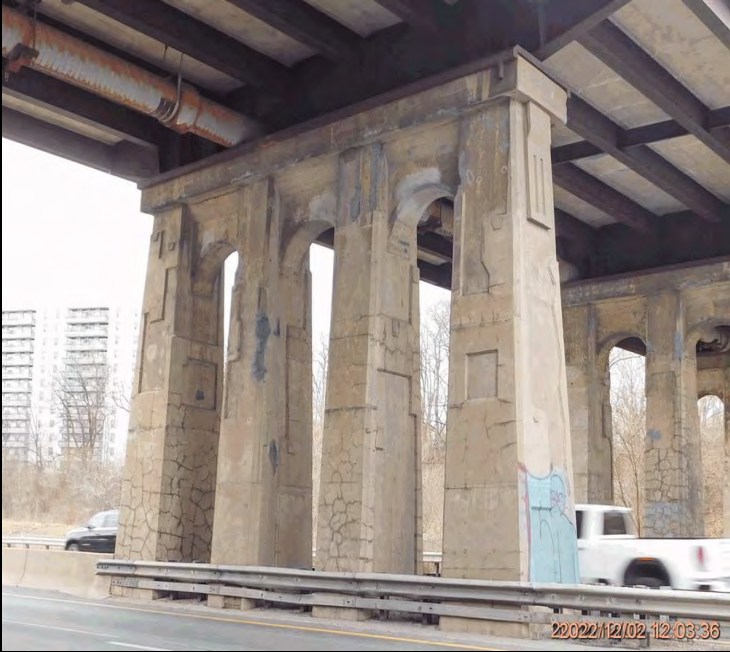
Description South Intermediate Pier (Pier 2), South Elevation		
	Elem Grp/Class Elem Type Sub Element Material Type Locator Defect Descript1 Defect Descript2 Defect Other	Piers/Shfts/columns/Pile Bent Conc rectangular columns with Cast-in-place concrete Intermediate Fair condition	
File Name	39 South Intermediate Pier (Pier 2), South Elevation.JPG

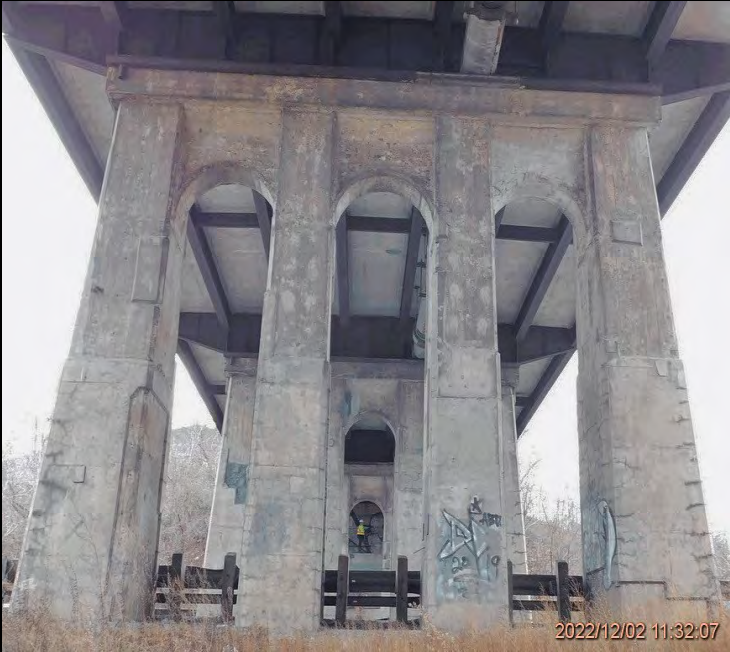
Description Pier 3, North Elevation		
	Elem Grp/Class Elem Type Sub Element Material Type Locator Defect Descript1 Defect Descript2 Defect Other	Piers/Shfts/columns/Pile Bent Conc rectangular columns with Cast-in-place concrete Intermediate Fair condition	
File Name	40 Pier 3, North Elevation.JPG

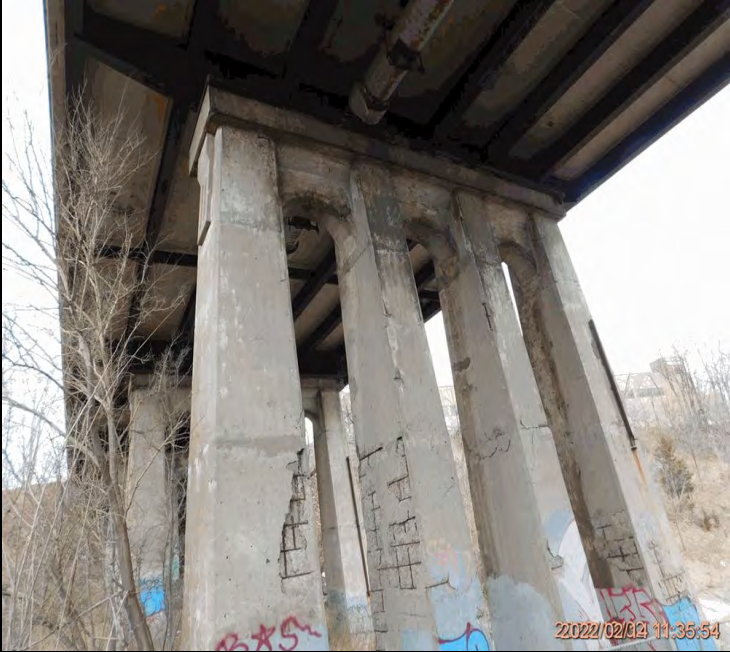
Description Pier 4, South Elevation		
	Elem Grp/Class Elem Type Sub Element Material Type Locator Defect Descript1 Defect Descript2 Defect Other	Piers/Shfts/columns/Pile Bent Conc rectangular columns with Cast-in-place concrete Intermediate Poor condition Spalling	
File Name		41 Pier 4, South Elevation.JPG

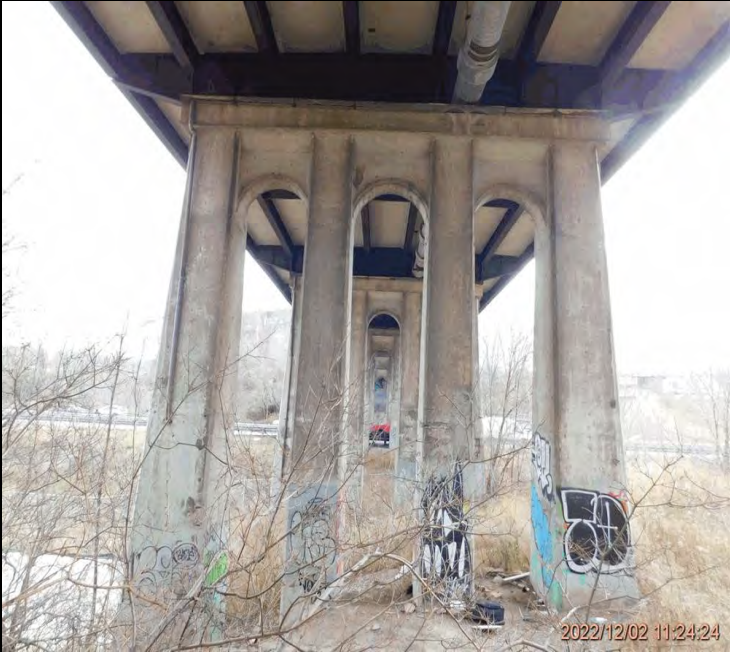
Description North Intermediate Pier (Pier 5), North Elevation		
	Elem Grp/Class Elem Type Sub Element Material Type Locator Defect Descript1 Defect Descript2 Defect Other	Piers/Caps Cast-in-place concrete Intermediate Good condition	
File Name		42 North Intermediate Pier (Pier 5), North Elevation.JPG

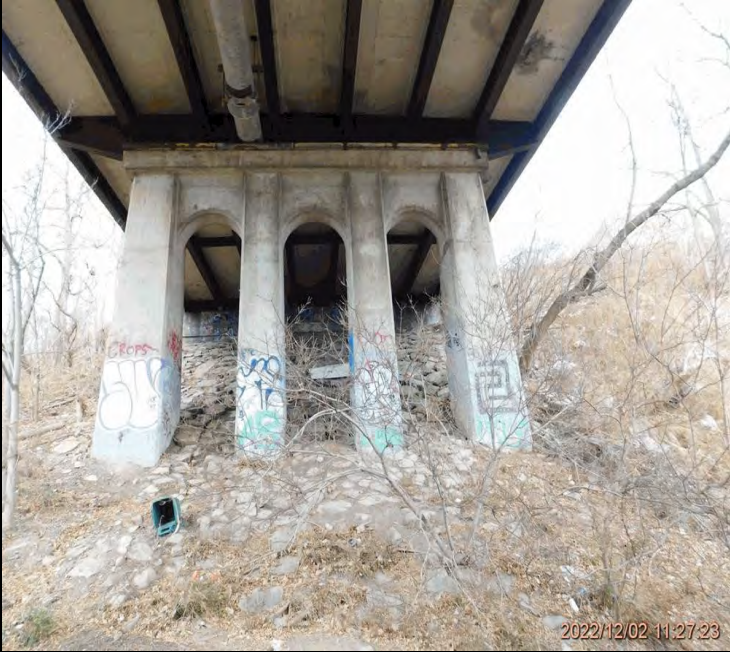
Description North Pier (Pier 7), South Elevation		
	Elem Grp/Class Elem Type Sub Element Material Type Locator Defect Descript1 Defect Descript2 Defect Other	Piers/Caps Cast-in-place concrete North Good condition	
File Name	43 North Pier (Pier 7), South Elevation.JPG

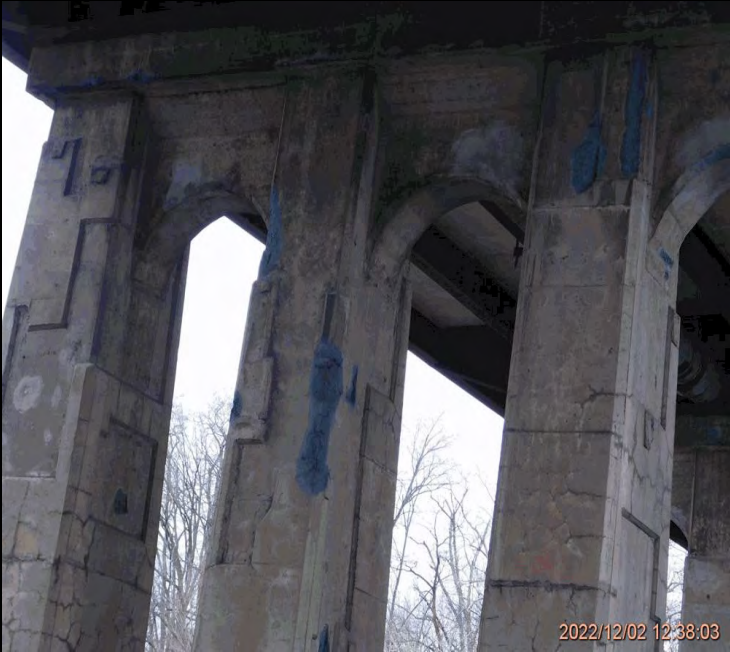
Description Pier 2, Spalls from Concrete Removal Operation in areas adjacent to Hwy 403 Traffic Lanes (TYP)		
	Elem Grp/Class Elem Type Sub Element Material Type Locator Defect Descript1 Defect Descript2 Defect Other	Piers/Shfts/columns/Pile Bent Conc rectangular columns with Cast-in-place concrete Intermediate Fair condition	
File Name	44 Pier 2, Spalls from Concrete Removal Operation in areas adjacent to Hwy 403 Traffic Lanes (TYI

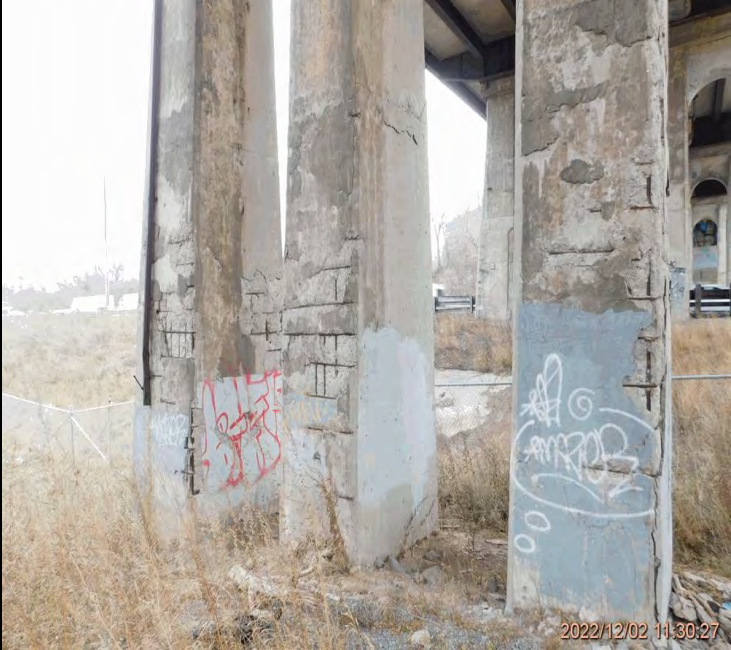
<p>Description</p> <p>Pier 4, Severe Delam & Spalls on Columns at Pier, looking East</p>

<table><tr> <td style="width: 25%;">Elem Grp/Class</td> <td>Piers/Shfts/columns/Pile Bent</td> </tr><tr> <td>Defect Descript1</td> <td>Poor condition</td> </tr><tr> <td>Defect</td> <td>Spalling</td> </tr></table>

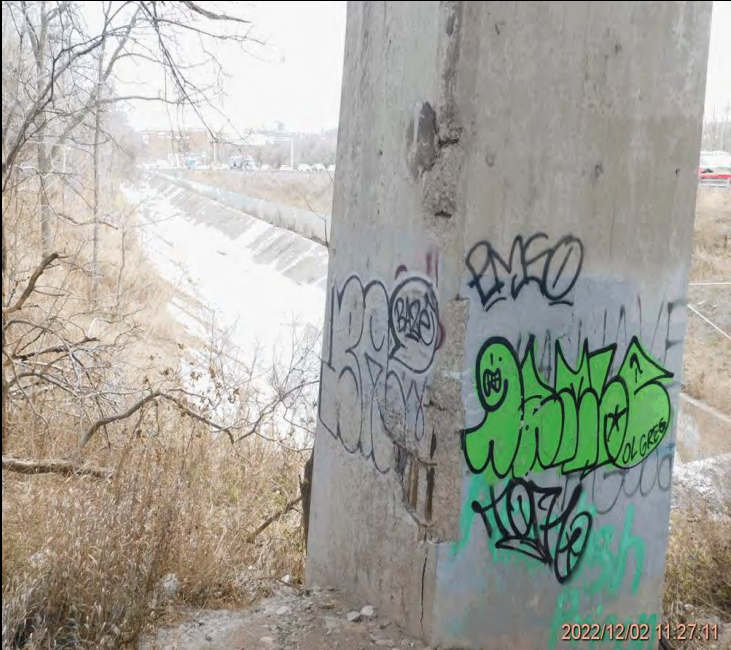
<p>Description</p> <p>Pier 5, Severe Delamination & Spalls on Bottom Section of East Column</p>

<table><tr> <td style="width: 25%;">Elem Grp/Class</td> <td>Piers/Shfts/columns/Pile Bent</td> </tr><tr> <td>Defect Descript1</td> <td>Poor condition</td> </tr><tr> <td>Defect</td> <td>Delamination</td> </tr></table>

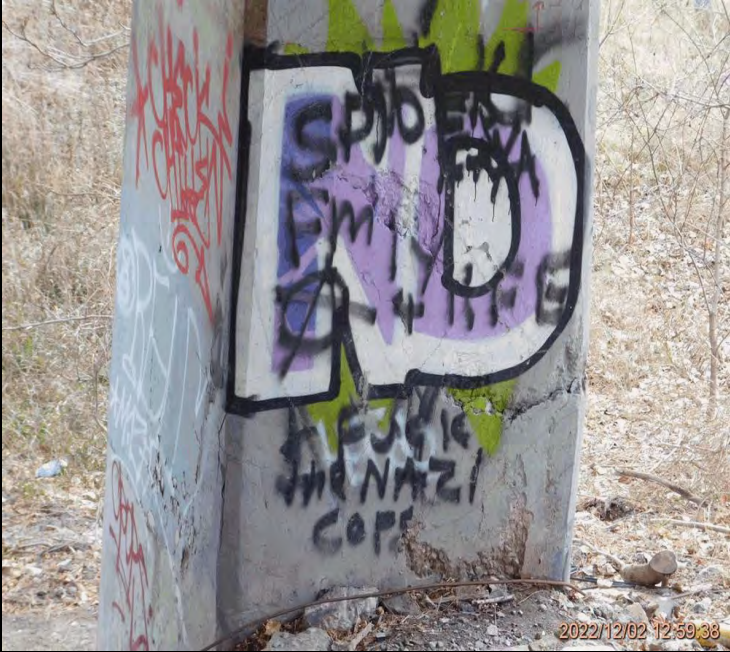
<p>Description Pier 6, Severe Delam on Bottom Section of East Column, looking East</p>

<table><tr> <td style="width: 25%;">Elem Grp/Class</td> <td>Piers/Shfts/columns/Pile Bent</td> </tr><tr> <td>Defect Descript1</td> <td>Poor condition</td> </tr><tr> <td>Defect</td> <td>Delamination</td> </tr></table>

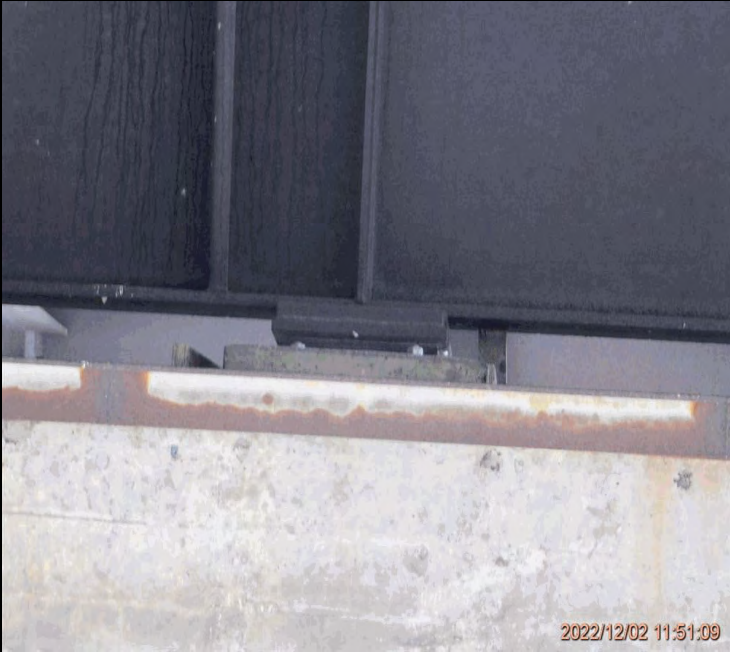
<p>Description Typical Bearing at Sout Piers, South Pier Shown</p>

<table><tr> <td style="width: 25%;">Elem Grp/Class</td> <td>Piers/Bearings</td> </tr><tr> <td>Defect Descript1</td> <td>Good condition</td> </tr></table>

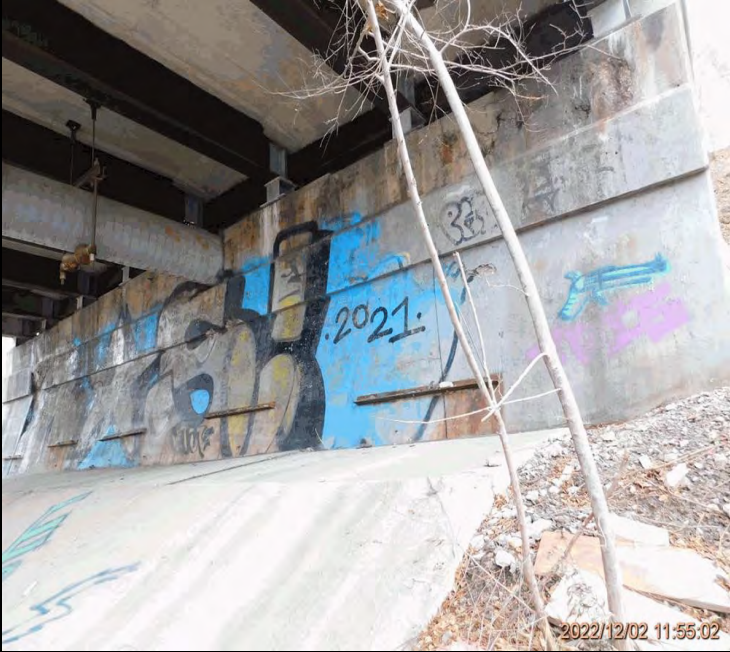
Description		
	South Abutment		
	Elem Grp/Class	Abutments/Abutment walls	
	Elem Type	Conventional closed	
	Sub Element		
	Material Type	Cast-in-place concrete	
	Locator	South	
	Defect Descript1	Fair condition	
	Defect Descript2		
	Defect		
	Other		
File Name	49 South Abutment.JPG

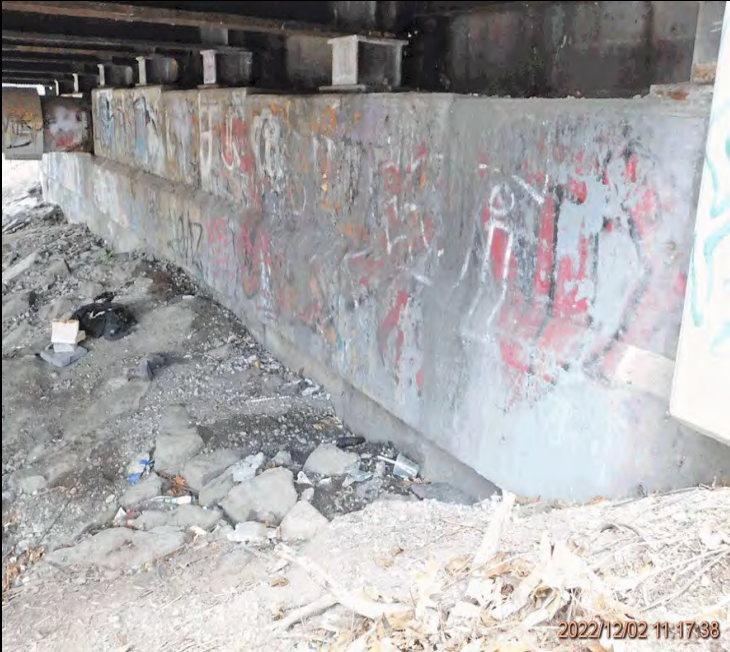
Description		
	North Abutment, looking West		
	Elem Grp/Class	Abutments/Abutment walls	
	Elem Type	Conventional closed	
	Sub Element		
	Material Type	Cast-in-place concrete	
	Locator	North	
	Defect Descript1	Fair condition	
	Defect Descript2		
	Defect		
	Other		
File Name	50 North Abutment, looking West.JPG

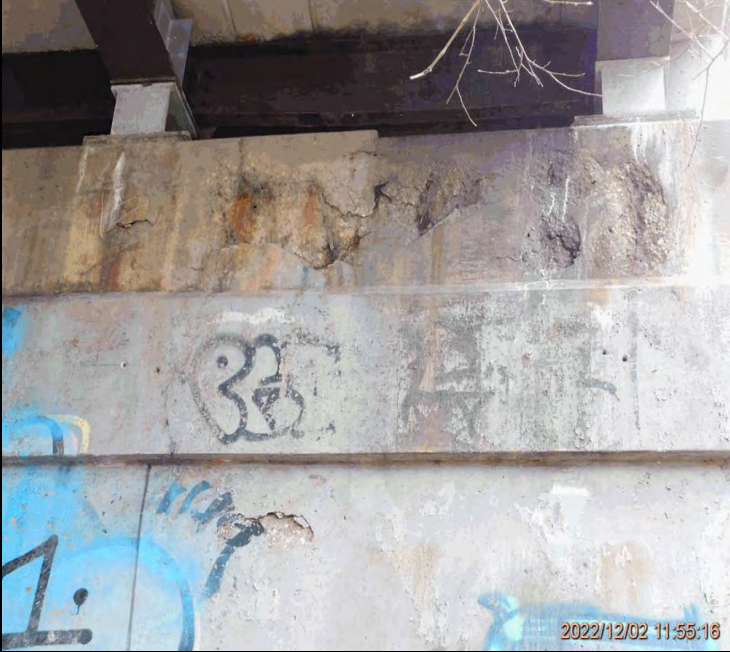
Description South Abutment, Local Severe Delamination & Spalls at Top West Section		
	Elem Grp/Class Elem Type Sub Element Material Type Locator Defect Descript1 Defect Descript2 Defect Other	Abutments/Ballast walls Cast-in-place concrete South Poor condition Spalling	
File Name	51 South Abutment, Local Severe Delamination & Spalls at Top West Section.JPG

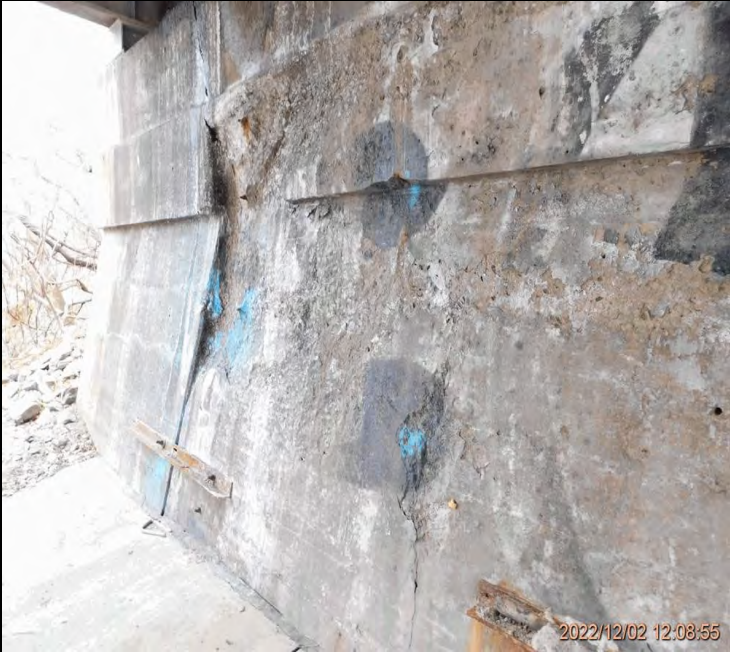
Description South Abutment, Severe Spalls on East Section, looking East		
	Elem Grp/Class Elem Type Sub Element Material Type Locator Defect Descript1 Defect Descript2 Defect Other	Abutments/Ballast walls Cast-in-place concrete South Poor condition Spalling	
File Name	52 South Abutment, Severe Spalls on East Section, looking East.JPG

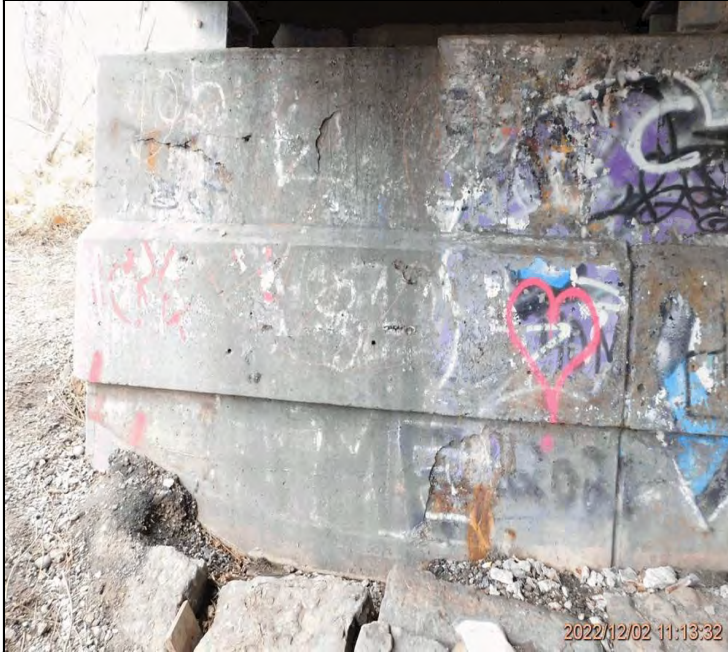
File Name 53 North Abutment, Severe Delam on West Section.JPG

Description North Abutment, Severe Delam on West Section	
Elem Grp/Class	Abutments/Ballast walls
Elem Type	
Sub Element	
Material Type	Cast-in-place concrete
Locator	North
Defect Descript1	Poor condition
Defect Descript2	
Defect	Delamination
Other

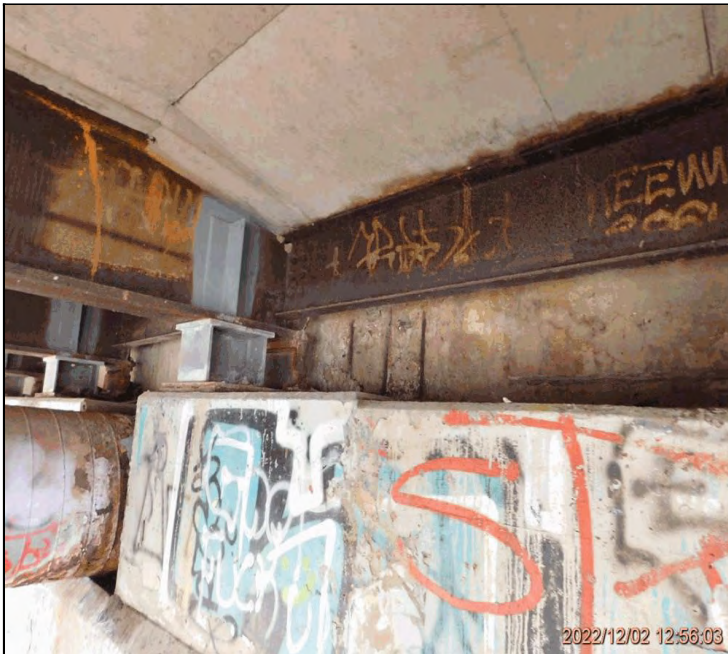
File Name 54 Local Severe Spalls on North Ballast Wall at Central Section of North Abutment.JPG

Description Local Severe Spalls on North Ballast Wall at Central Section of North Abutment	
Elem Grp/Class	Abutments/Ballast walls
Elem Type	
Sub Element	
Material Type	Cast-in-place concrete
Locator	North
Defect Descript1	Poor condition
Defect Descript2	
Defect	Spalling
Other

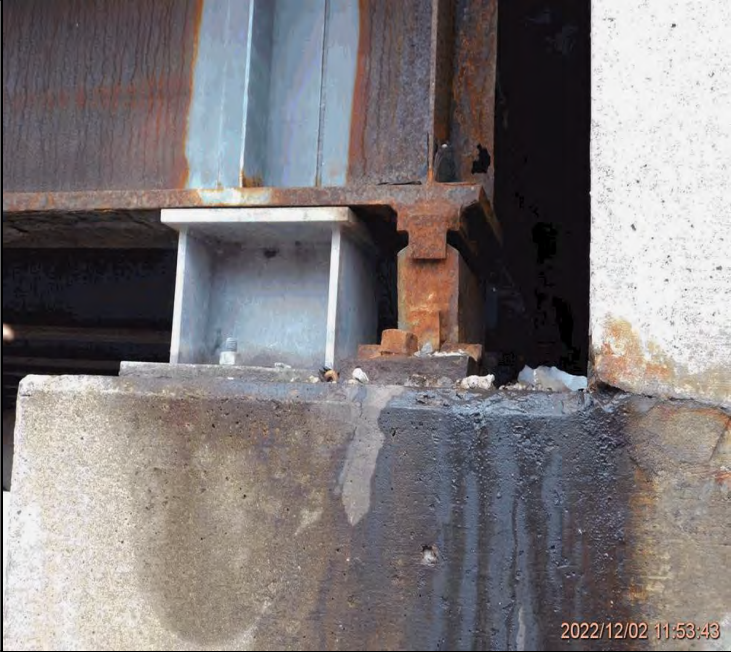
Description Typical Bearings at Abutments, West Bearing at South Abutment Shown

<table><tr> <td style="width: 70%;">Elem Grp/Class</td> <td>Abutments/Bearings</td> </tr><tr> <td>Defect Descript1</td> <td>Fair condition</td> </tr></table>

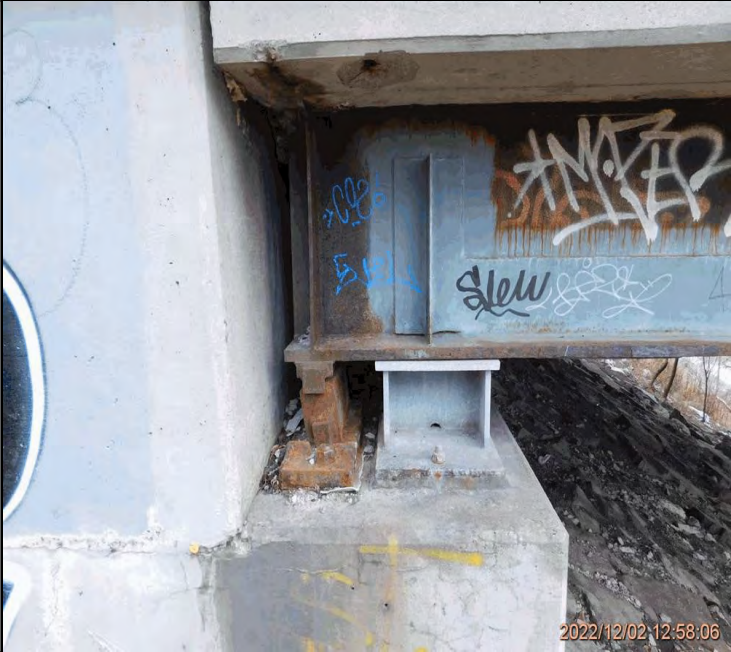
Description Typical Bearings Abutments, West Bearing at North Abutment Shown

<table><tr> <td style="width: 70%;">Elem Grp/Class</td> <td>Abutments/Bearings</td> </tr><tr> <td>Defect Descript1</td> <td>Fair condition</td> </tr></table>

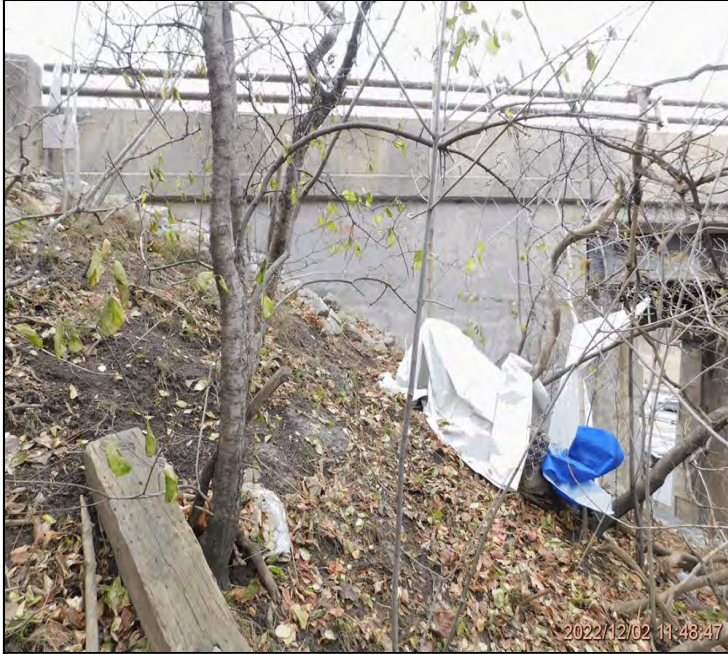
File Name 57 Southeast Wingwall.JPG

Description Southeast Wingwall	
Elem Grp/Class	Abutments/Wingwalls
Elem Type	Reinforced concrete
Sub Element	
Material Type	Cast-in-place concrete
Locator	South
Defect Descript1	Good condition
Defect Descript2	
Defect	
Other

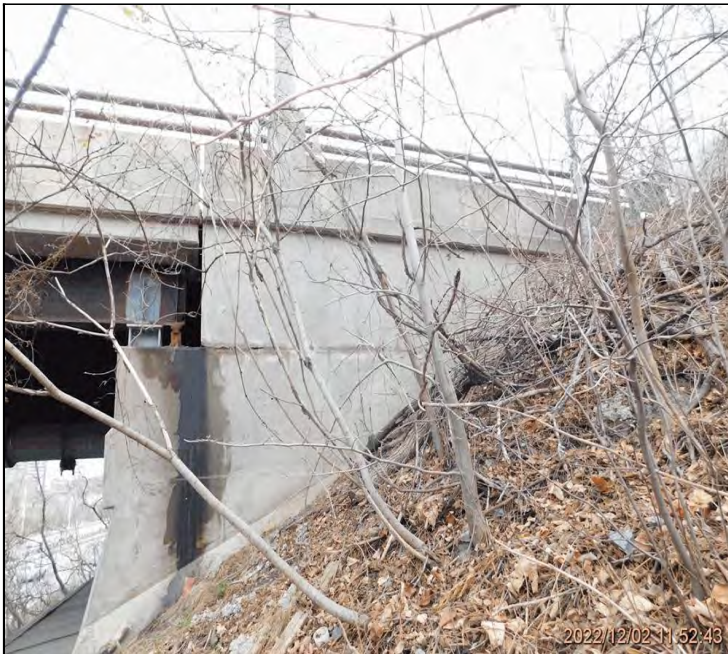
File Name 58 Southwest Wingwall.JPG

Description Southwest Wingwall	
Elem Grp/Class	Abutments/Wingwalls
Elem Type	Reinforced concrete
Sub Element	
Material Type	Cast-in-place concrete
Locator	South
Defect Descript1	Good condition
Defect Descript2	
Defect	
Other

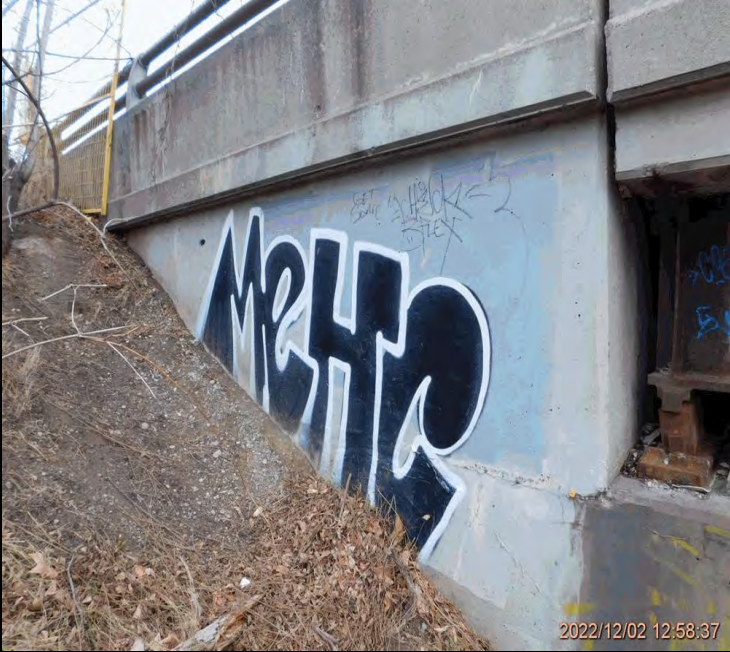
Description		
	Northwest Wingwall		
	Elem Grp/Class	Abutments/Wingwalls	
	Elem Type	Reinforced concrete	
	Sub Element		
	Material Type	Cast-in-place concrete	
	Locator	North	
	Defect Descript1	Good condition	
	Defect Descript2		
	Defect		
	Other		
File Name	59 Northwest Wingwall.JPG

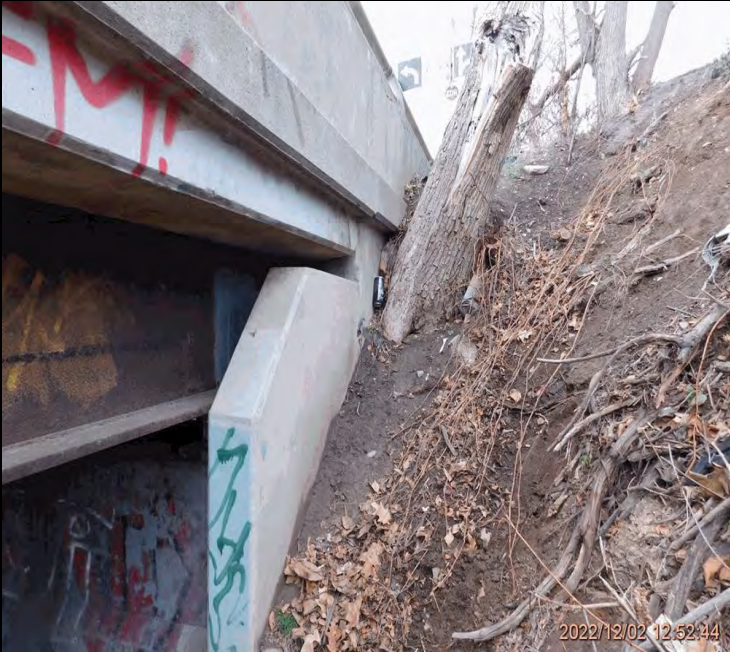
Description		
	Northeast Wingwall		
	Elem Grp/Class	Abutments/Wingwalls	
	Elem Type	Reinforced concrete	
	Sub Element		
	Material Type	Cast-in-place concrete	
	Locator	North	
	Defect Descript1	Good condition	
	Defect Descript2		
	Defect		
	Other		
File Name	60 Northeast Wingwall.JPG

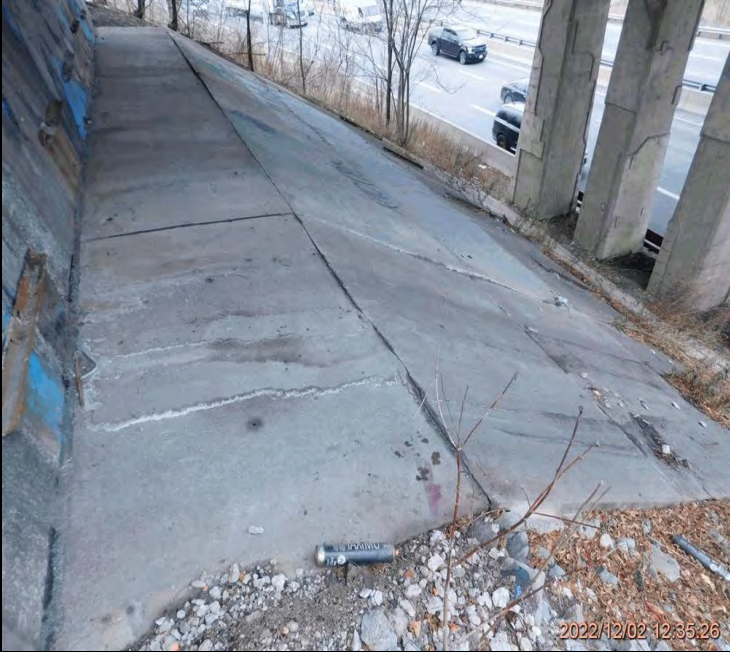
Description		
			South Embankment Slope Protection
		Elem Grp/Class	Embankments & Streams/Slop
		Elem Type	Concrete
		Sub Element	
		Material Type	
		Locator	South
		Defect Descript1	Good condition
		Defect Descript2	
		Defect	
		Other	
File Name		61 South Embankment Slope Protection.JPG

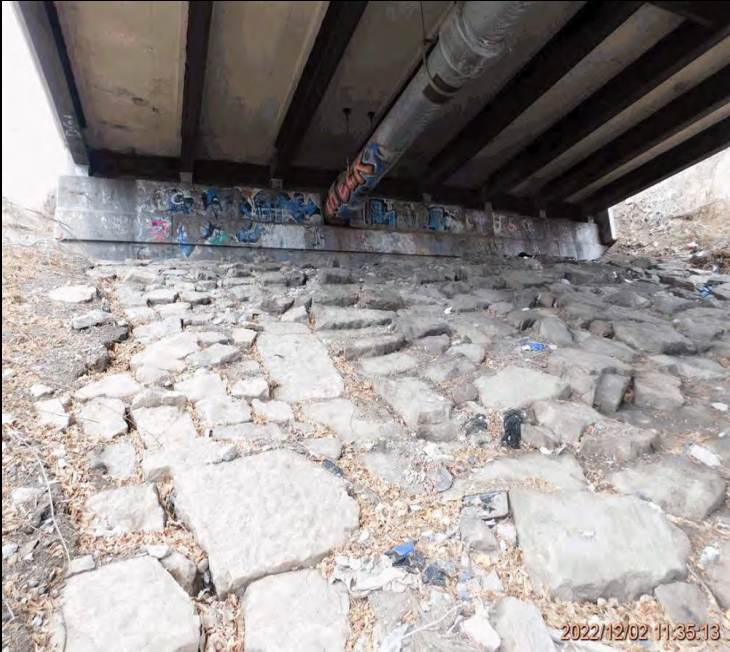
Description		
			Rock Protection at North Embankment Slope, looking North
		Elem Grp/Class	Embankments & Streams/Slop
		Elem Type	Concrete
		Sub Element	
		Material Type	
		Locator	North
		Defect Descript1	Good condition
		Defect Descript2	
		Defect	
		Other	
File Name		62 North Slope Protection, looking North.JPG

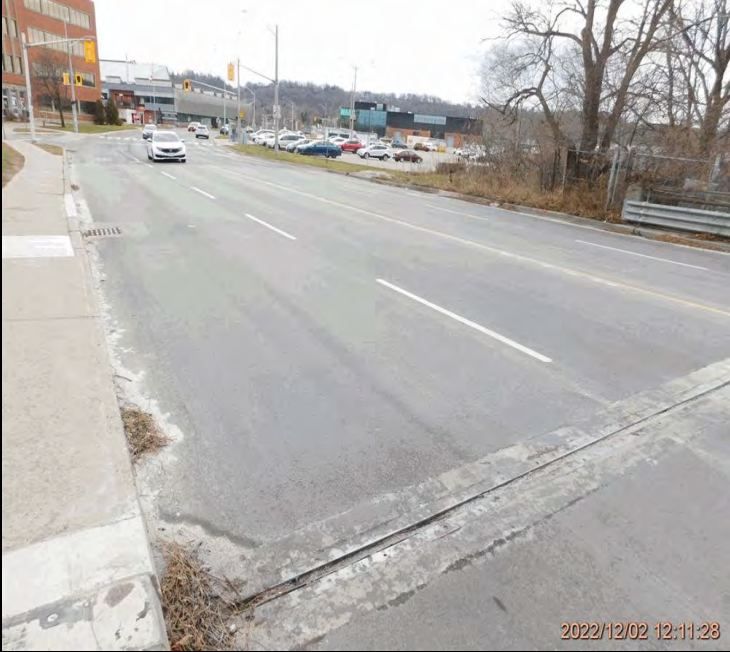
Description South Approach, looking South		
	Elem Grp/Class Elem Type Sub Element Material Type Locator Defect Descript1 Defect Descript2 Defect Other	Approaches/Wearing surface Asphalt South Excellent condition	
File Name	63 South Approach, looking South.JPG

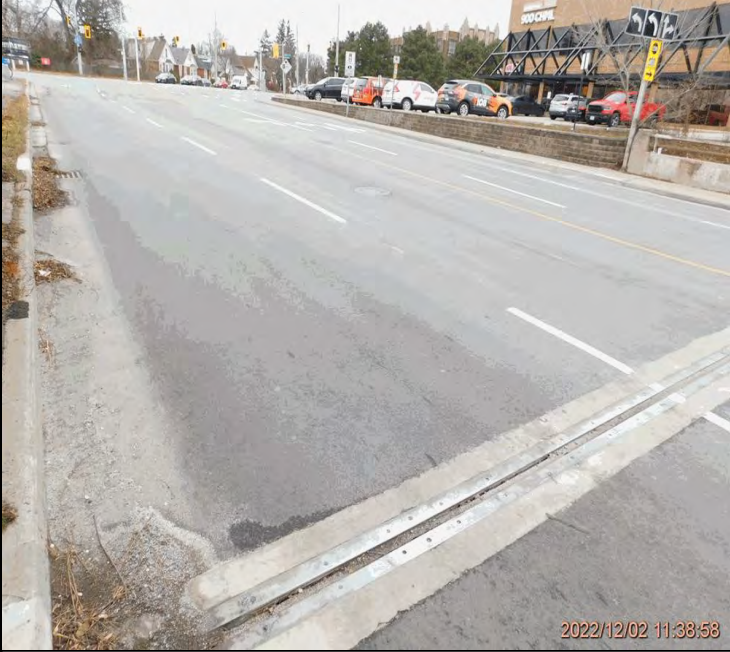
Description North Approach, looking North		
	Elem Grp/Class Elem Type Sub Element Material Type Locator Defect Descript1 Defect Descript2 Defect Other	Approaches/Wearing surface Asphalt North Excellent condition	
File Name	64 North Approach, looking North.JPG
