Upper West Side Secondary Plan Area Fluvial Geomorphological Assessment And Natural Channel Design

Twenty Road West, City of Hamilton

November 20, 2023
PN23079

Report Title: Upper West Side Secondary Plan Area
Fluvial Geomorphological Assessment and Natural
Channel Design

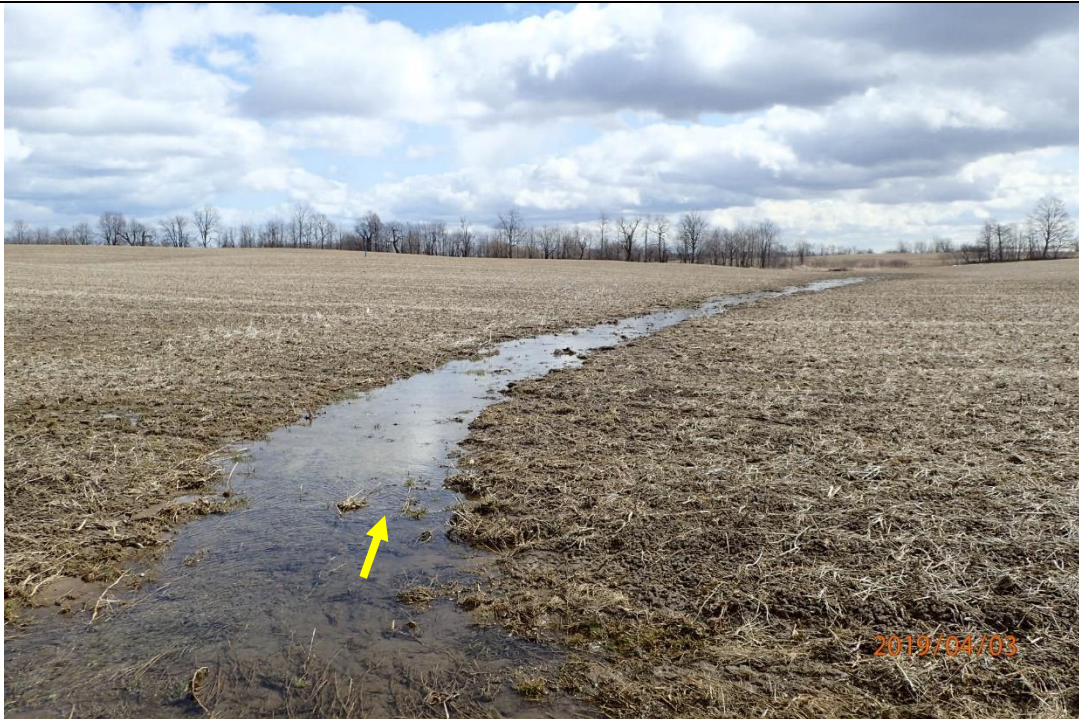
Photo 1
Tributary of Twenty Mile Creek: Visit 1
Reach TTCM2-9

The feature lacked defined bed and banks and conveyed substantial flow through an agricultural field during the spring visit. The Yellow arrow denotes the flow direction.

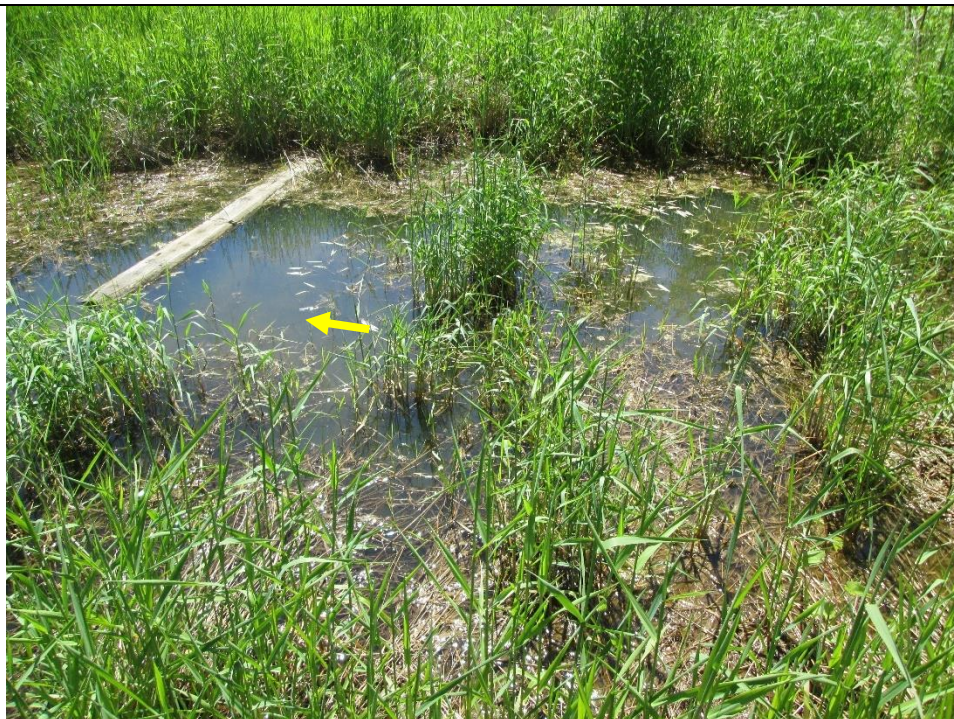
Photo 8
Tributary of Twenty Mile Creek: Visit 2
Reach TTMC2-10-1

The wet meadow corridor consisted mostly of hydrophilic herbaceous and grass species. Bed materials were silt and organic material.

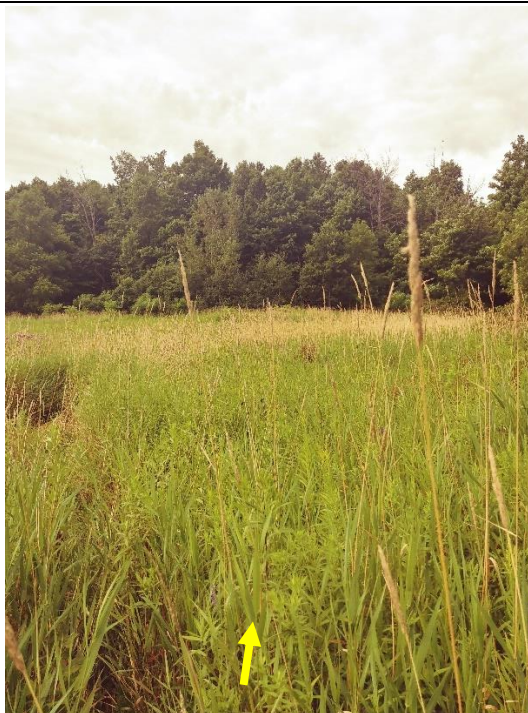
Photo 9
Tributary of Twenty Mile Creek: Visit 3
Reach TTMC2-10-1

The feature was dry and indistinguishable from the surrounding landscape during the summer, with no channel formation.

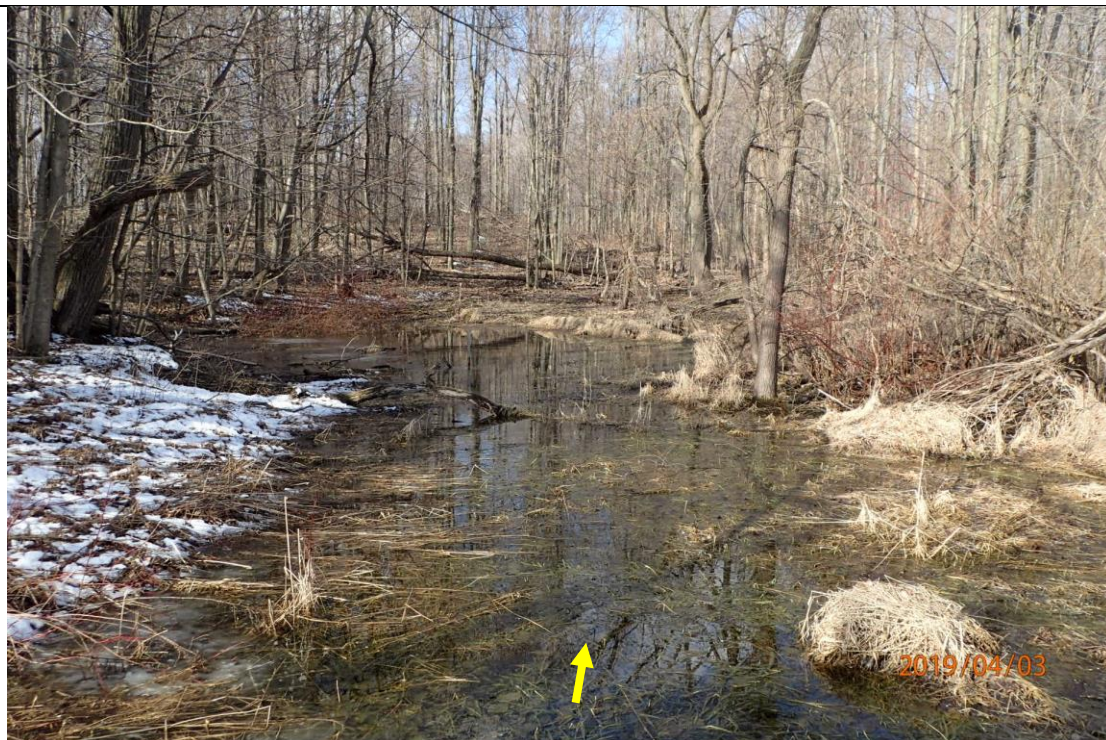
Photo 10
Tributary of Twenty Mile Creek: Visit 1
Reach TTMC2-10-2

The feature lacked defined bed and banks and conveyed substantial flow through a woodlot during the spring visit.

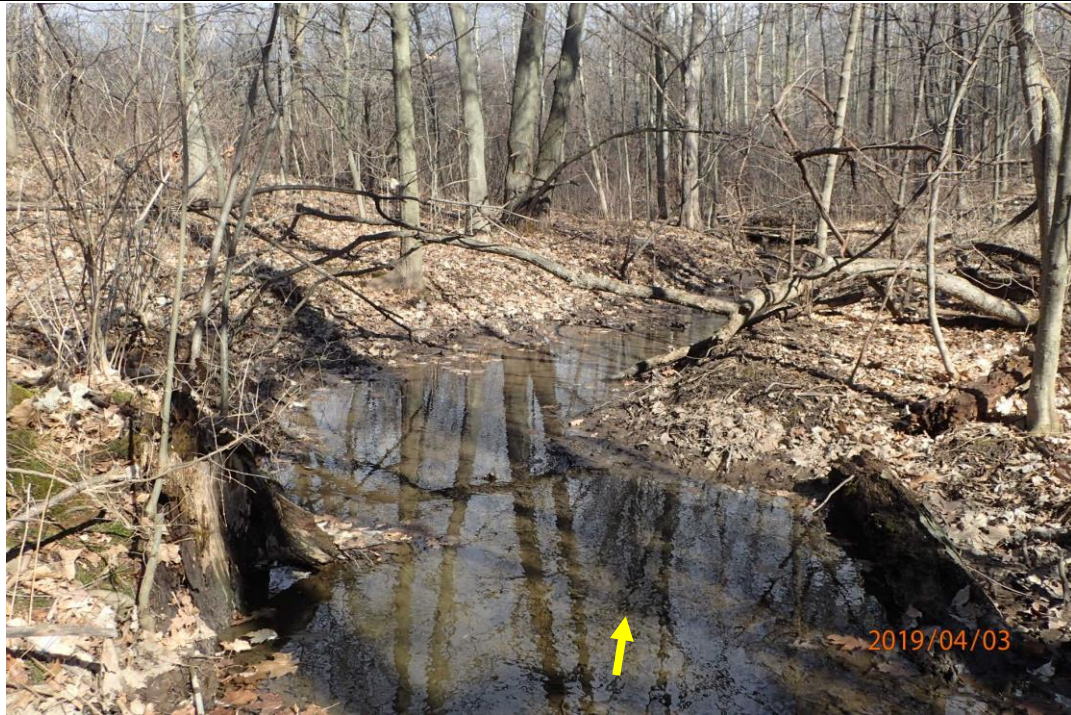
Photo 13
Tributary of Twenty Mile Creek: Visit 1
Reach TTMC2-11

The feature had defined bed and banks, with substantial water flowing during the spring visit.

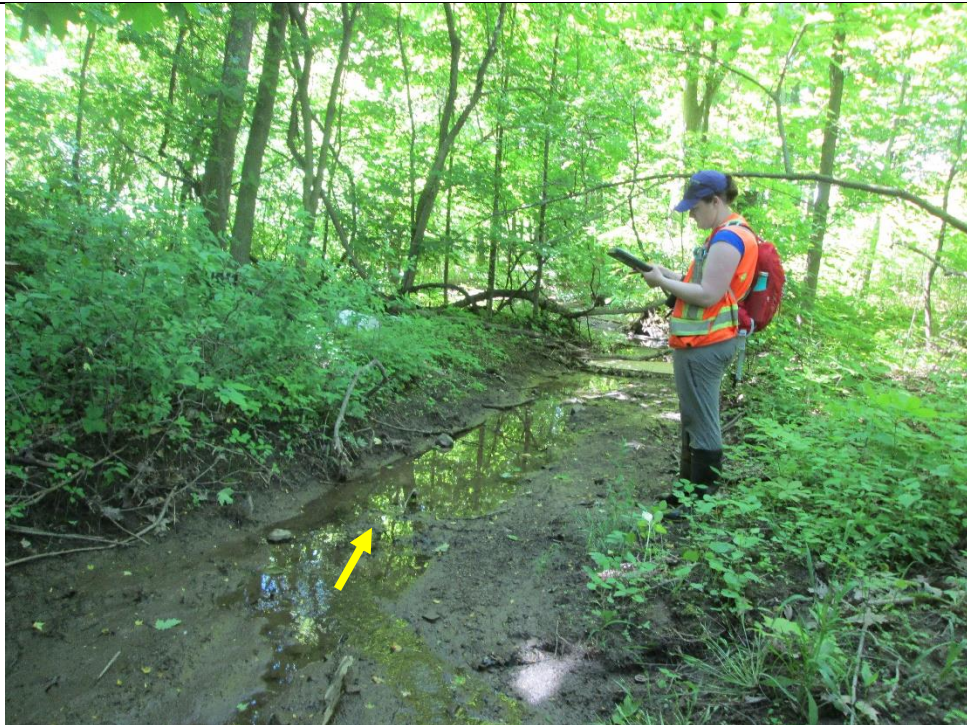
Photo 14
Tributary of Twenty Mile Creek: Visit 2
Reach TTMC2-11

Minimal flow was conveyed through the deciduous forest during the second visit.

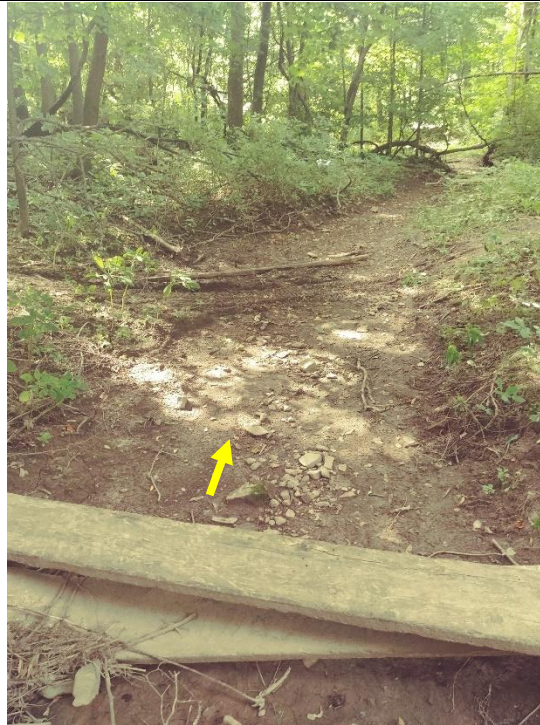
Photo 15
Tributary of Twenty Mile Creek: Visit 3
Reach TTMC2-11

Feature was dry but distinguishable from the surrounding landscape in the summer visit. Bed materials consisted predominantly of silt, clay and some gravel which were poorly sorted.

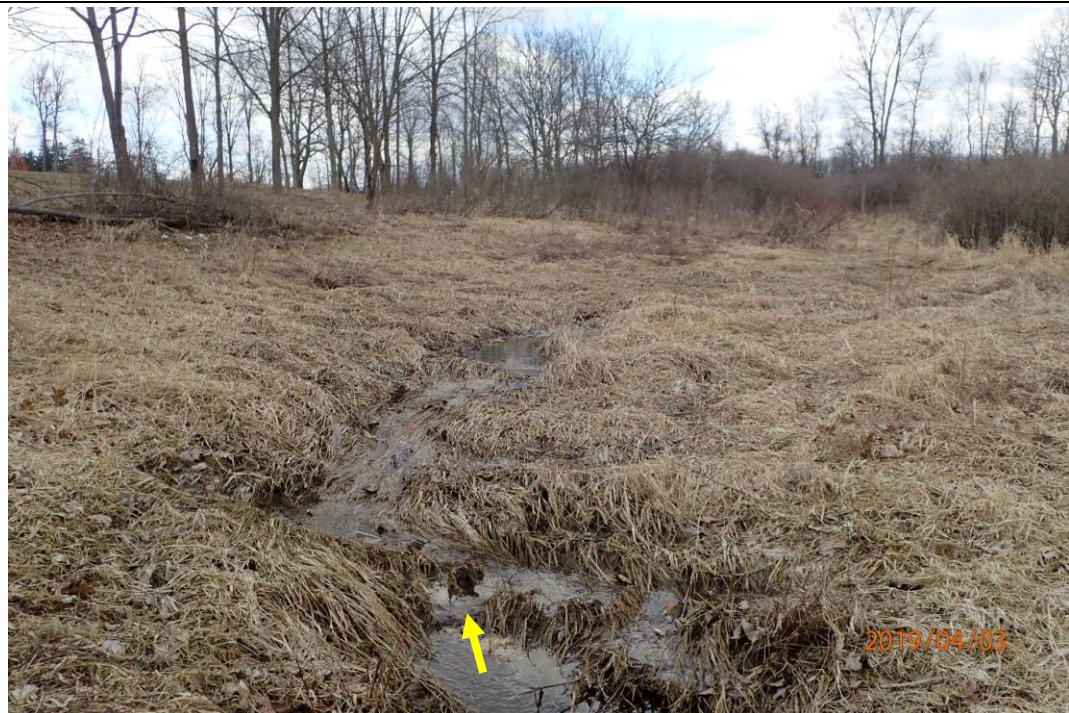
Photo 16
Tributary of Twenty Mile Creek: Visit 1
Reach TTMC2-12

The feature lacked defined bed and banks and conveyed minimal flow nearby to the woodlot during the spring visit.

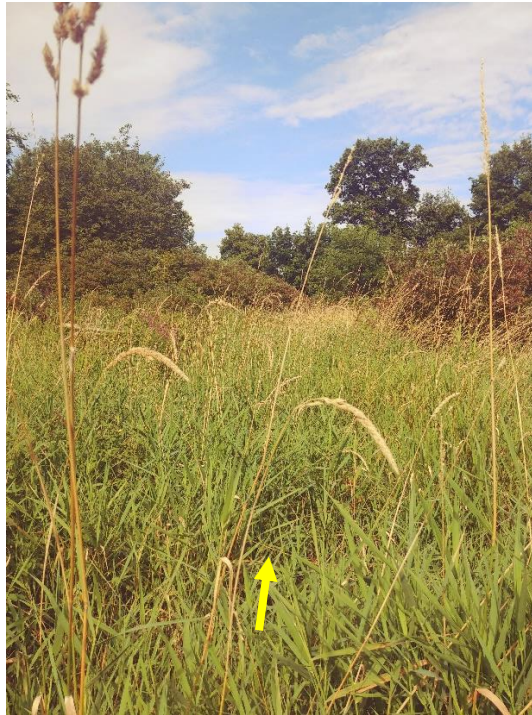
Photo 18
Tributary of Twenty Mile Creek: Visit 3
Reach TTMC2-12

The feature was dry and indistinguishable from the surrounding landscape during the summer, with no channel formation. Bed materials consisted of clay, silt and organic matter.

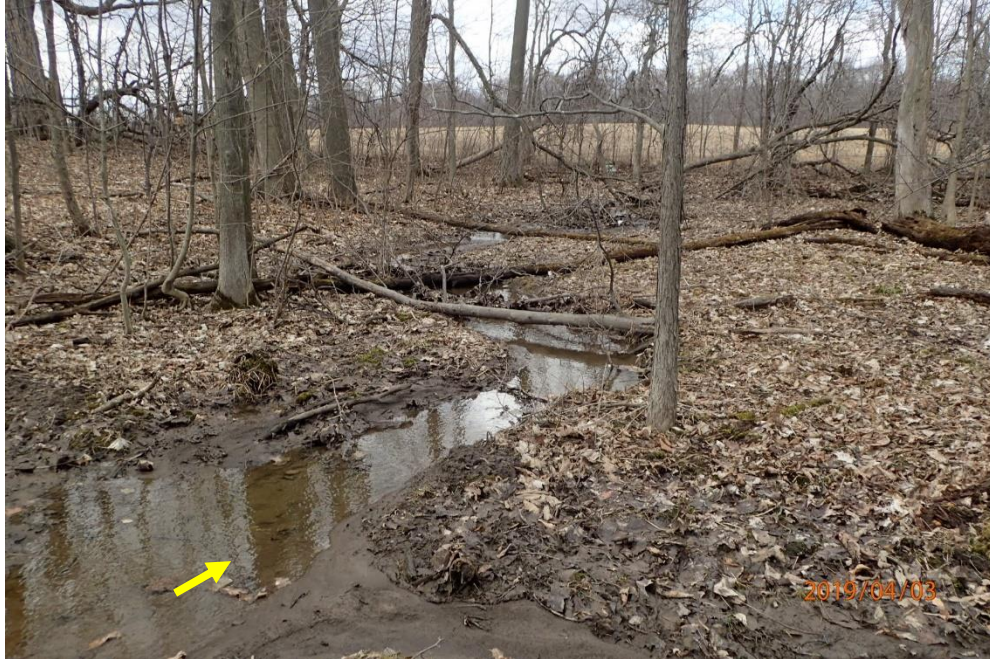
Photo 19
Tributary of Twenty Mile Creek: Visit 1
Reach TTMC2-12-1

The feature lacked defined bed and banks and conveyed minimal flow through the woodlot during the spring visit.

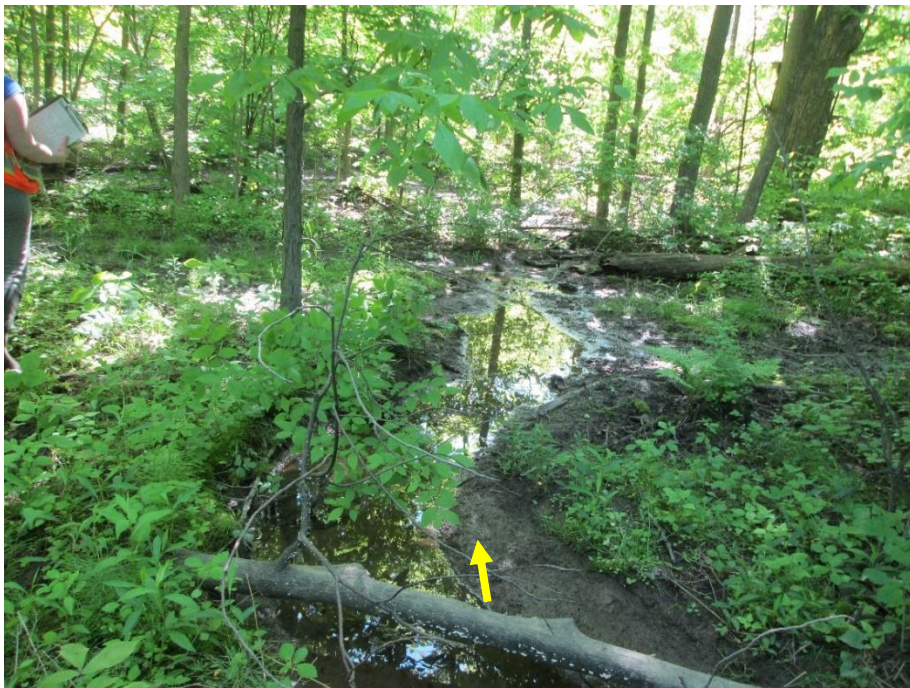
Photo 20
Tributary of Twenty Mile Creek: Visit 2
Reach TTMC2-12-1

Riparian vegetation for the reach consisted predominantly of deciduous trees. Standing water was present during the second visit.

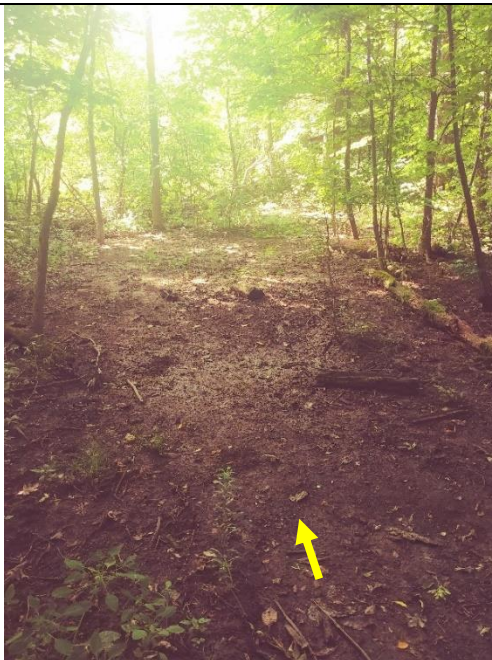
Photo 21
Tributary of Twenty Mile Creek: Visit 3
Reach TTM2-12-1

The feature was dry during the summer visit but was distinguishable from the surrounding woodlot. Bed materials consisted of clay, silt and organic matter.

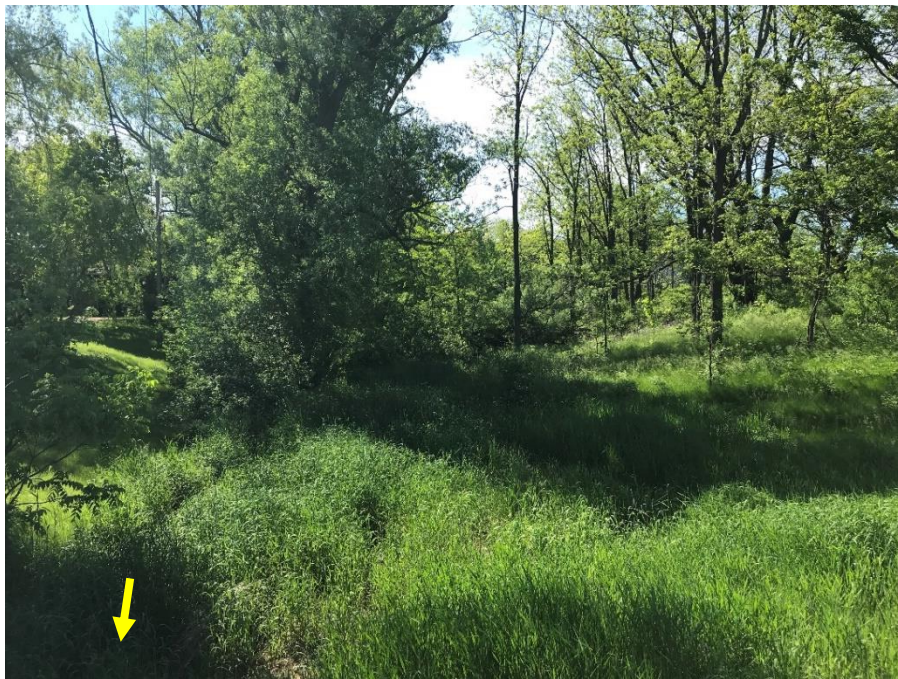
Photo 26
Tributary of Twenty Mile Creek: Visit 2
Reach TTMC3-1

Riparian vegetation consisted of scrubland and some hydrophilic vegetation. Bed materials consisted of clay and silt.

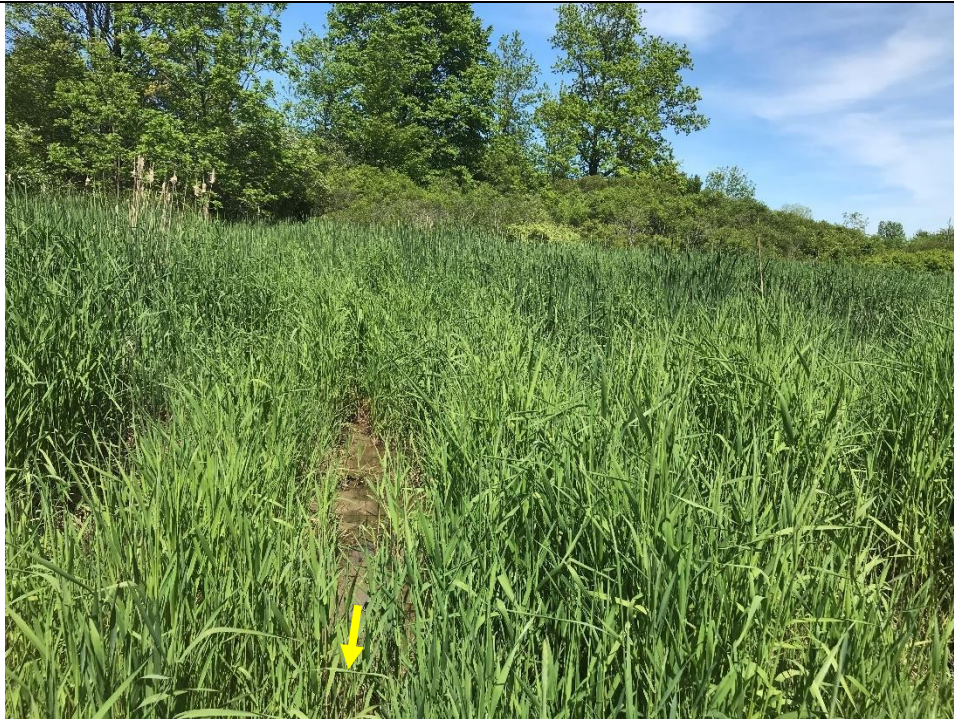
Photo 29
Tributary of Twenty Mile Creek: Visit 2
Reach TTMC3-2

Riparian vegetation consisted of grasses with sparse herbaceous vegetation, and water was present during all 3 visits.

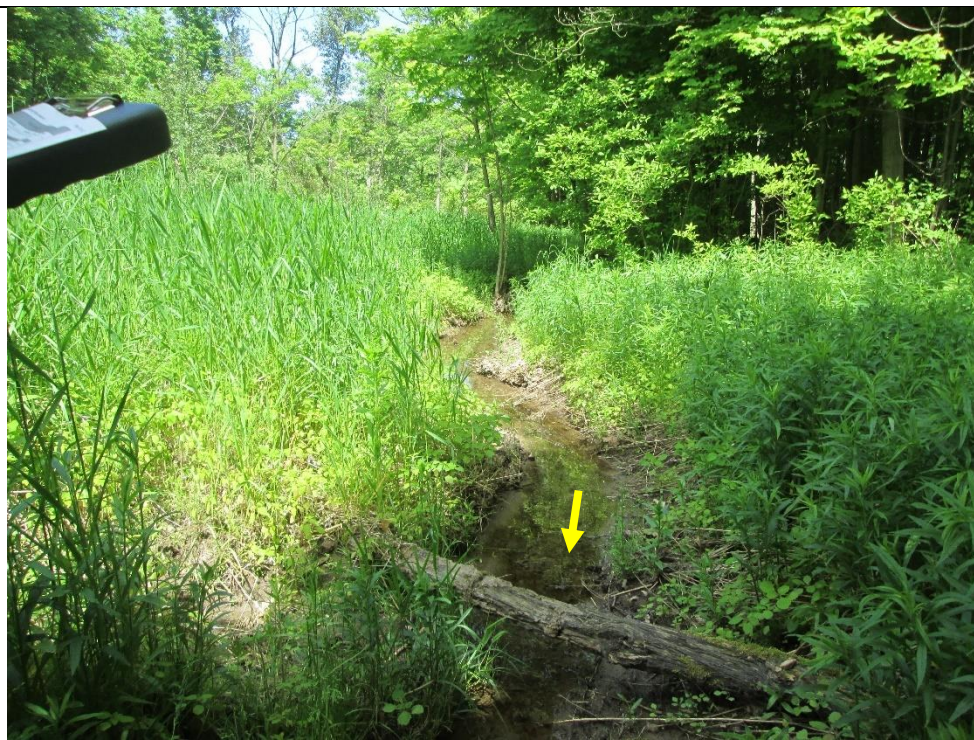
Photo 32
Tributary of Twenty Mile Creek: Visit 2
Reach **TTMC3-2-1**

Riparian vegetation included mature deciduous trees as well as some shrubs and hydrophilic herbaceous vegetation

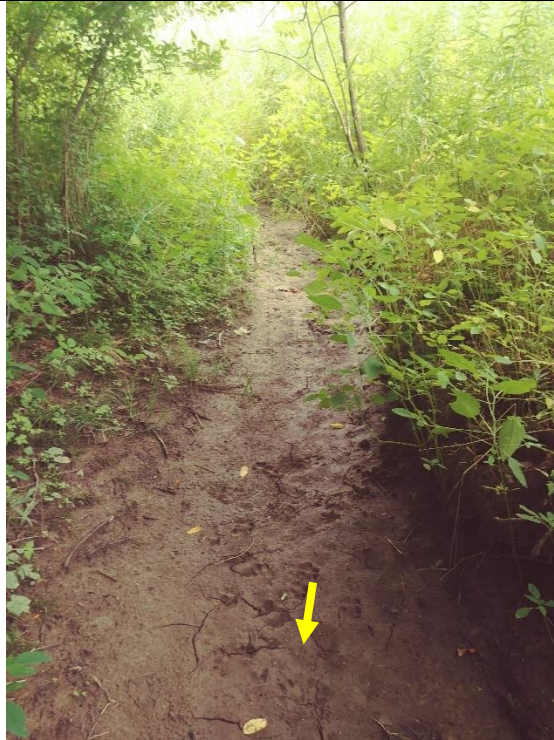
Tributary of Twenty Mile Creek: Visit 3
Reach TTM3-2-1

The feature was dry during the summer visit but distinguishable from the surrounding landscape. Bed materials consisted predominantly of clay, silt and organic material

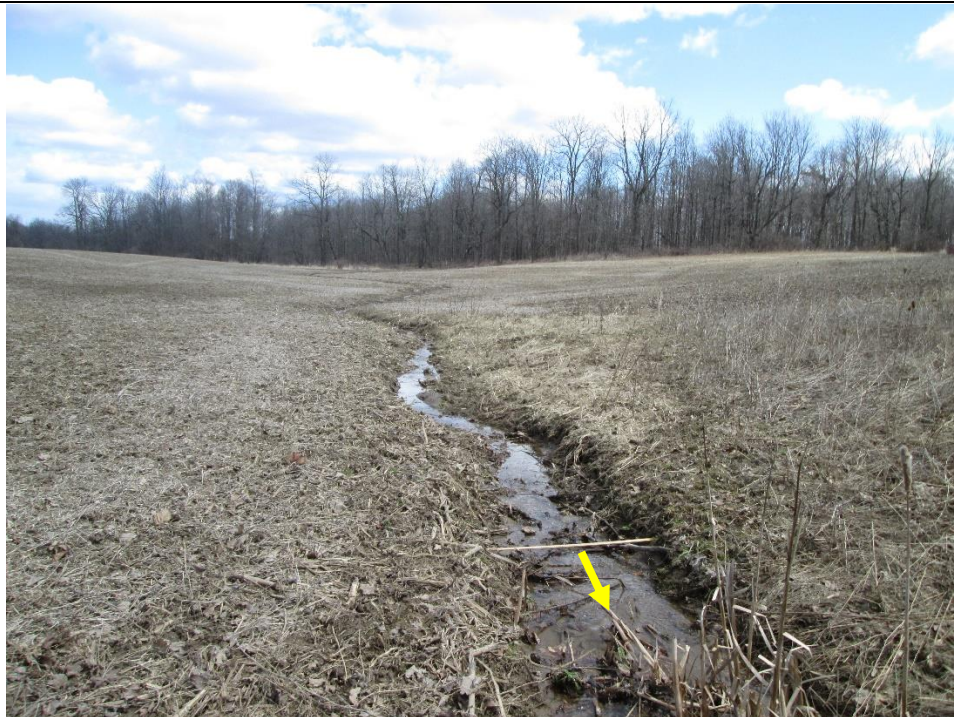
Tributary of Twenty Mile Creek: Visit 1
Reach TTM3-2-2

The feature had defined bed and banks within the agricultural lands during freshet.

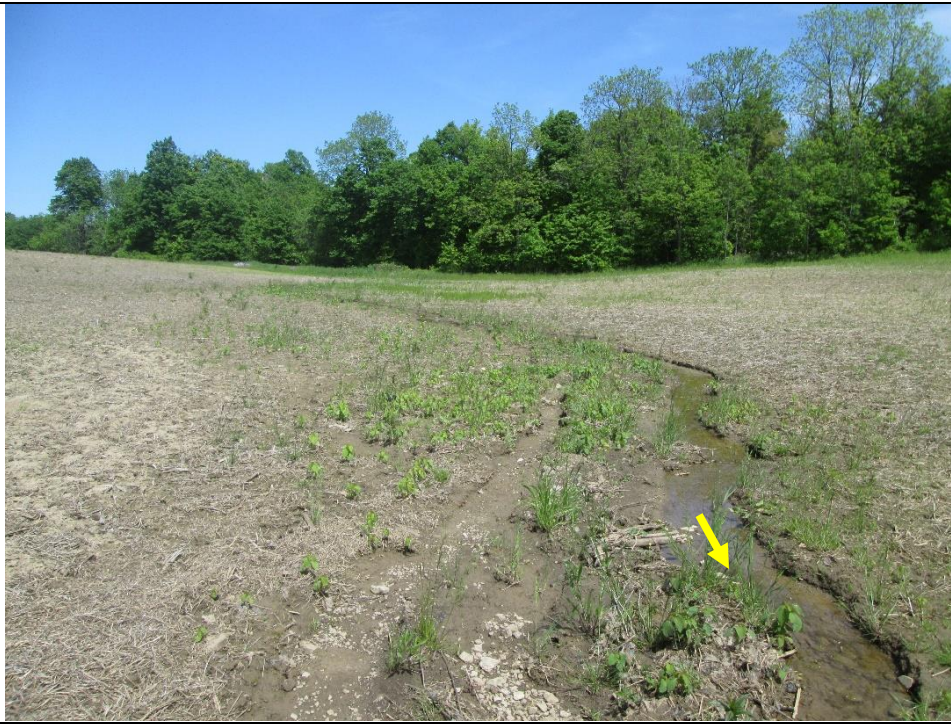
Photo 35
Tributary of Twenty Mile Creek: Visit 2
Reach TTM3-2-2

The feature was surrounded by agricultural crops along its upstream section and ends in a woodlot populated by deciduous trees. Some water was flowing during the second visit.

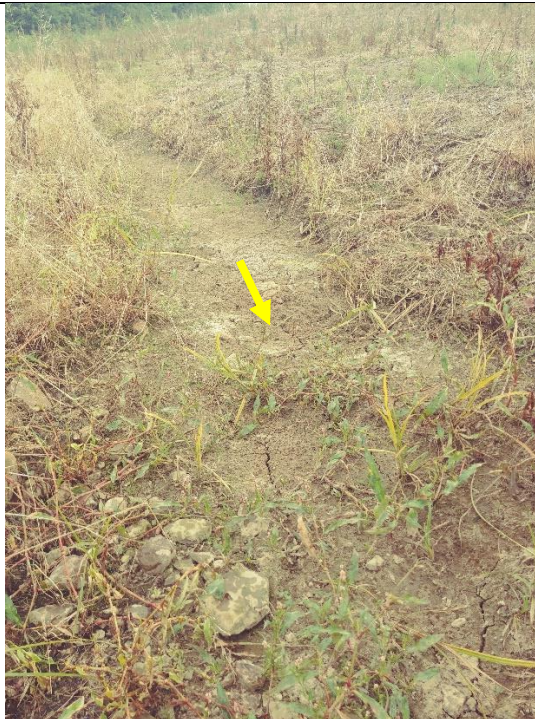
Photo 36
Tributary of Twenty Mile Creek: Visit 3
Reach TTM3-2-2

The feature was dry during the last visit and the substrate consisted predominantly of clay, silt and gravel.

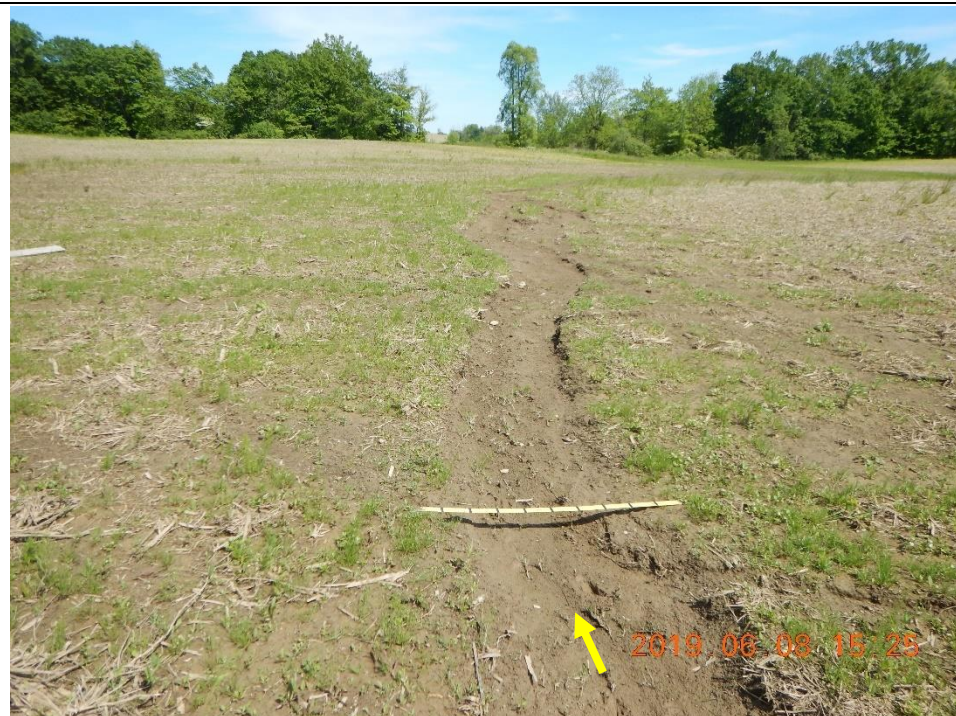
Photo 38
Tributary of Twenty Mile Creek: Visit 2
Reach TTM3-3

Riparian vegetation consisted predominantly of crops, with some grasses. Bed materials were indistinguishable from the surrounding fields.

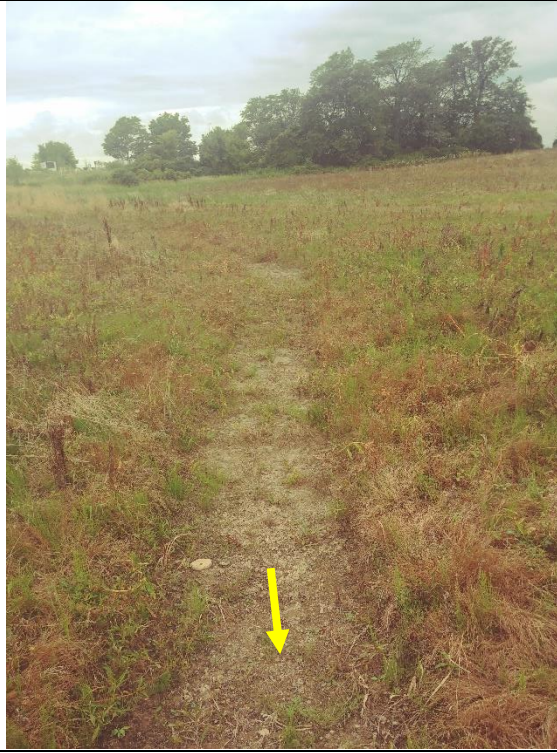
Photo 39
Tributary of Twenty Mile Creek: Visit 3
Reach TTMC3-3

The feature was dry and almost indistinguishable from the surrounding landscape during the summer.

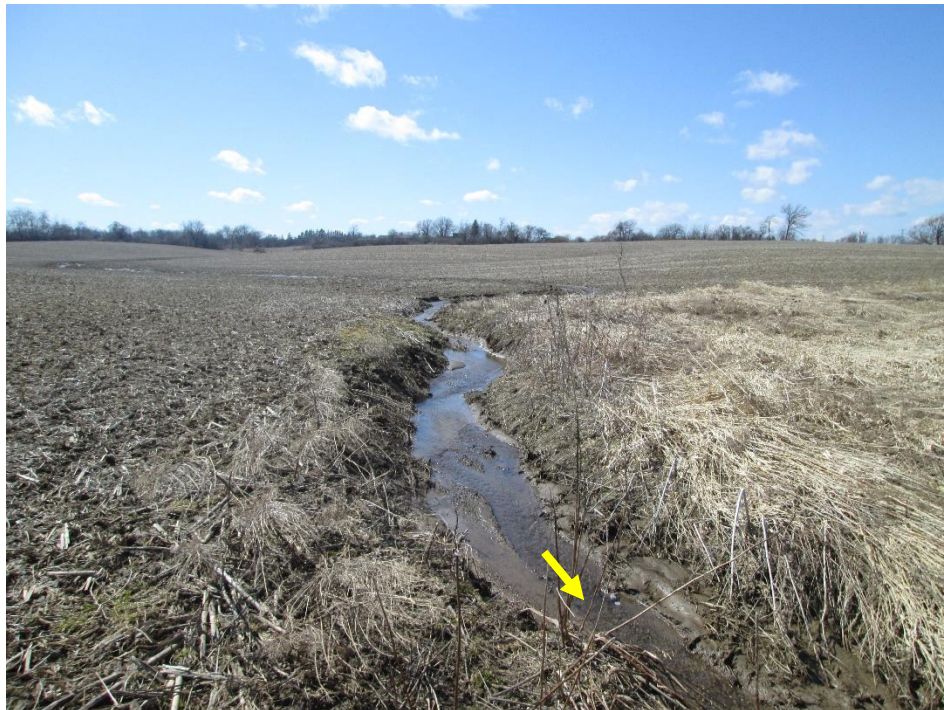
Photo 40
Tributary of Twenty Mile Creek: Visit 1
Reach TTMC3-4

The feature had well defined bed and banks within the agricultural fields during the spring visit and was conveying flow.

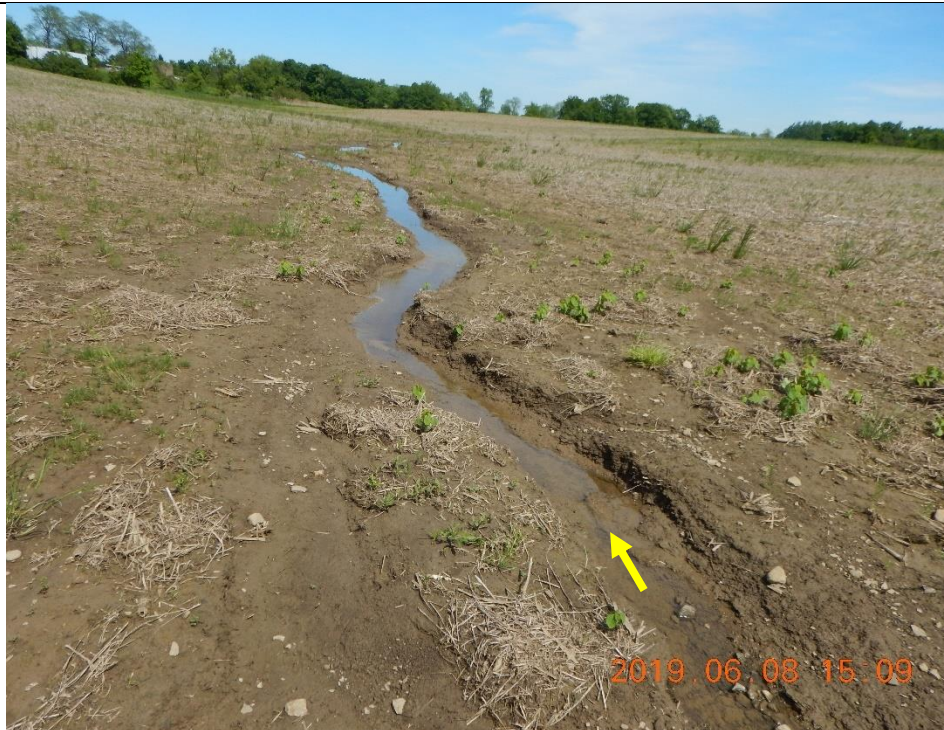
Photo 44
Tributary of Twenty Mile Creek: Visit 2
Reach TTM3-5

The majority of the riparian buffer consisted of agricultural crops.

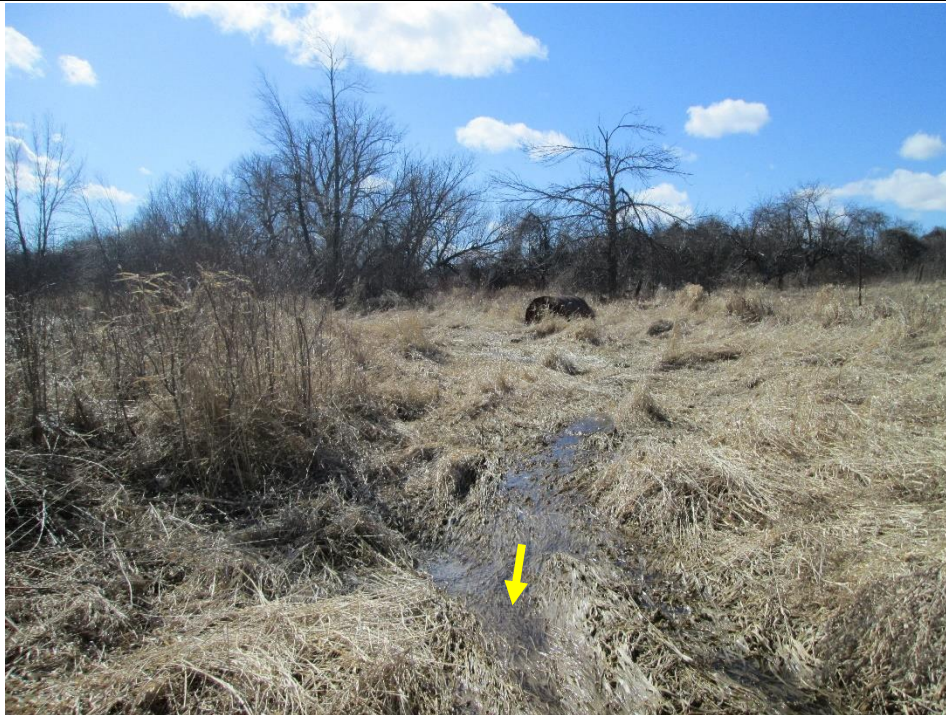
Photo 49
Tributary of Twenty Mile Creek: Visit 1
Reach TTMC3-7

The feature lacked bed and bank definition and conveyed flows from the central woodlot though a meadow to the agricultural field.

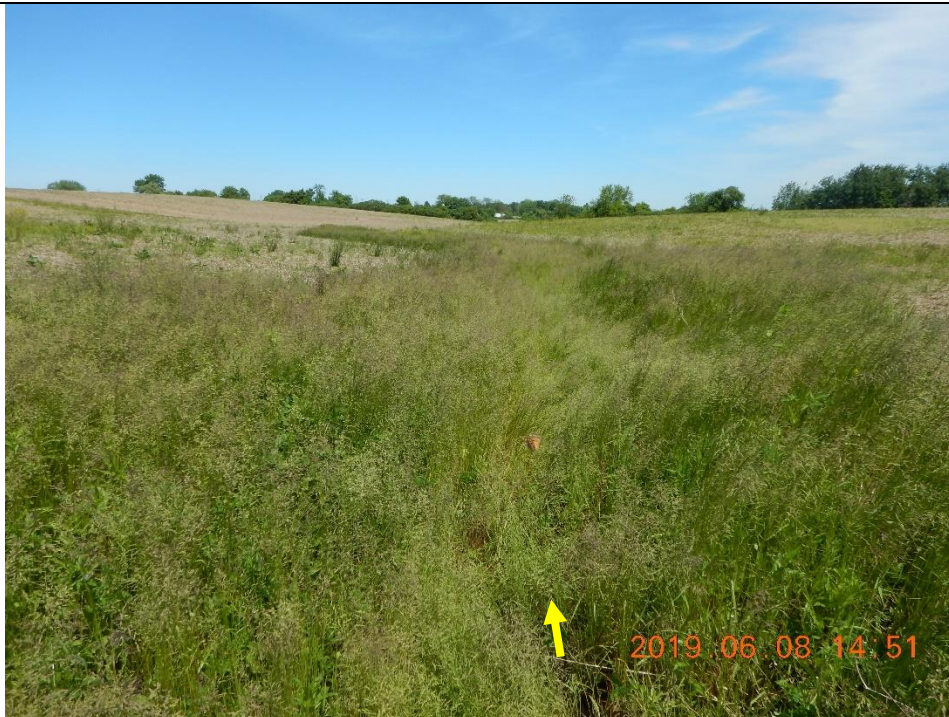
Photo 50
Tributary of Twenty Mile Creek: Visit 2
Reach TTMC3-7

The feature was dry and indistinguishable from the surrounding landscape during the summer, with no discernible channel.

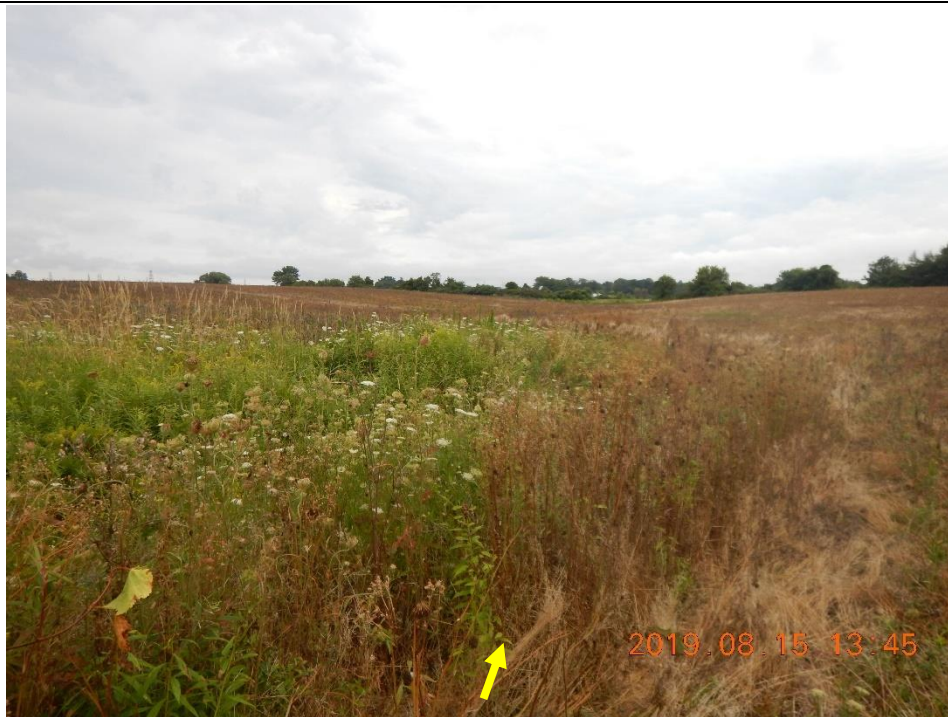
Photo 51
Tributary of Twenty Mile Creek: Visit 3
Reach TTM3-7

The bed was composed of poorly sorted clay, silt, sand and sparse gravel. The feature was dry during the summer visit.

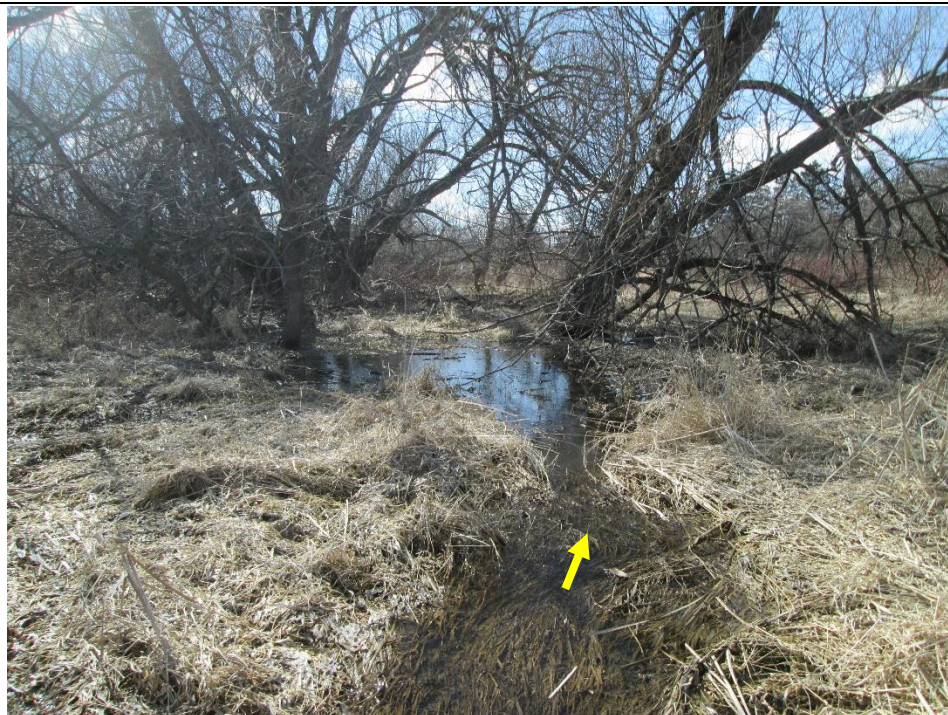
Photo 52
Tributary of Twenty Mile Creek: Visit 1
Reach TTM3-8

The feature was poorly defined and conveyed flows from the online pond to the meadow flanking the agricultural field to the east.

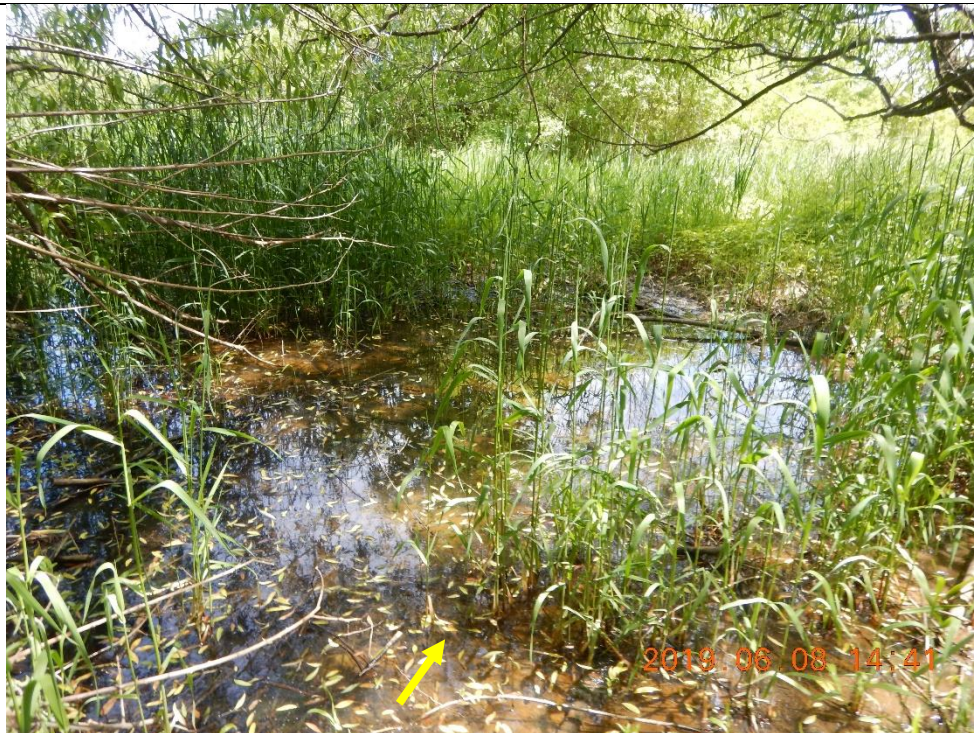
Photo 53
Tributary of Twenty Mile Creek: Visit 2
Reach TTM3-8

Riparian vegetation consisted of deciduous trees and herbaceous vegetation.

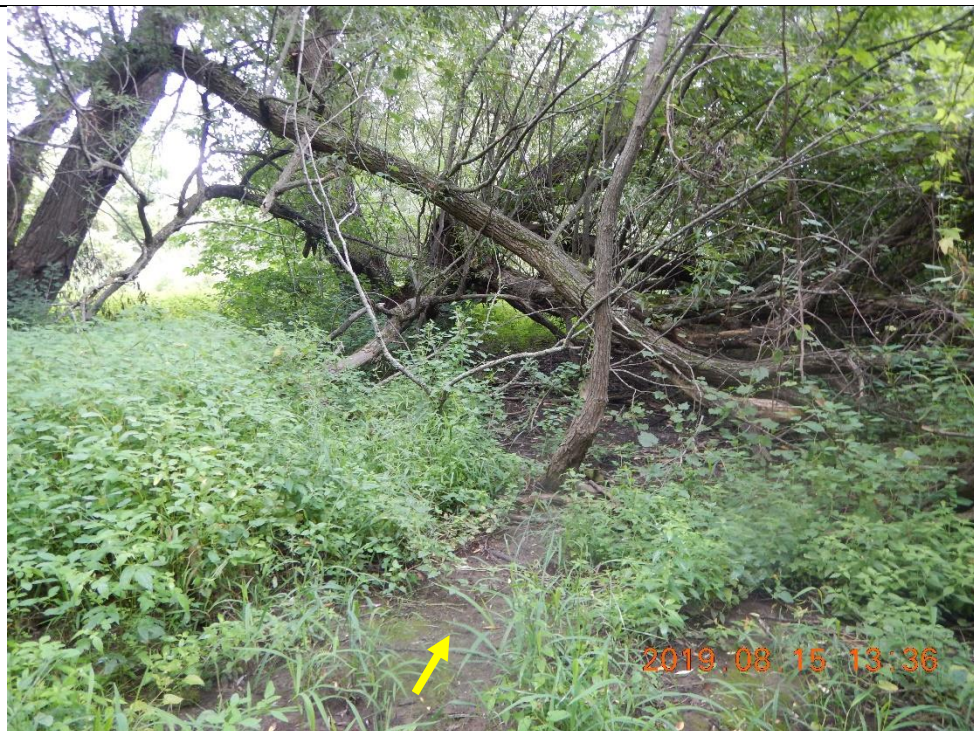
Photo 54
Tributary of Twenty Mile Creek: Visit 3
Reach TTM3-8

Bed materials consisted of clay, silt, sand and organic material. The feature was dry during the summer visit.

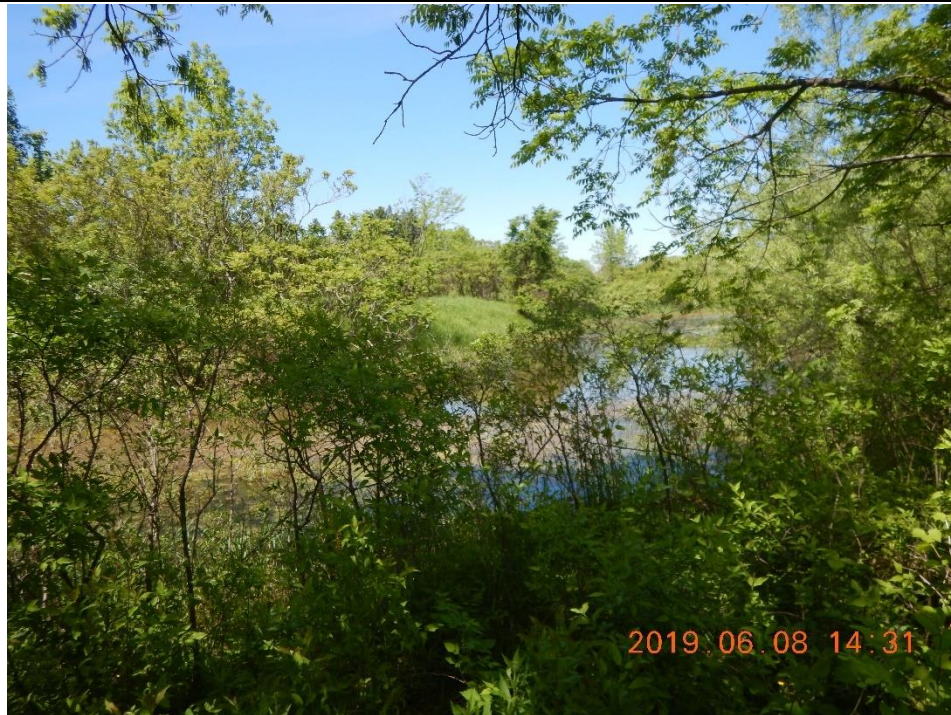
Photo 55
Tributary of Twenty Mile Creek: Visit 2
Reach TTMC3-9

The feature was an online pond located roughly in the middle of the subject lands within a woodlot.

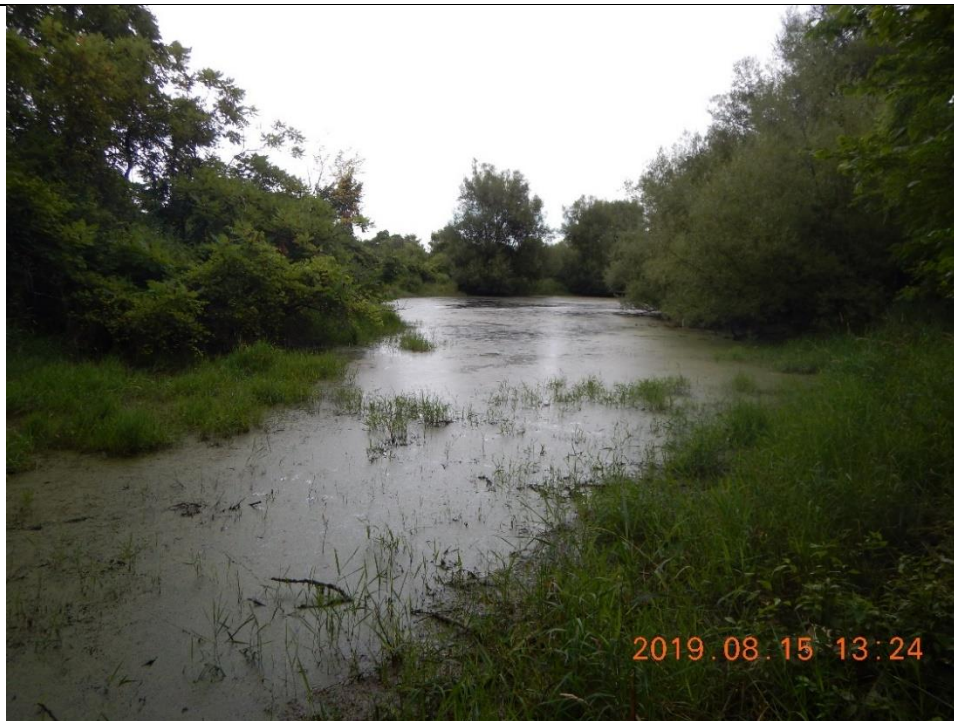
Photo 56
Tributary of Twenty Mile Creek: Visit 3
Reach TTMC3-9

Riparian vegetation consisted predominantly of mature deciduous trees which provided shading to the pond

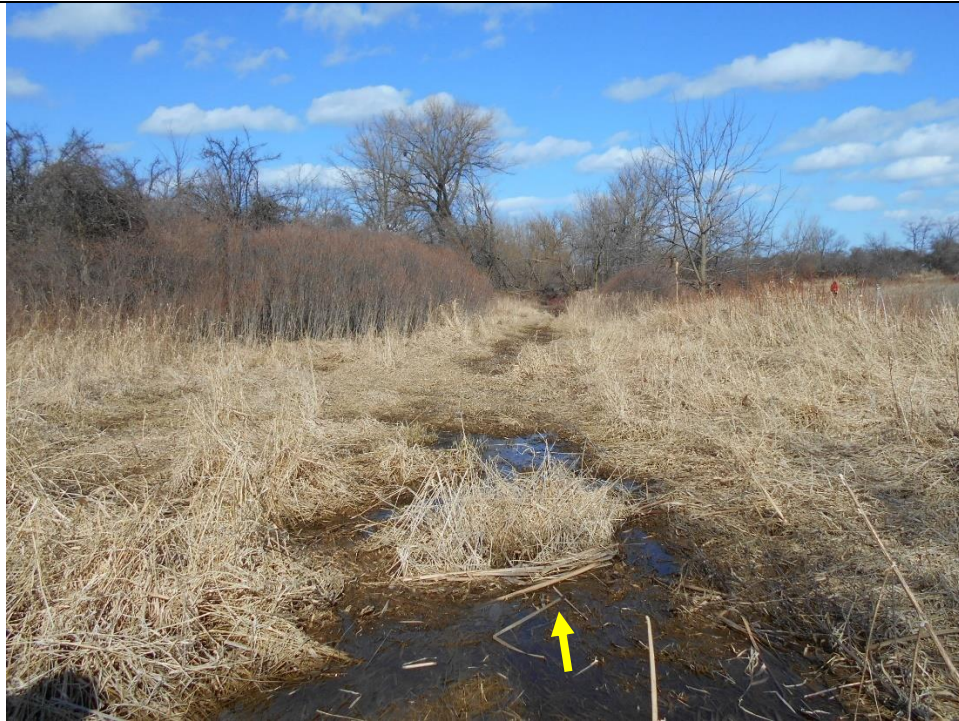
Photo 57
Tributary of Twenty Mile Creek: Visit 1
Reach TTM3-10

The feature lacked bed and bank definition and conveyed flows through a meadow.

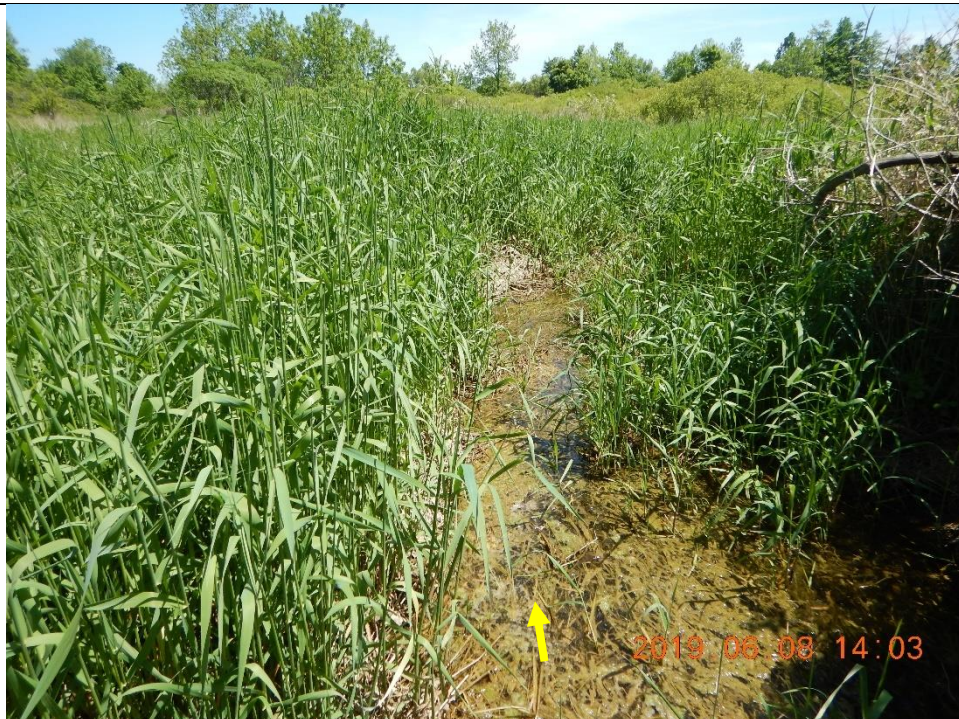
Photo 58
Tributary of Twenty Mile Creek: Visit 2
Reach TTM3-10

The swale was populated by dense hydrophilic vegetation in the feature itself and its riparian zone.

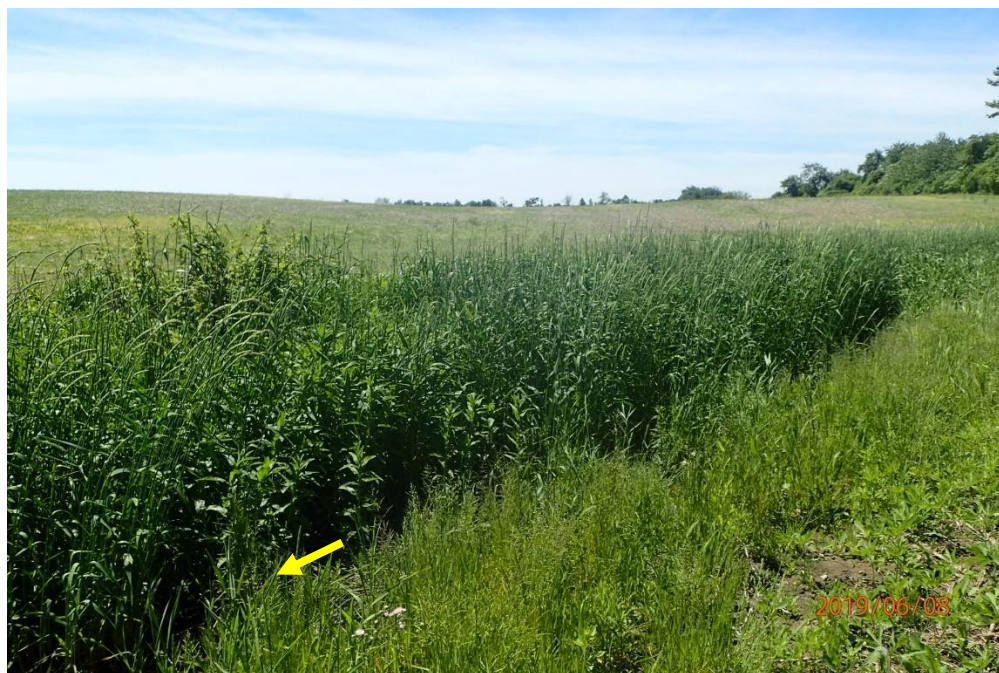
Photo 61
Tributary of Twenty Mile Creek: Visit 2
Reach TTMCS-4

The feature occupied a relatively wide corridor composed of hydrophilic herbaceous vegetation and grasses.
