Upper West Side Secondary Plan Area Fluvial Geomorphological Assessment And Natural Channel Design

Twenty Road West, City of Hamilton

November 20, 2023
PN23079

Report Title: Upper West Side Secondary Plan Area
Fluvial Geomorphological Assessment and Natural
Channel Design

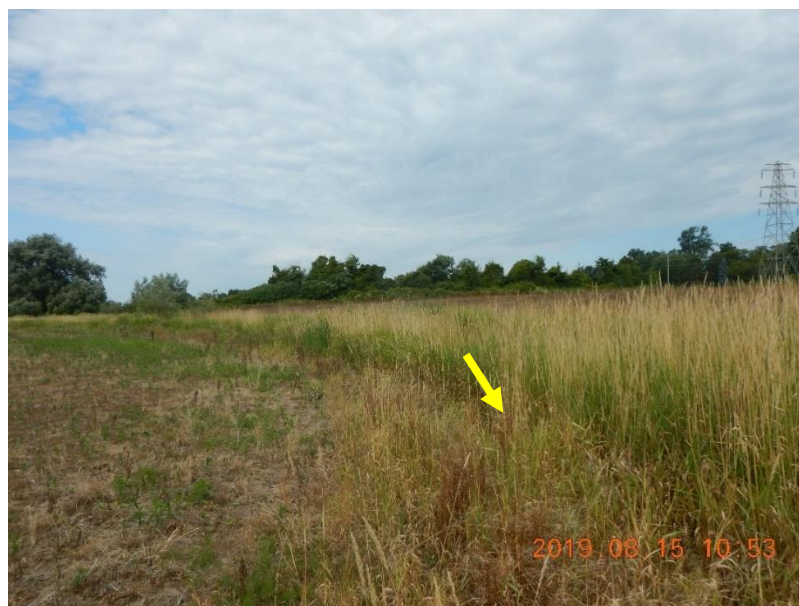
Photo 62
Tributary of Twenty Mile Creek: Visit 3
Reach TTMCS-4

The substrate material was equivalent to the surrounding fields and consisted of clay, silt and sand.

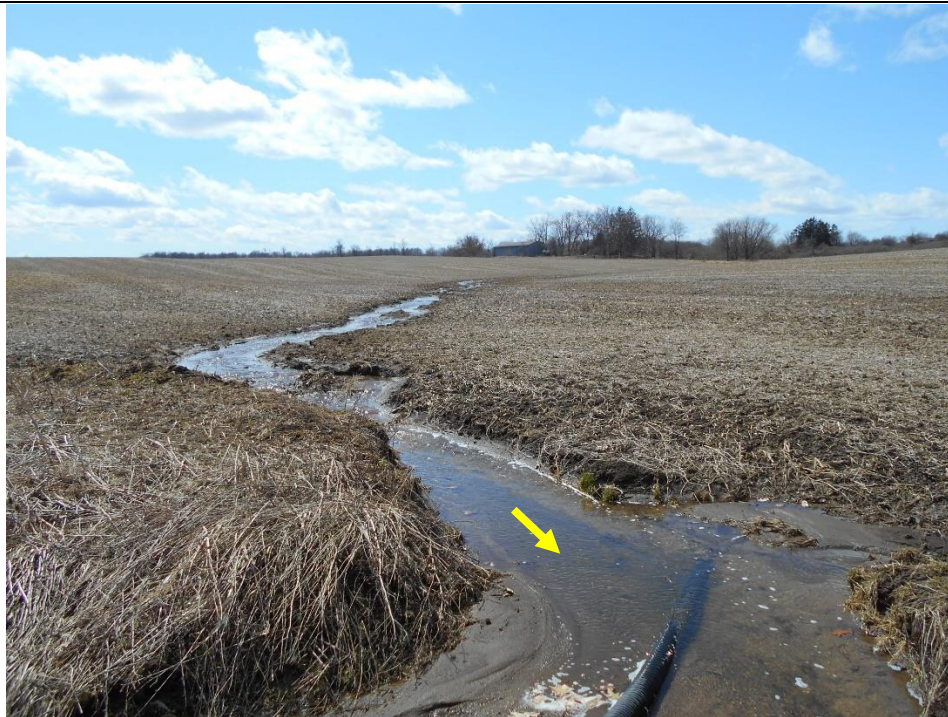
Photo 63
Tributary of Twenty Mile Creek: Visit 1
Reach TTMCS-5

The feature lacked bed and bank definition and conveyed flows through an agricultural field.

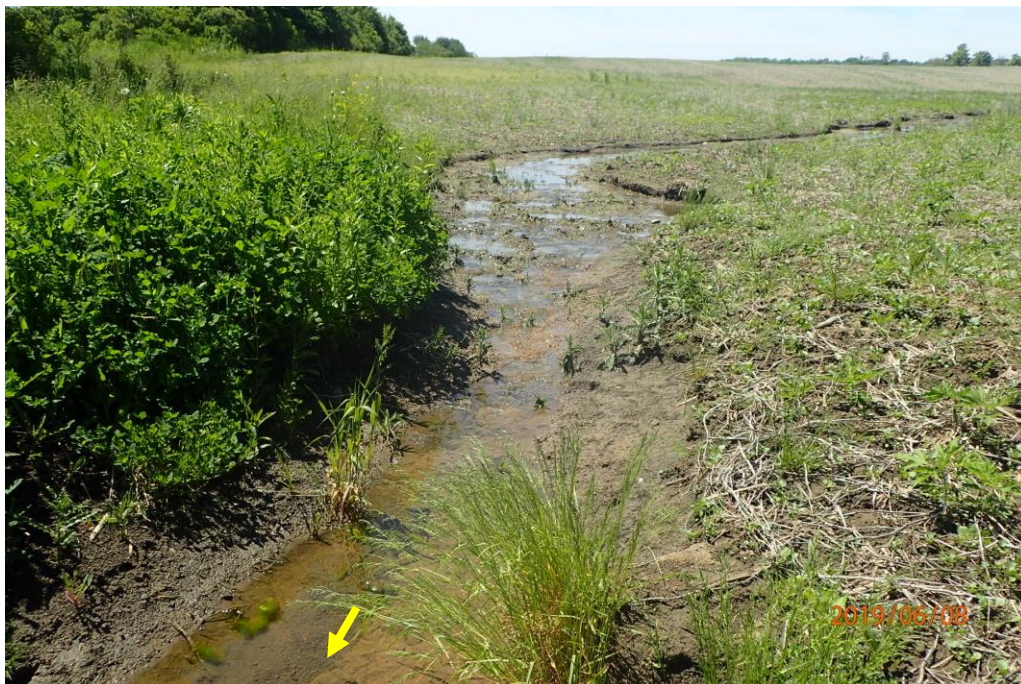
Photo 64
Tributary of Twenty Mile Creek: Visit 2
Reach TTMCS-5

The swale lacked a natural riparian corridor and was instead flanked by agricultural fields.

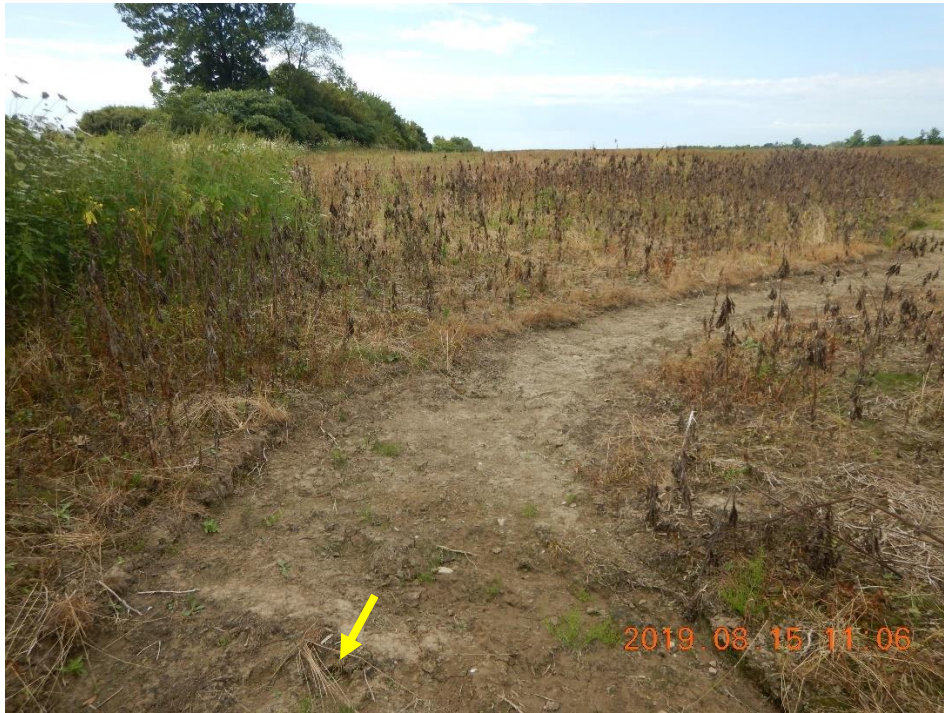
Photo 65
Tributary of Twenty Mile Creek: Visit 3
Reach TTMC5-5

The feature was dry during the summer visit and substrate was generally consistent with the adjacent fields.

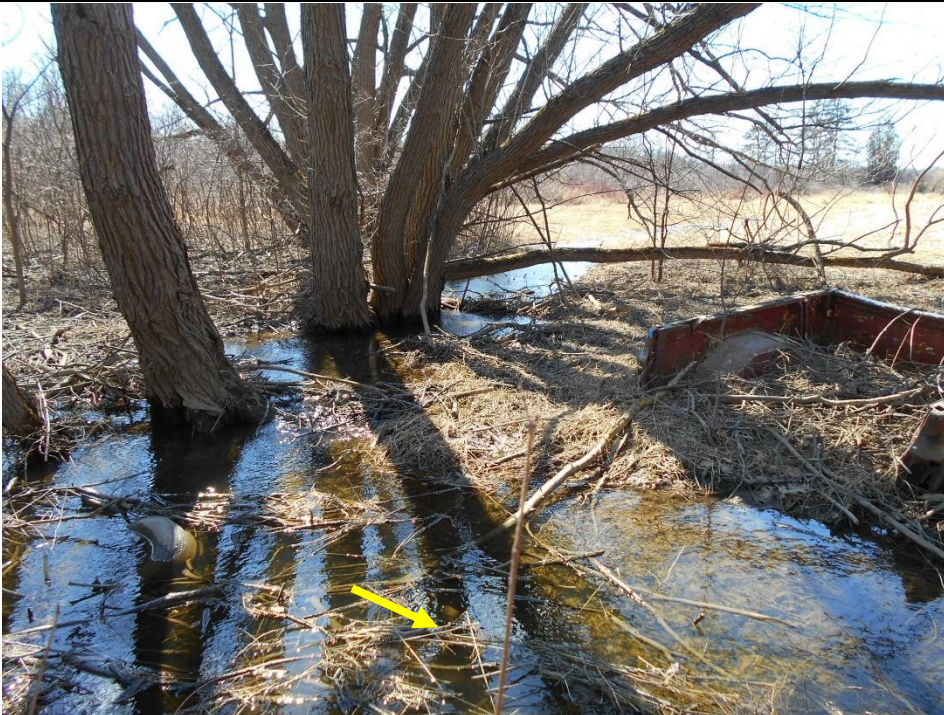
Photo 66
Tributary of Twenty Mile Creek: Visit 1
Reach TTMC5-6

The feature lacked bed and bank definition and conveyed flows within a wooded area.

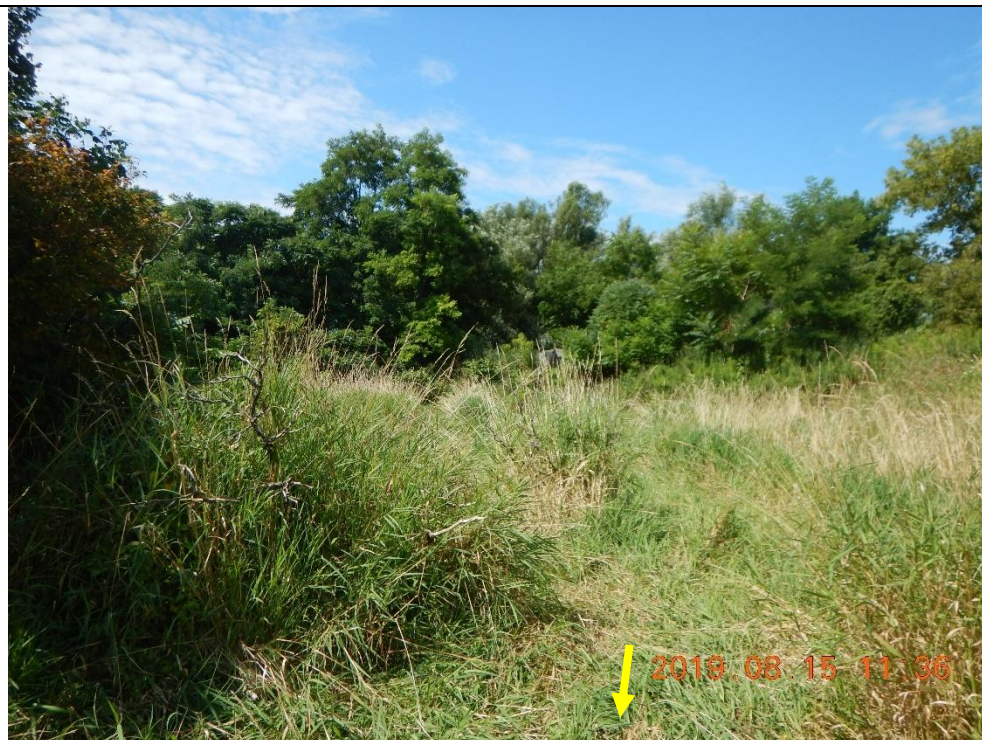
Photo 67
Tributary of Twenty Mile Creek: Visit 3
Reach TTMCS-6

The feature was a wide grassy corridor composed of hydrophilic vegetation with deciduous trees occupying the riparian buffer.

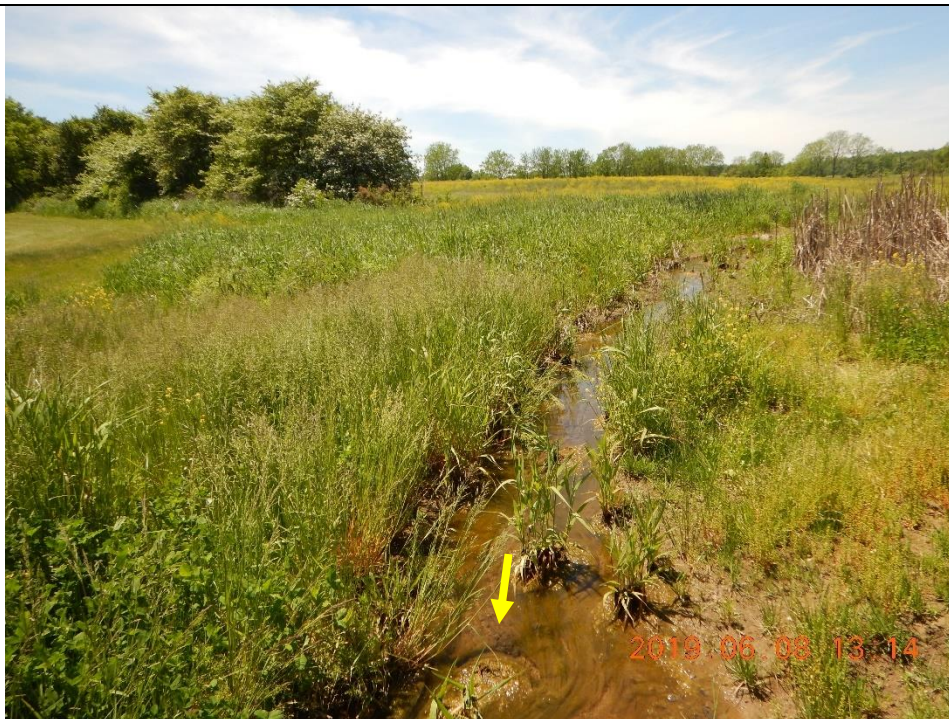
Photo 70
Tributary of Twenty Mile Creek: Visit 2
Reach TTMCS-7

Riparian vegetation consisted of grasses, with some areas lacking a buffer and instead being flanked by crops.

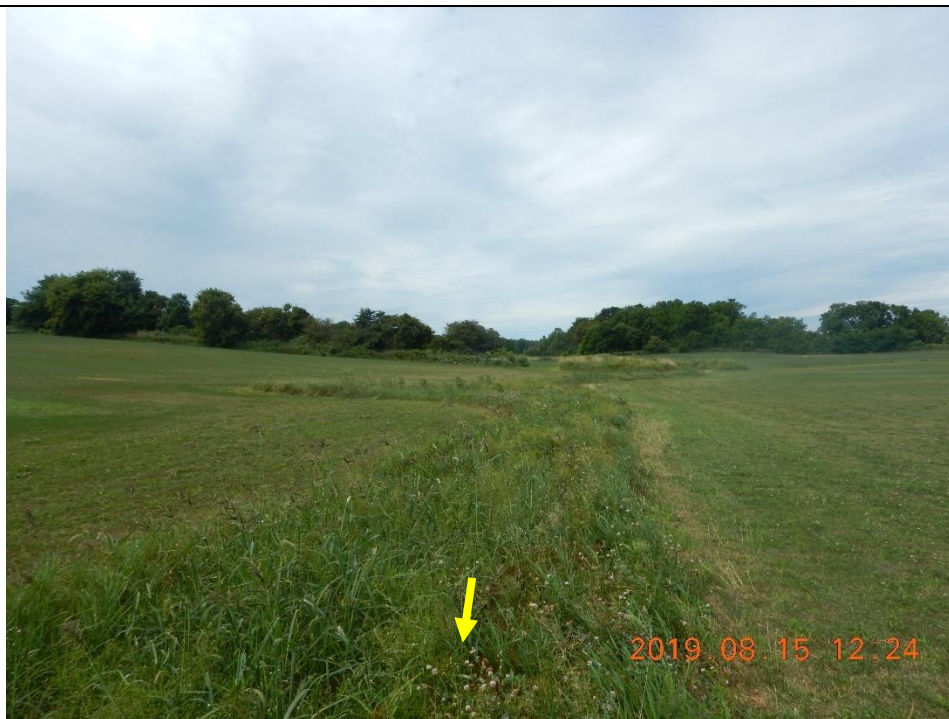
Photo 71
Tributary of Twenty Mile Creek: Visit 3
Reach TTMCS-7

Substrate within the feature consisted of clay, silt, and sand and the channel was occupied by sparse rooted emergent aquatic vegetation and grasses.

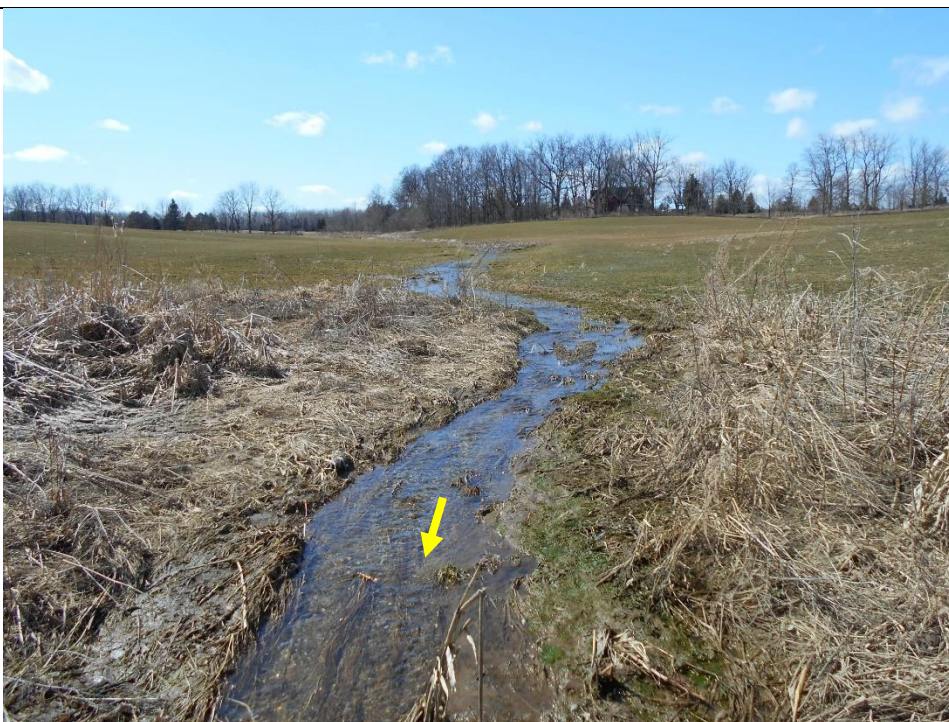
Photo 72
Tributary of Twenty Mile Creek: Visit 1
Reach TTMCS-8

The feature was a swale which conveyed flows through an agricultural field.

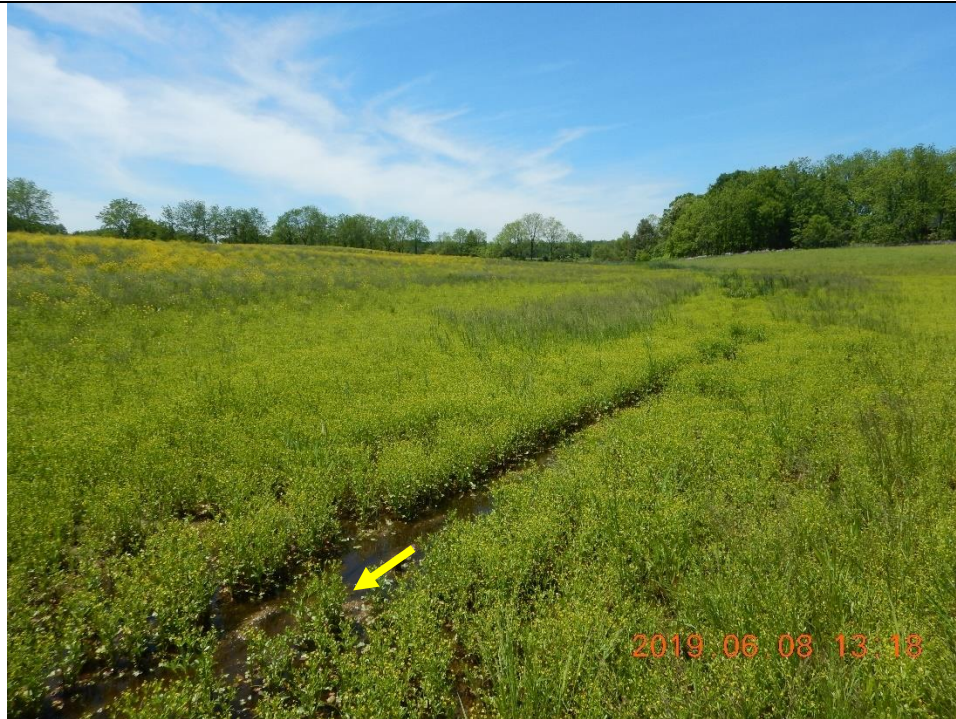
Photo 73
Tributary of Twenty Mile Creek: Visit 2
Reach TTMC5-8

The feature had a narrow riparian corridor composed of herbaceous vegetation and grasses.

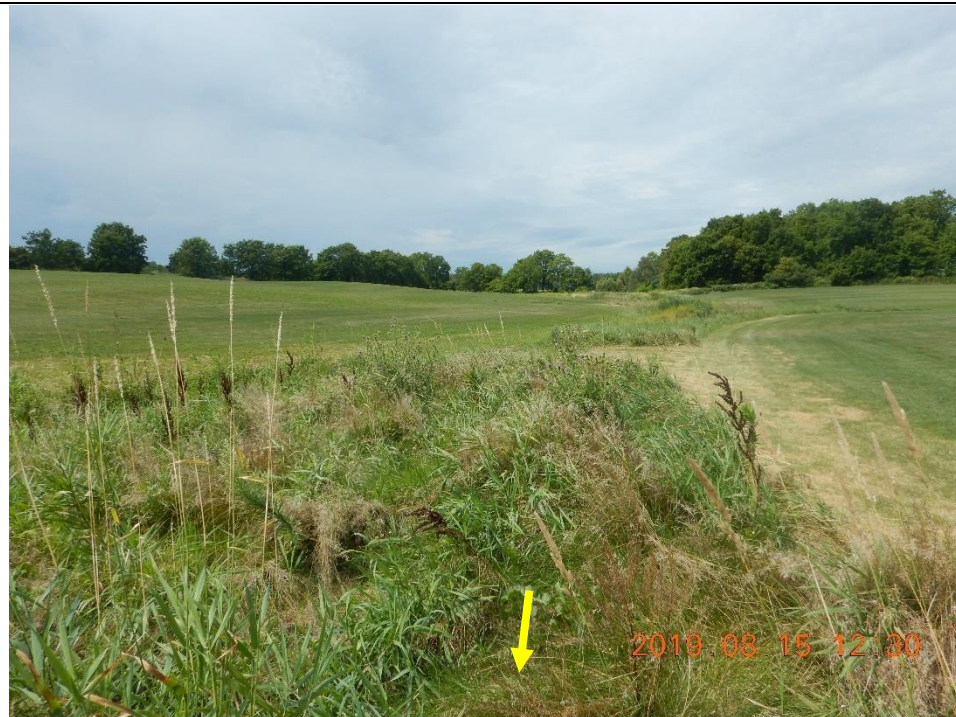
Photo 74
Tributary of Twenty Mile Creek: Visit 3
Reach TTMC5-8

Substrate composition was predominantly clay, silt and sand with some scattered gravels.
The feature was dry during the summer visit.

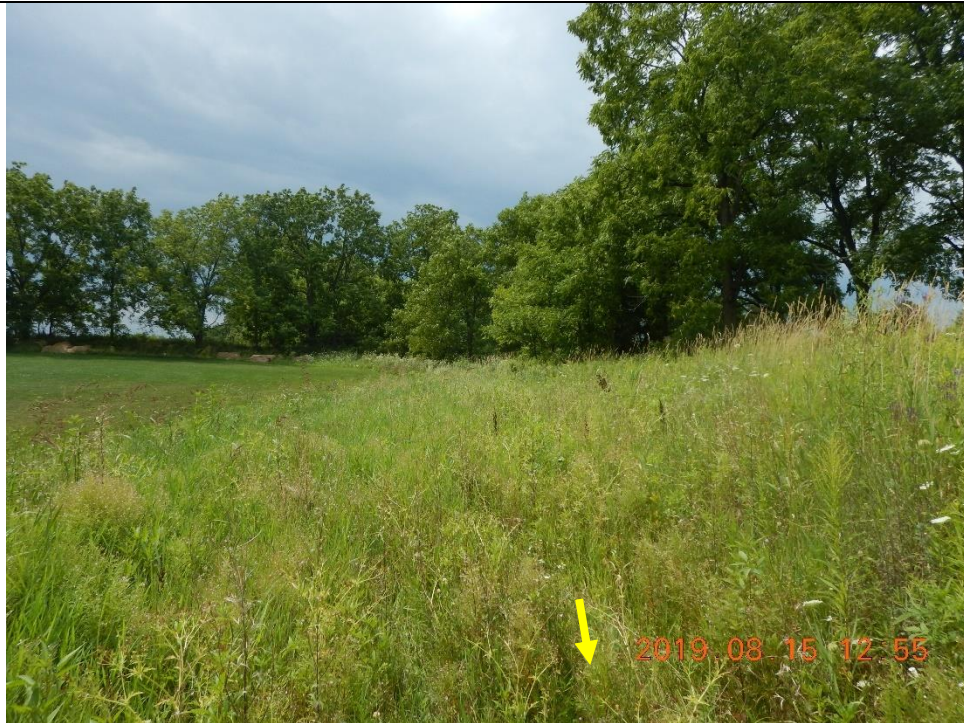
Photo 77
Tributary of Twenty Mile Creek: Visit 3
Reach TTM5-8-1

Bed substrate consisted of clay, silt and sand. The feature was again dry during the summer visit.

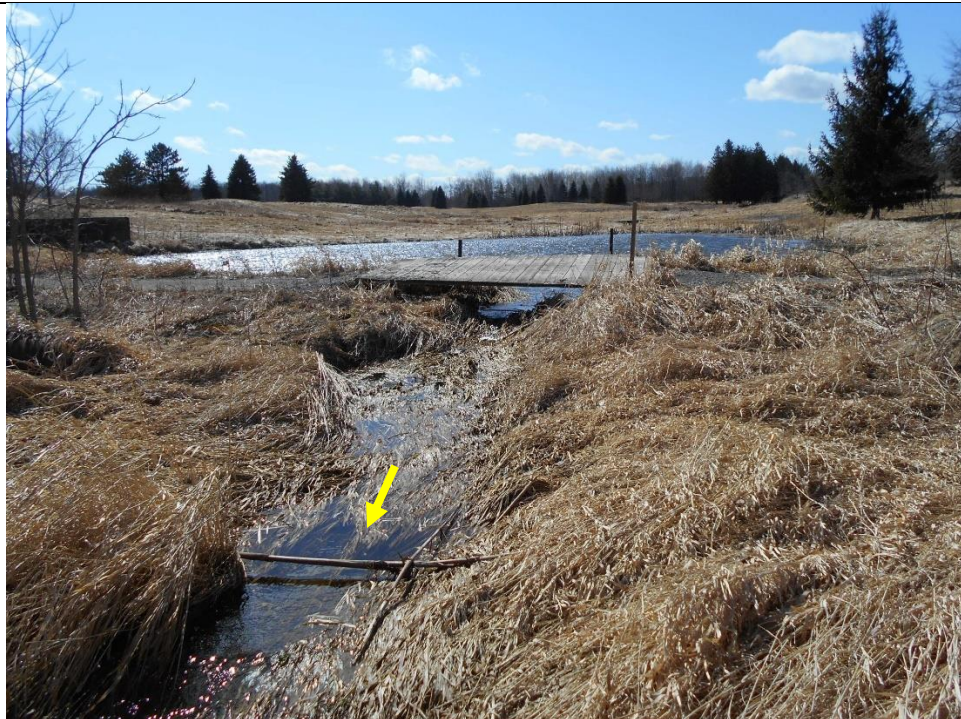
Photo 78
Tributary of Twenty Mile Creek: Visit 1
Reach TTM5-9

The feature originated at the outlet of a small pond within the former Glancaster Golf and Country Club and conveyed flows through an agricultural field.

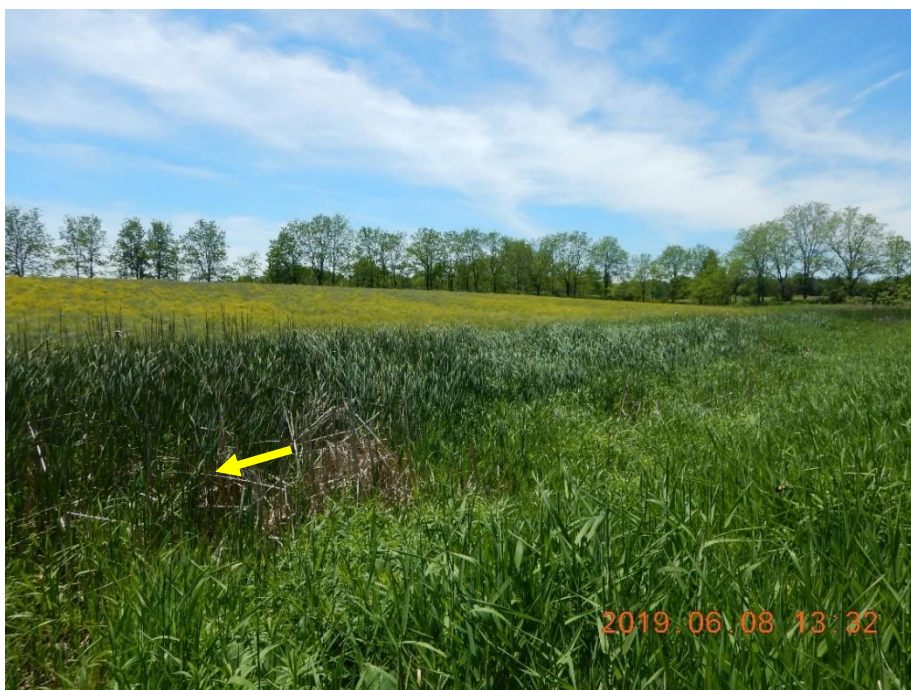
Photo 79
Tributary of Twenty Mile Creek: Visit 2
Reach TTM5-9

The feature's substrate consisted predominantly of organic material, silt and sand.

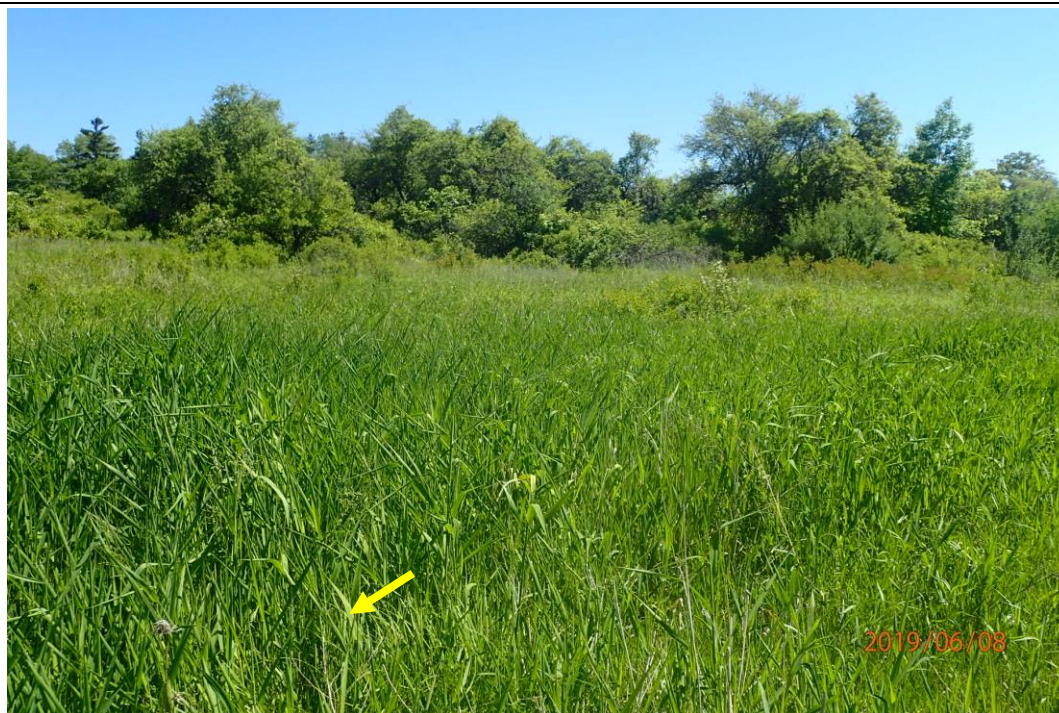
Photo 84
Tributary of Twenty Mile Creek: Visit 2
Reach TTM6-2

The feature was filled with dense, rooted emergent aquatic vegetation, particularly grasses, and was flanked by both meadow and scrubland within the riparian buffer.

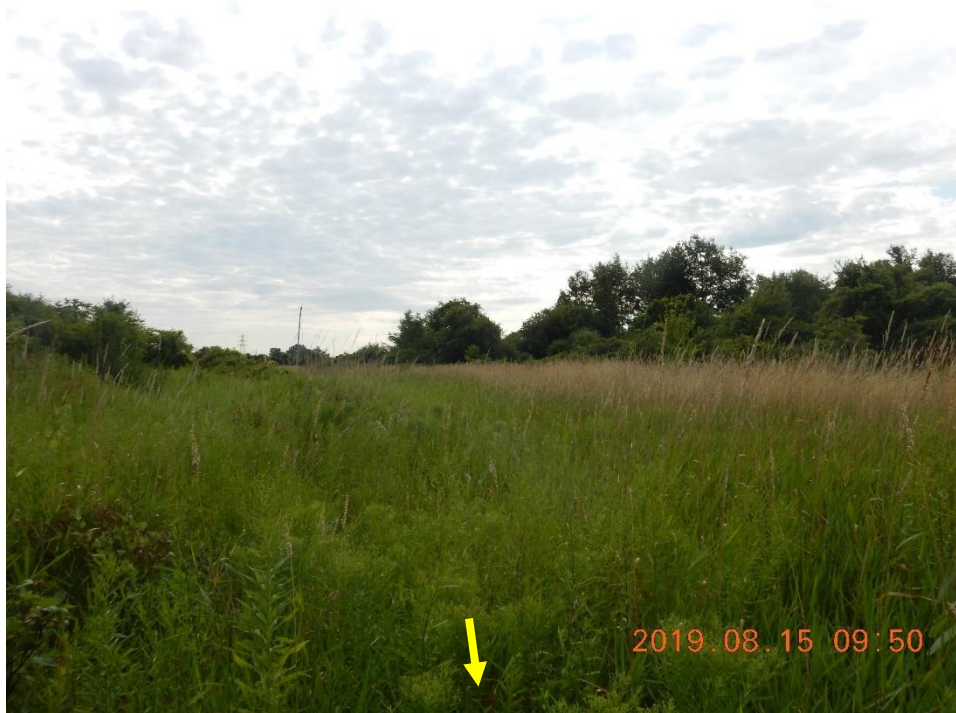
Photo 85
Tributary of Twenty Mile Creek: Visit 3
Reach TTMC6-2

Bed substrate within the feature was predominantly clay, silt and sand. No water was present during the summer visit.

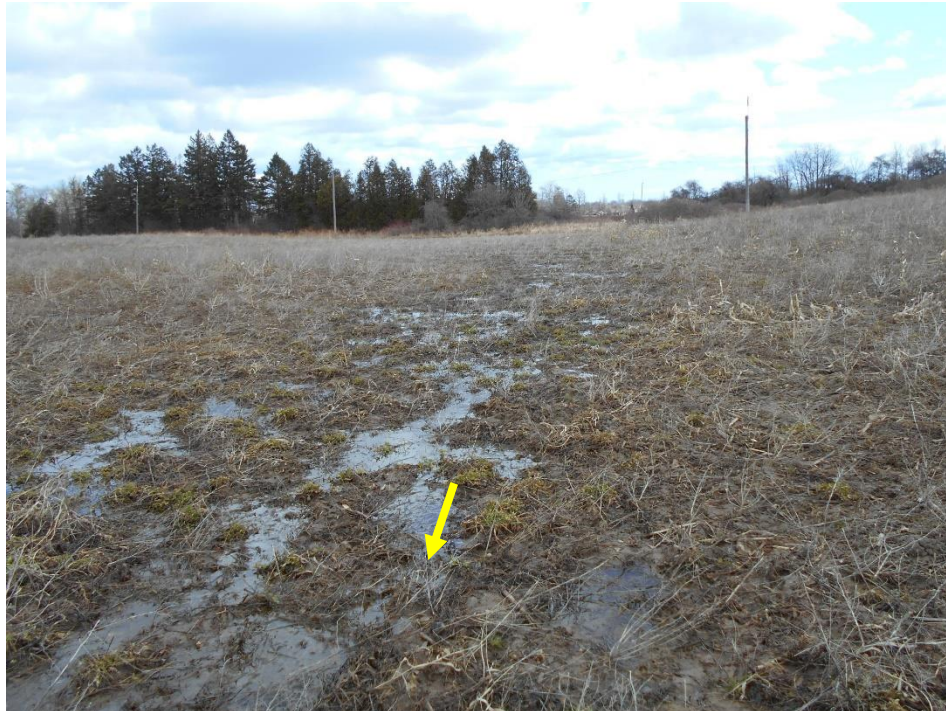
Photo 86
Tributary of Twenty Mile Creek: Visit 1
Reach TTMC6-3

The feature lacked bed and bank definition and conveyed flows through an agricultural field north of a central residential property.

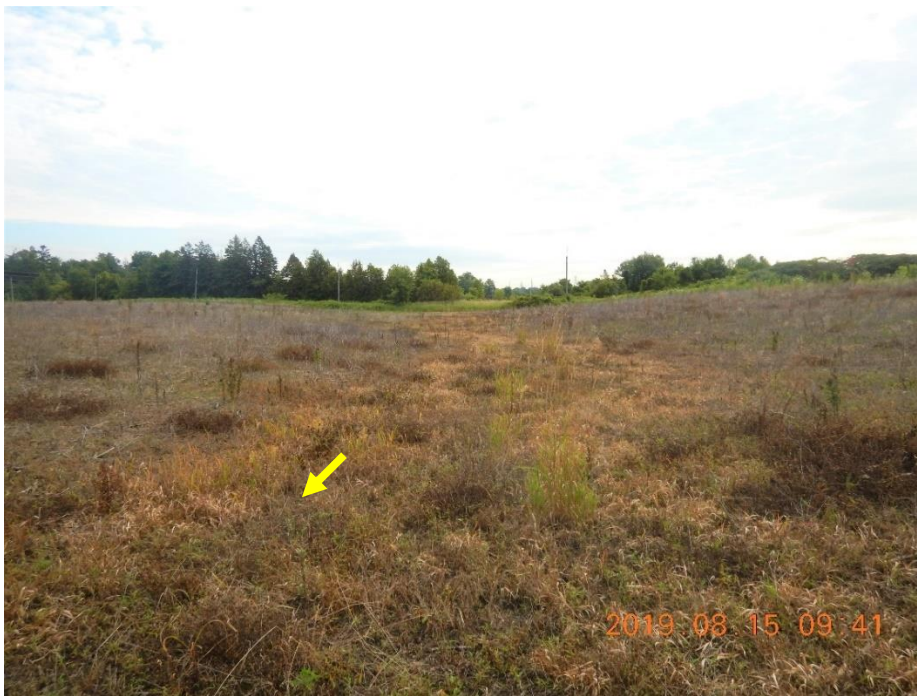
Photo 88
Tributary of Twenty Mile Creek: Visit 3
Reach TTMC6-3

Substrate within the feature was clay, silt and sand. No discernable channel could be located at the upstream extent of the reach. The feature was dry during the summer visit.

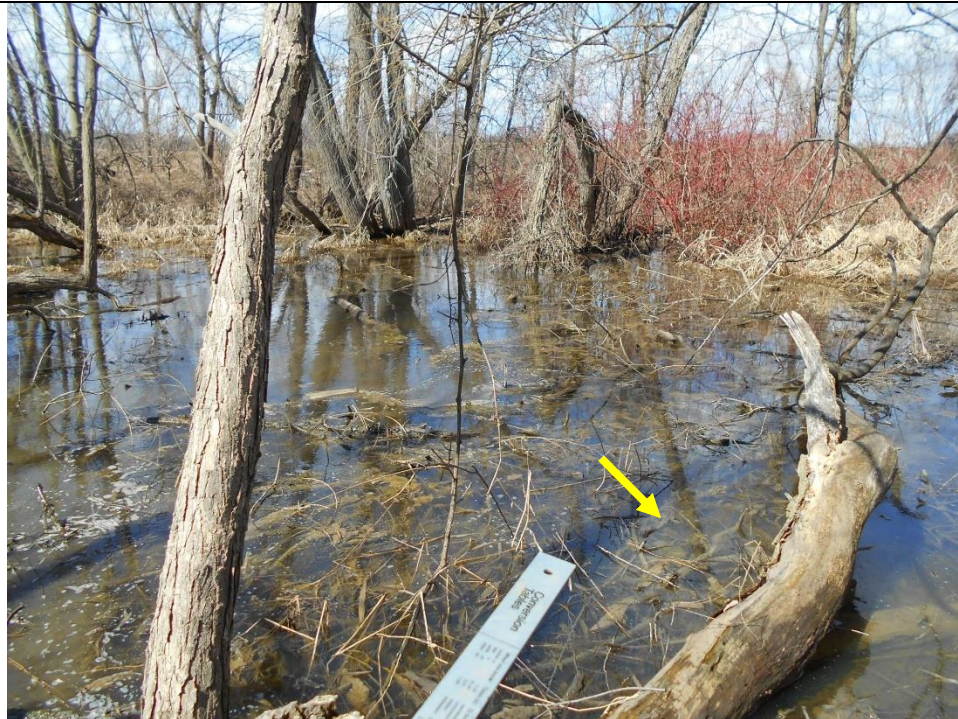
Photo 89
Tributary of Twenty Mile Creek: Visit 1
Reach TTM6-4

The feature lacked definition and is best described as a vernal pool within a wide hedgerow between two agricultural fields.

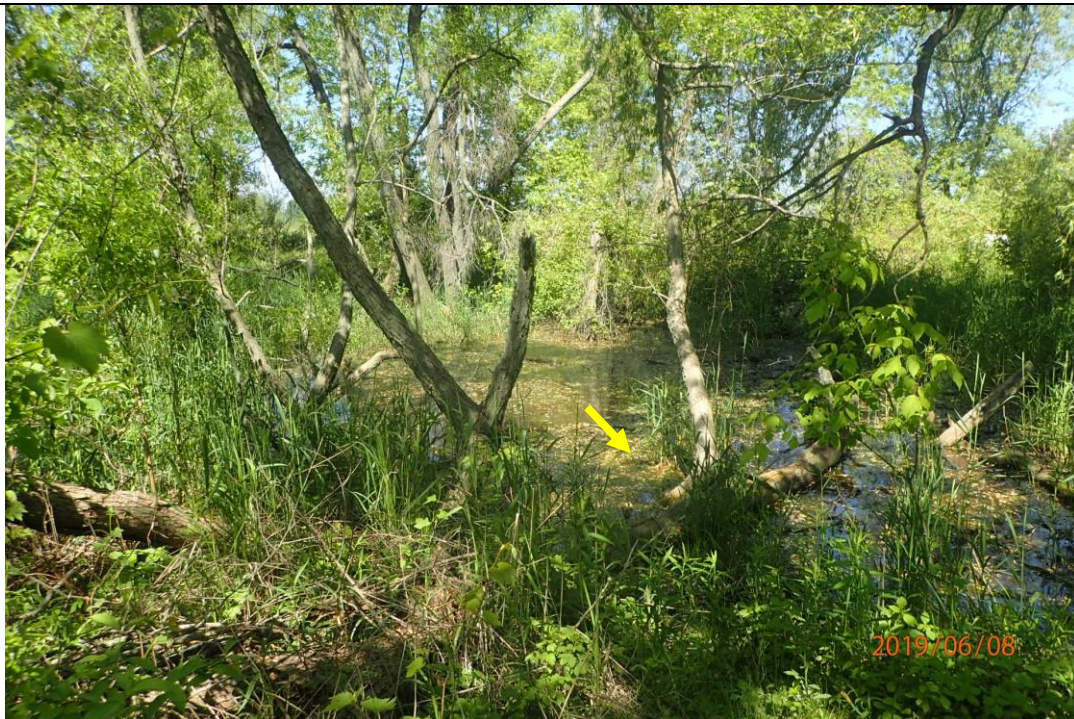
Photo 90
Tributary of Twenty Mile Creek: Visit 2
Reach TTM6-4

The feature was surrounded by scrubland and deciduous trees.

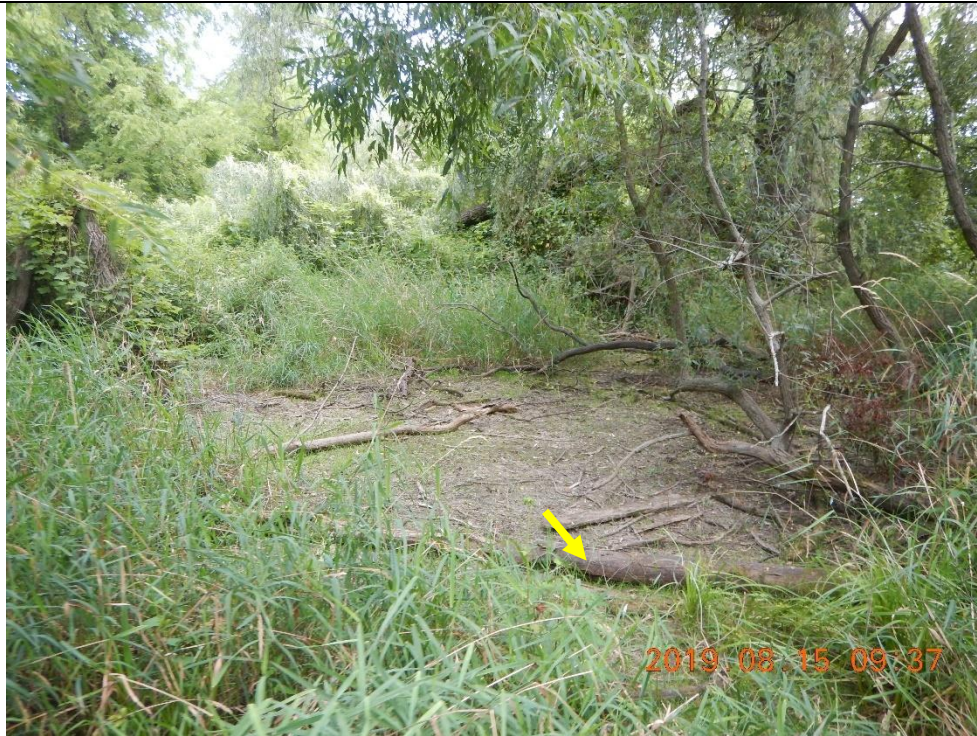
Tributary of Twenty Mile Creek: Visit 3
Reach TTM6-4

The feature was dry during the summer visit and its substrate consisted predominantly of decomposing organics.

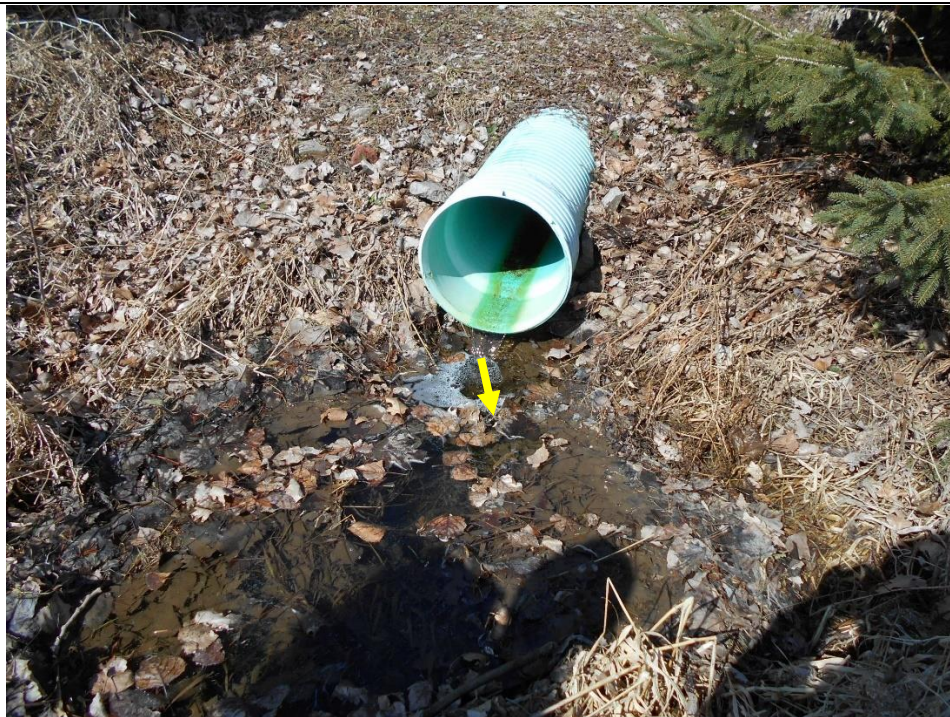
Tributary of Twenty Mile Creek: Visit 1
Reach TTM7-1

The feature originated at a culvert and was poorly defined.

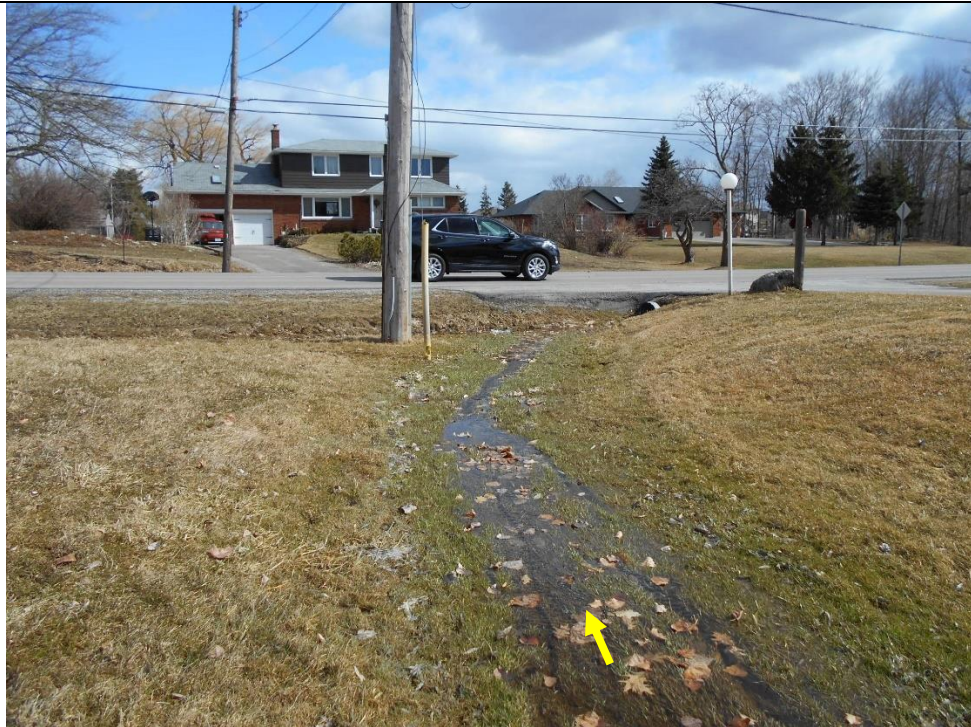
Photo 95
Tributary of Twenty Mile Creek: Visit 1
Reach TTMC8-6

The feature lacked bed and bank definition and conveyed flows towards a roadside ditch at Twenty Road West.

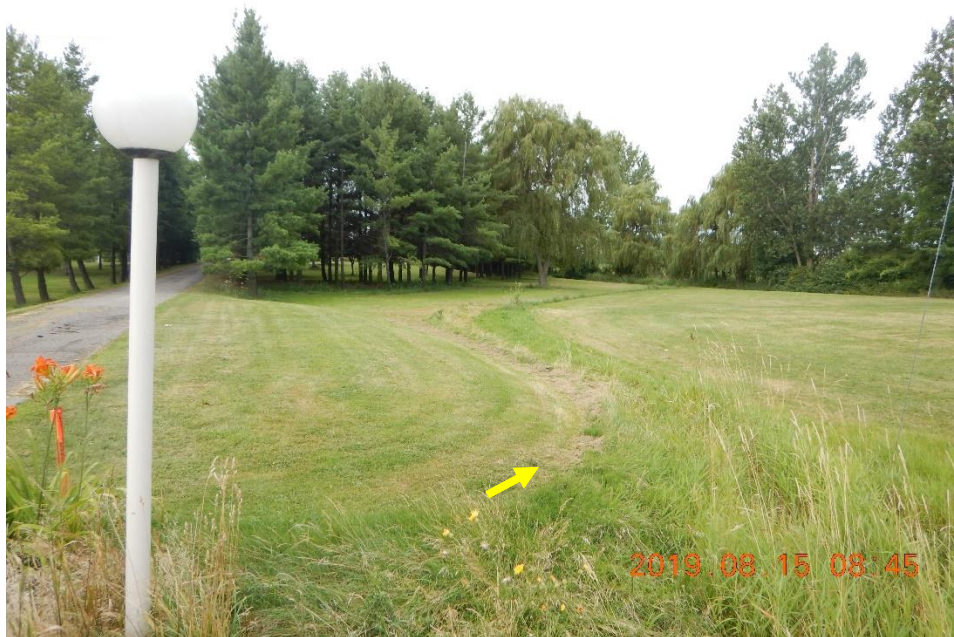
Photo 96
Tributary of Twenty Mile Creek: Visit 2
Reach TTMC8-6

The feature's vegetation was equivalent to the surrounding area, and consisted of a manicured lawn.

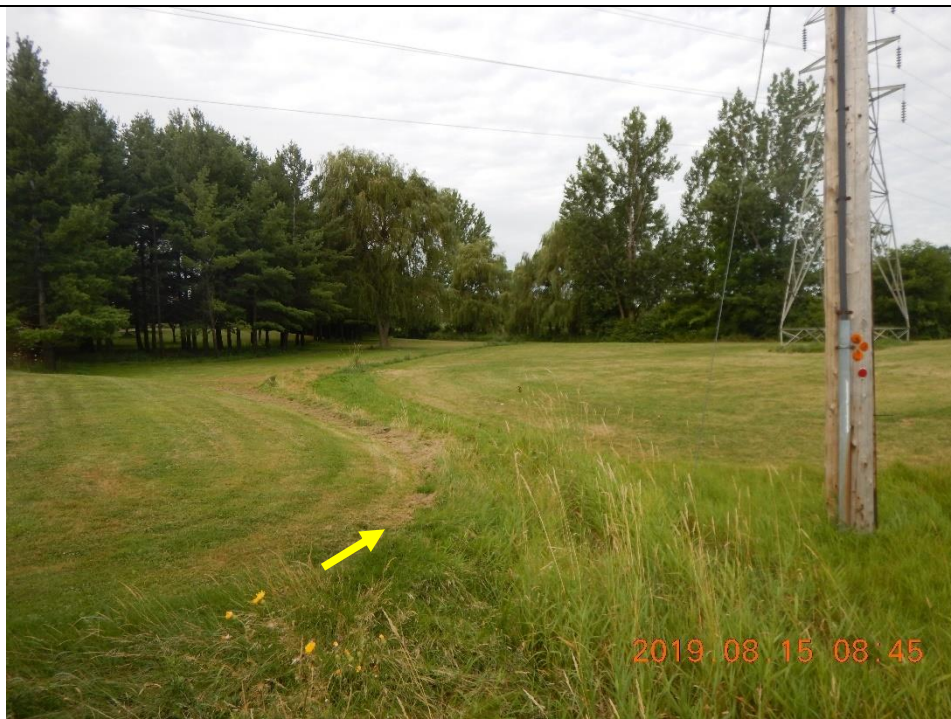
Photo 97
Tributary of Twenty Mile Creek: Visit 2
Reach TTMC8-6

The feature was dry during the 2nd visit.

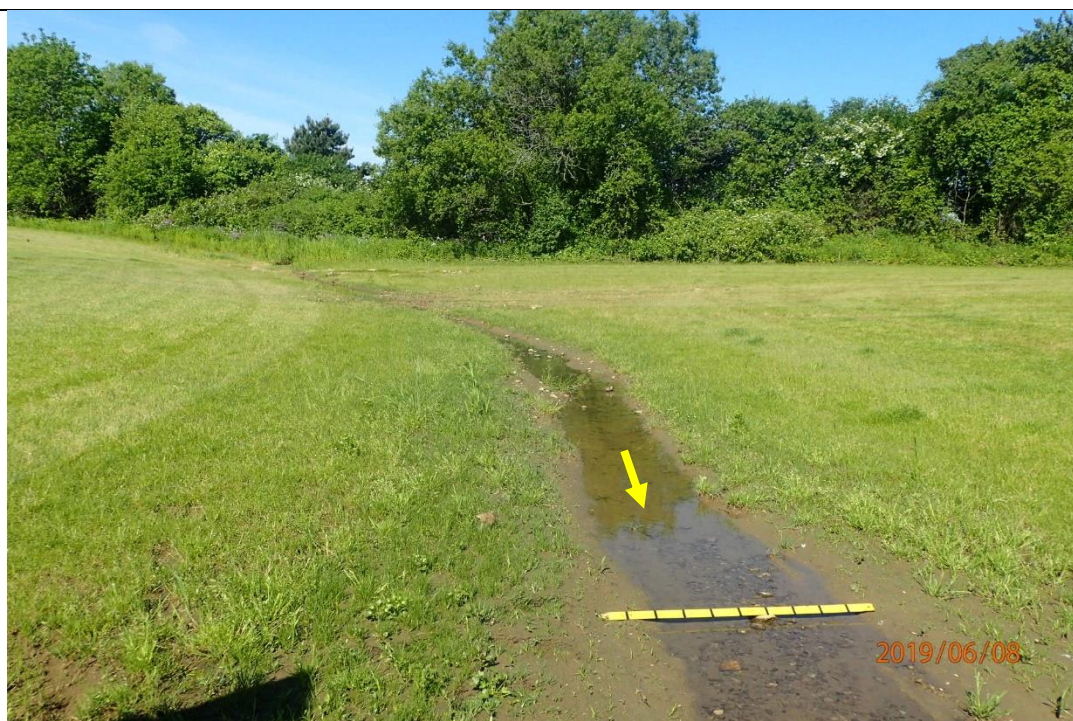
Photo 98
Tributary of Twenty Mile Creek: Visit 1
Reach TTMC8-7

The feature lacked a natural riparian buffer, and was predominantly cropped with some areas lacking any vegetation.

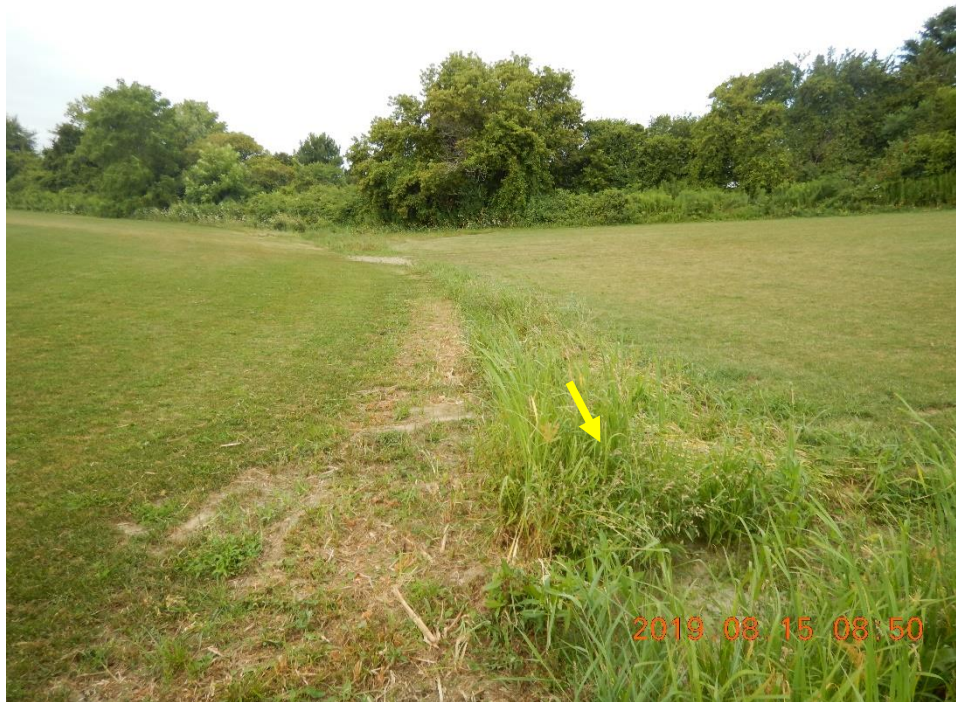
Photo 99
Tributary of Twenty Mile Creek: Visit 3
Reach TTMC8-7

Substrate composition was predominantly clay, silt, sand and sparse gravel. The feature was dry during the summer visit.

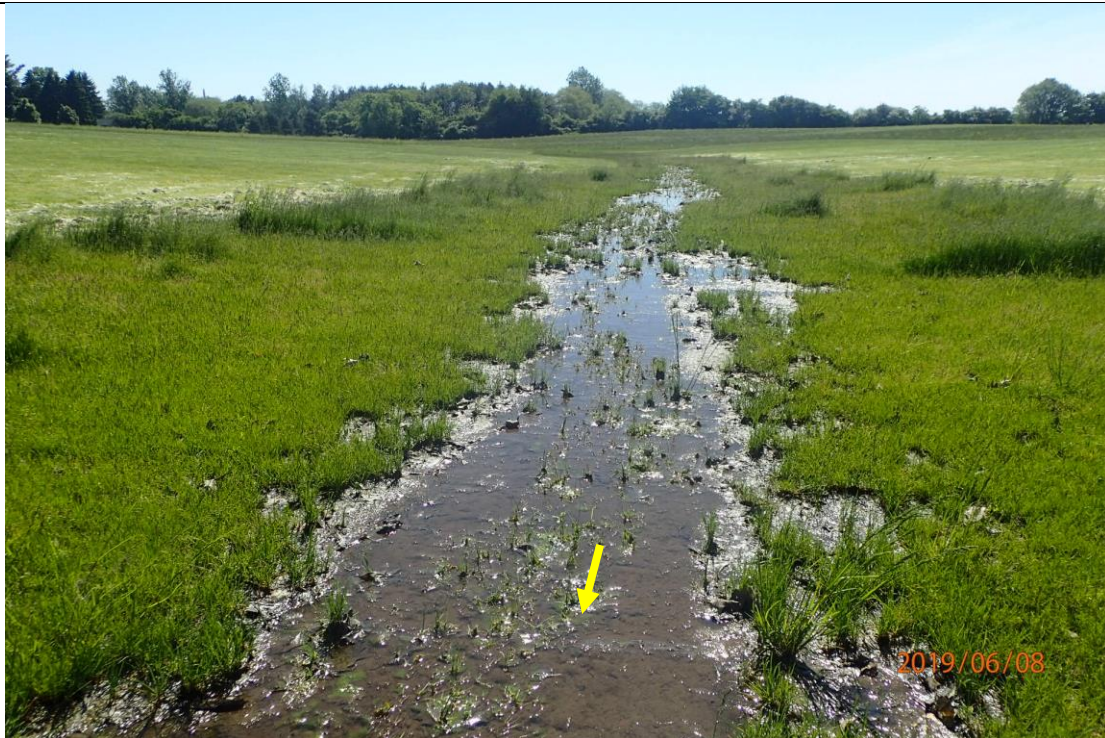
Photo 100
Tributary of Twenty Mile Creek: Visit 2
Reach TTMC8-9

The feature was a swale which conveyed flows through an agricultural field.

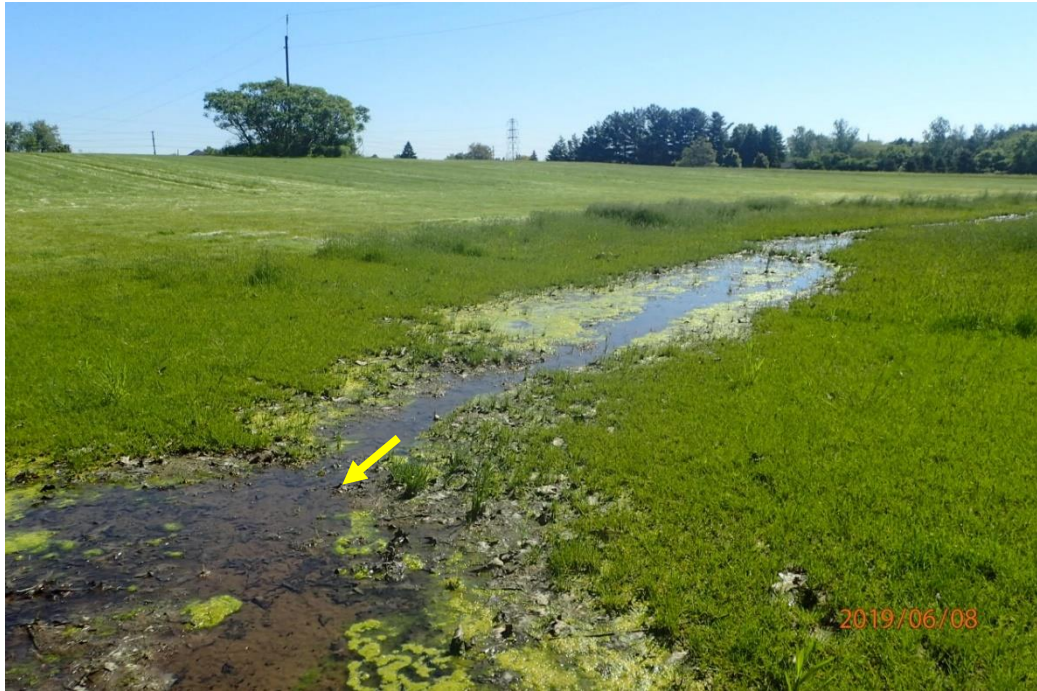
Photo 101
Tributary of Twenty Mile Creek: Visit 2
Reach TTM8-9

Riparian vegetation consisted predominantly of agricultural crops, which were generally absent from the channel during the spring.

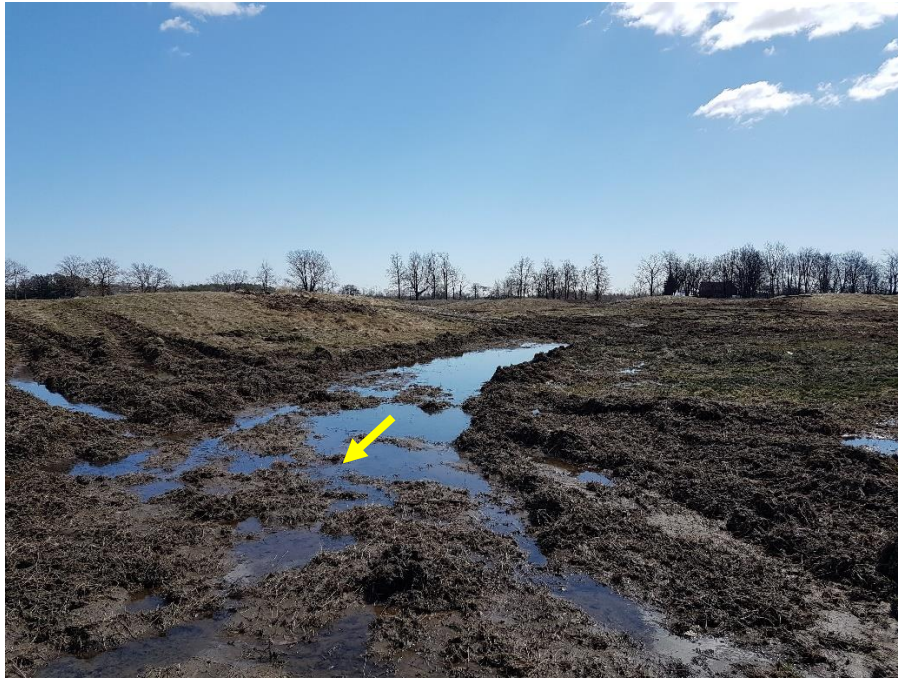
Photo 105
Tributary of Twenty Mile Creek: Visit 1
Reach TTMC8-10

The feature lacked channel definition and conveyed flows through an agricultural field.

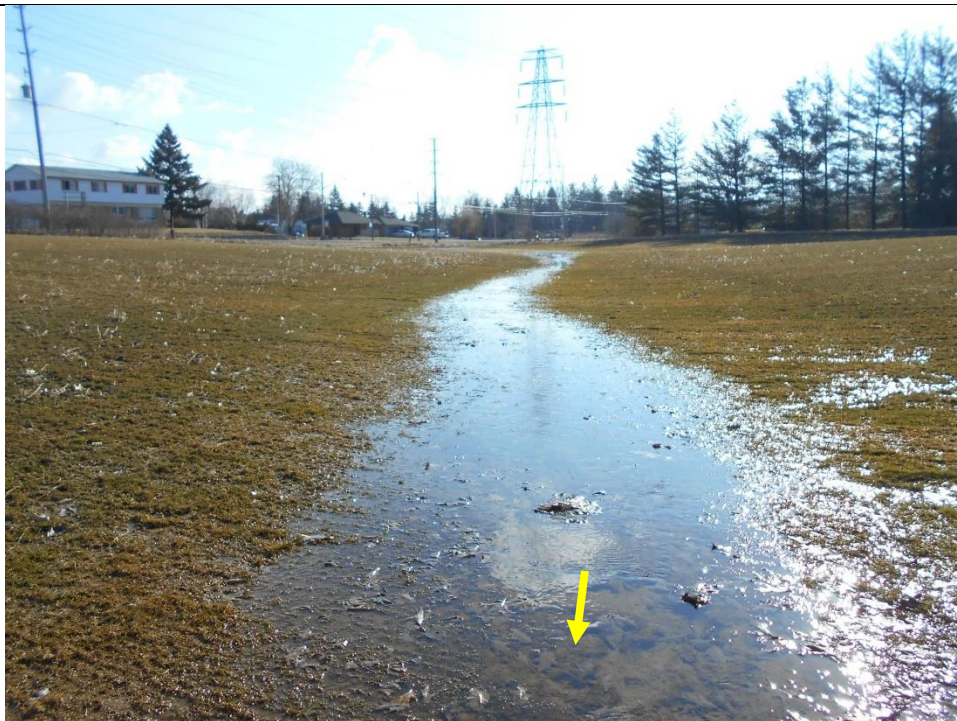
Photo 106
Tributary of Twenty Mile Creek: Visit 1
Reach TTMC8-3-3

The feature lacked channel definition and conveyed flows through an agricultural field.
