Upper West Side Secondary Plan Area Fluvial Geomorphological Assessment And Natural Channel Design

Twenty Road West, City of Hamilton

November 20, 2023
PN23079

Report Title: Upper West Side Secondary Plan Area
Fluvial Geomorphological Assessment and Natural
Channel Design

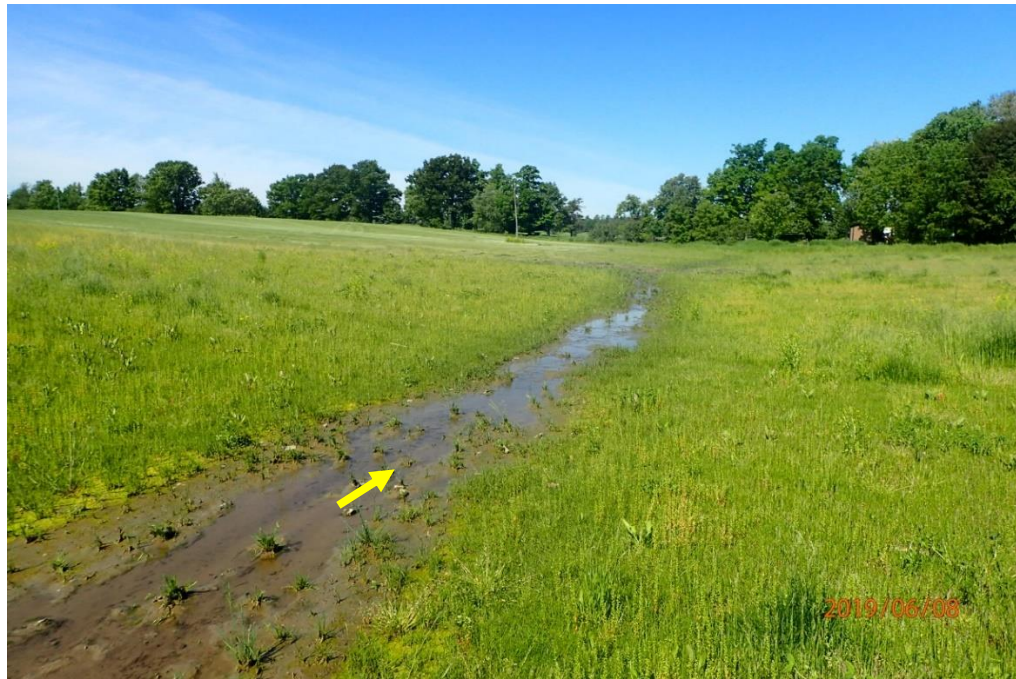
Photo 107
Tributary of Twenty Mile Creek: Visit 2
Reach TTMC8-3-3

The feature lacked natural riparian vegetation and was flanked by crops, which encroached the channel.

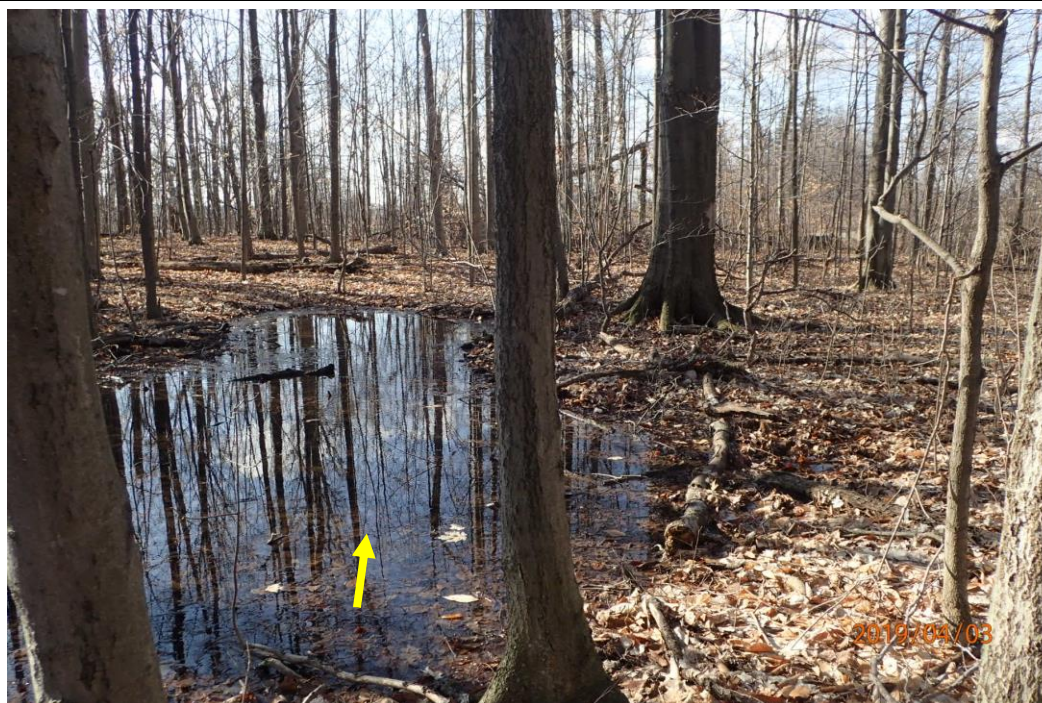
Photo 110
Tributary of Twenty Mile Creek: Visit 1
Reach TTMC9-1

The feature lacked channel definition and conveyed flows through a woodlot.

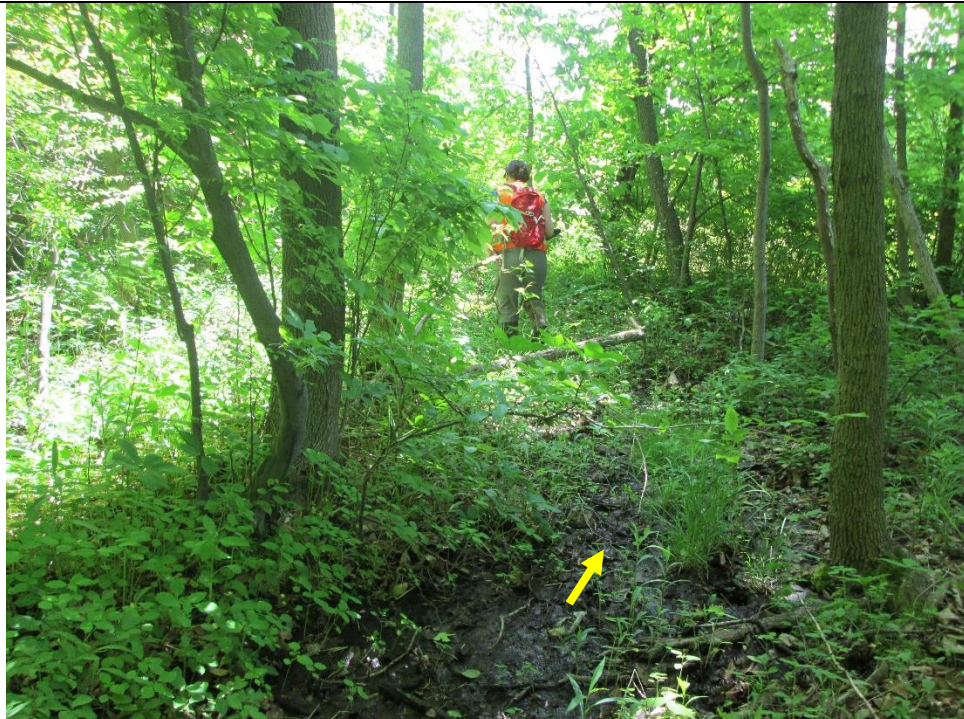
Photo 111
Tributary of Twenty Mile Creek: Visit 2
Reach TTM9-1

Riparian vegetation adjacent to the feature consisted of deciduous trees. No water was present during the 2nd visit.

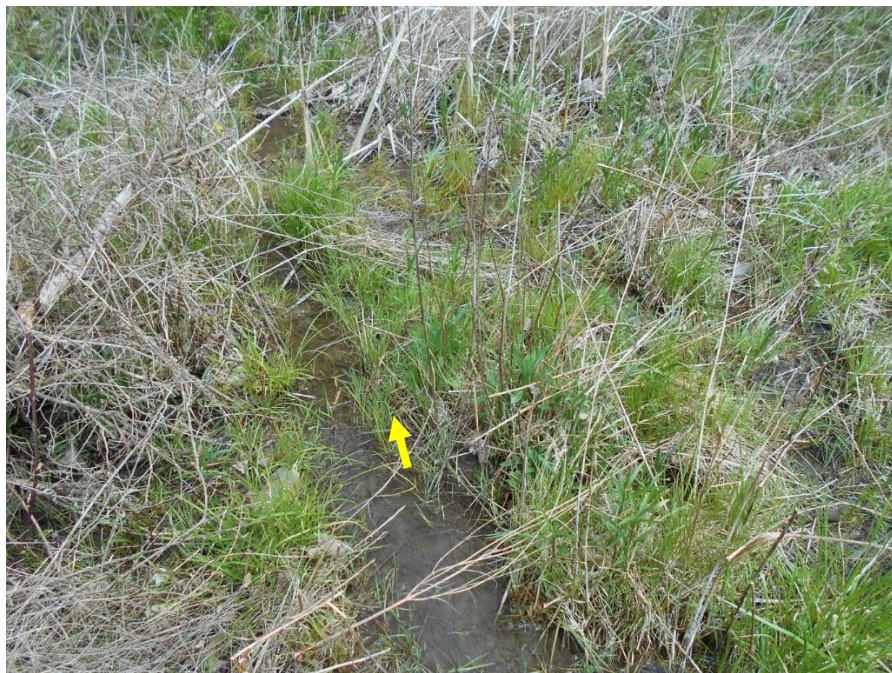
Photo 114
Tributary of Twenty Mile Creek: Visit 2
Reach TTMC9-1a

The feature was narrow, but partially defined. Dense vegetation present during visit 2.

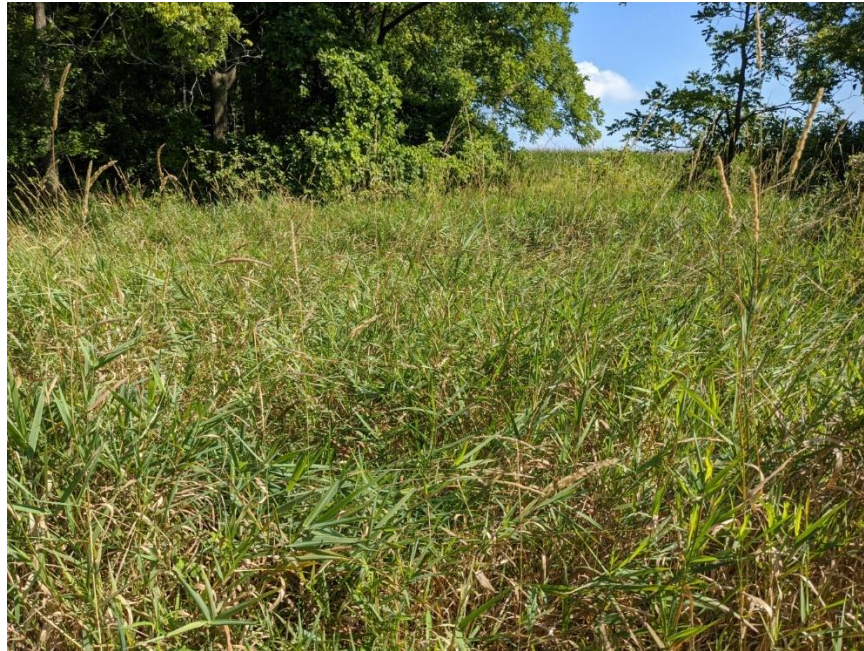
Photo 115
Tributary of Twenty Mile Creek: Visit 3
Reach TTM9-1a

Extreme vegetation encroachment during visit 3. Poorly defined feature.

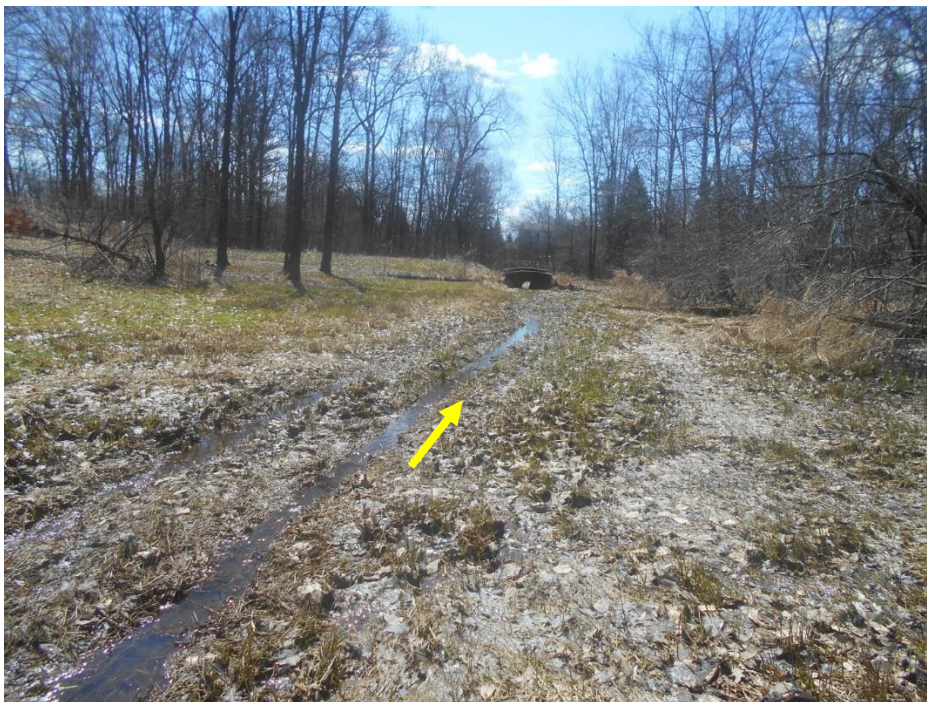
Photo 116
Tributary of Twenty Mile Creek: Visit 1
Reach TTM10-1-2

The feature lacked channel definition and ran through a meadow.

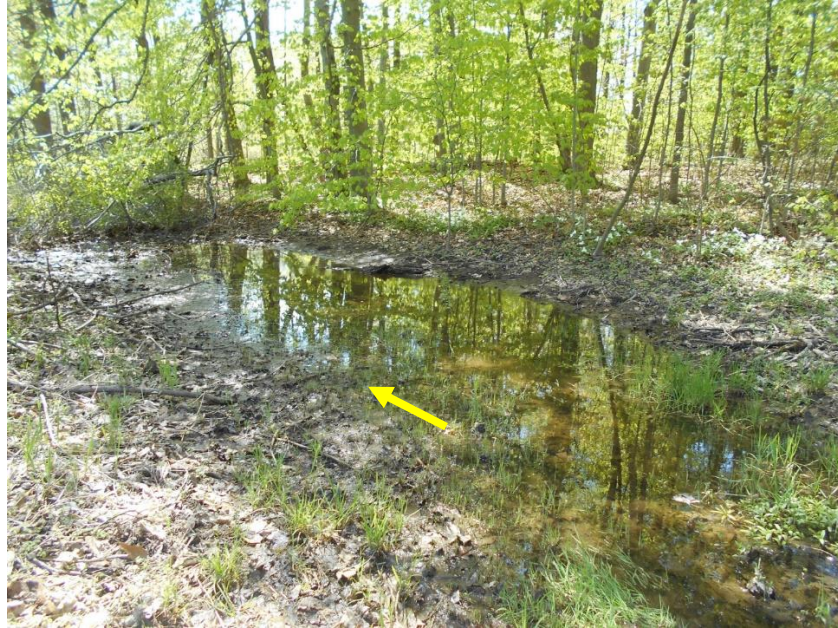
Photo 117
Tributary of Twenty Mile Creek: Visit 2
Reach TTMC10-1-2

The feature lacked channel definition and conveyed through area with wooded riparian area.

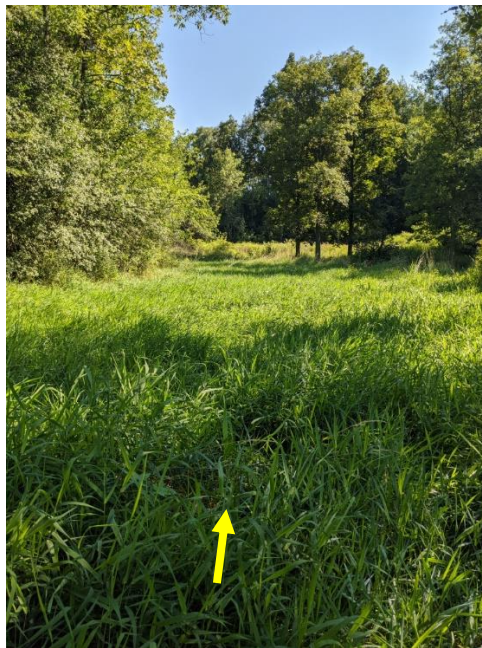
Photo 118
Tributary of Twenty Mile Creek: Visit 3
Reach TTMC10-1-2

The feature lacked channel definition and was overgrown by grasses in the summer months

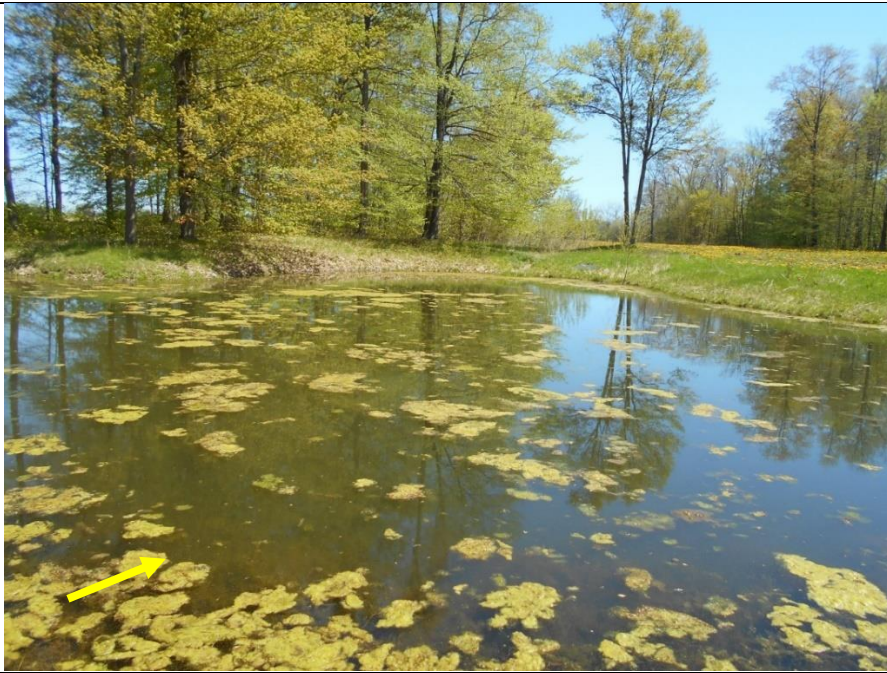
Photo 120
Tributary of Twenty Mile Creek: Visit 2
Reach TTM10-1-2a

The feature is composed of a small pond which outflows to the south. Contained submergent vegetation and standing water

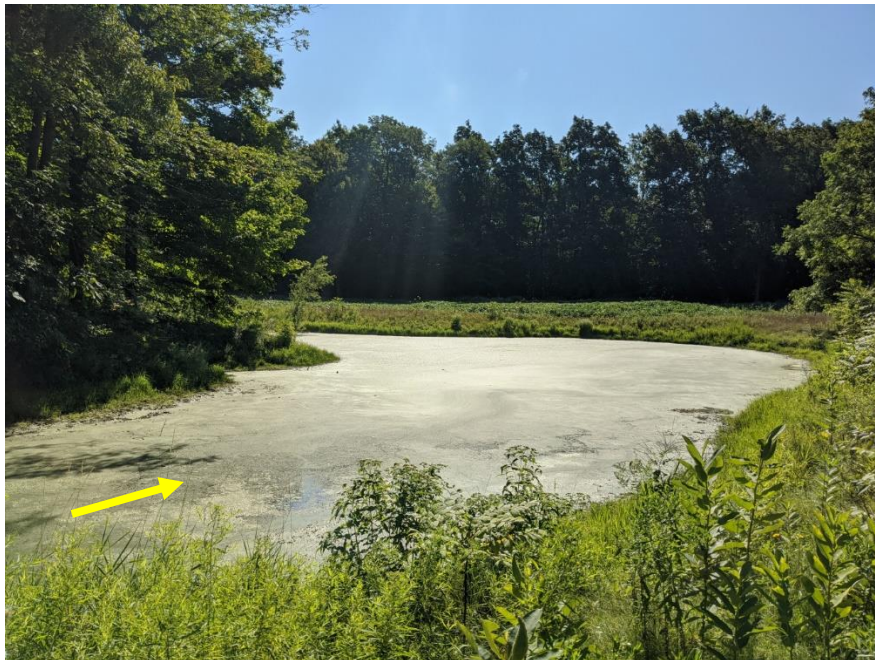
Photo 121
Tributary of Twenty Mile Creek: Visit 3
Reach TTM10-1-2a

The feature is composed of a small pond which outflows to the south. Contained submergent vegetation and standing water.

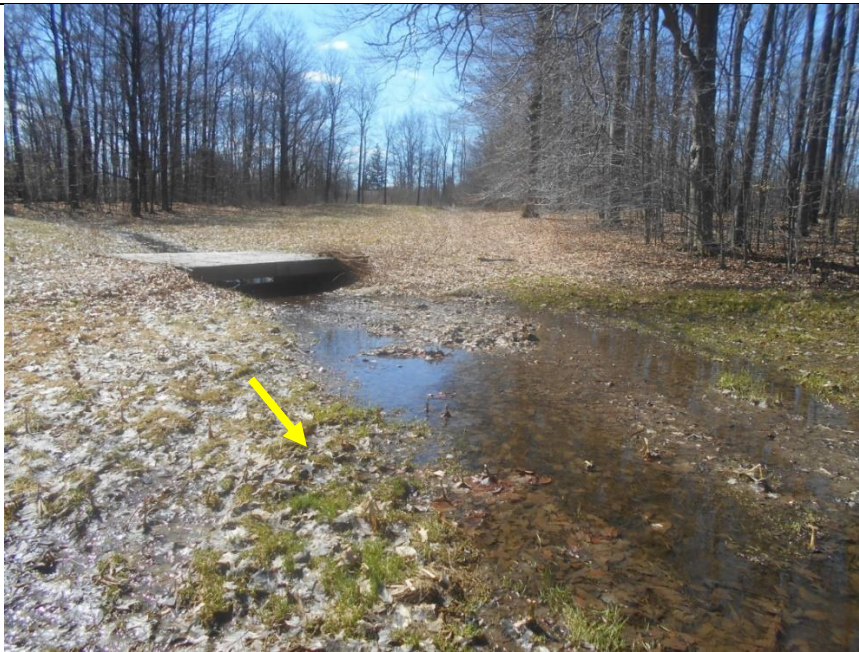
Photo 122
Tributary of Twenty Mile Creek: Visit 1
Reach TTMCI0-1-3

The feature lacked channel definition and conveyed flow through a woodlot into an open meadow.

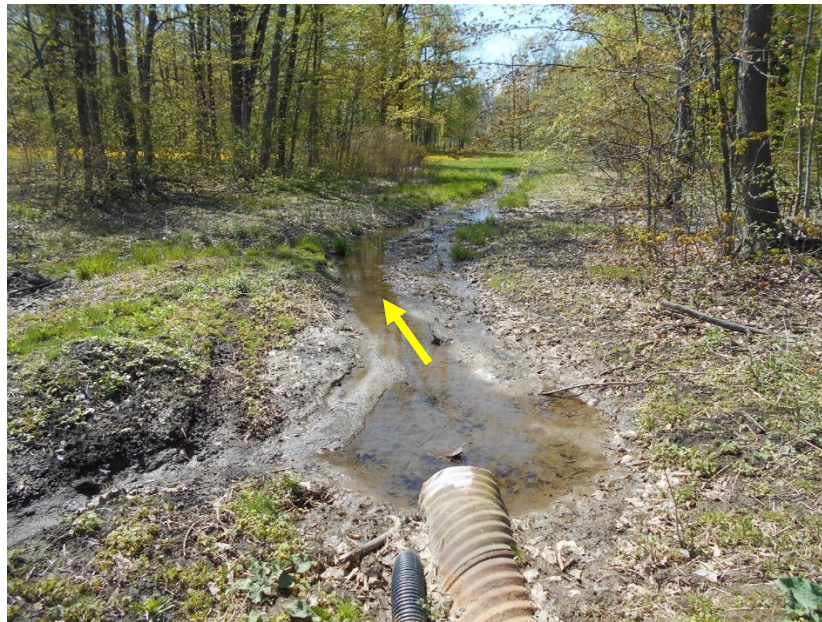
Photo 123
Tributary of Twenty Mile Creek: Visit 2
Reach TTMCI0-1-3

A culvert was present at the feature and was well defined.

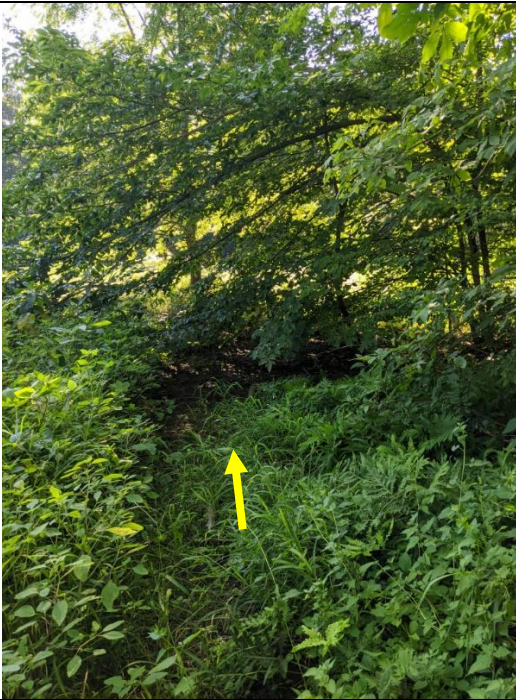
Photo 124
Tributary of Twenty Mile Creek: Visit 3
Reach TTMC10-1-3

The feature lacked channel definition and was surrounded by dense vegetation.

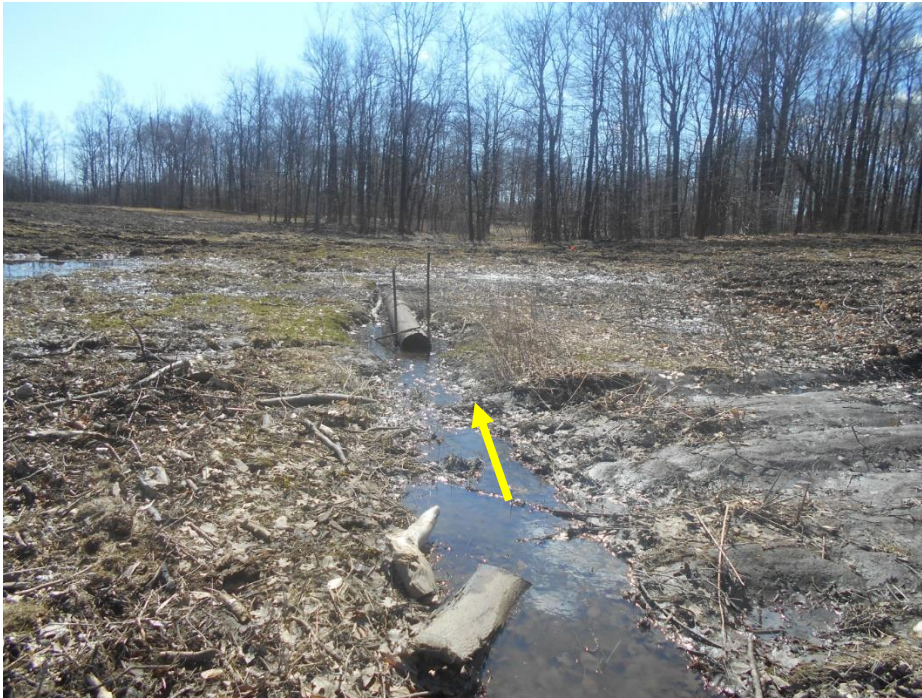
Photo 125
Tributary of Twenty Mile Creek: Visit 1
Reach TTMC10-1-4

The feature had poor channel definition and originated at a culvert.

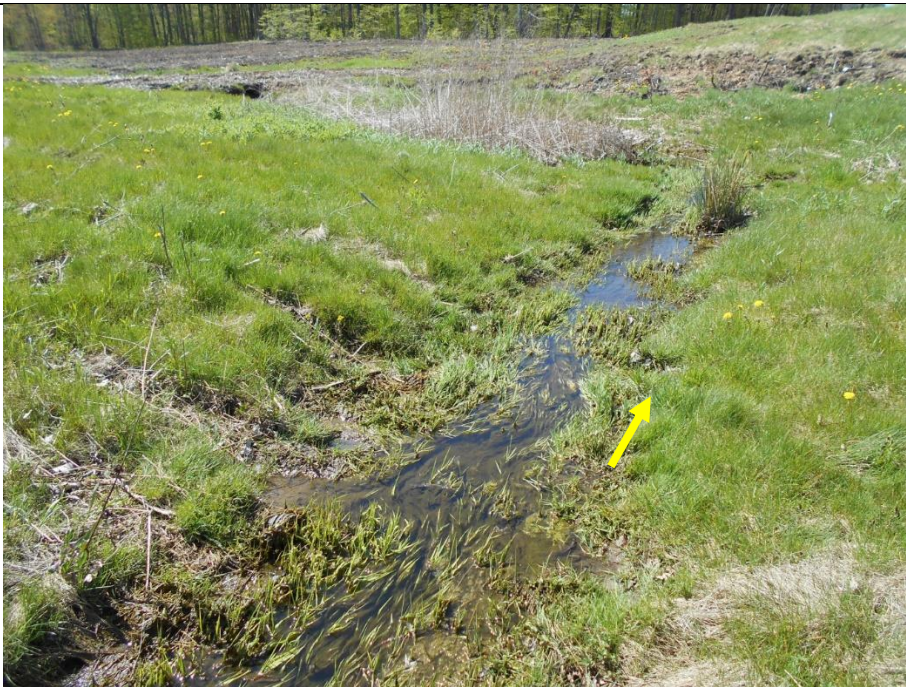
Photo 126
Tributary of Twenty Mile Creek: Visit 2
Reach TTM10-1-4

The feature flowed through a grassy meadow and had a defined channel

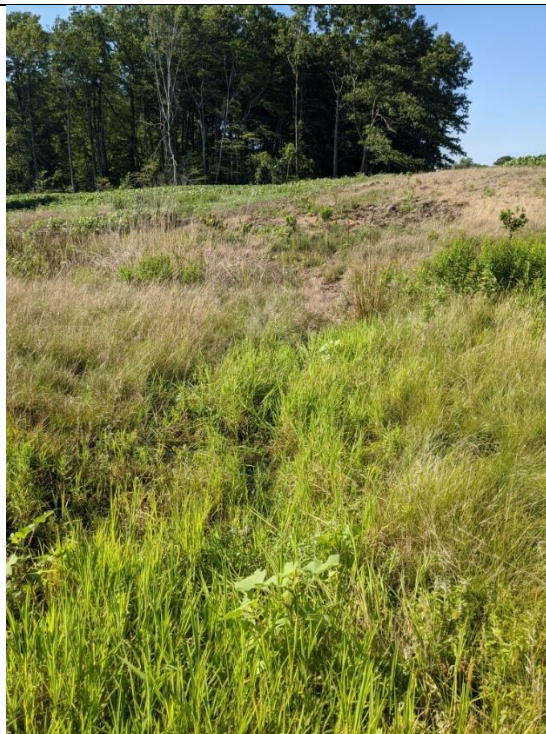
Photo 127
Tributary of Twenty Mile Creek: Visit 3
Reach TTM10-1-4

The feature lacked channel definition and was surrounded by dense vegetation.
