Garner Road Municipal Class Environmental Assessment: Cultural Heritage Report – Existing Conditions and Preliminary Impact Assessment

Final Report

Prepared for:
City of Hamilton

Prepared by:
Stantec Consulting Ltd.
400-1305 Riverbend Road
London, Ontario N650J5

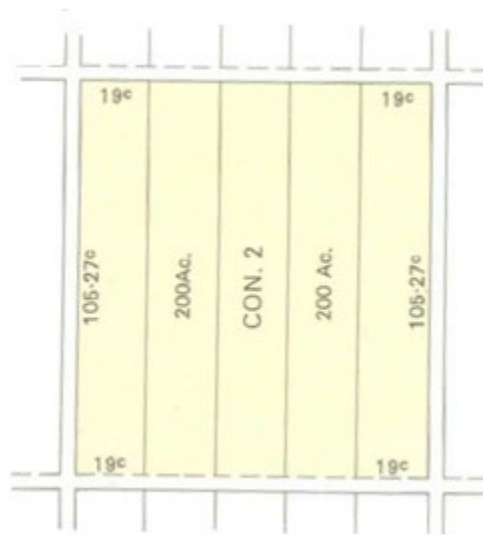
Plate 3: Single-front survey system (Dean 1969)

In 1793, the township was surveyed and laid out using a single-front system with each concession comprised of long and narrow lots approximately 200 acres in size (Plate 2). Lot sizes in the township were often irregular due to the township's triangular shape (ATHS 1973). Simcoe named the Township after the Village of Ancaster located in Lincolnshire, England (ATHS 1973).

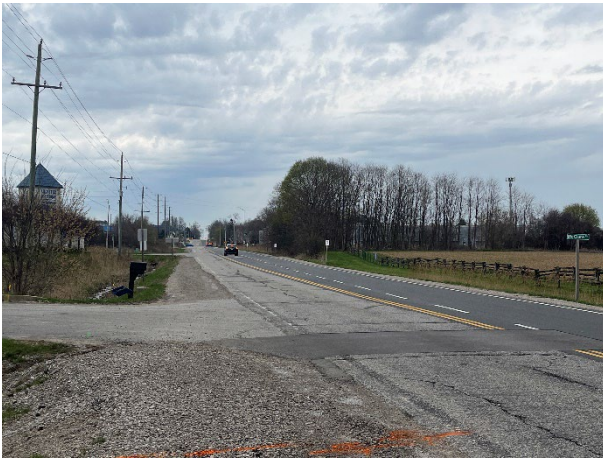
Photo 1: Garner Road West with a commercial property on the north side of the road and an agricultural field on the south side, looking east

The Study Area is situated along Garner Road between Wilson Street West and Highway 6. The entire Study Area contains scattered historic properties with infill of various types and ages. At the western end of the Study Area, Garner Road West is a two lane, paved road with turn lanes, gravel shoulders, and timber utility poles (Photo 1). Between Wilson Street West and Shaver Road, the Study Area contains a mixture of commercial properties and plazas with large parking lots and agricultural/rural properties. East of Shaver Road, Garner Road West transitions to a suburban area. It remains a two lane road with turn lanes, but the road has curbs and sidewalks in a small area between Shaver Road and Hamilton Drive (Photo 2). There are modern subdivision developments on the north side of the road, with residential properties with large lot sizes and occasional agricultural properties along the south side of the road (Photo 3).

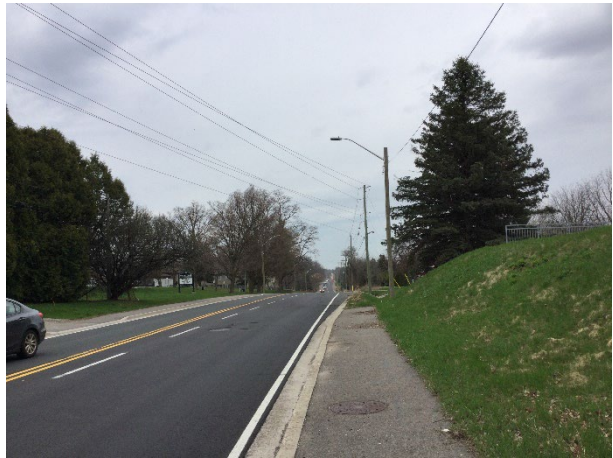
Photo 2: Garner Road West with curbs and sidewalks, looking east

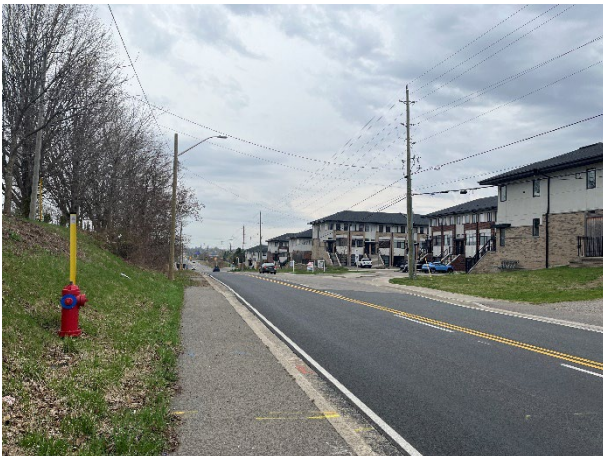
Photo 3: Garner Road West with a modern subdivision development on the north side of the road, looking west

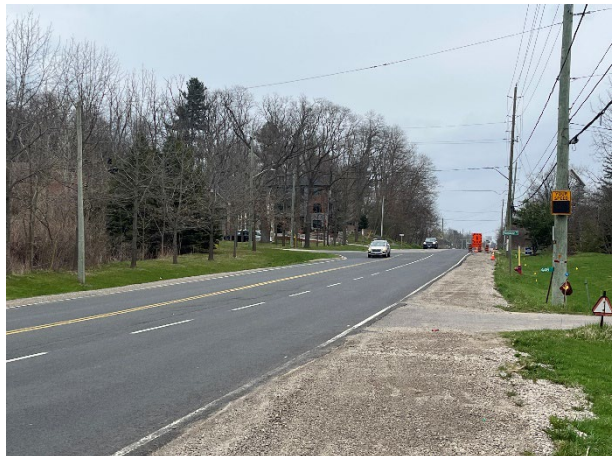
Photo 4: Garner Road West transitioning back to gravel shoulders near Hamilton Drive, looking east

West of Hamilton Drive, Garner Road West returns to having primarily gravel shoulders without curbs or sidewalks (Photo 4). Between Hamilton Drive and Braithwaite Avenue, Garner Road West remains suburban. Most of the properties immediately adjacent to Garner Road West in this area are residential ones with larger lot sizes, but this area also includes the football field for Bishop Tonnos High School, James Smith Park, Resurrection Catholic Cemetery, and the occasional agricultural field (Photo 5). East of Braithwaite Avenue there are late 20th to 21st century subdivision developments on the

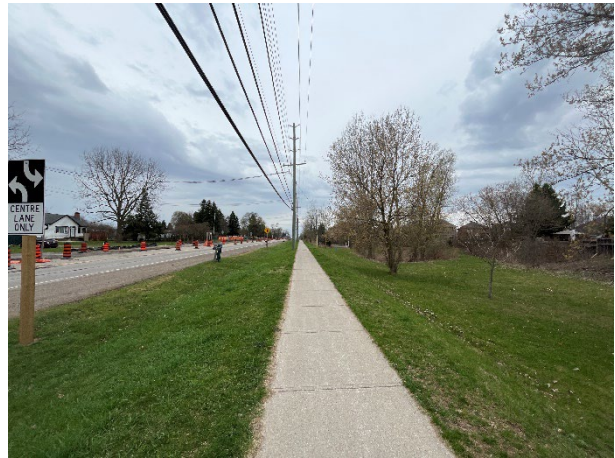
**Photo 6: Sidewalks along the north
side of Garner Road
West between
Braithwaite Avenue and
Fiddler's Green Road
with the late 20th to 21st
century subdivision on
the north side of the
road visible behind the
trees, looking west**

north side of Garner Road West and the south side contains primarily residential properties with larger lots. There is a sidewalk lining the north side of the road between Braithwaite Avenue and Fiddler's Green Road (Photo 6 and Photo 7).

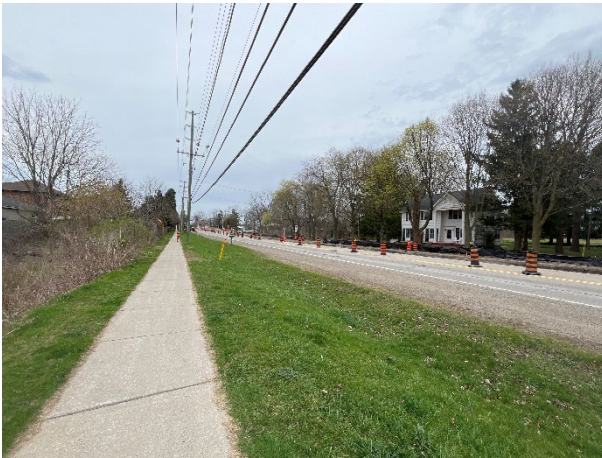
Photo 7: Sidewalks along the north side of Garner Road West between Braithwaite Avenue and Fiddler's Green Road, looking east

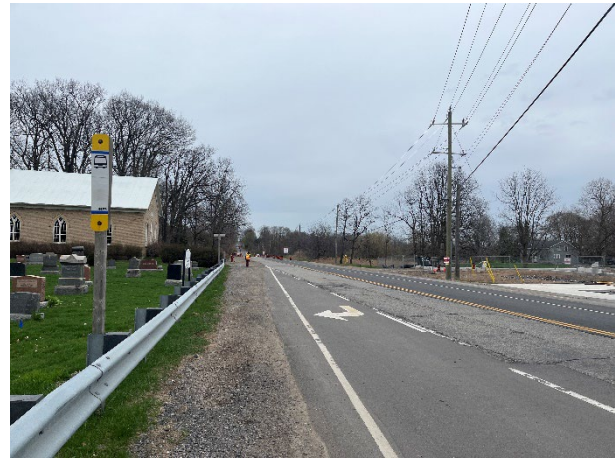
Photo 8: Garner Road East transitioning to a more rural character with a woodlot visible in the distance, looking east

Garner Road West transitions to Garner Road East at Fiddler's Green Road. It also begins to transition to a slightly more rural character east of Fiddler's Green Road, especially on the south side of the road where the residences are spaced farther apart and there is a woodlot (Photo 8). A small section of sidewalk exists along the north side of the road between Anson Drive and Woodmount Avenue where there is a late 20th to 21st century subdivision development.

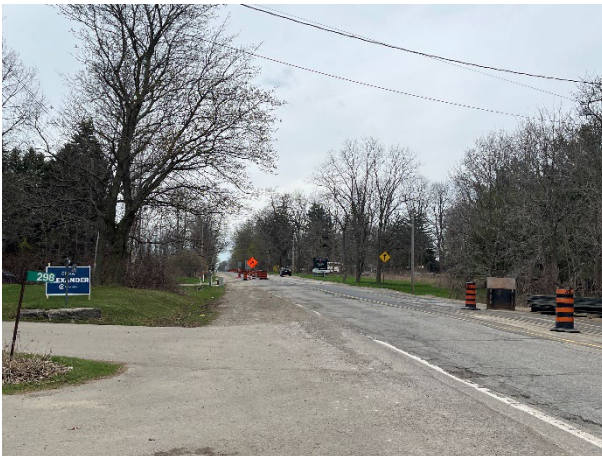
Photo 9: Garner Road East, east of Woodmount Avenue, looking west

At the eastern end of the Study Area, Garner Road remains a two lane, paved road with gravel shoulders. Between Woodmount Avenue and Highway 6, there are mid- to late 20th century residential properties on both sides of the road with large lot sizes and mature trees (Photo 9). The Study Area terminates at the Highway 6 overpass (Photo 10).

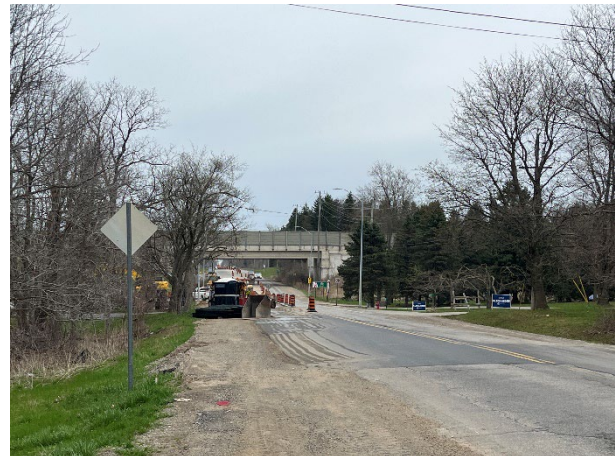
Photo 10: Garner Road East, looking east towards the Highway 6 overpass

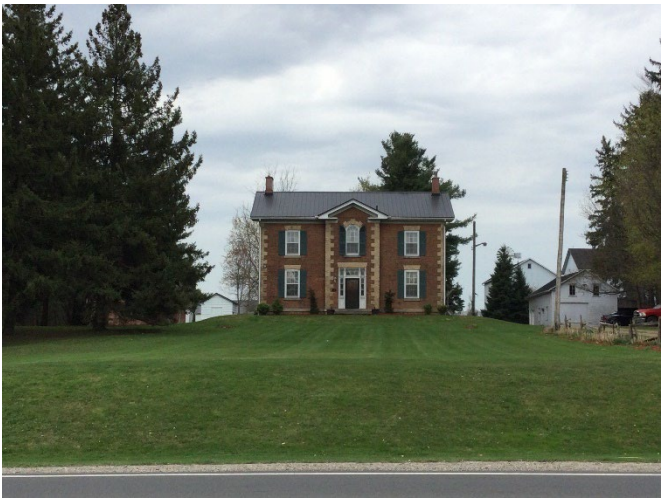
Reference Number	Type of Property	Location	Heritage Recognition	Description of Known or Potential CHVI	Photograph
BHR-1	Farmstead	1166 Garner Road West	Designated under Part IV of the <i>Ontario Heritage Act</i>	This property contains a residence and an unconfirmed number of outbuildings and barns. The residence is a two storey structure with a side facing gable and a projecting centre gable bay with return eaves. The roof of the structure is clad in metals and has two red brick book end chimneys. The residence is clad in red brick with buff brick quoins and voussoirs. The structure has a wood door surround with sidelights and a transom. The foundation was not visible. This property was designated in 2024 under by-law no. 24-084 (City of Hamilton 2024c: 5). The residence was identified to have been built around 1830. The property also contains eight other historic structures built between 1830 and 1942. The property has been identified to have design and physical value as a representative and rare example of a 19 th century Ontario farmstead (City of Hamilton 2024c: 5). The property has historical and associative value due to its long-standing association with the Shaver family, a prominent family in the history of the Township of Ancaster who played a significant role in the development of the local community (City of Hamilton 2024c: 5). The property is still owned by the Shavers. Additionally, the property has contextual value as it helps define the former rural agricultural character of the area, is linked functionally, visually, and historically to several other Shaver properties, and is considered a local landmark (City of Hamilton 2024c: 5-6).

Reference Number	Location	Heritage Recognition	Type and Description of Potential/Anticipated Impact	Mitigation
BHR-1	1166 Garner Road West	Designated under Part IV of the <i>OHA</i>	No Impacts Anticipated: The property is located adjacent to the proposed right-of-way. However, construction activities are proposed approximately 54 metres north of the residence. Therefore, no direct or indirect impacts are anticipated.	Continued avoidance is recommended.
CHL-1	1160 Wilson Street West or 1156 Highway 2	Designated under Part IV of the <i>OHA</i>	No Impacts Anticipated: The property is located adjacent to the proposed right-of-way. However, construction activities are proposed approximately 89 metres south of the stone wall surrounding the cemetery. Therefore, no direct or indirect impacts are anticipated.	Continued avoidance is recommended.
BHR-2	1034 Garner Road West	Designated under Part IV of the <i>OHA</i>	Indirect: The residence is situated adjacent to the proposed right-of-way. Construction activities are proposed approximately 18 metres north of the residence. The position of the residence within 18 metres of construction activities creates potential for indirect impacts resulting from vibration damage during construction activities.	Preferred Option: Avoid the BHR by establishing a buffer zone around the residence to limit construction activity to more than 50 metres away. This should use appropriate preventive measures such as mapping the BHR on construction maps and temporary fencing. Where avoidance is not feasible, the alternative option should be applied. Alternative Option: Where construction activities are anticipated within the 50-metre buffer zone, a pre-construction vibration assessment by a qualified engineer is recommended to determine if vibration monitoring or site plan controls are required.

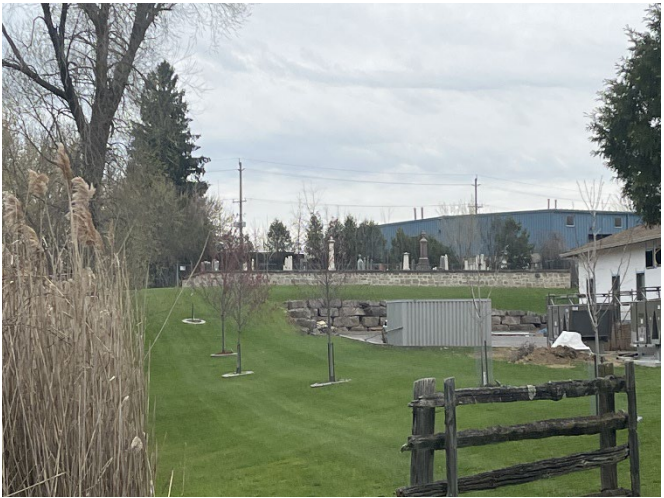
CHL-1	Cemetery	1160 Wilson Street West or 1156 Highway 2	Designated under Part IV of the <i>Ontario Heritage Act</i>	This property contains a family cemetery and retaining stone wall. The cemetery was established in 1848, following the death of William and Mary Catherine Shaver. Their children established this cemetery across the road from the family’s original homestead. This property was designated in 1993 under by-law no. 93-68 (Town of Ancaster 1993). The property has been identified to have historical and associative value due to its association with the Shaver family, a prominent family in the history of the Township of Ancaster who played a significant role in the development of the local community (Town of Ancaster 1993). The property also has contextual value as a landmark (Town of Ancaster 1993).

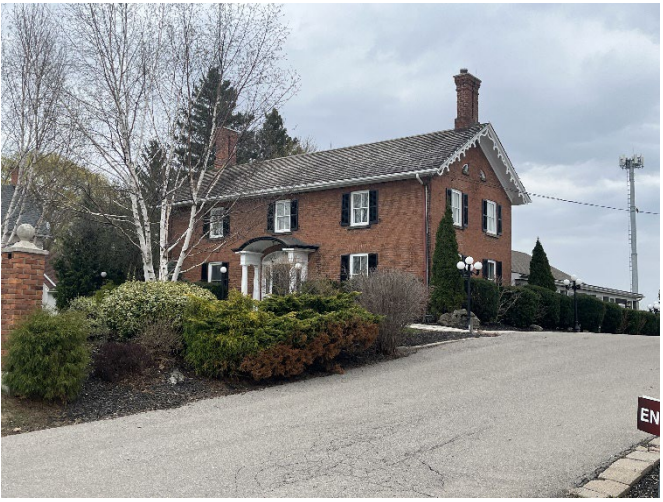
Reference Number	Type of Property	Location	Heritage Recognition	Description of Known or Potential CHVI	Photograph
BHR-2	Residence	1034 Garner Road West	Designated under Part IV of the <i>Ontario Heritage Act</i>	This property contains a residence. The residence is two storeys with a side facing gable clad in asphalt shingles. The structure is clad in red brick and has two red brick book end chimneys. The residence has a symmetrical front façade with replacement windows. The windows have brick voussoirs and stone sills and the sides of the structure have two small quarter circle windows. The door has sidelights and a large arched transom and is covered by a small entryway with pillars and wood details. The foundation was not visible. The structure was partially screened behind a brick retaining wall. The structure has a date stone which reads “1835”. This property was designated in 1983 under by-law no. 83-95 (Town of Ancaster 1983). The residence has design and physical value as a representative example of the Georgian style (Town of Ancaster 1983). The by-law provides only architectural details for this property but it is also associated with Philip Shaver and the Shaver family more generally.

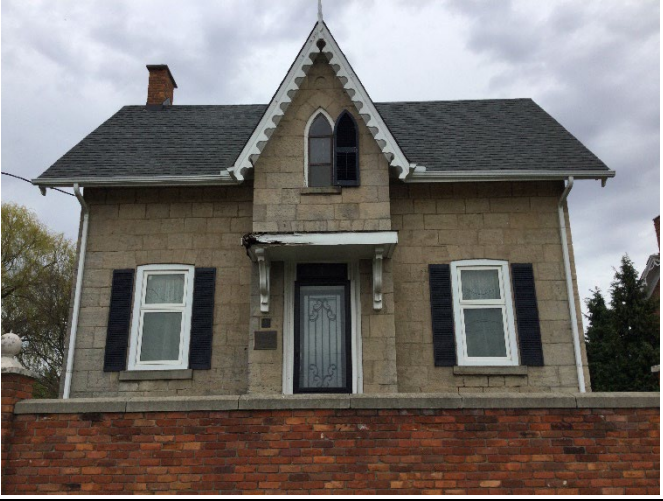
BHR-3	Residence	1028 Garner Road West	Designated under Part IV of the <i>Ontario Heritage Act</i>	This property contains a residence. The residence is one and one half storeys with a side facing gable with a projecting centre gable bay. The roof is clad in asphalt with a single red brick chimney and the residence is clad in stone. The front door is a replacement door with a transom window with stained glass and a wood entrance covering. The residence windows are replacements with shutters. All the windows and the front door have stone voussoirs and stone sills. The centre gable peak has bargeboard decoration and an upward facing finial as well as a date stone which reads “1863” and an arched window. The foundation is stone. The residence has modern rear additions. This property was designated in 1985. The property was identified to have design and physical value as one of the “best remaining” Gothic Revival style homes in Ancaster (Town of Ancaster 1985a: 1). This property also has historical and associative value due to its associations with the Shaver family (Town of Ancaster 1985a: 2).

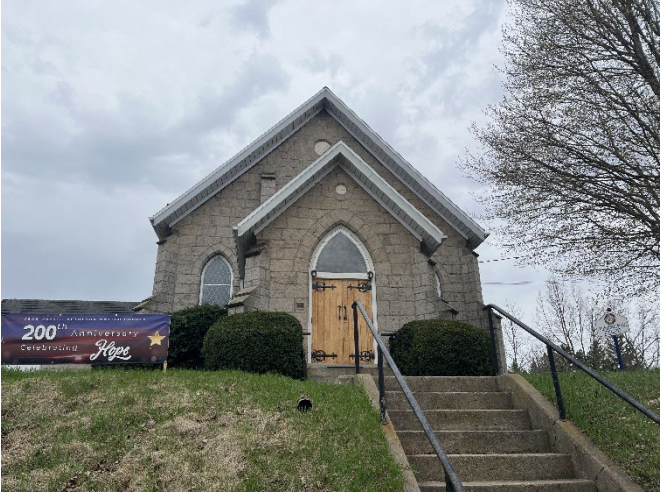
CHL-2	Church and Cemetery	584 Garner Road West	Listed on the municipal heritage register	This property contains a church and a cemetery. The church has a front facing gable and a smaller projecting entranceway both with metal roofs. The structure is clad in stone and has stone voussoirs over the arched windows and doors throughout the structure. The structure has two datestones, one which reads “Bethesda”. The other datestone was illegible from the public right of way. The structure has stained glass windows throughout and wooden front door. The cemetery has stones from the 18 th to 20 th centuries. The Bethesda United Church Cemetery opened in 1795 and the earliest recorded burial is of John Shaver, one of Ancaster Township’s first settlers (City of Hamilton 2005: 22). Church meetings were first held at the home of William Shaver, before moving to Bethesda School (City of Hamilton 2005: 22). In 1860, the land where the church and cemetery are located was donated by Horace Shaver to the Wesleyan Methodist congregation which had been in operation since 1825 (City of Hamilton 2005: 22). This property has potential design value as a representative example of a mid 19 th century Vernacular place of worship. Additionally, this property has potential historical and associative value due to its connection to the Wesleyan Methodist congregation, an

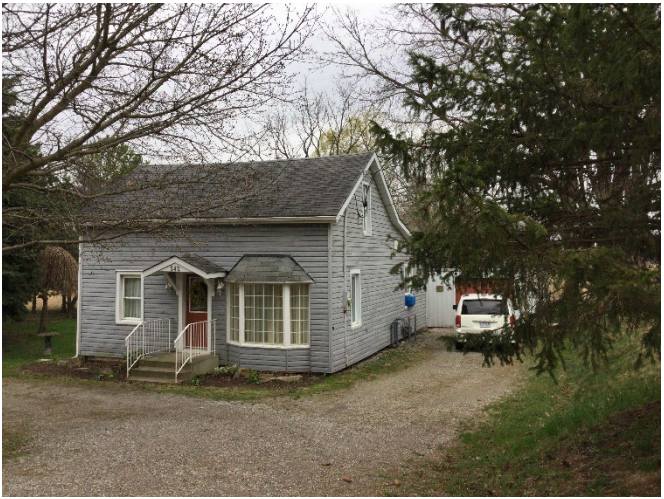
BHR-4	Residence	542 Garner Road West	Listed on the municipal heritage register	This property contains a residence. The residence is one and one half storey with a side facing gable clad in asphalt shingles. The rear of the structure has a sloping roof to a one storey addition. The residence is clad in vinyl siding and has replacement windows and doors throughout. The residence has a wood covering above the front entryway. The residence has a parged foundation. Based on architectural details, township development, and historical mapping, this residence was most likely constructed between 1875 and 1890. This property has potential design and physical value as a representative example of a mid to late 19 th century Vernacular structure.

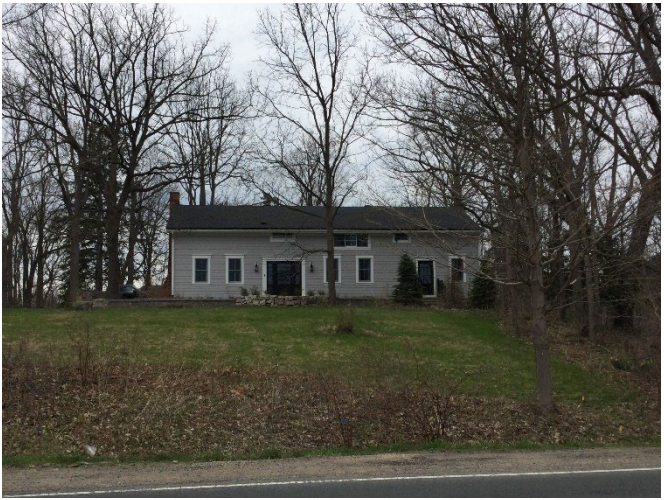
BHR-5	Residence	467 Garner Road West	Listed on the municipal heritage register	This property contains a residence. The residence is one and one half storeys with a side facing gable clad in asphalt. The residence has red brick book end chimneys with large bases. The residence is clad in vinyl siding. The windows on the first storey of the residence appear to have wood window surrounds and replacement windows. The front door has a wood surround with sidelights and a replacement door. The residence has a small stone wall in front of the front entryway. The foundation is obscured. Based on architectural details and township development, this residence was most likely constructed between 1855 and 1865. The property has potential design and physical value as a representative example of a mid 19 th century Vernacular structure with Georgian design influences.

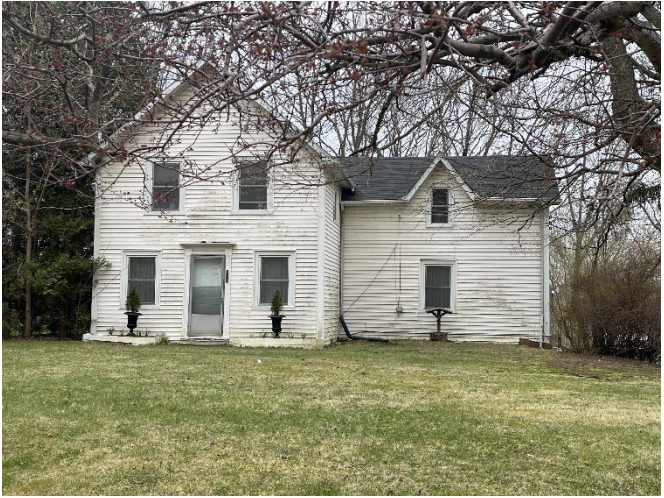
Reference Number	Type of Property	Location	Heritage Recognition	Description of Known or Potential CHVI	Photograph
BHR-6	Residence	392 Garner Road West	Identified during field review	<p>This property contains a residence. The residence is two storeys with a front facing gable and a side facing gable addition clad in asphalt. The residence has wood siding and modern windows and doors throughout. The residence has a wooden door surround as well as a window in the small gable peak. The foundation was obscured. Based on architectural details, township development, and historical mapping this residence was likely constructed between 1860 and 1875. This property may have design and physical value as a representative example of a late 19th century Gothic Revival residence.</p>

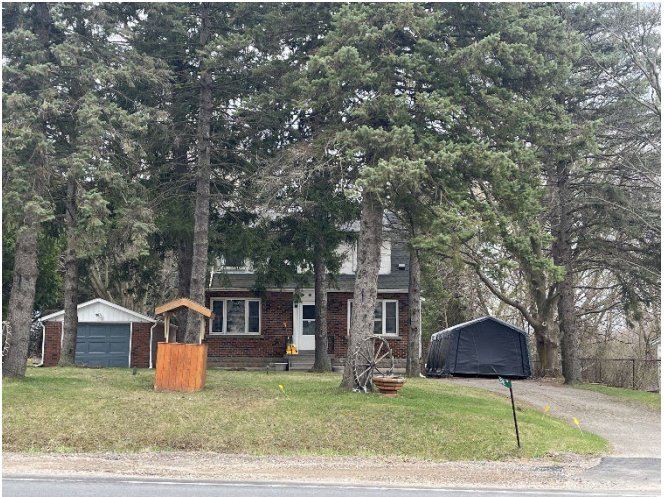
BHR-7	Residence	318 Garner Road West	Identified during field review	<p>This property contains a residence and a detached garage building. The residence is one storey with a side facing gable clad in asphalt shingles. The residence is clad in vinyl siding. The front door has a wood surround with diamond details. The residence has a rusticated concrete block foundation with some parging. Based on architectural details and township development, this residence was likely constructed between 1930 and 1945. This property may have design and physical value as a representative example of an early 20th century Craftsman style residence.</p>

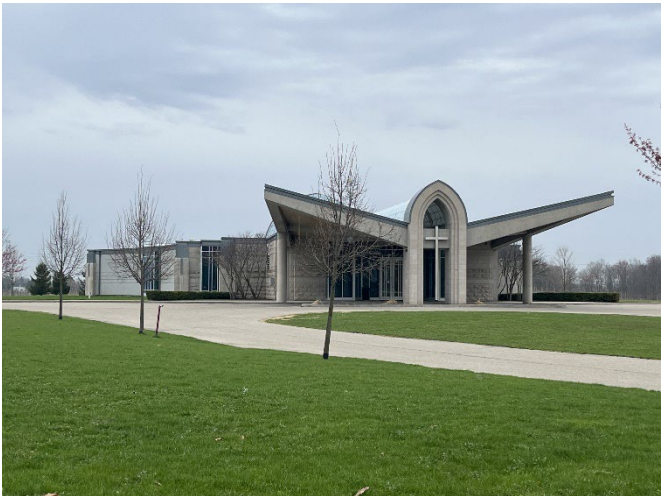
CHL-3	Church and Cemetery	254 Garner Road West	Listed on the municipal heritage register	<p>This property contains a mausoleum, a former residence, and a cemetery. The mausoleum was constructed in 2012 and was designed by Young + Wright/IBI Group Architects (Lintz 2013: 21). The structure has been described as “one of the most spectacular and innovative mausoleums in North America” (Lintz 2013: 21). The structure was inspired by the theology of light. It has a cantilevered concrete canopy at the entrance. The structure has skylights throughout. The mausoleum was entirely constructed of cast in place concrete (Lintz 2013: 21).</p> <p>The former residence is a red brick one and one half storey structure with a cross gable roof clad in asphalt shingles. The structure has replacement windows throughout that have brick voussoirs and stone sills. The doors to the residence are replacement. The structure has a partial width front porch with wood decorations. The residence has a brick foundation.</p> <p>The property contains many tombstones from the late 20th and 21st centuries. The property became a church in 1973 after the Catholic Diocese of Hamilton purchased the land to establish a Roman Catholic Cemetery in Ancaster (City of Hamilton</p>

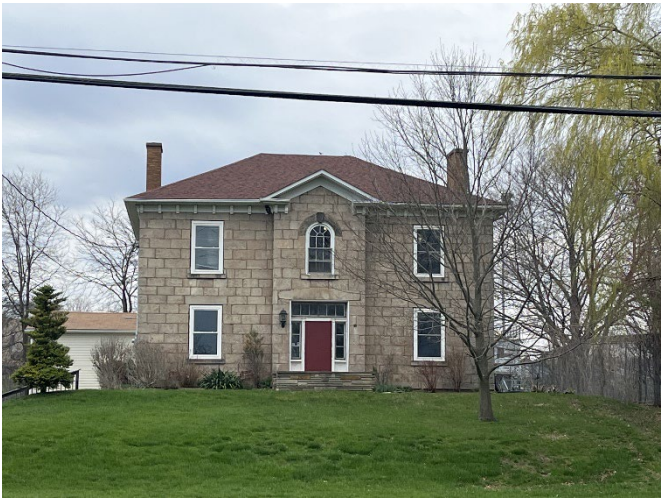
Reference Number	Type of Property	Location	Heritage Recognition	Description of Known or Potential CHVI	Photograph
BHR-9	Residence	245 Garner Road West	Designated under Part IV of the <i>OHA</i>	This property contains a residence. The residence is two storeys with a hip roof. The residence has two bookend chimneys and brackets along the roofline. The residence is clad in stone and has a centre projecting bay with return eaves. The residence has replacement windows throughout as well as stone lintels. There is a stone drip mold with keystone around the arched second storey window in the projecting gable bay. The residence has a replacement door with a wood surround including a transom and sidelights. The foundation is obscured. This residence was constructed in 1857 for Philip Rymal. The property was designated in 2004 under by-law no. 04-065 (City of Hamilton 2004). The property was determined to have design and physical value as a representative vernacular interpretation of the Italianate architectural style as well as a rare surviving example of a pre-confederation stone structure (City of Hamilton 2004). The residence has historical and associative value due to its associations with the Rymal and Marshall families (City of Hamilton 2004). The structure is currently occupied by Tapply Binet College.

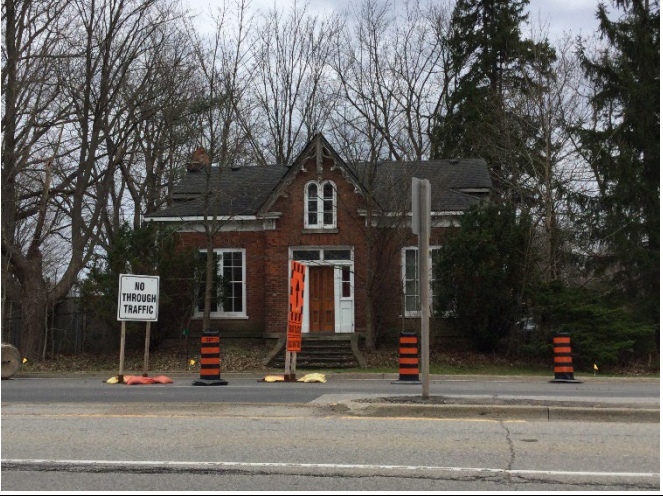
BHR-13	Residence	4 Garner Road East	Listed on the municipal heritage register Previously identified in Golder Associates Ltd. 2022 and WSP Golder 2023	This property contains a residence. The residence is one and one half storeys with a hipped roof and double gable roof dormers clad in asphalt shingles. The residence is clad in red brick, wood brackets along the roofline, and has a single red brick chimney. The residence has a projecting centre gable bay with return eaves, bargeboard decoration, a downward facing finial, and a double arched wood window with a stone sill. The residence has a wood double door with a wood surround with a double transom and sidelights. The windows of the residence appear to be wood. The foundation of the residence is stone. This residence was constructed in 1850 for George Clink and his family (WSP Golder 2023: 13). The residence has potential design and physical value as a representative mid-19 th century example of the Gothic Revival style. The residence may also have potential historical and associative value due to its connection to the Clink family.

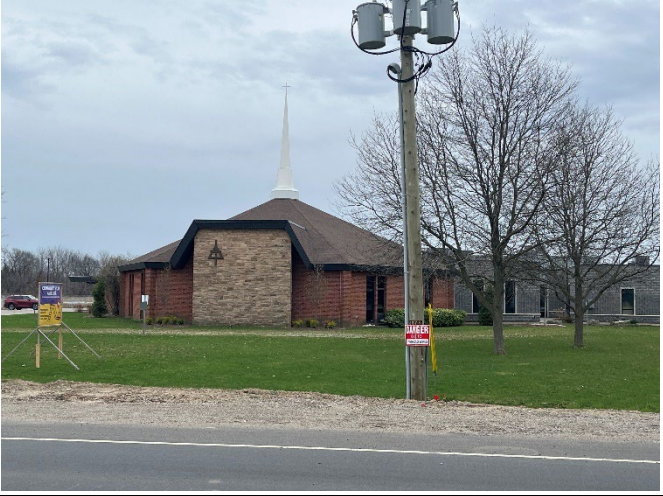
BHR-16	Church	70 Garner Road East	Identified during field review Previously identified in Golder Associates Ltd. 2022 and WSP Golder 2023	This property contains the Grace Community Christian Reformed Church. The church is one storey with a hexagonal roof and plan. The roof is clad in asphalt shingles and has a white spire in the centre. The church is clad in red brick with pairs of tall, vertical windows and a projecting stone accent wall on the north façade. There is an addition clad in grey brick attached to the building's south façade. The foundation is not visible. Originally called the Ancaster Christian Reformed Church, the Grace Community Christian Reformed Church was instituted in 1976 and moved to the building at 70 Garner Road East in 1986 (Grace Community Christian Reformed Church 2023). The church may have potential design and physical value as a late 20 th century example of modern architecture. The church also has potential historical or associative value for its connection to the Grace Community Christian Reformed Church.

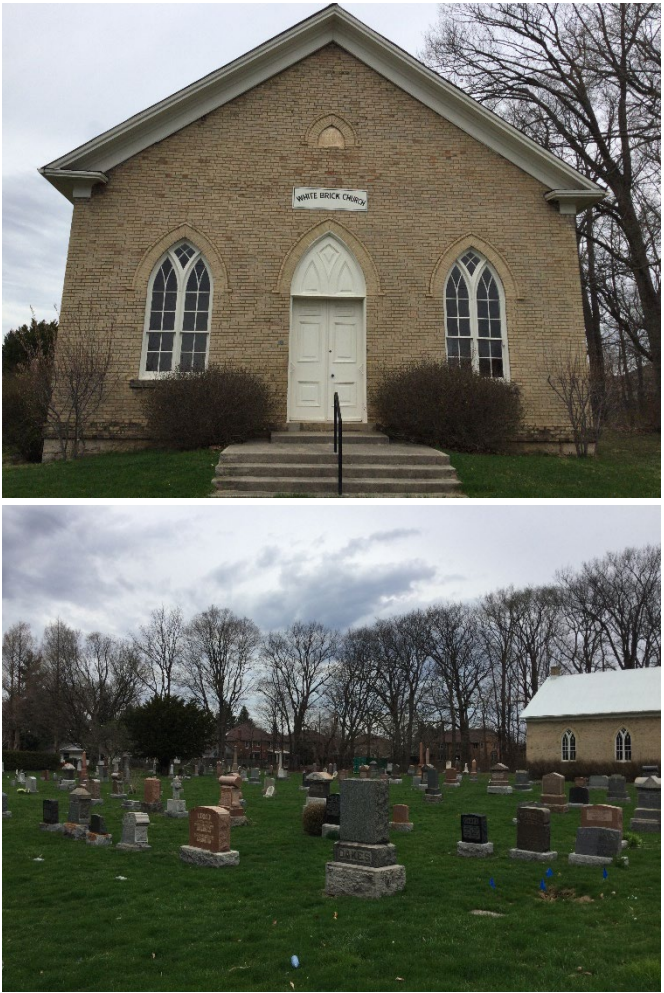
Reference Number	Type of Property	Location	Heritage Recognition	Description of Known or Potential CHVI	Photograph
CHL-5	Church and Cemetery	99 Garner Road East	<p>Listed on the municipal heritage register</p> <p>Previously identified in Golder Associates Ltd. 2022 and WSP Golder 2023</p>	<p>This property contains a church and a cemetery. The church is a one storey structure with a front facing gable with return eaves. The structure is clad in buff brick in a Flemish bond pattern. The structure has decorative brick arches over the windows and door. The windows are original wood windows and the front door is wood as well. The structure has a date stone with “1857” inscribed. The structure has a stone foundation. The cemetery on the property was in use as early as 1846 by an Episcopal Methodist Church (City of Hamilton 2025: 43). The White Brick Church was built on land donated by John Rymal and was dedicated on October 11, 1857 (Ontario Ancestors n.d.). This property may have potential design and physical value as a representative example of a mid-19th century Vernacular church structure. The property may also have historical and associative value due to its connections to the original Episcopal Methodist Church and the congregation of the White Brick Church.</p>

It should be noted that both CHL-2 and CHL-5 contain historic cemeteries with stone grave markers. These grave markers should be considered heritage structures and should also be considered for potential vibration-related mitigation measures by the qualified building condition specialist or engineer.

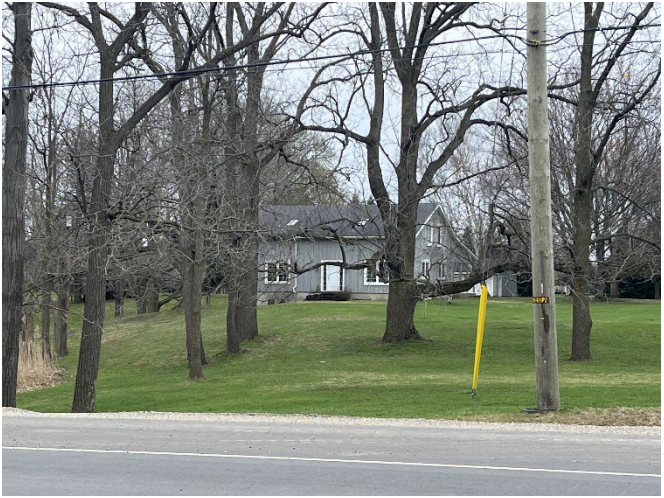
BHR-17	Residence	114 Garner Road East	<p>Listed on the municipal heritage register</p> <p>Previously identified in Golder Associates Ltd. 2022 and WSP Golder 2023</p>	<p>This property contains a residence. The residence is one storey and has a side facing gable clad in asphalt shingles. The residence is clad in wood board and batten and has modern, but sympathetic, windows throughout. The front door is a modern door with sidelights. The foundation is parged. Based on architectural details, city mapping, past environmental assessments, and township development this residence was constructed in 1850 (WSP Golder 2023: 14). This property has potential design value as a representative example of a mid-19th century Vernacular structure. The property may also have historical and associative value due to its associations with the Book family, an important local family.</p>
