West 5th Street Corridor Improvements from Stone Church Road West to Rymal Road West Municipal Class Environmental Assessment

Environmental Study Report – Final Post-Public Review

Prepared for:
City of Hamilton

Project/File:
165001381

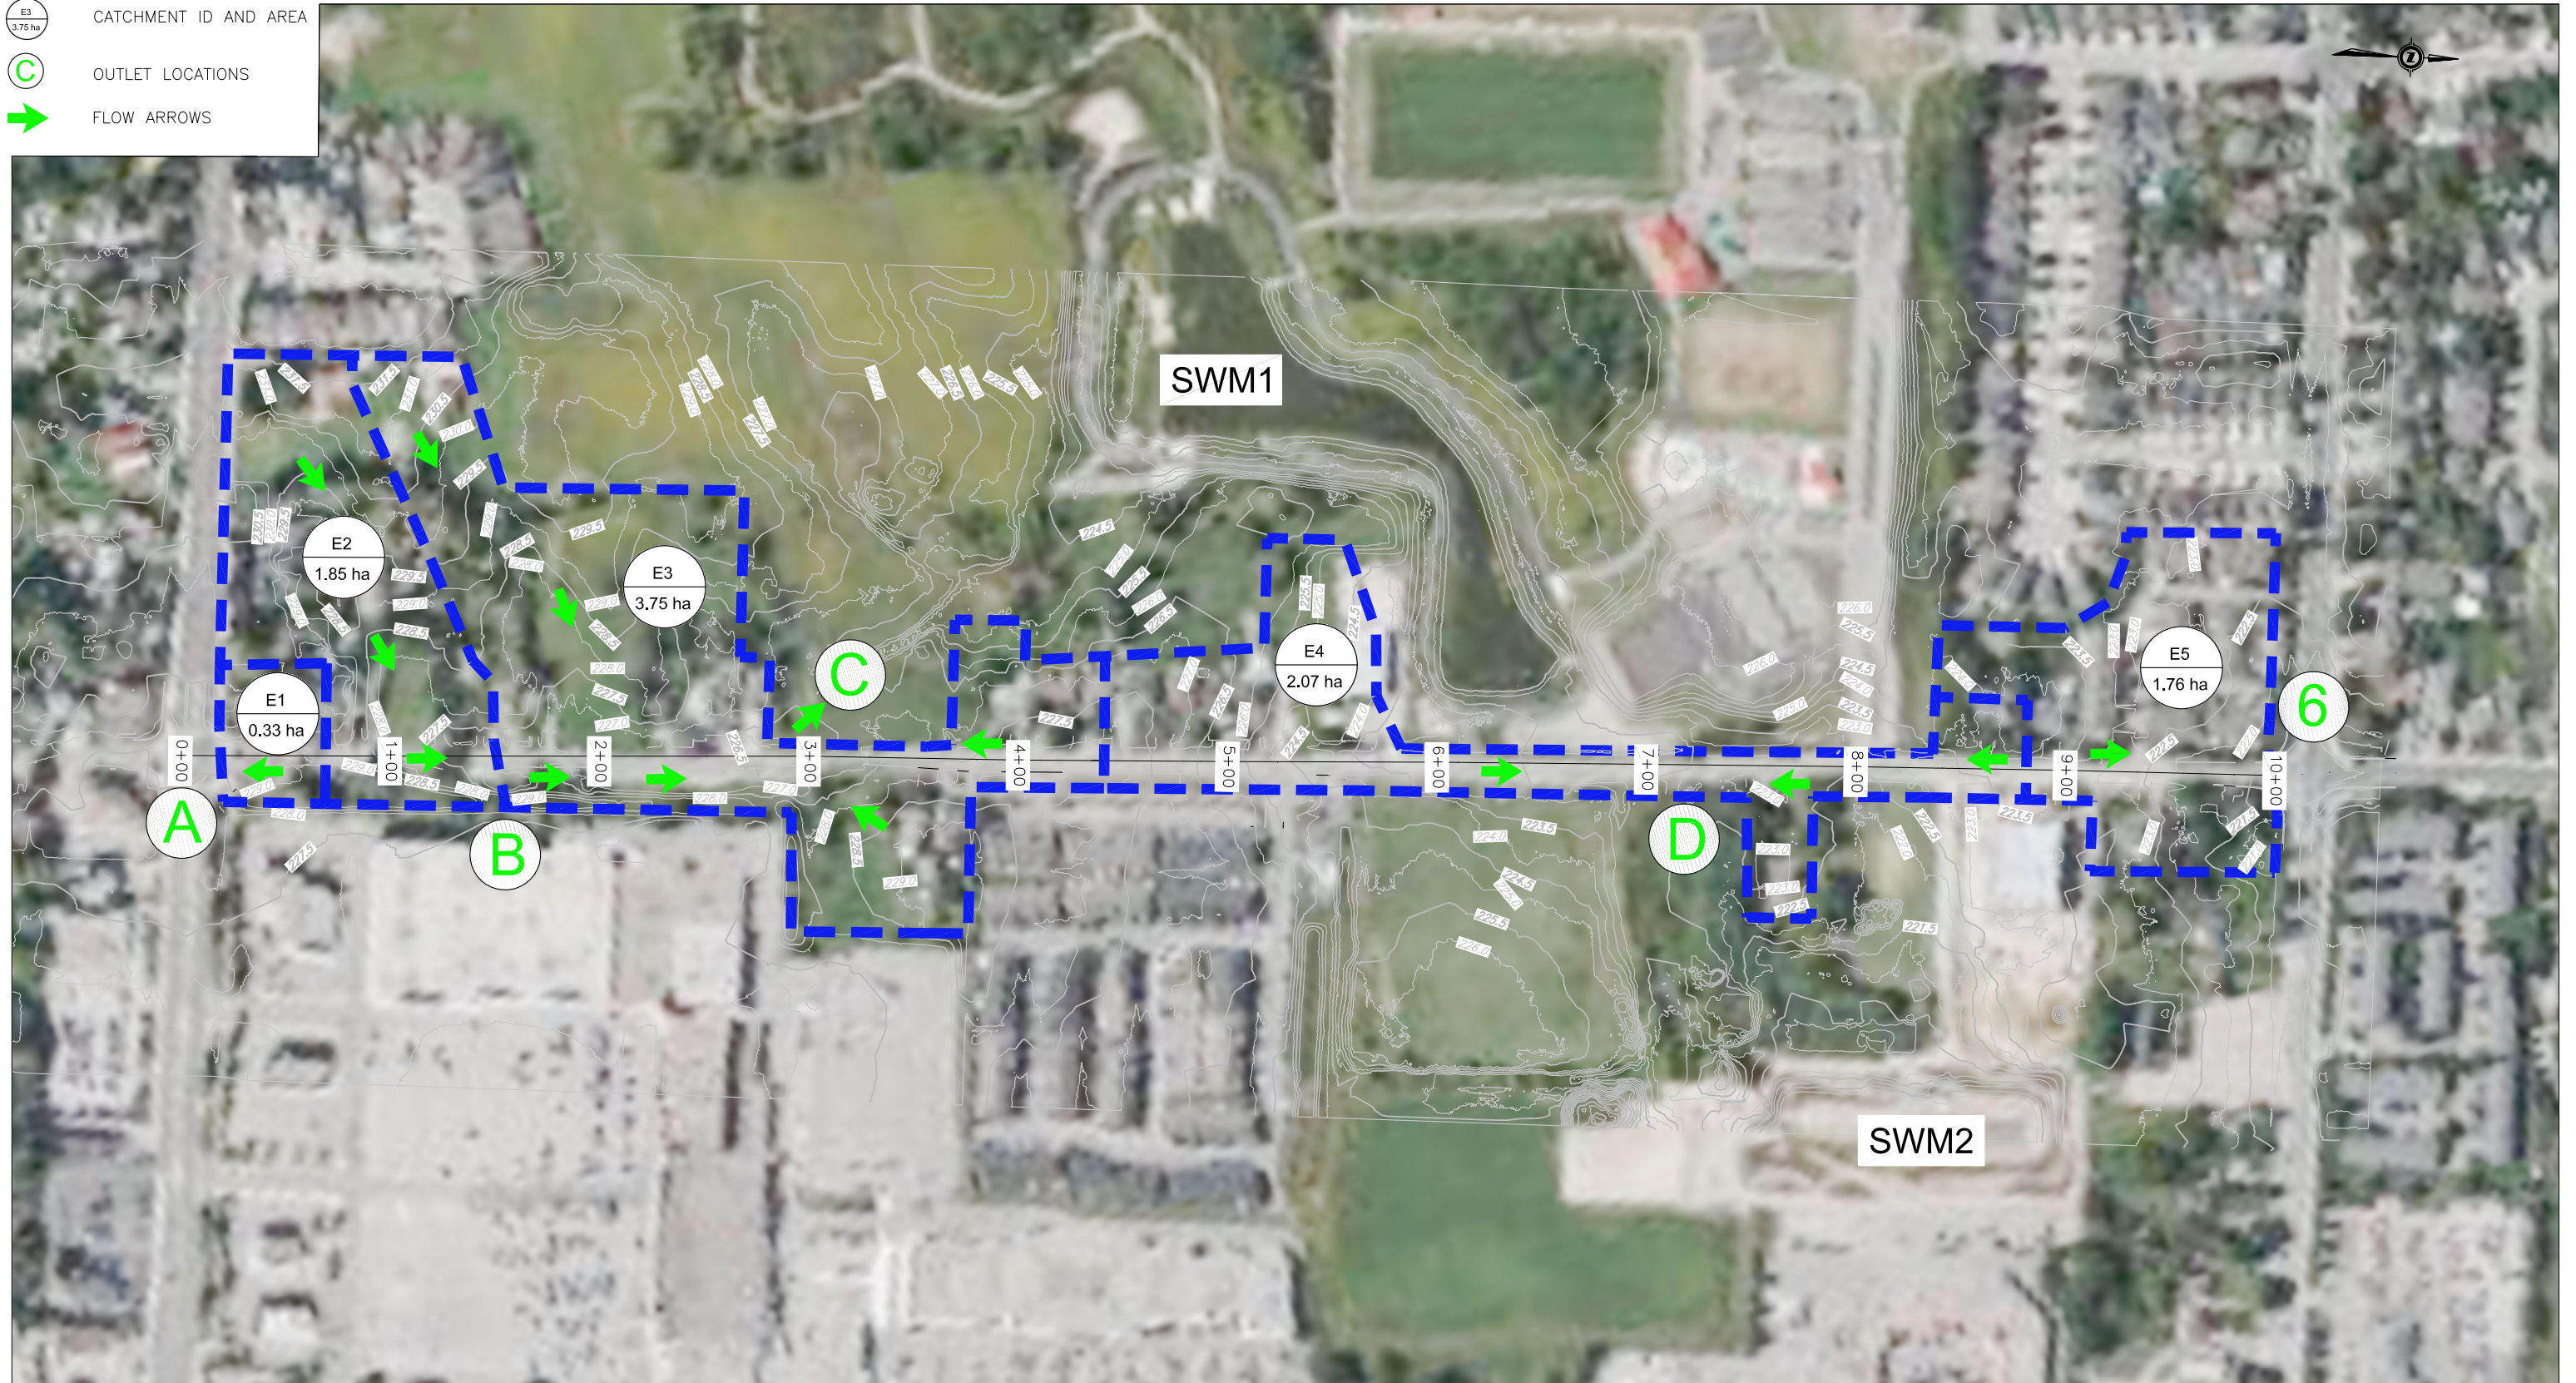
Under existing and ultimate conditions, every catchment is within the Upper Ottawa Creek subwatershed, itself part of the Red Hill Creek watershed. These catchments ultimately discharge to the Mount Albion Pond.

- CATCHMENT AREA
- E3
3.75 ha CATCHMENT ID AND AREA
- C OUTLET LOCATIONS
- ➔ FLOW ARROWS

As part of the study, the existing drainage conditions were examined and documented. The 1 km section of road in the study area has multiple high points, resulting in five outlets from the West 5th Street right-of-way (ROW). Stantec's Stormwater Management (SWM) assessment (Stantec, 2025) provides a summary of the existing drainage conditions through the study area and outlines the specific SWM/drainage criteria that will need to be considered in the design. Existing drainage patterns and stormwater infrastructure have been documented, as well as the SWM criteria and ultimate conditions based off the assumptions listed in the SWM reports of the surrounding lands.

- South of the study area is an 825mm storm sewer in the Rymal Road West ROW which collects the drainage from existing catchment E1.
- At STN 2+95 is a suspected storm sewer which drains to the proposed Sheldon neighbourhood. It replaces the previously existing culvert at STN-2+83. This sewer consists of 3 manholes and 3 lengths of pipe leading into the Sheldon neighbourhood from the West 5th Street ROW

- There is a single length of storm sewer at the intersection of Carmel Dr and West 5th Street (STN-5+26). As designed for the 1155 West 5th Street development, the sewer flows towards West 5th Street. However, the Mewburn Pond drainage plan treats the entire development at 1155 West 5th Street as one catchment. Therefore, it is assumed that under existing conditions, the sewer does not flow to the West 5th Street ROW. The status of this length of storm sewer should be confirmed during the West 5th Street storm sewer design to determine whether the flows from this area need to be accommodated. Regardless, this area has been accommodated in SWM2.

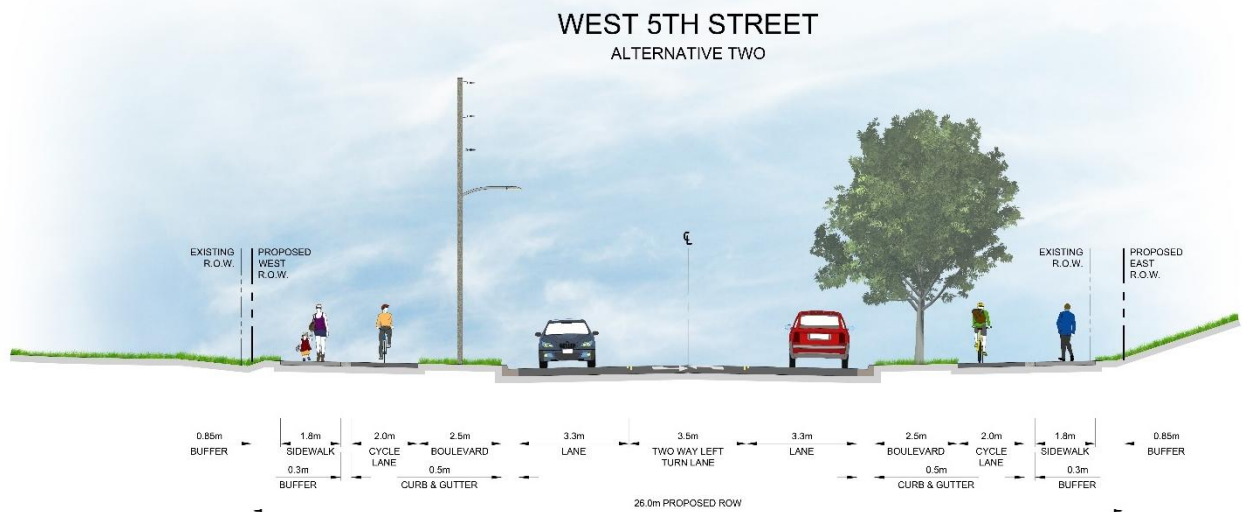
Figure 5 Alternative Design 2 Preliminary Cross-Section

Alternative 2 uses a modified version of the typical connector cross-section from the Complete Streets Manual for a 26 m ROW. The road accommodates a 3.5 m two-way left-turn lane to better accommodate traffic flow and access. A 2.0 m uni-directional cycle track and 1.8 m sidewalk is provided on both sides of West 5th Street, with a buffer zone for separation between the cycle track and sidewalk.

Both Alternative 2 and Alternative 4 offer feasible alternatives for the West 5th Street Corridor. However, the increased roadside safety and connectivity offered by Alternative 2 is recommended as the preferred Alternative Design.

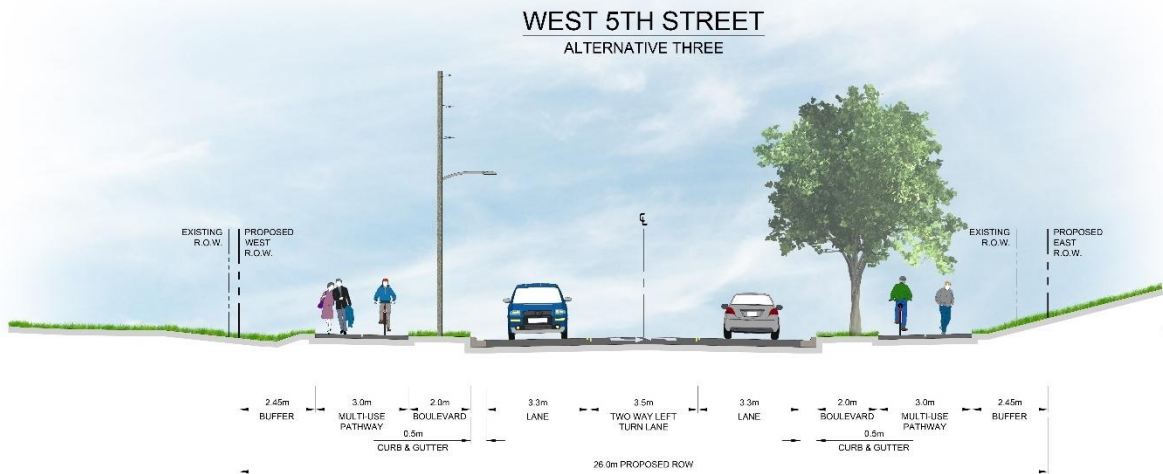
Figure 6 Alternative Design 3 Preliminary Cross-Section

Alternative 3 includes a modified version of the typical connector cross-section from the Complete Streets Manual for a 26 m ROW. The road accommodates a 3.5 m two-way left-turn lane to better accommodate traffic flow and access. A 3.0 m Multi-Use Path (MUP) is included that provides a dedicated shared path for both cyclists and pedestrians. The MUP would be on both sides of the road in the boulevard in lieu of a sidewalk.
