WATERDOWN VILLAGE BUILT HERITAGE INVENTORY FORM

4 CHURCH ST

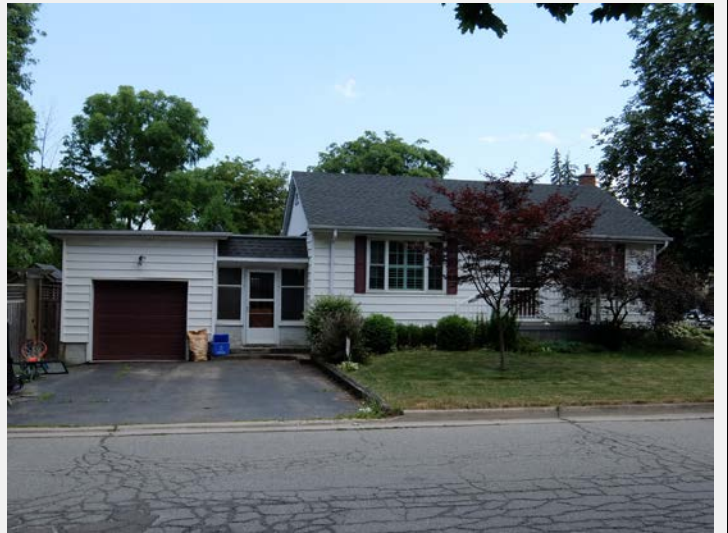
The property is representative of a modest vernacular one-storey post-war residence, including the side gable roof with flush (shallow) verges, side brick chimney, flat-headed windows, ornamental shutters and raised front entrance. The residence also demonstrates early Ranch style influences including the long low profile, low side-gable roof and windows below the projecting eaves.

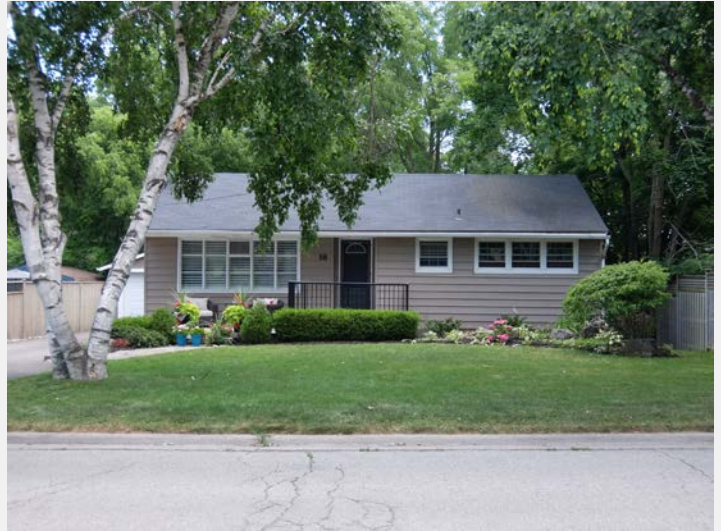
10 CHURCH ST

The property is an early representative example of Ranch style vernacular architecture from the mid-20th century, including the one-storey massing, low side gable roof with projecting eaves, flat-headed windows below the eaves, raised front entrance and large scenic window. The original 1953 rear detached garage also remains.

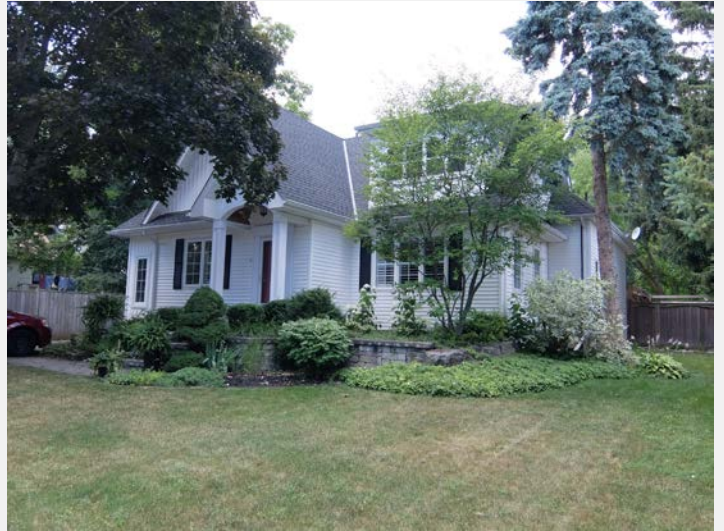
11 CHURCH ST

The property is a modified vernacular post-war residence.

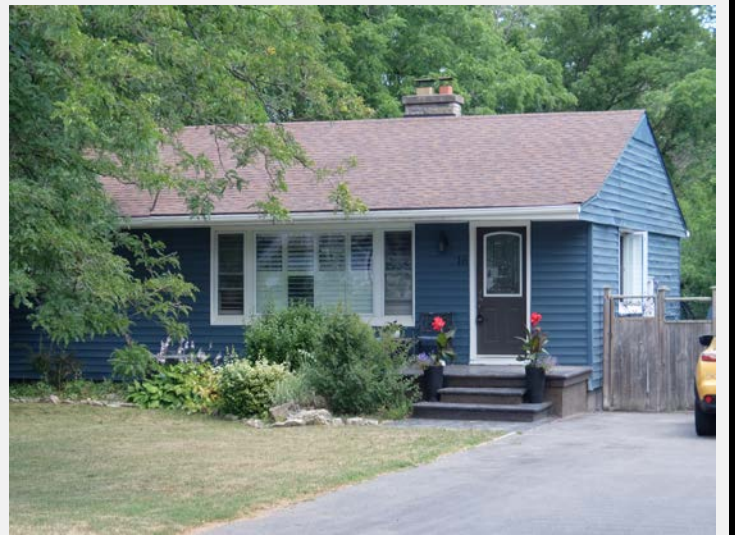
16 CHURCH ST

The property is an early representative example of Ranch style vernacular architecture from the mid-20th century, including the one-storey massing, low side gable roof with flush verges and projecting eaves, flat-headed windows below the eaves, raised front entrance and large scenic window.

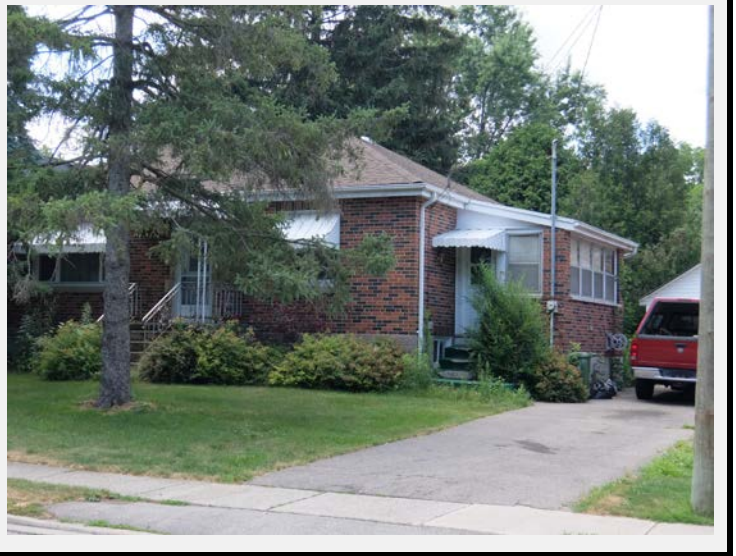
17 CHURCH ST

The property is representative of a modest vernacular one-storey post-war residence, including the one-storey massing, flat-headed window openings with concrete lug sills and raised front entrance. The residence also demonstrates Ranch style influences including the low profile and low hip roof with projecting eaves. The original 1953 rear detached garage also remains.

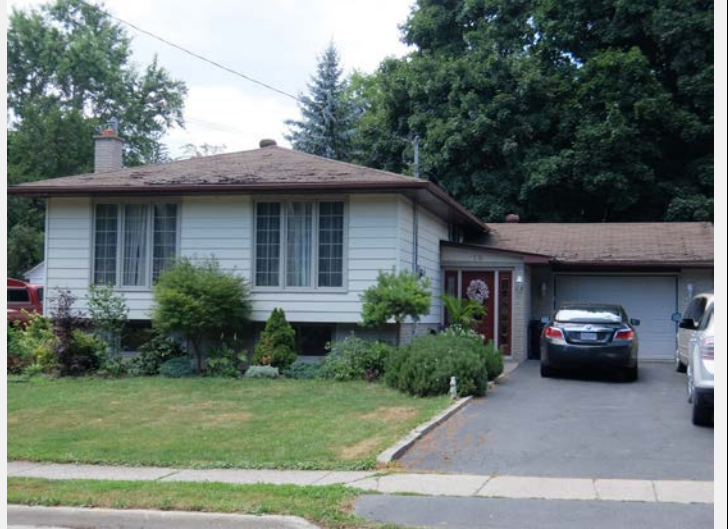
19 CHURCH ST

The property is reflective of the Suburban Split-level style including the low hip roof with projecting eaves and partially-raised basement level and attached side garage.

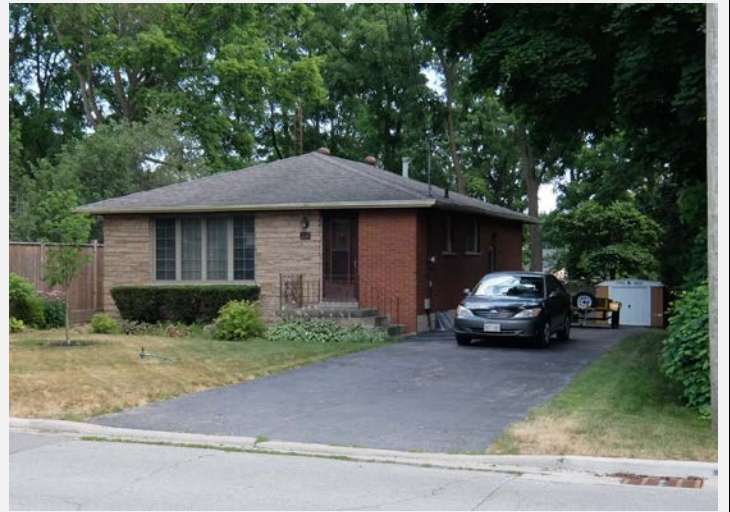
Classification: Inventory Property (IP)

None identified.

The 1970 vernacular dwelling neither supports nor detracts from the historic character of the area, which consists of late-19th and early-20th century dwellings.

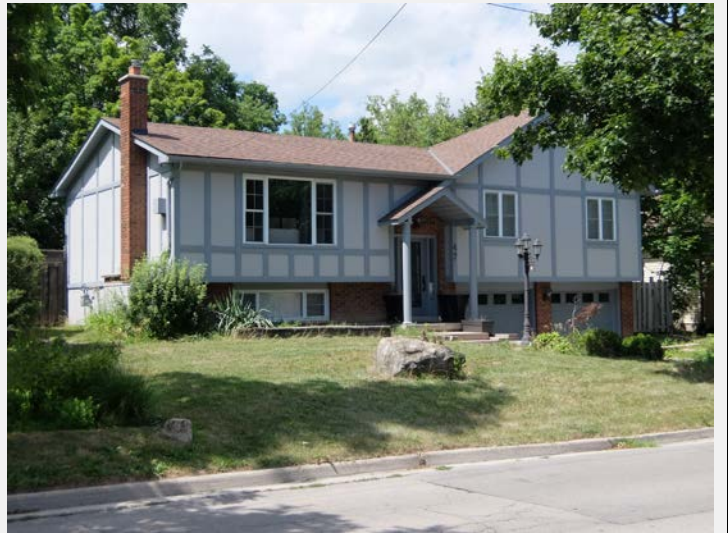
47 CHURCH ST

The property is reflective of the Suburban Split-level style including the gable roof with projecting eaves and partially-raised basement level with two-car garage. The property also displays Period Revival influences, specifically the Tudor Revival style, including the stucco and half-timber cladding.

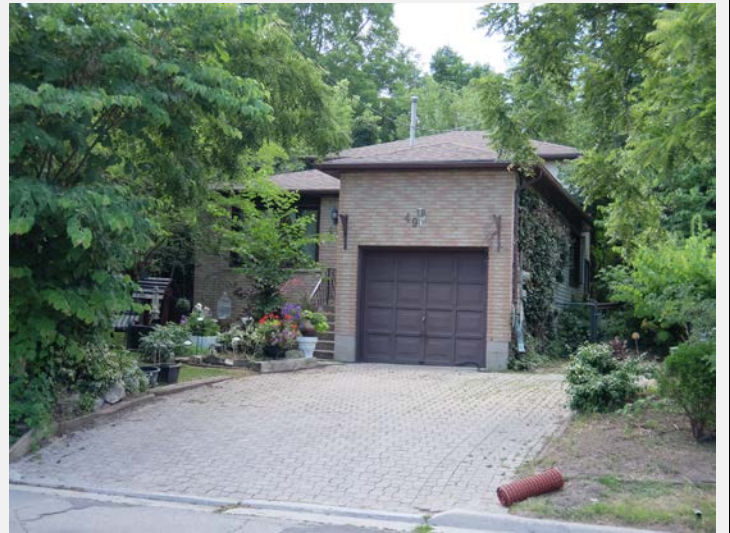
49 CHURCH ST

Architectural Style / Influence: Vernacular; Suburban

Number of Storeys: 2

Classification: Inventory Property (IP)

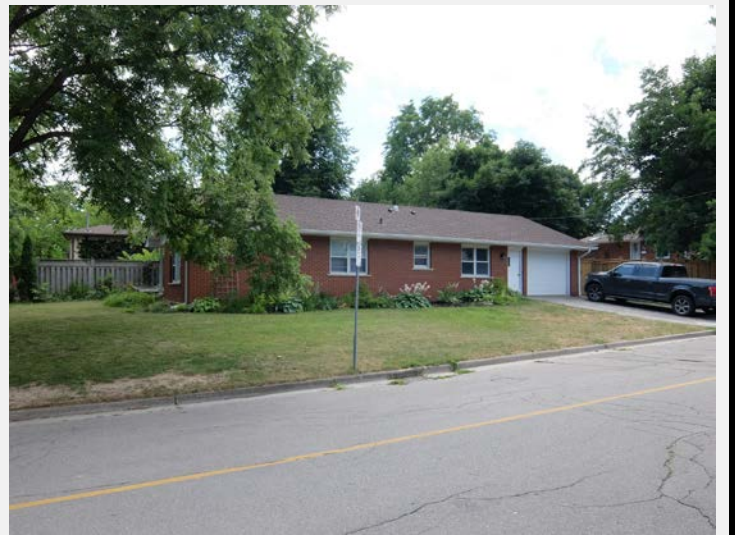
51 CHURCH ST

The property is reflective of a vernacular Suburban Ranch-style design including the low profile, low front gable roof with projecting eaves, flat-headed windows and attached one-car side garage.
