# WATERDOWN VILLAGE BUILT HERITAGE INVENTORY FORM

## 1 JOHN ST E

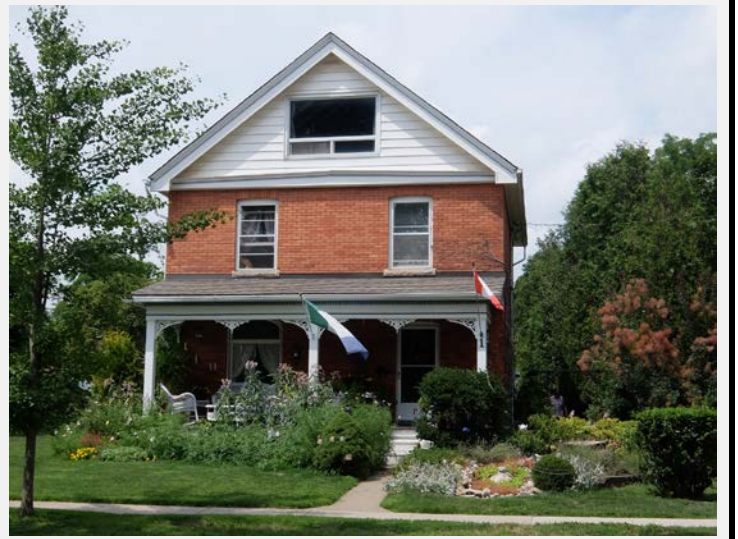
This simple two-and-a-half storey red brick residence which sits on the corner of Main and John is vernacular in style with Edwardian Classicism influences. Oriented towards John Street it is rectangular in plan with a front gable roof and clapboard siding. The main elevation is two bays wide with a side entrance door and window on the first floor and two windows on the second floor. A modern window unit is located in the peak of the gable. The first floor window is semi-elliptical with a transom while the upper window openings are segmental. The one storey verandah that extends across the front of the house has been renovated with square posts. The house exhibits simple but decorative dentil work on the gable vergeboard, on a wooden band stretching across the bottom of the wooden gable siding and on the porch cornice. The same front gable detailing, but on a larger scale, was used on 155 Main Street North. A double garage is set to the rear of the property off Main Street. The 1939 Fire Insurance Plan depicts a brick veneer construction and wood roof shingles.

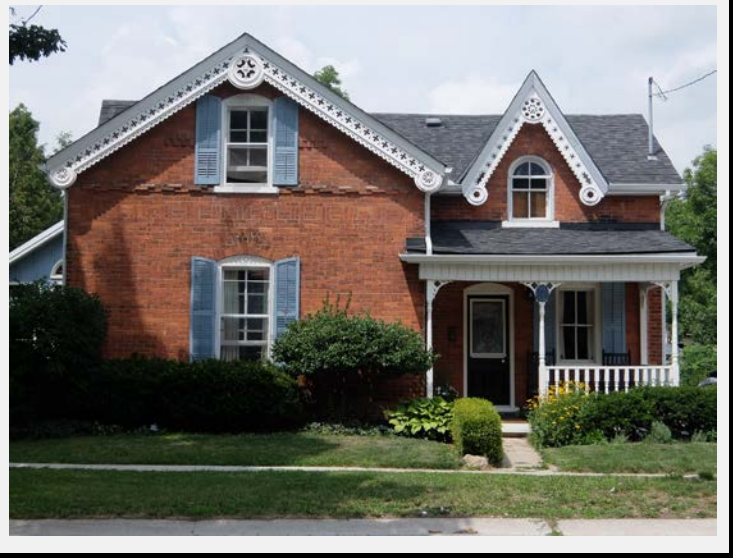
## 7 JOHN ST E

This vernacular one and-a-half storey red brick dwelling is set low to the ground and features an "L" shape plan. A cross gable roof with a front gable comprises the arm of the "L" plan. The low pitch roof of the front gable and dormer are distinguished by highly decorative vergeboard. A one storey verandah with shed roof, delicately turned supporting posts with decorative fretwork and turned balusters extends across the front of the recessed cross gable marking the main entry. The window openings are segmental with brick voussoirs, stone sills and operable louvred shutters. The front gable window is semi-circular. The sash are double hung, two-over-two wood units. Decorative incised woodwork is found in the upper segmental window and door opening. It would appear that the panelled window opening on the west side of the verandah was once a doorway. A decorative brickwork panel is located under the first floor windows on the main elevation and a decorative brick band of three headers and three stretchers is located between the first and second floor on the front gable projection. The 1939 Fire Insurance Plan indicates a brick veneer construction and wood roof shingles.

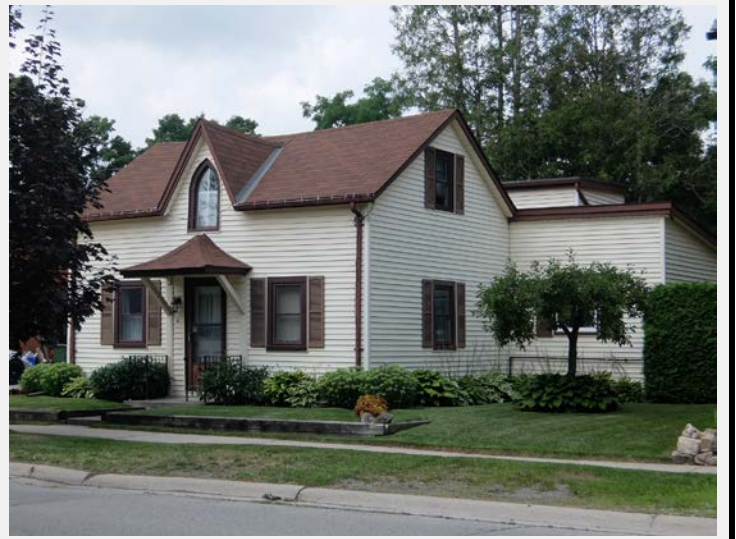
## 13 JOHN ST E

The property is representative of the Ontario Cottage style with Gothic Revival influences. Typical of the Ontario Cottage style is the 1.5 storey massing, side gable roof with projecting eaves and centre front gable and three-bay front facade with central entrance and flanking windows. The pointed arched window below the centre gable reflects a Gothic Revival influence. A one storey wing extends to the rear and an addition is set to the east.

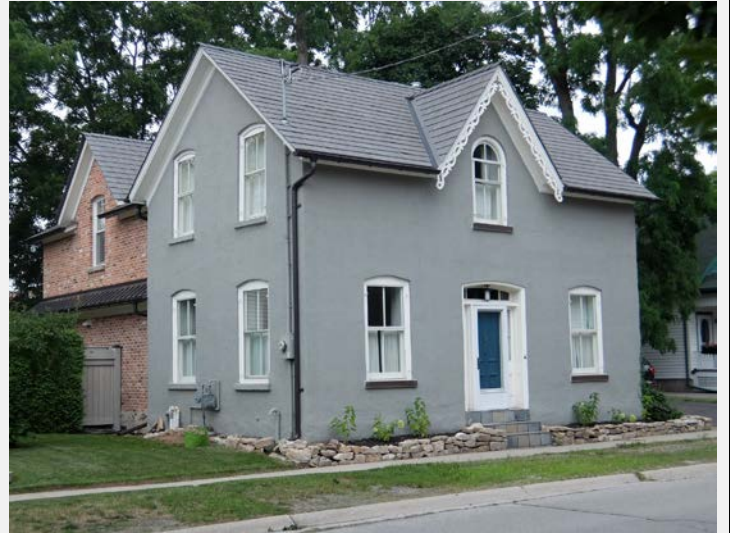
19 JOHN ST E

This house is similar in style and proportion to the building at 33 John Street East. Set close to the street, it is significantly higher than its neighbour to the west. It is a vernacular one-and-a-half storey house reflective of the Ontario Cottage style, including three bay front facade with central entrance and flanking windows and central gable with round-headed window below. The main entry is slightly recessed in the thickness of the wall and is distinguished by half sidelights with lower panels and a transom. The side walls feature symmetrically arranged window openings on the first and second floors. The two over two rectangular, double hung windows have stone sills and shutters. Each is set in a segmental opening with the exception of the dormer window which is semi-circular in shape. The 1939 Fire Insurance Plan for Waterdown indicates that this structure is of stone construction with a concrete coating on the exterior.

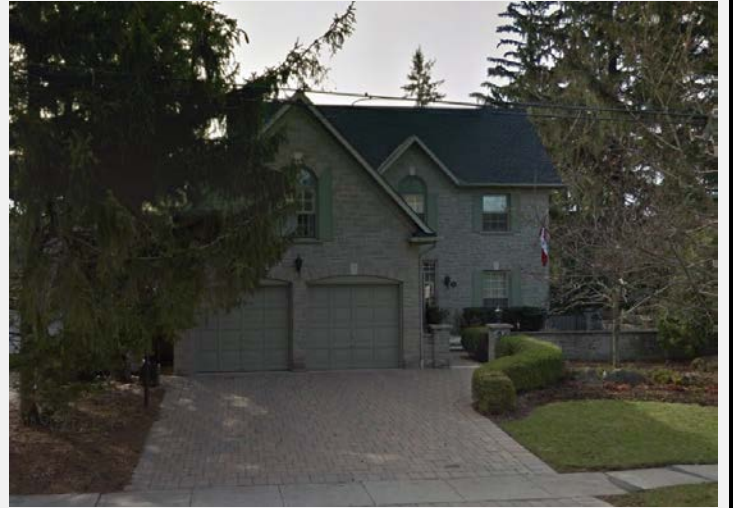
## 24 JOHN ST E

Contemporary 1980s infill

The 1988 Suburban-style dwelling detracts from the historic character of the area.

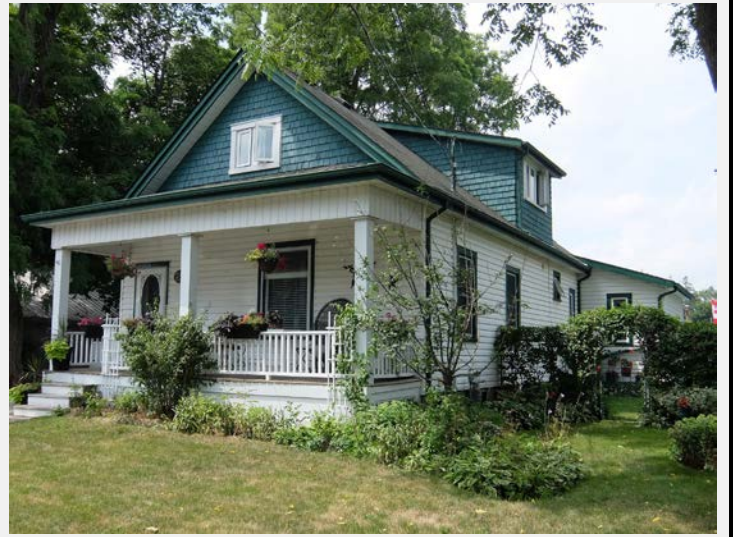
## 25 JOHN ST E

This one-and-a-half frame residence is a modest example of the Bungalow style popular in the early part of the twentieth century. Characteristically the building presents a low profile to the street with a one storey verandah across the front and wood shingles in the gable end. The first floor walls have been clad in horizontal siding while the upper level retains wood shingles stained green. The rectangular structure extends back from the street with dormers on either side openings up the second floor.

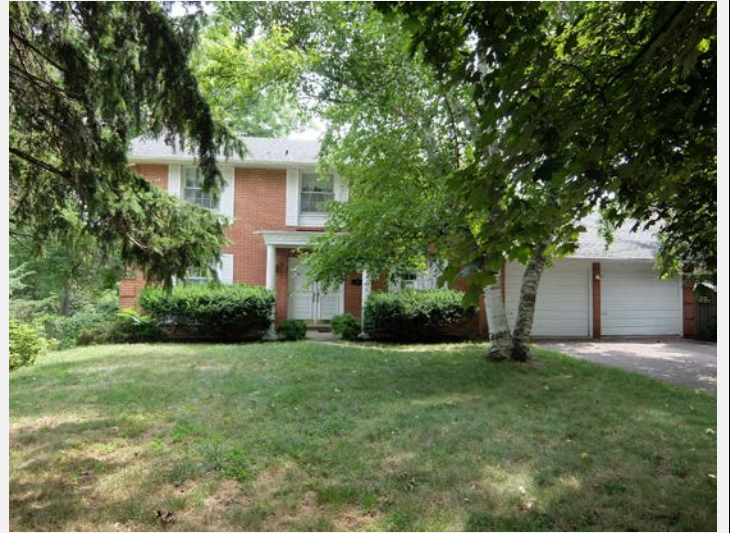
## 26 JOHN ST E

1960s contemporary infill reflecting the Georgian period revival style of architecture.

The 1968 Suburban Two-storey dwelling influenced by the Georgian Revival style, with two-car projecting front garage, does not support the historic character of the area.

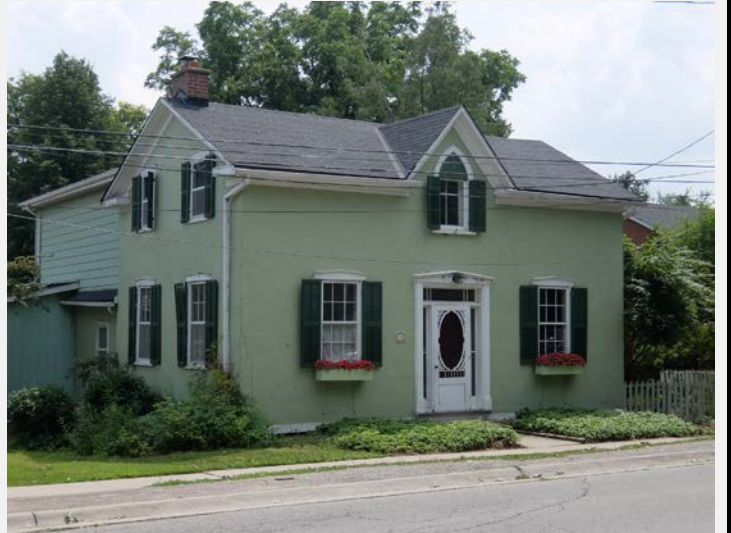
32 JOHN ST E

This one-and-a-half storey Ontario Cottage stucco-clad frame residence has a centre door, flanking windows and pointed arch window in the centre gable directly above the entry (influenced by the Gothic Revival style). The side elevations contain two window openings on the first floor and two upper window openings. Notable features of the building include: entrance door with full sidelights, transom, pilasters and pediment on the door surround, six-over-six double hung sash with casings, moulded pediments and louvred shutters a pointed arch window with upper and lower shutters and cornice returns on the side elevations of the shallow pitched gable roof. The 1939 Fire Insurance Plan indicates that this house is of wood construction with a roughcast coating. Although similar in detailing to 19 and 33 John Street East, this house is lower in height with a more horizontal emphasis than the other houses.

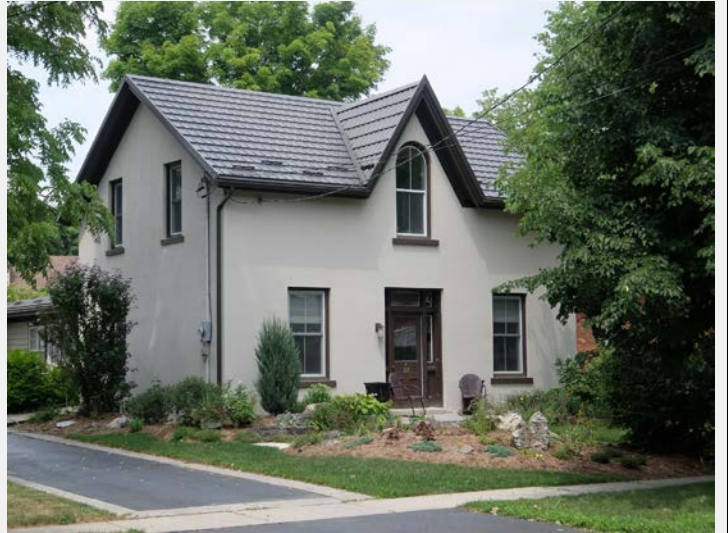
33 JOHN ST E

The property is comprised of a vernacular, one-and-a-half storey, Ontario Cottage featuring a typical three bay division of the front elevation with a centre door, a window to either side and a centre gable window directly above the front door. Notable elements include the main entry with its half sidelights and lower panelling and embrasure mouldings, the tripartite transom over the main entrance, the semi-circular arch dormer window with a transom and the exterior cementitious rendering. The side walls feature symmetrically arranged window openings on the first and second floors. The windows are primarily two-over-two double hung wood sash set in rectangular openings. A one-and-a-half storey wing extends to the rear with a more modern one storey frame addition on the west side. The 1939 Fire Insurance Plan for Waterdown indicates that the house and the rear addition are of stone construction with a concrete coating and wood shingle roof. A drive is placed on the west side of the lot with parking to the rear. At one time the house had a chimney located on each gable end of the roof and decorative vergeboard in the front gable. This house is similar in style and proportion to the building at 19 John Street East.

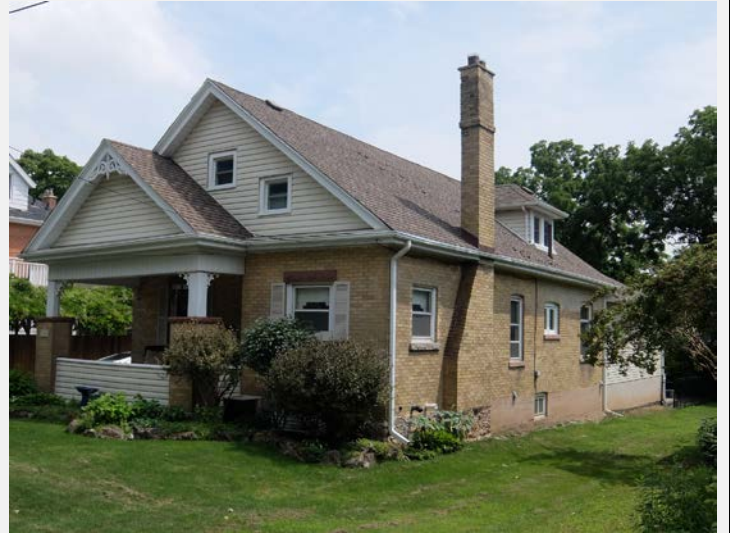
38 JOHN ST E

Built in the Bungalow style this one-and-a-half storey yellow brick residence was characteristically designed with a lower gable over an open porch and a larger gable over the main portion of the house. The horizontal lines of the house are emphasized through the wide eaves, the continuation of the eaves across the gable ends and a change of wall cladding above and below the eaves; the vertical dimensions are minimized through short porch columns and squat window openings. Frequently such houses masked their true size by extending well back into the lot and opening up the second floor with the extensive use of dormers along the side of the house. The yellow brick is accented with red stone lintels, sill and piers caps on the porch. The eaves and gable ends have been covered in horizontal siding. The window sash has been replaced. The 1939 Fire Insurance Plan depicts a brick veneer construction and wood roof shingles.

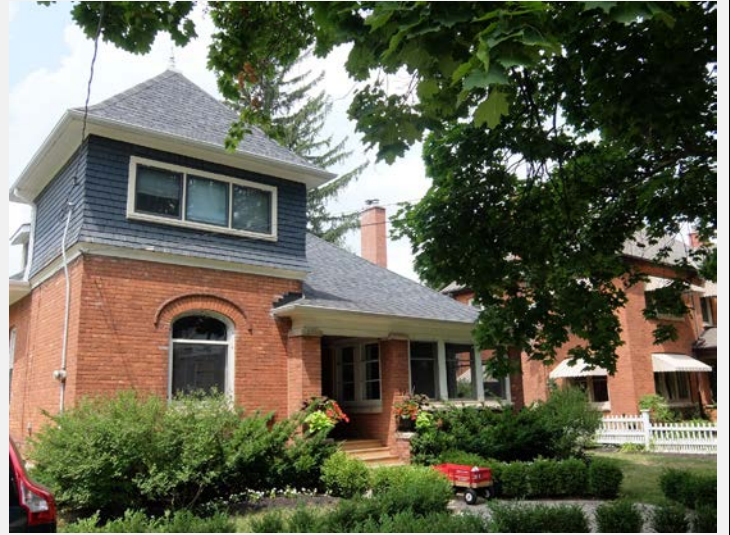
39 JOHN ST E

This one-and-a-half storey brick residence is built in a vernacular style. The basic form of the house is roughly square with low red brick walls and a steeply pitched truncated hip roof with wide eaves. The front elevation features a squat square tower with hip roof set into the southwest corner. This roof pitch and composition is typical of a post-1900 Queen Anne building. The height of the tower is visually diminished through the use of strong horizontal bands at the first and second floor levels and at the eaves. The upper windows in the tower and to the east end of the main elevation are bounded together in groups of three to create a horizontal band. The single elliptical headed window at the base of the tower is atypical in its shape and format. Hipped dormers with wide eaves are set along the side of the house and an addition extends to the rear. The tower roof has a decorative wooden pinnacle. The front door is the same one as the oval glass door shown in an circa 1911 photograph of the H. Slater House. The asphalt shingle roof is also shown in the 1911 photograph. The original open front porch with curved wooden balusters, brick piers and short squat posts has been enclosed by brick walls. The 1939 Fire Insurance Plan depicts brick veneer construction.

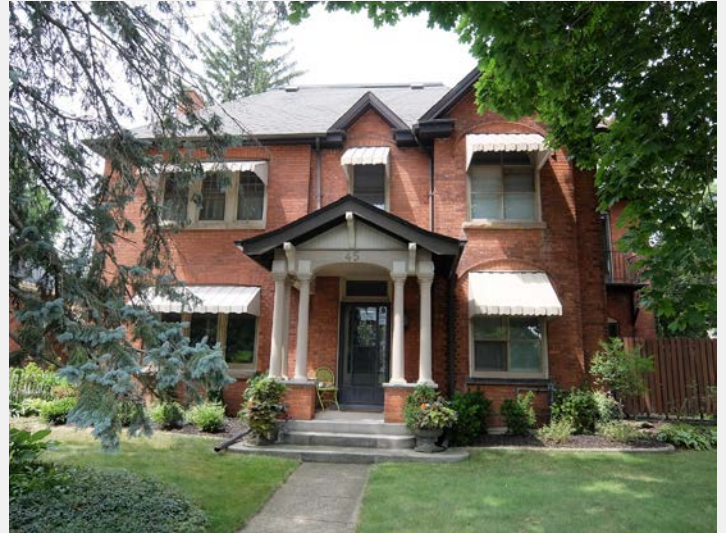
45 JOHN ST E

This two storey residence has undergone extensive modifications in its history. It appears that the original house was L shape in plan with a cross gable roof, the main entry to the house in the arm of the L plan may have fronted onto Mill Street. The projecting gable on the Mill Street elevation has the distinguishing decorative window on the first floor with segmental shaped window above and adjacent. The current main elevation oriented to John Street is formed by an extensive addition placed to the south and slightly to the west of the original house. Built in an Edwardian Classical style, this addition features a central portico with a bellcast roof supported by a grouping of three columns. The windows to the east are paired and elliptical in shape while those to the west are placed in threes and are segmental. The 1939 Fire Insurance Plan depicts brick veneer construction.
