# WATERDOWN VILLAGE BUILT HERITAGE INVENTORY FORM

## 2 UNION ST

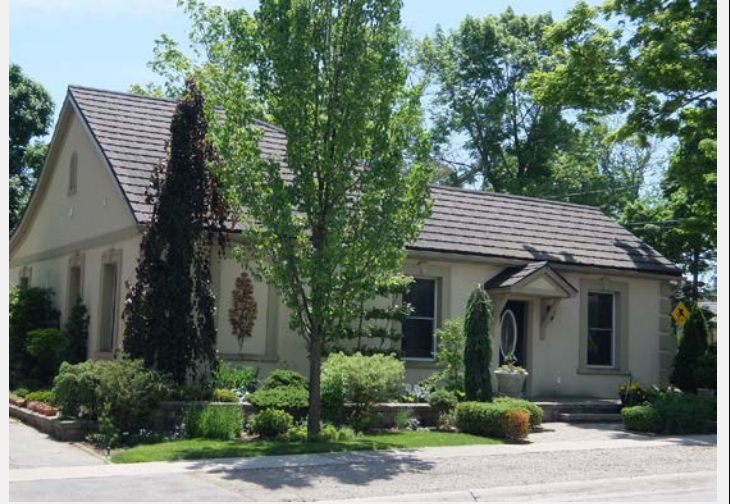
Very little of the original character of this residence remains. It was probably a one storey cottage with a centre door and a window to either side on the front facade. Additions have been constructed to the east side of the building and to the rear and the entire structure sheathed in metal siding and asphalt shingles. The 1939 Fire Insurance Plan indicates that the house is of stone construction and that it had wood roof shingles.

The late-19th century property, though modified, helps support the historic character of the area. The property is shown as a semi-detached building in the 1930s FIP.

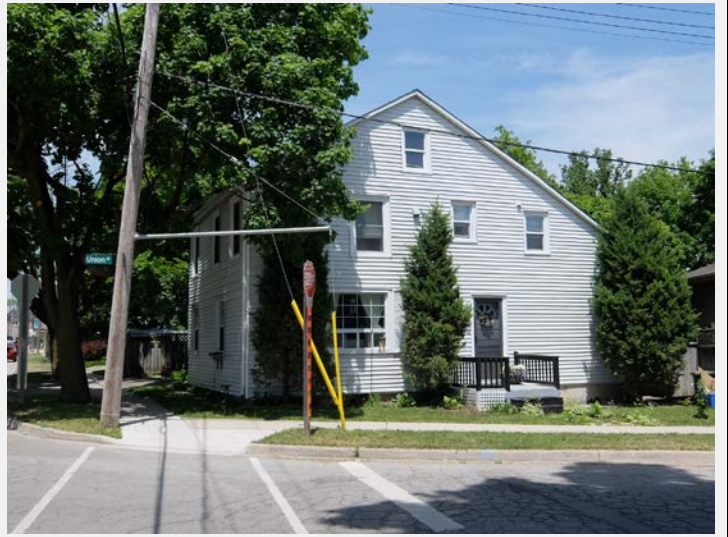
## 3 UNION ST

This two-and-a-half storey vernacular residence is a frame structure set on a stone foundation. The gable roof is oriented east/west, almost saltbox in shape as the eaves dip close to the one storey height along the east elevation. The main elevation was probably oriented originally towards Main Street although there are no distinguishable marks due to the modern horizontal siding. The principal entrance and the window openings on Union are randomly located across the elevation. Some of the window sash have been replaced.

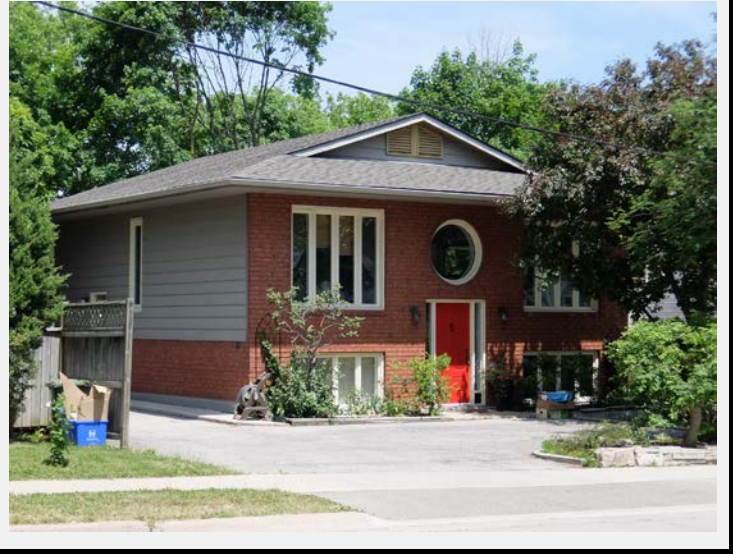
## 5 UNION ST

Contemporary late-20th century residential infill.

The 1983 Suburban Split-level dwelling detracts from the historic character of the area.

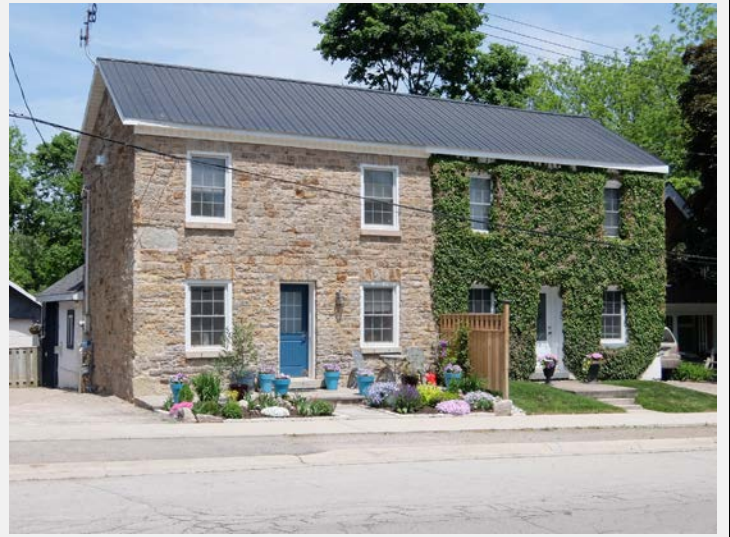
## 11 UNION ST

The property is a rare and early example of a two-storey semi-detached dwelling in the village.

The property is important in defining the character of the area. The property is the western half of a semi-detached residence.

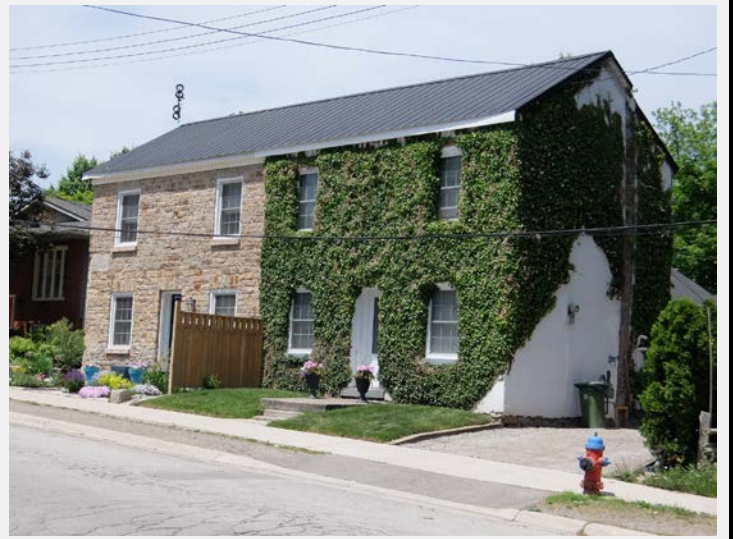
## 13 UNION ST

The property is a rare and early example of a two-storey semi-detached dwelling in the village.

The property is important in defining the character of the area. The property is the eastern half of a semi-detached residence.

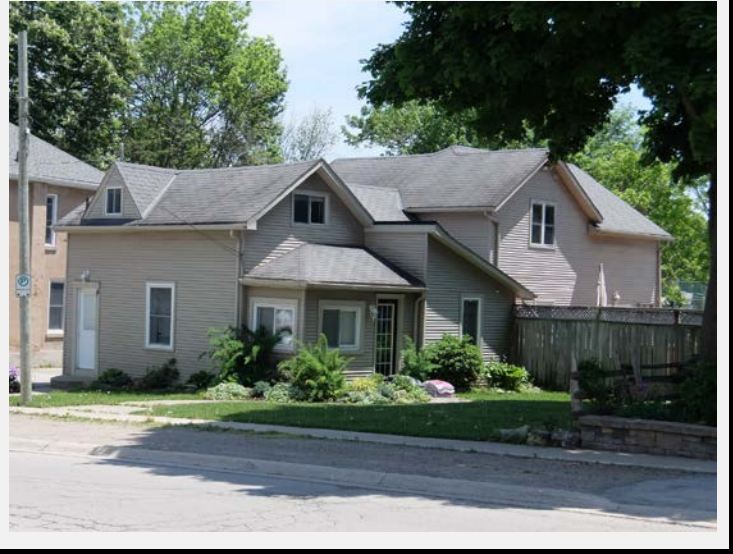
## 14 UNION ST

This one-and-a-half vernacular frame dwelling is clad in narrow horizontal siding. It is set low to the ground on a rubble stone foundation. The main elevation is characterized by the non-symmetrical placement of the door and window. The original side gable roof has been modified with the introduction of a pediment-like dormer roughly above the main entrance door. An enclosed porch is situated at the west end of the building and a one storey wing with shed roof along the back.

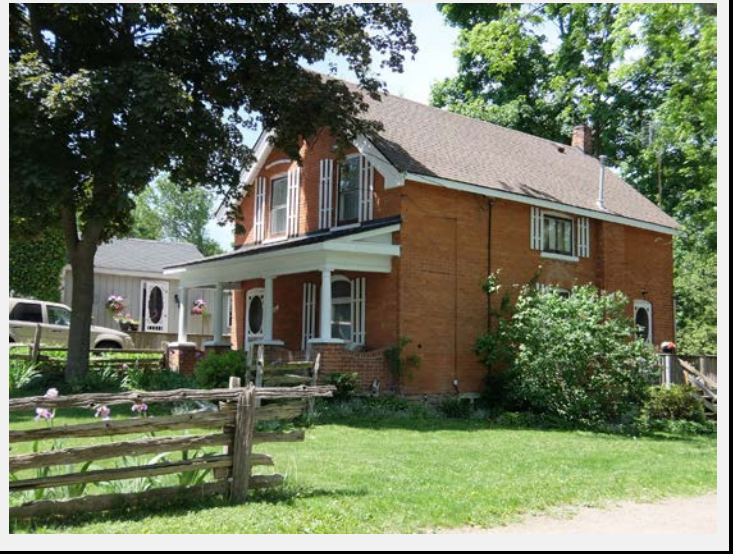
## 17 UNION ST

Set back from the street, this one-and-a-half storey vernacular residence is oriented with the gable end to the street. A one storey verandah runs across the front of the house with turned wood posts set on brick piers. The red brick-clad structure is two bays wide with the entrance door to the west end and a large segmental arched window with decorative transom to the east. The two-second storey windows are segmental in shape with the curve emphasized with bricks painted white above the voussoirs. The wood window sash appear to be original. The gable end is highlighted with a diamond shaped decorative brick panel and dentil patterning on the wooden vergeboard. The 1939 Fire Insurance Plan depicts brick veneer construction with a one storey frame addition.

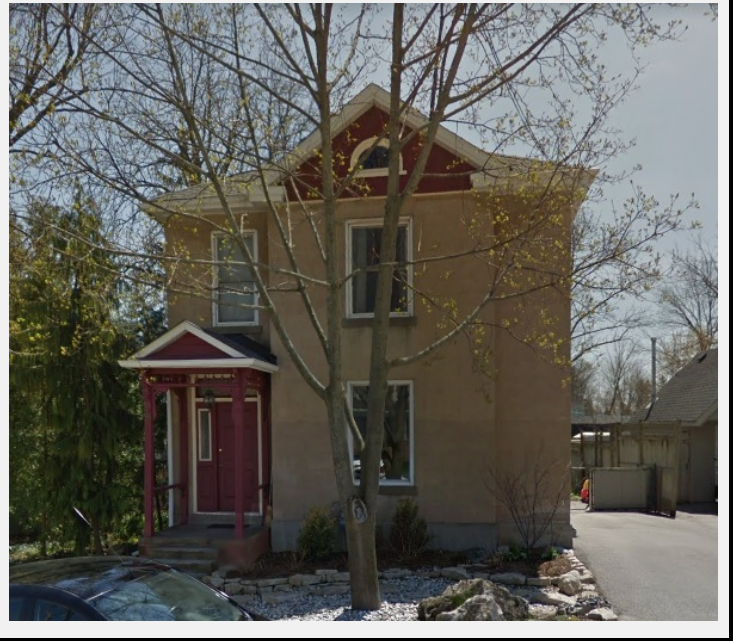
## 20 UNION ST

This two storey residence was built in the Edwardian Classical style circa 1900. It is characterized by the hip roof and a shallow two storey gabled bay with decorative shingles and semi-circular window on the main elevation. It has (rough cast) stucco cladding. The two bay front facade is asymmetrical with the entrance door and gabled porch to the east end. The house sits on a plinth, now parged, about three feet above grade. The windows have been replaced. The 1939 Fire Insurance Plan indicates that the building is of stone construction and had a concrete rendering.

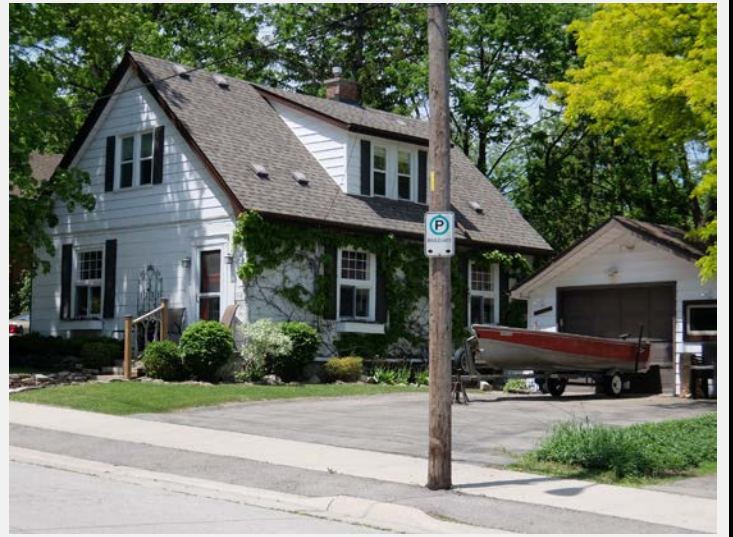
## 23 UNION ST

This one-and-a-half storey vernacular frame residence is oriented with a gable end to the street. The building is clad with horizontal siding and is set on a concrete foundation. The main elevation comprises door and window at the first floor level with a centre window above for the second floor. The windows have been replaced with modern units. The 1939 Fire Insurance Plan indicates that the roof was once wooden shingles.

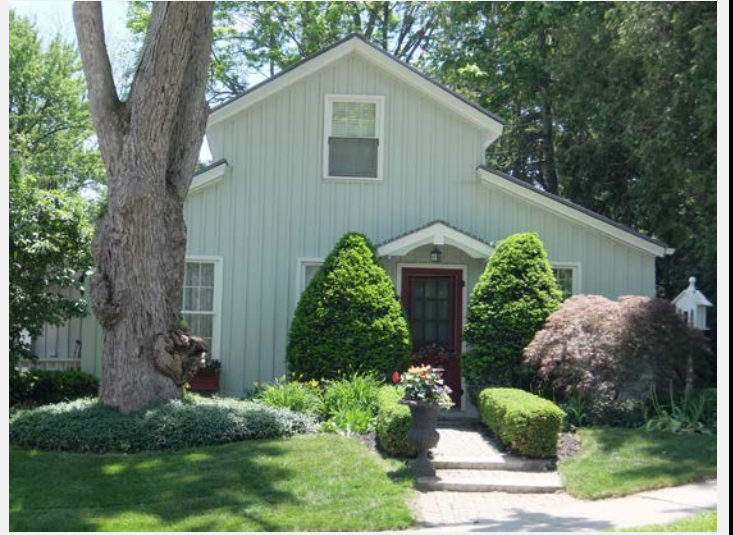
## 24 UNION ST

This vernacular frame residence is a one-and-a-half storey, front gabled structure that is flanked on either side by one-storey shed roof wings. The entire building is clad in board and batten. The structure sits low to the ground, with one step to the front entrance. The window sash and entrance door have been replaced. The 1939 Fire Insurance Plan indicates that this was once a one storey building with wood shingle roofing. The design of this building closely resembles the vernacular dwelling located at 21-23 Barton Street.

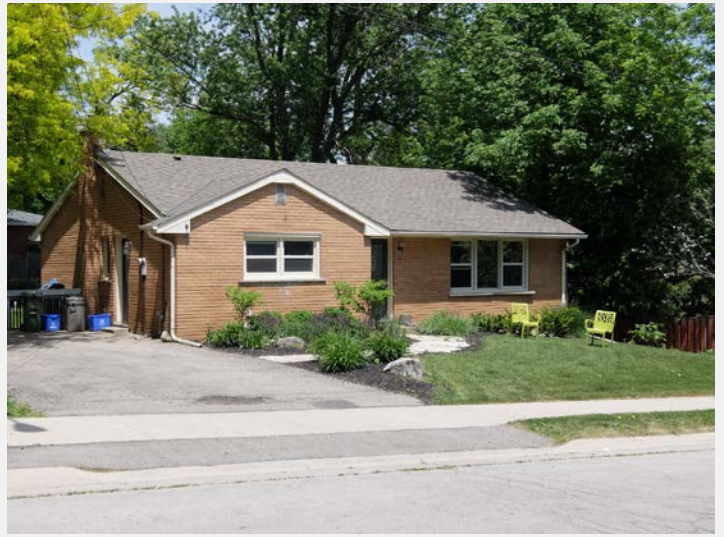
## 29 UNION ST

1960s residential infill

The 1962 Ranch-style dwelling neither supports nor detracts from the historic character of the area.

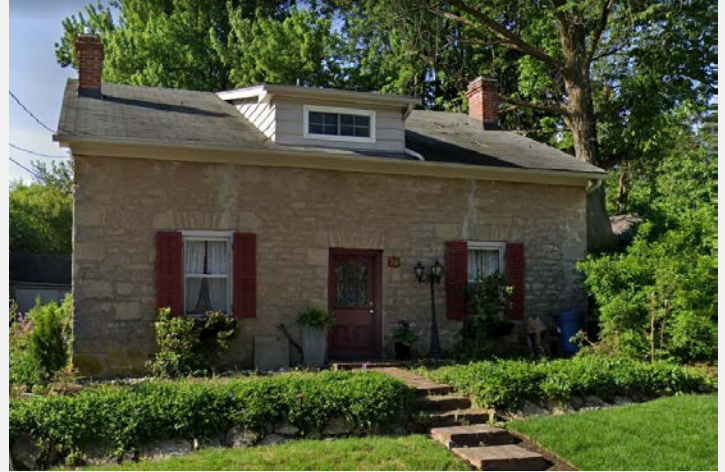
36 UNION ST

This one-and-a-half storey vernacular stone house is a simply designed structure, rectangular in plan with side gable roof and a central door flanked to either side by a window. The side elevations are characterized by two windows on the first floor and two smaller windows above. The window openings feature stone sills and voussoirs. The original window sash have been replaced but the openings still carry operable shutters. The dwelling has been enlarged significantly with a two storey addition to the rear and with the introduction of a modern, small shed dormer above the main entrance.

The property is important in defining the character of the area and is historically, visually and physically linked to its surroundings. The house sits on a raised elevation from Union Street.

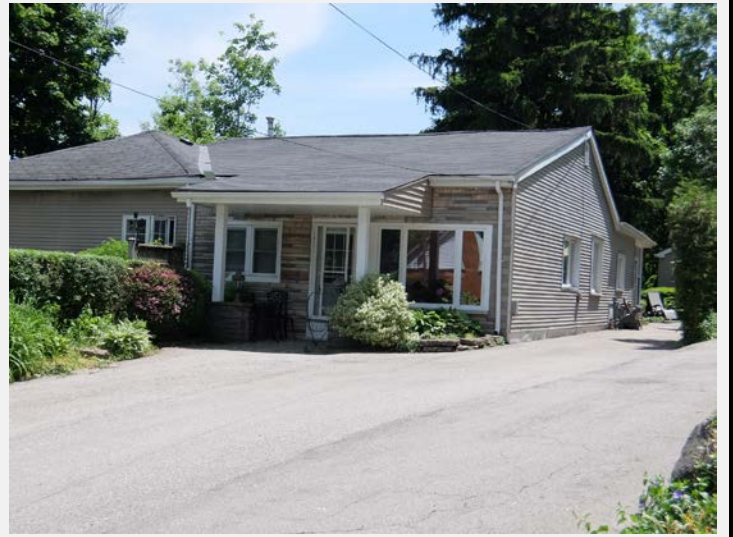
## 40 UNION ST

Situated on Lot 4, Block XLIII, on the southwest corner of Mill and Union Streets, this one storey vernacular frame dwelling appears to have been originally constructed as a one-storey rear wing for 80 Mill Street South. The property was severed and a separate residence created sometime after 1937.

The property helps maintain the character of the area. The property is comprised of the western half of a semi-detached building consisting of 80 Mill Street South and 40 Union Street.
