WATERDOWN VILLAGE BUILT HERITAGE INVENTORY FORM

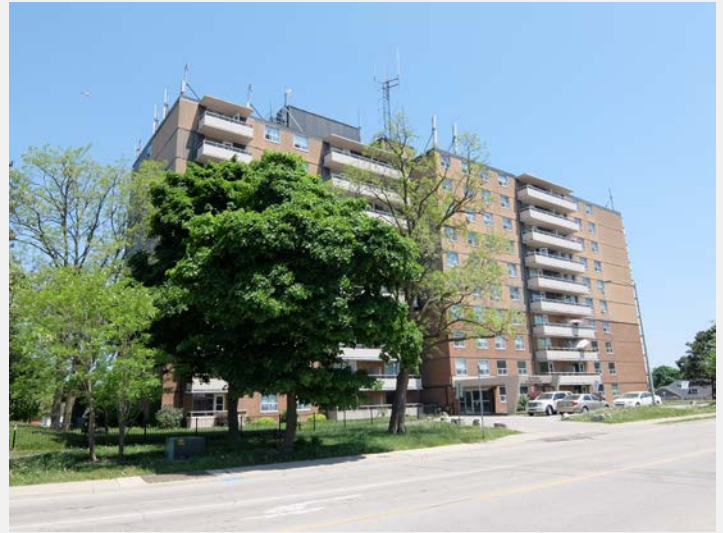
1 HAMILTON ST S

The property yields, or has the potential to yield, information that contributes to an understanding of a community or culture. Braeburn Apartments was one of the first high rises constructed in the Village of Waterdown, shortly after the Waterdown Towers were built on John Street West.

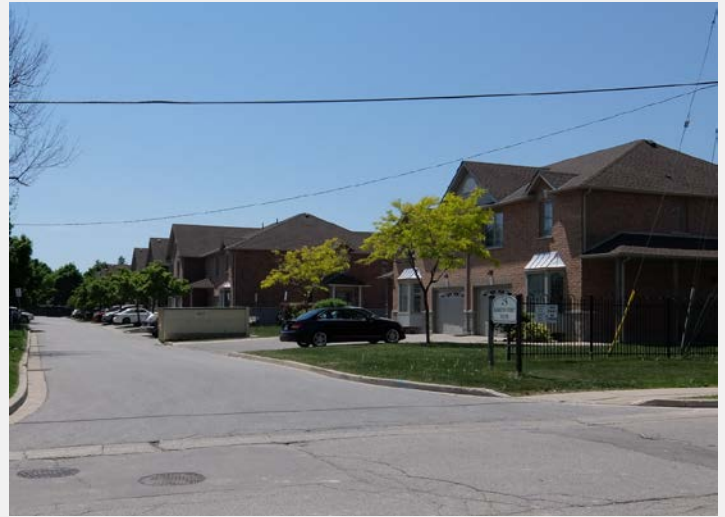
25 HAMILTON ST S

Architectural Style / Influence: Vernacular; Post-Modern

Number of Storeys: 2

Classification: Inventory Property (IP)

Preliminary Design/Physical Value:
None identified.

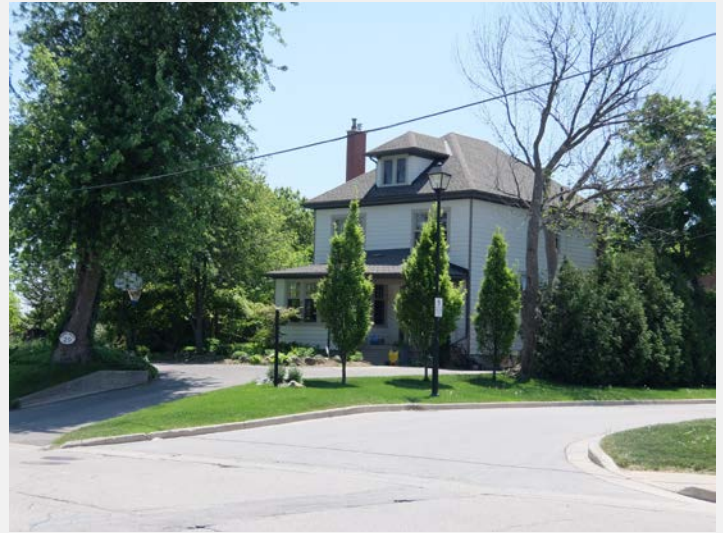
29 HAMILTON ST S

The property is representative of a vernacular building influenced by the Edwardian Classicism architectural style, including its two-and-one-half storey massing, hip roof with projecting eaves and dormers and covered front porch.

The property is important in supporting the historic character of the area. The early-20th century single-detached building contributes to the early residential character west of the historic boundary of the Village of Waterdown. The property is physically and historically linked to its surroundings, located on a raised topography that lowers as you travel south along Hamilton Street.

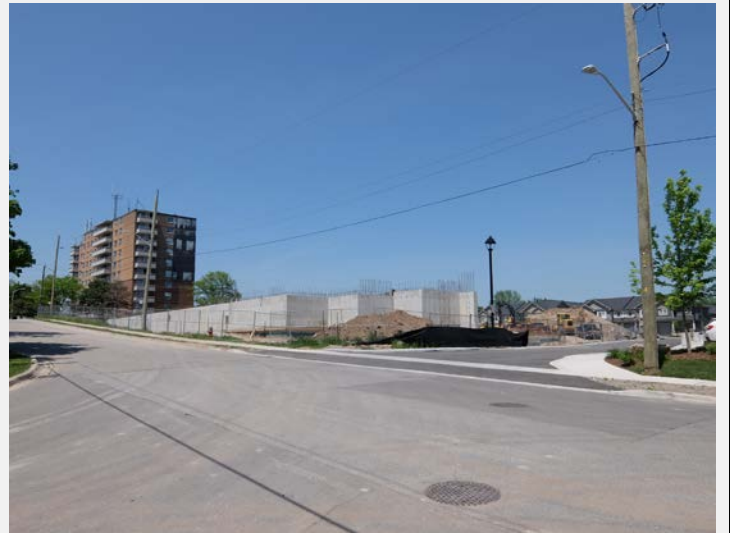
30 HAMILTON ST S

Classification: Inventory Property (IP)

New construction on the site of the former St. Thomas Catholic School

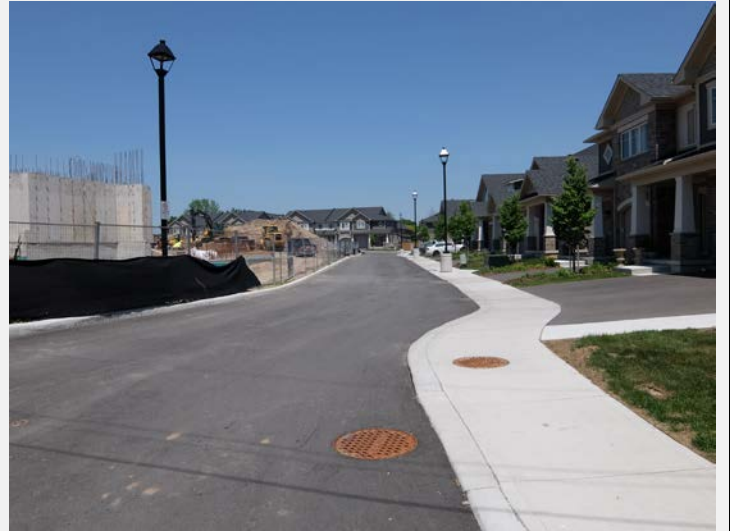
40 HAMILTON ST S

Architectural Style / Influence: Vernacular

Number of Storeys: 2

Classification: Inventory Property (IP)

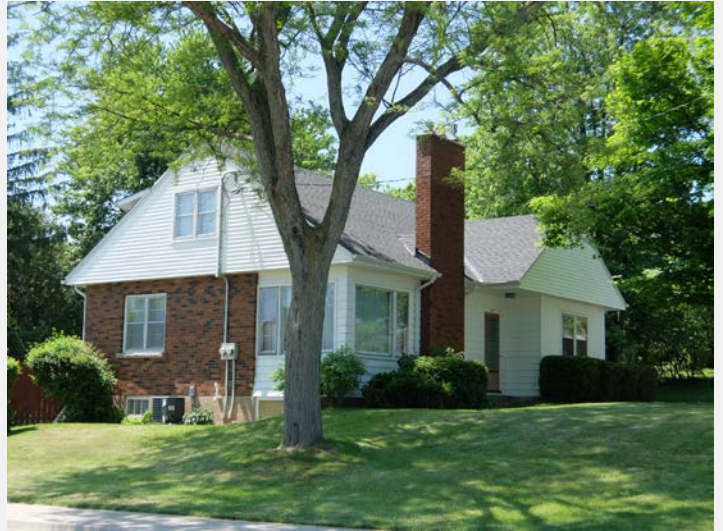
41 HAMILTON ST S

The property is an early representative example of Ranch style vernacular architecture from the 1950s, including the scenic window, hung wood windows with horizontal muntins, attached side garage and wide brick chimney projecting from the long, low profile of the house.

The property is visually and historically linked to its surroundings and is important in supporting the character of the area. Though not part of the adjacent Hawksview Gardens Subdivision and built a year before it was registered in 1954, the residence supports its character.

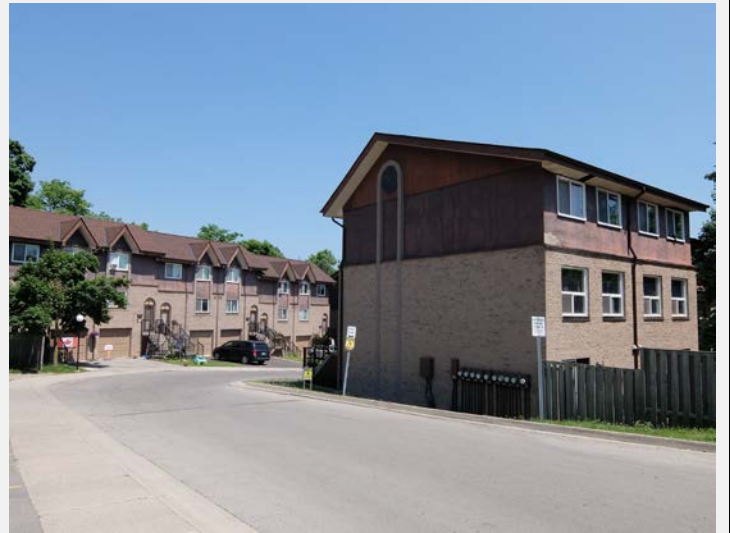
50 HAMILTON ST S

The property is physically, visually and historically linked to its surroundings. The residential complex of buildings are tucked in between the fork of the Grierson Creek (part of the Grindstone Creek) and the naturalized area that surrounds it.
